# Rail Accident Report

**Fatal accident involving a track worker near  
Newark North Gate station  
22 January 2014**

Report 01/2015  
February 2015

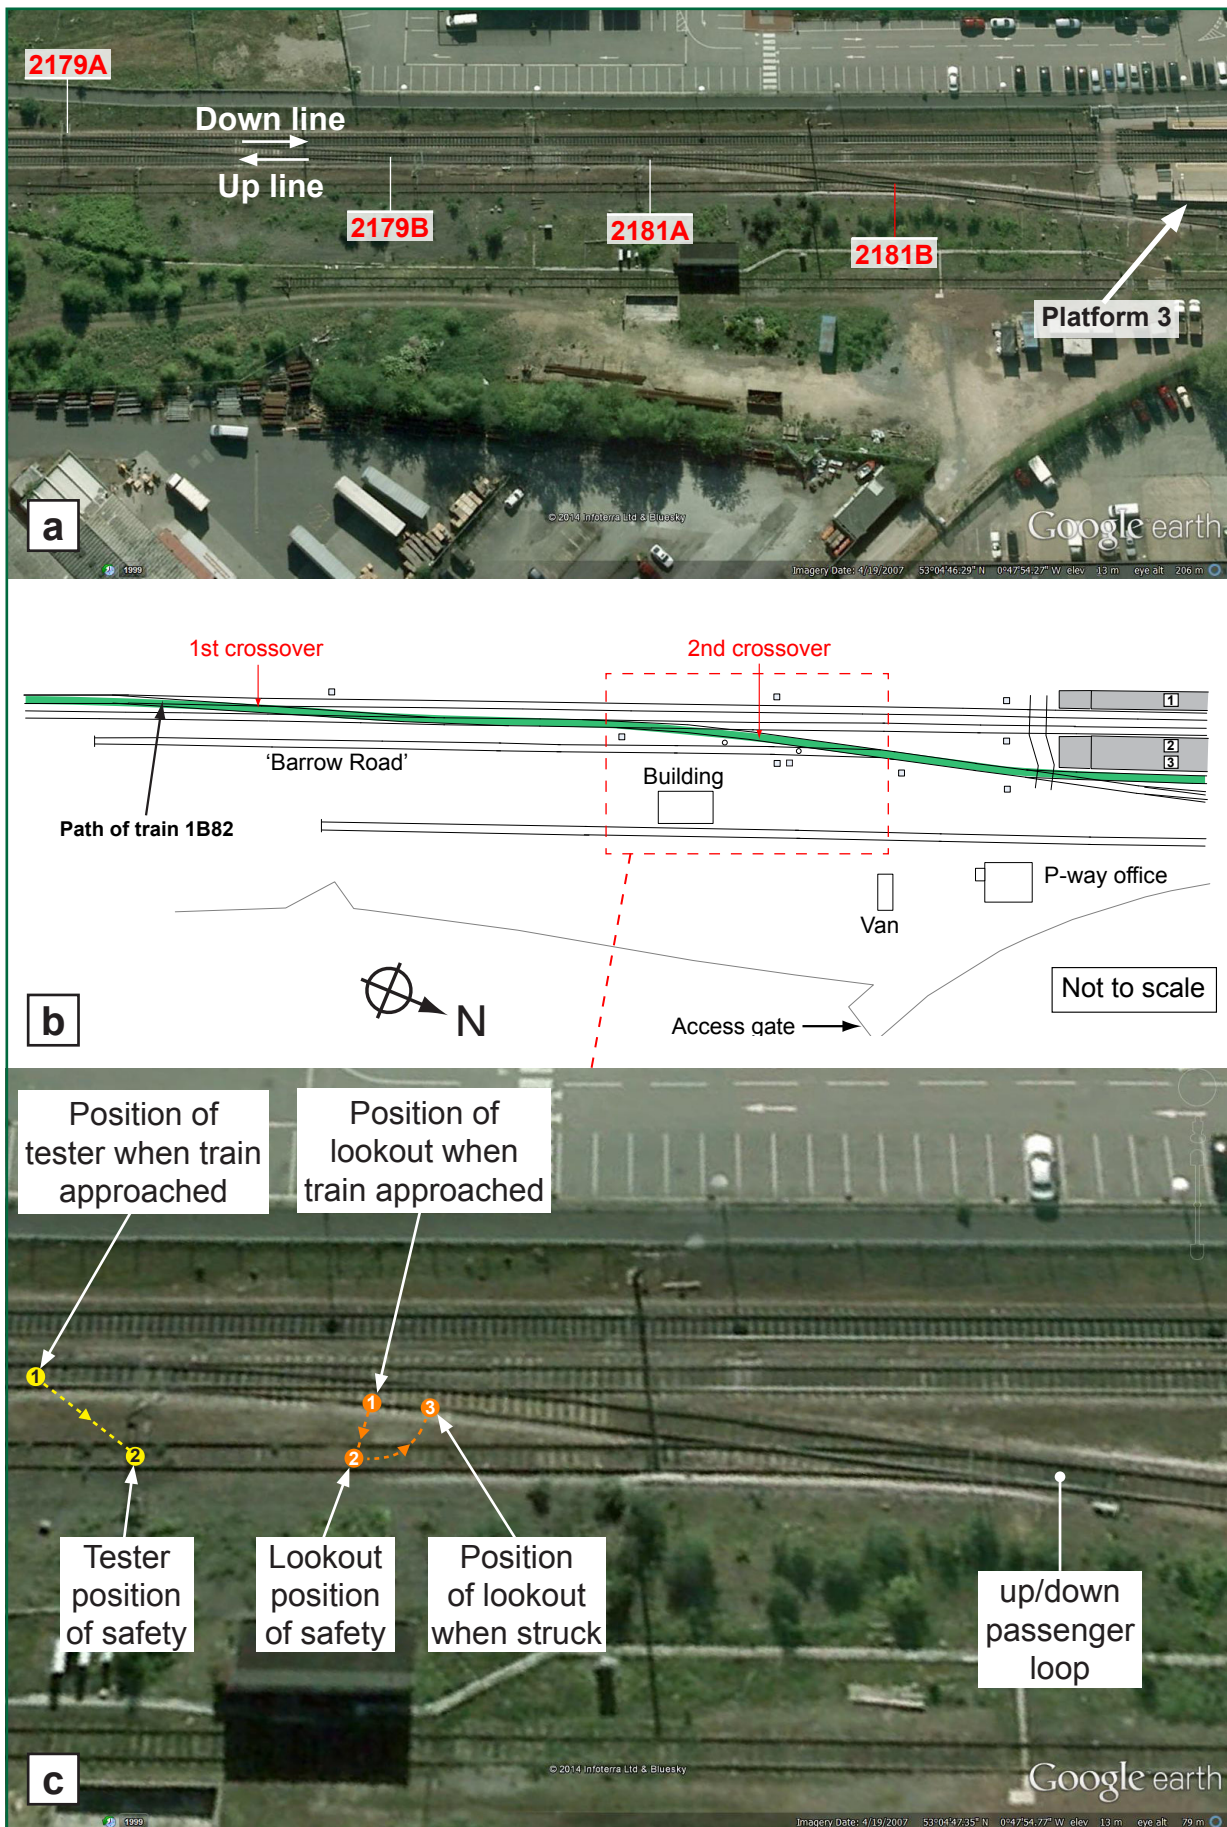
Figure 3: Layout of the tracks at Newark South Junction (located at 119 miles 73 chains)

- 12 The train involved in this accident had been routed over two crossovers. The first is between 2179A points and 2179B points (figure 3a) and takes northbound trains (approaching from the left in figure 3) from the down main line onto the up main line. The second crossover is between 2181A points and 2181B points and takes northbound trains from the up main line onto the up/down Passenger Loop. The maximum permitted speeds through both crossovers is 30 mph (48 km/h). The lookout was standing on the right hand rail of the second crossover (viewed in the direction of travel of the train) at the position shown in figure 3c when he was struck by train 1B82.

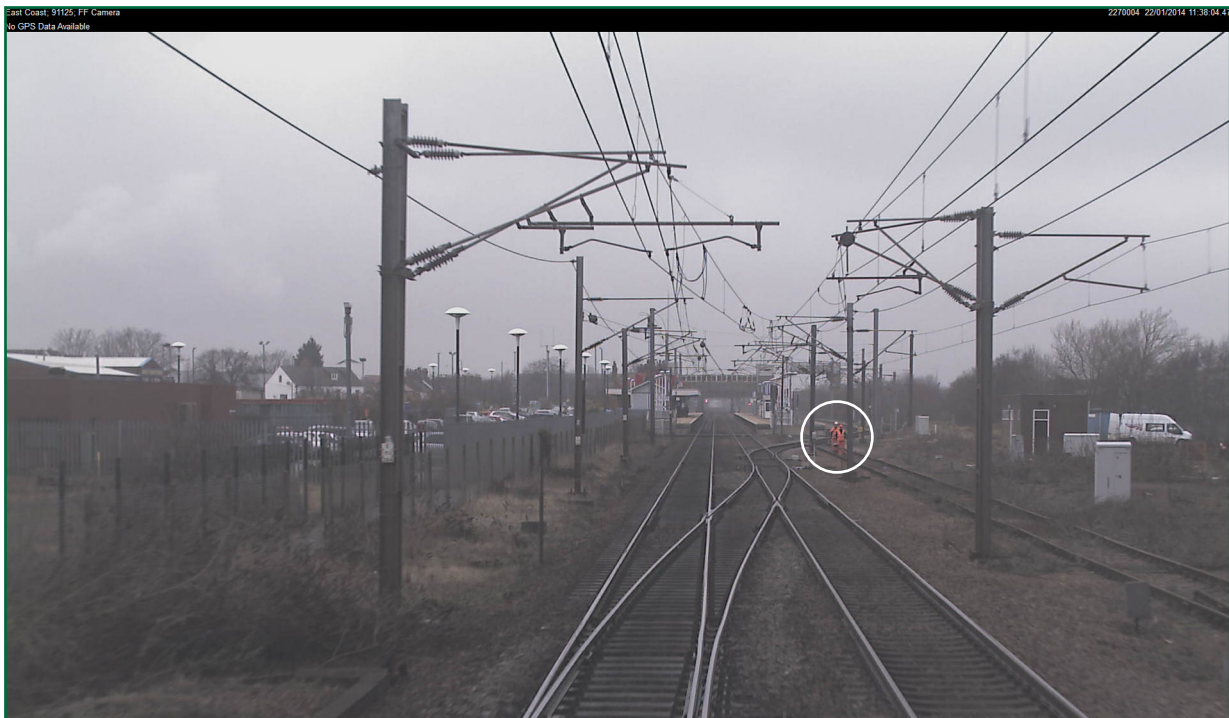
Figure 5: The lookout and tester in the position of safety (image courtesy of East Coast Railways Mainline Company Ltd)

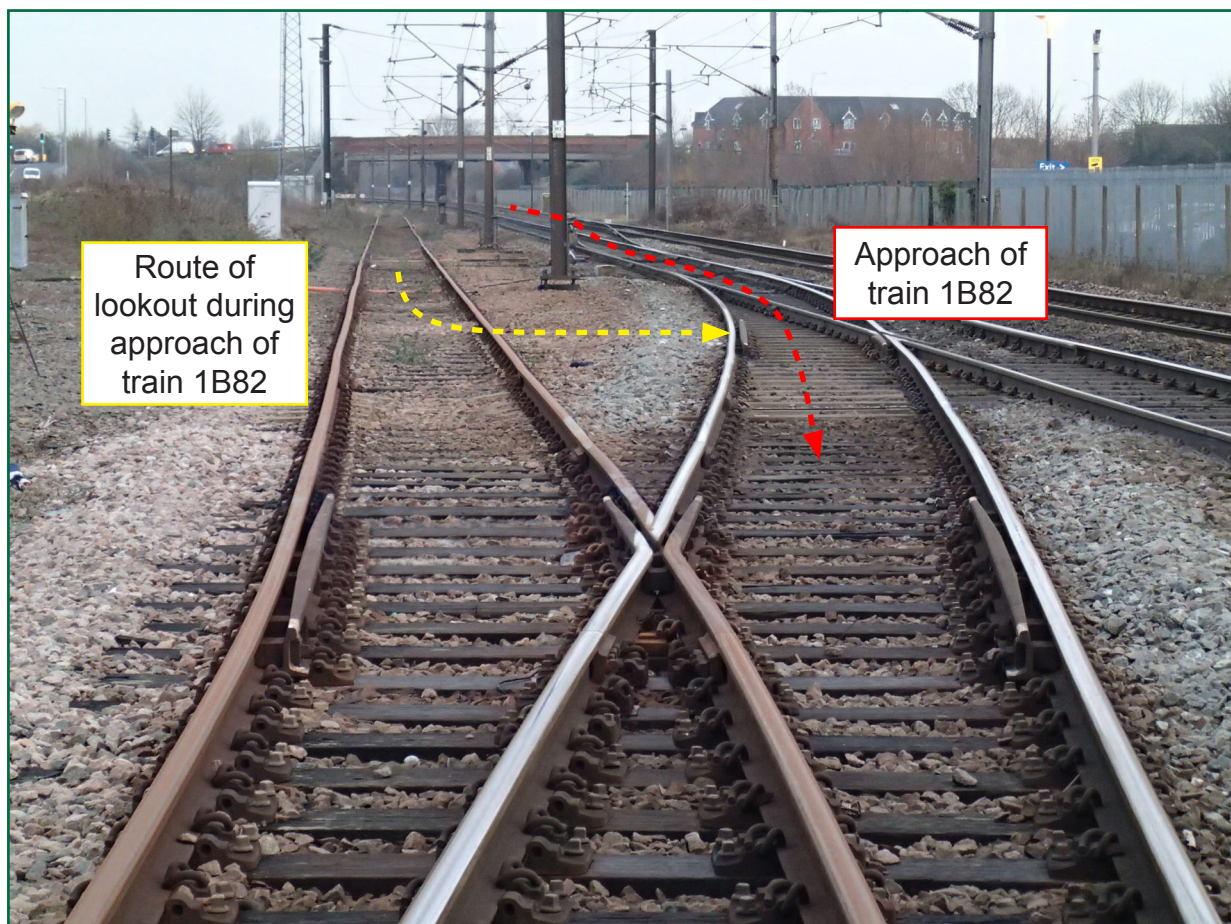
- 35 The lookout reached the right hand rail of the second crossover (position shown in figure 3c) at 11:34:10 hrs (around 3 seconds before being struck). The proximity of the train to the lookout as he approached the crossover is shown in figure 7. The lookout stood on the right hand rail while continuing to look in the direction of the station. Data from the train's OTDR shows that at this time the train driver simultaneously blew the train's warning horn and applied the emergency brake. The speed of the train at that time, recorded by the OTDR, was 26 mph (42 km/h) and its distance from the lookout was around 35 metres. The tester has stated that when he heard the blast from the train horn as the train was passing him, he first wondered why the driver had used the horn a second time because he believed both he and the lookout were in the position of safety, and he had already acknowledged the first train horn a second time from the position of safety.

Figure 6: The path taken by the lookout toward the up/down Passenger Loop and the position he was struck.

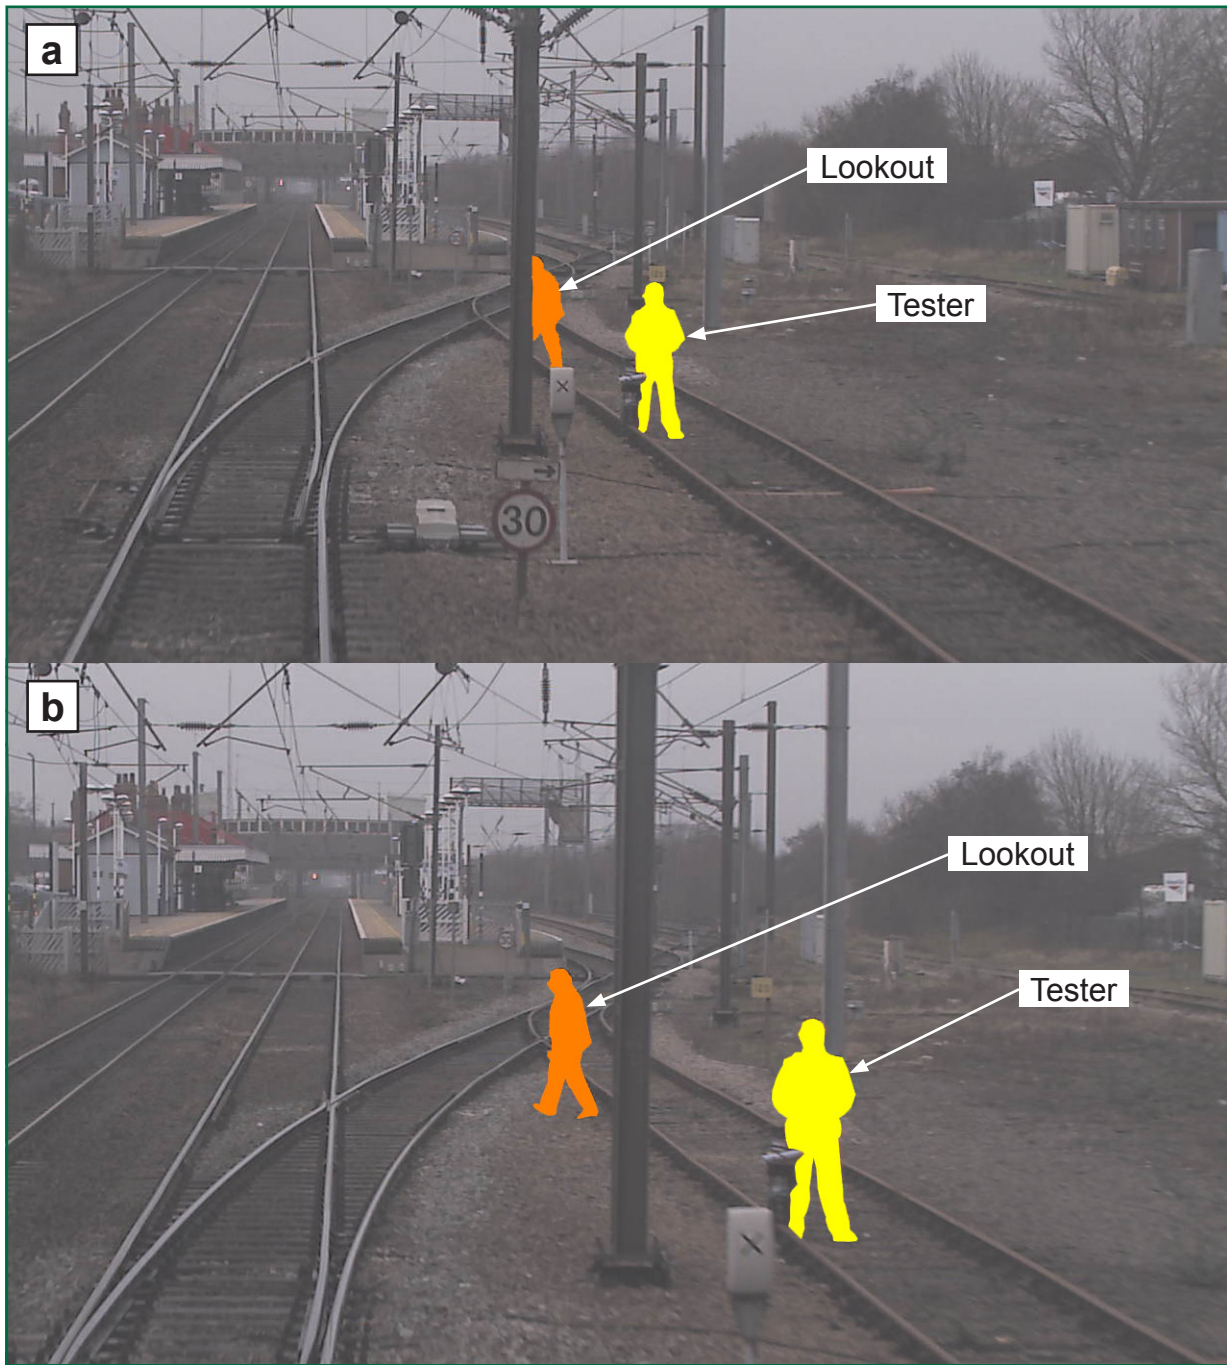
*Figure 7: Forward facing CCTV images showing position of lookout approximately 2 seconds (a) and 1 second (b) before the train's second horn and emergency brake (images courtesy of East Coast Railways Mainline Company Ltd)*

- 63 The expected reaction time for a driver responding to a familiar but unexpected hazard is likely to be around 1.5 seconds<sup>3</sup>. The positions of the lookout at one and two seconds before the emergency brake and horn were applied (based on CCTV images), are shown in figures 7a and 7b respectively. These indicate that the driver reacted as soon as it was clear the lookout had left the position of safety and was moving towards the up/down Passenger Loop.

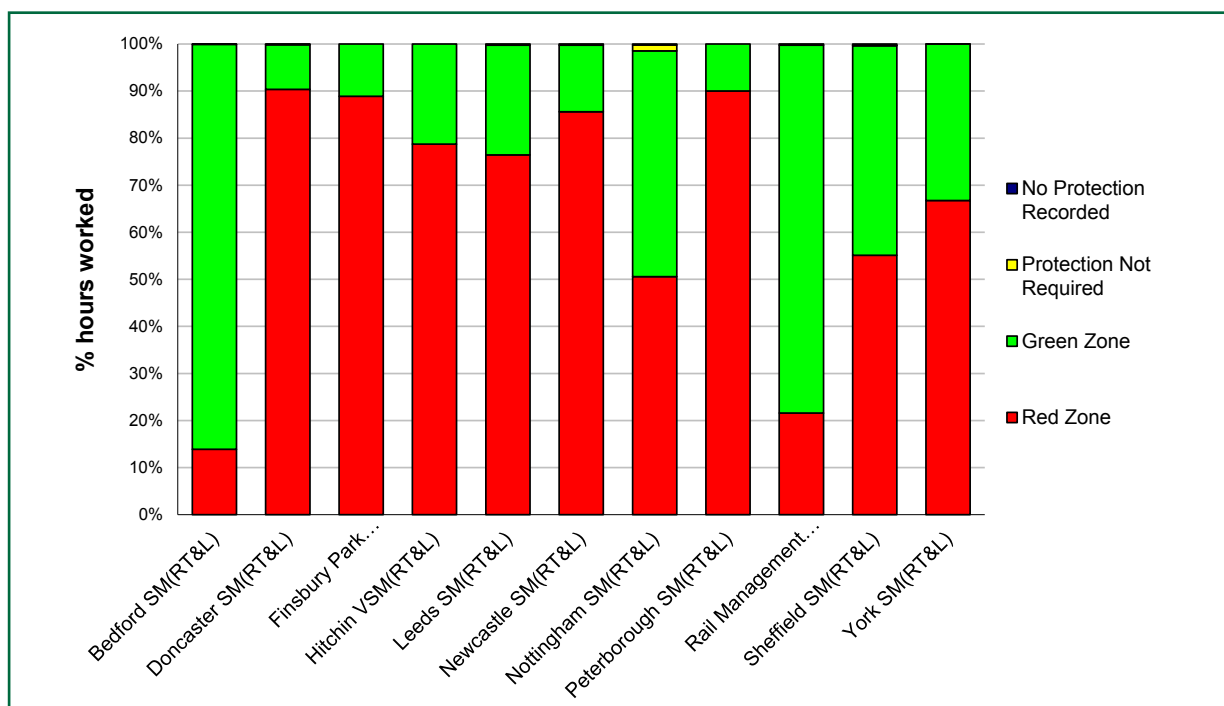
- 84 Figure 8 shows data provided by Network Rail on the proportion of red and green zone working for the rail testing and lubrication teams of each *delivery unit* of the LNE&EM route between August 2013 and January 2014. For some units, such as Doncaster, Finsbury Park and Peterborough, which mainly service the ECML, the proportion of red zone working was around 95%. For others such as Bedford, the proportion was much lower at around 15%. The overall target for the proportion of red zone working in the LNE&EM route was 30% at the time of the accident<sup>8</sup>. However, the overall average proportion of red zone working for the rail testing and lubrication team, across the route, was 61%.

Figure 8: Proportion of red zone to green zone working on the Network Rail's LNE&EM route for each delivery unit

- 89 Although not linked to the cause of this accident, the RAIB observes that the SSOW planning at Doncaster Marshgate Depot was not being implemented in accordance with the hierarchy of risk set out in Network Rail standard NR/L2/OHS/019. The intention of the standard is that the planner should choose the safest practicable system of work. However, in the case of the rail testing and lubrication teams, this was being disregarded in favour of the most flexible and convenient system of work for the availability of staff and equipment or one that fitted with custom and practice. The amount of red zone working undertaken by the rail testing and lubrication teams based in the Doncaster delivery unit was significantly higher than the target for the LNE&EM route (**paragraph 84, Recommendation 2**).

- 2 *The intent of this recommendation is to improve the implementation of Network Rail's procedures for planning safe systems of work, so that the hierarchy of risk is used in the intended way.*
