# Rail Accident Report

## **Child nearly falling through a missing toilet floor, South Devon Railway 22 June 2017**

Report 02/2018  
January 2018

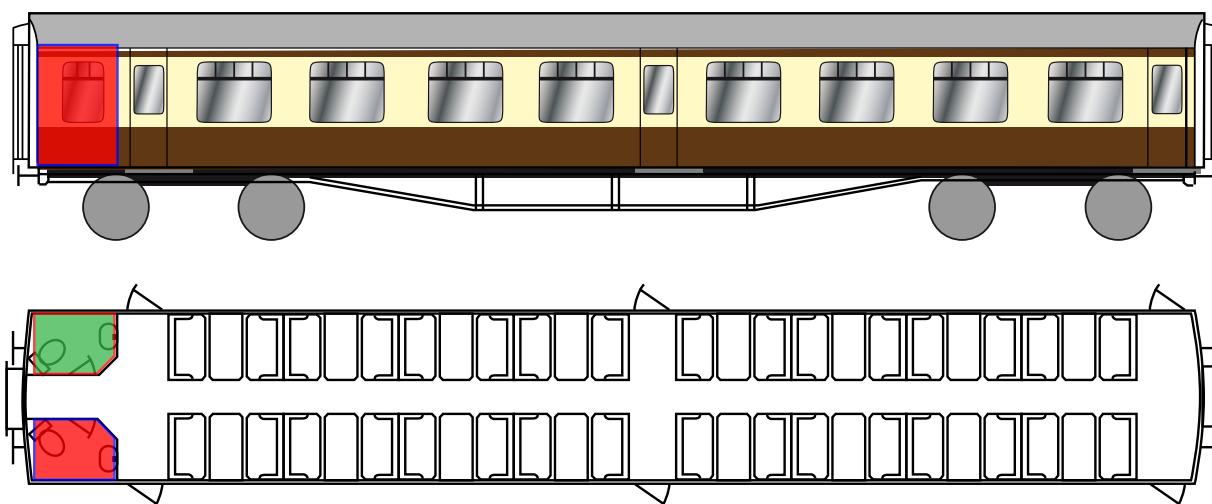
Figure 3: Side elevation and plan of the carriage showing the location of the toilet cubicle with the floor missing (green box). The toilet opposite (red box) was also out of use.

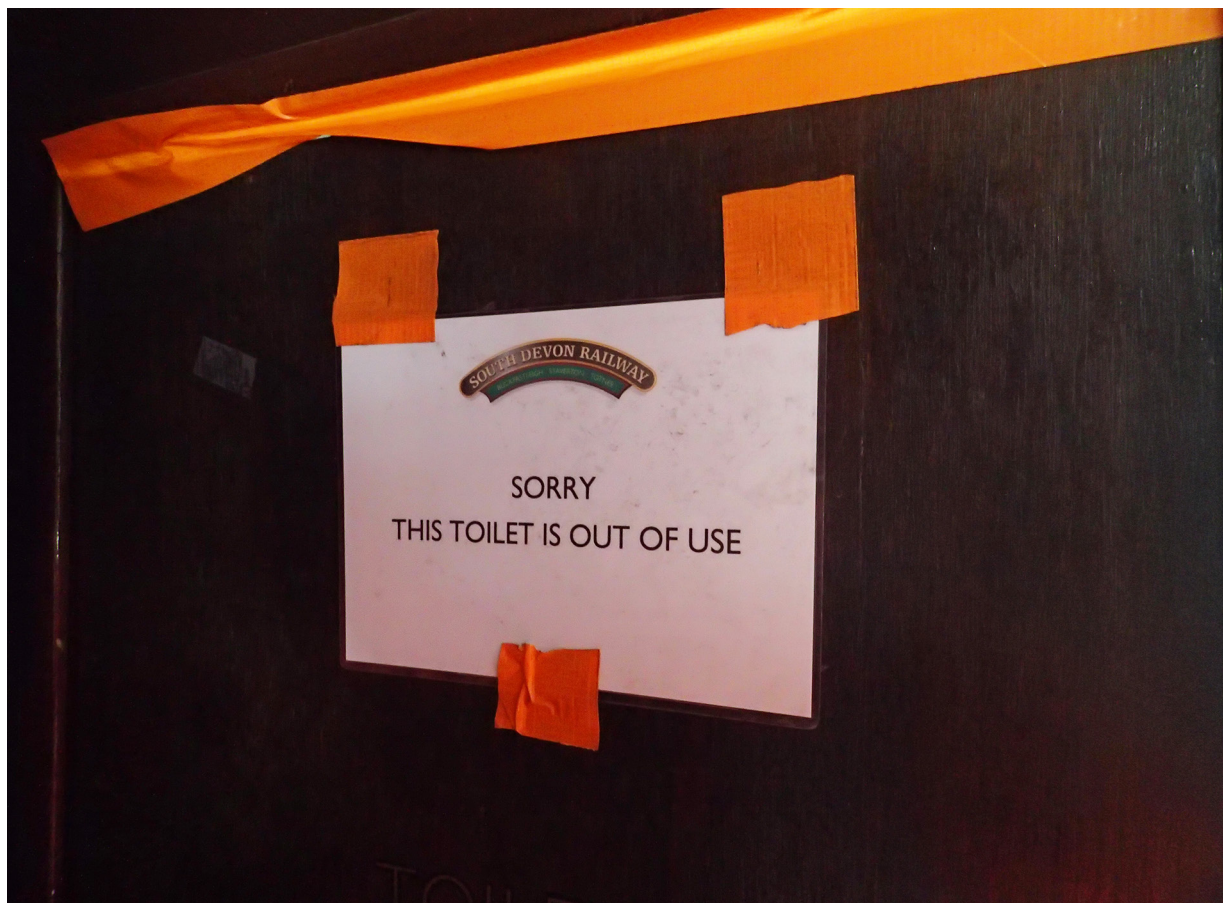
Figure 5: The 'out of use' sign and orange tape placed on the toilet cubicle door

- 21 One of the fitters stated that when he arrived at the carriage to carry out repairs, he found the toilet door was open, part of the wooden door frame had broken off and the screws that were supposed to be holding the door closed were missing. The screws holding the vacant / engaged sign to the door frame and door were also loose (figures 6 and 7). The 'out of use' sign on the door was still present, but the orange tape which was said to have been stuck all round the door frame was only present on the top part of the frame above the door (figure 5).

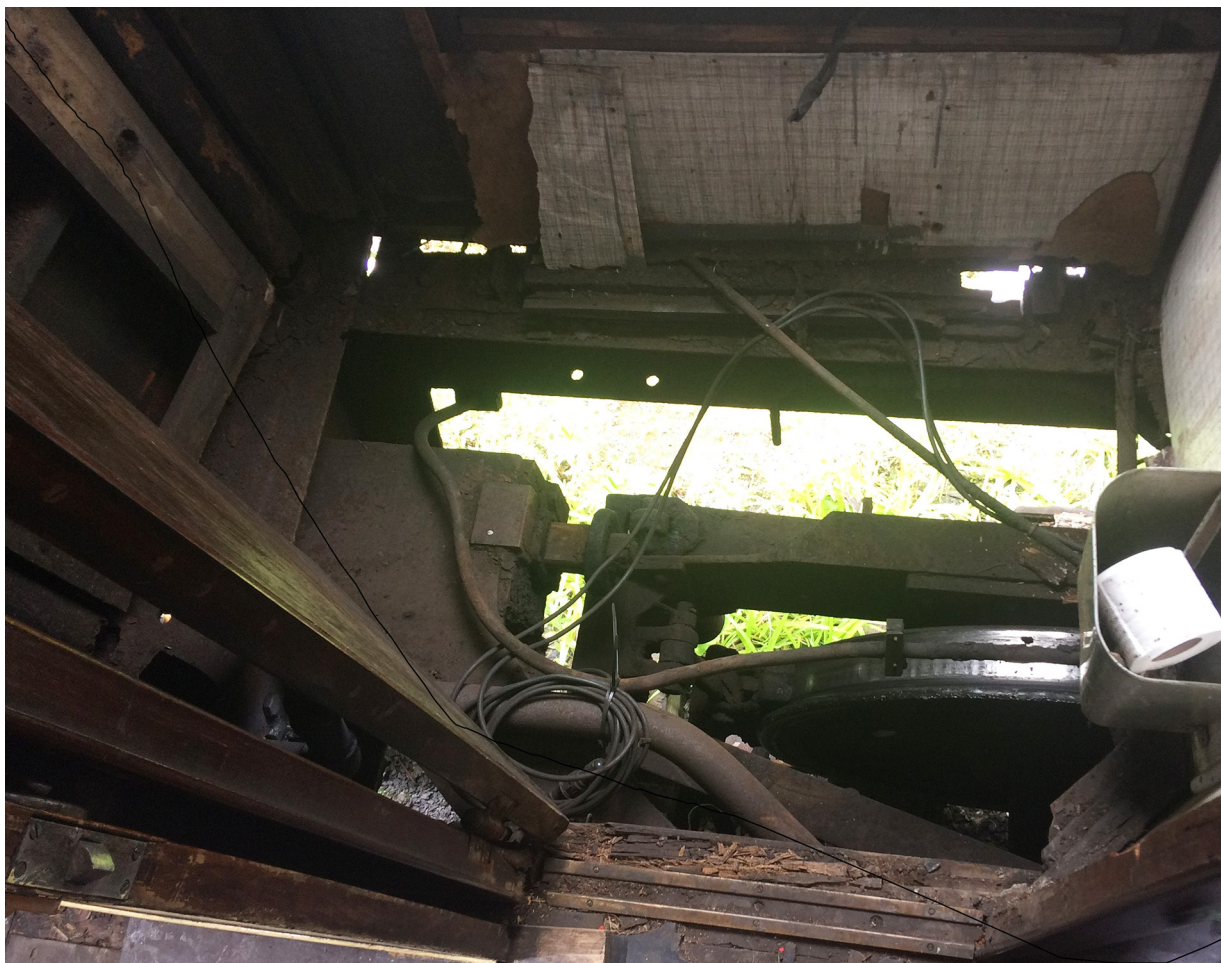
- 18 Although the toilet cubicle door was supposed to have been secured closed (see paragraphs 30 to 37), the child was able to enter the cubicle (it is not known whether he used the door knob or simply pushed the door). The door of the toilet cubicle opened inwards. The mother stated that the child fell forward towards the track, breaking his fall on the brake pipe. The mother reacted quickly and grabbed the child's arm, preventing him from falling onto the track (figure 8).

Figure 8: The interior of the toilet cubicle on carriage 4805

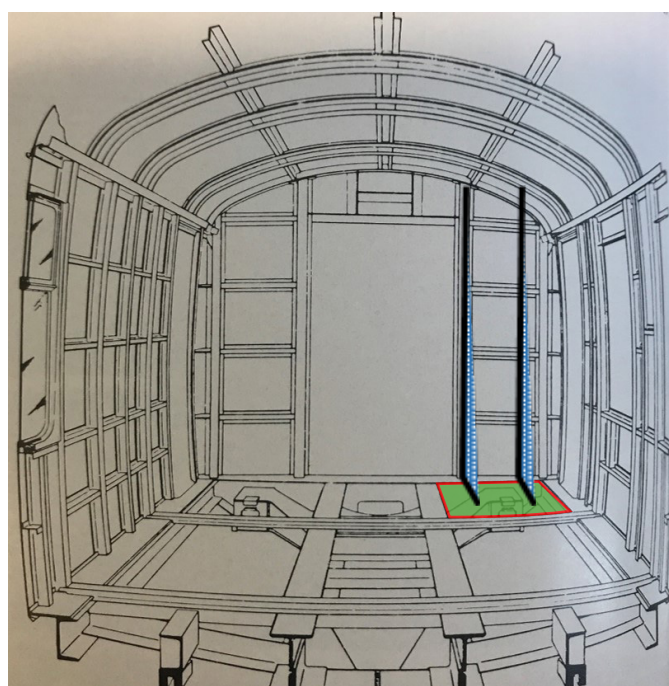
- 27 The area of the vehicle around the ends and the toilet compartments is prone to damage and deterioration caused by ingress of water through joints in the roof, via door and window openings, and spillage from the lavatory equipment, and from substances used to clean the toilet areas. These penetrate the floor and, if not dealt with effectively, may result in wet rot affecting the toilet floor and the partition wall bases, and corrosion of the underframe cross-members and bracing (figure 14).

Figure 14: Diagram showing the structure of the Mark 1 carriage. Probable areas where water may enter the carriage panelling are shown in blue. The green shaded area shows the location of the toilet floor (see figure 7). (Image courtesy of the Institute of Locomotive Engineers).

- 67 The investigation identified that water from the exterior of the carriage is likely to have leaked into the body causing the corrosion to the cross members of the chassis, and that the normal usage and cleaning of the toilet facilities would have contributed to the wood rot within the timber floor and panelling on the carriage (paragraph 27). At the time of the accident the SDR was in the process of building undercover storage facilities (see paragraph 90 (vii)) for its carriages, which were still being kept outside. When stored outdoors, normal weather conditions would have exacerbated the decay of carriage 4805.

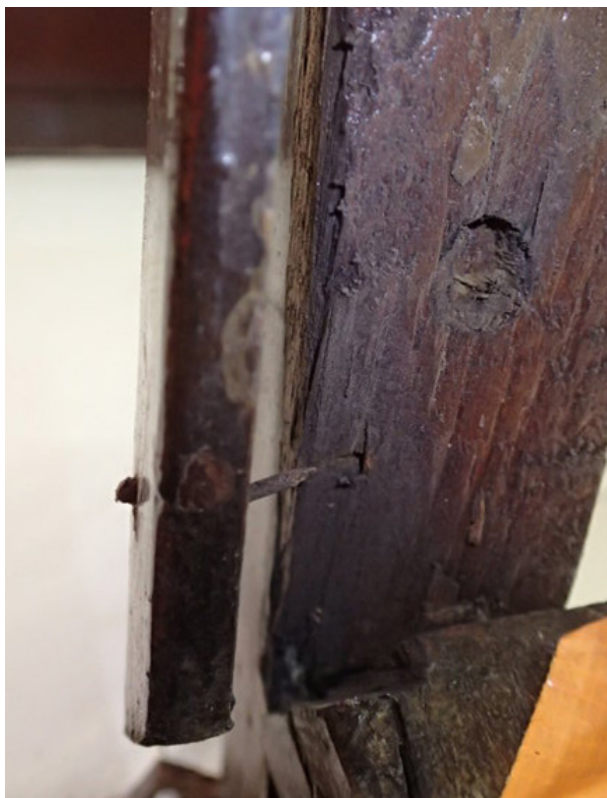
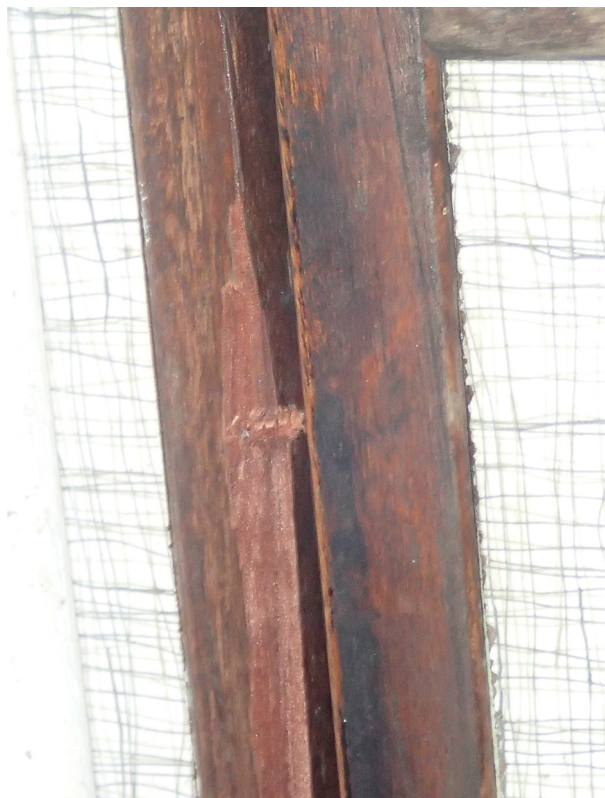
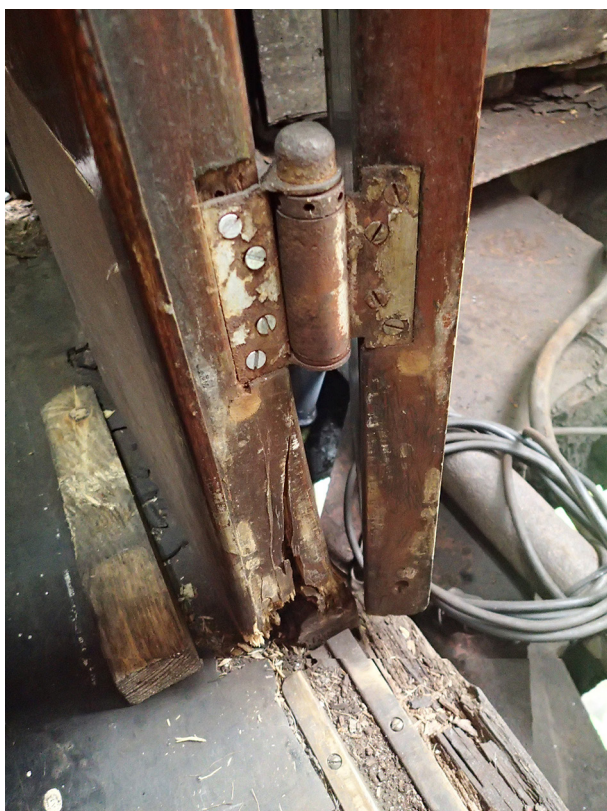
- 37 The RAIB's examination of the toilet cubicle and the damage to the door and the frame, after the accident and the subsequent repairs, found that the screws were inserted through the door frame and door at an angle (figures 16 to 19). Although the physical evidence is not conclusive, the RAIB considers that the screws could have become ineffective as a result of one or a combination of the following factors:

- a. The door was accidentally or intentionally forced open, resulting in damage to the door frame, allowing the screws to become loose or fall out.
  - b. The removal of the toilet floor and the decay at the base of the partitions resulted in a loss of integrity of the structure of the toilet cubicle, because the floor was no longer tying the partition walls together. This meant the structure was no longer rigid, and the movement of the train may have resulted in the door frame and the door moving relative to each other. This movement caused the screws securing the door to become loose, fracture or fall out.

Figures 16 to 19: The damage to the toilet cubicle frame and door of carriage 4805
