Rail Accident Report

Fatal collision between a tram and pedestrian at Woodbourn Road, Sheffield 22 December 2016

Report 13/2017
September 2017

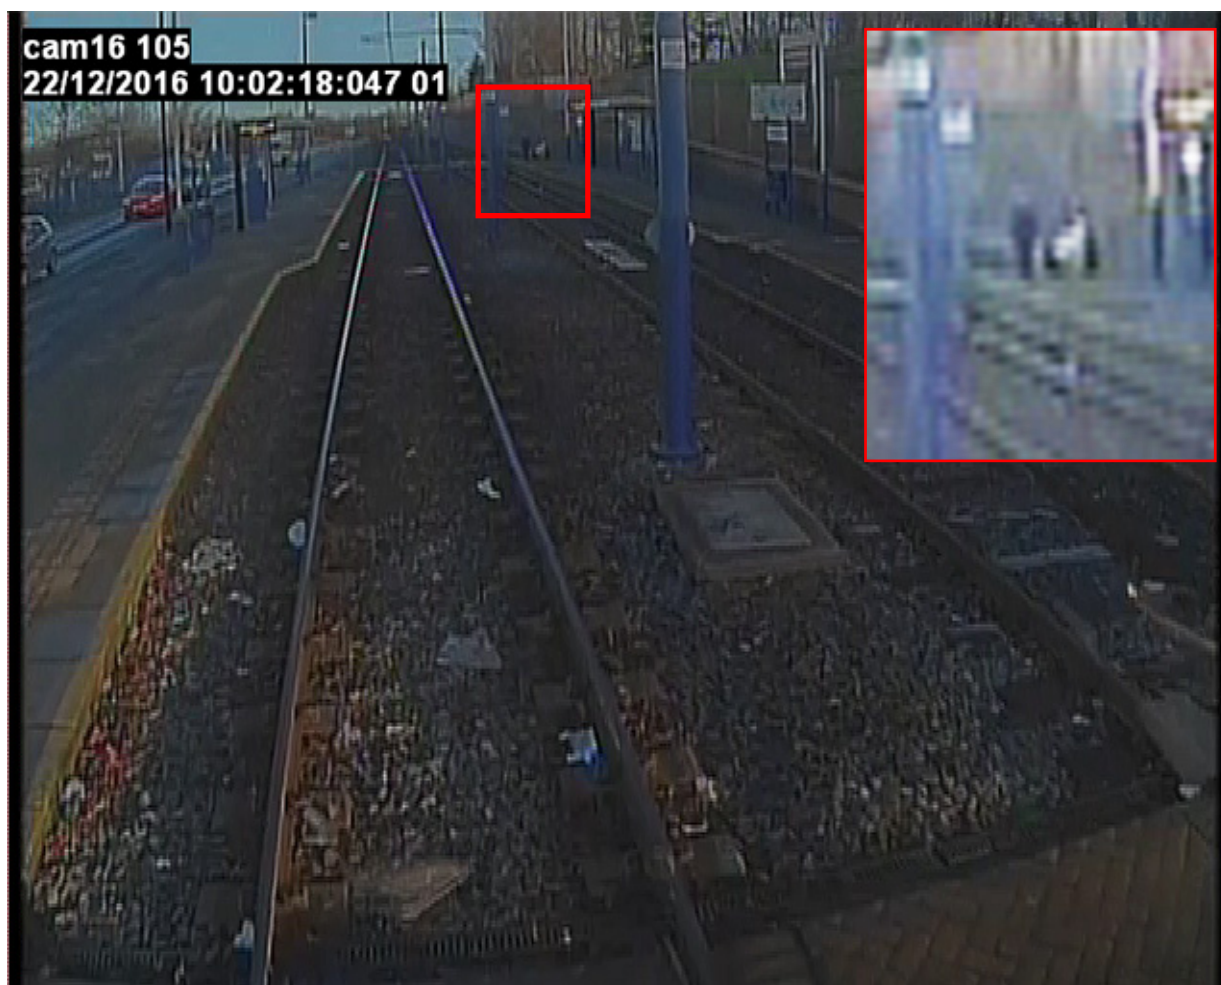
Figure 6: Forward facing CCTV footage from tram 105 as it was entering the tram stop (courtesy of Stagecoach Supertram)

- 21 At 10:02:23 hrs, the front of tram 105 was at about the middle of the outbound platform and 24 metres from the point of collision. By now, the pedestrian had begun to cross the tramway and was walking over the inbound track. Figure 7 shows the sequence of events from 10:02:24.2 hrs, when the tram was about 17.5 metres from the point of collision, through to when the collision happened.

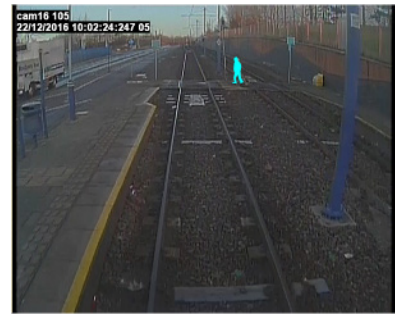
Time: 10:02:24.2 - Tram distance to collision: 17.5 metres

The tram is now straight in the tram stop and it is braking. Its speed is between 13 and 11 mph (21 and 18 km/h).

The pedestrian is nearing the halfway point of the crossing.

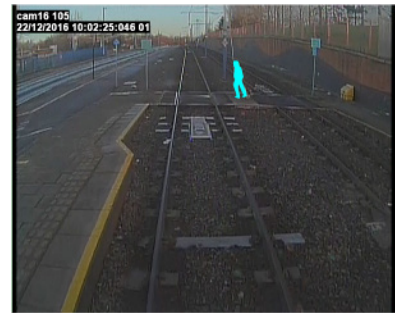
Time: 10:02:25.0 - Tram distance to collision: 13.5 metres

The tram stops braking and traction power is applied. Its speed is 11 mph (18 km/h).

The pedestrian is halfway across, in the centre of the crossing.

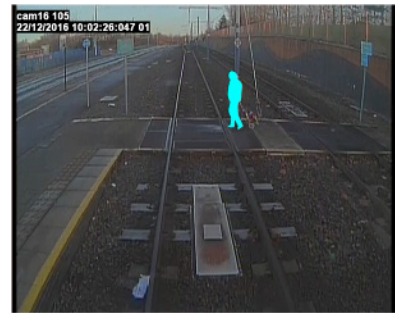
Time: 10:02:26.0 - Tram distance to collision: 9.0 metres

The tram is nearing the front edge of the crossing with traction power applied. Its speed is between 11 and 13 mph (18 and 21 km/h).

The pedestrian is moving onto the outbound track.

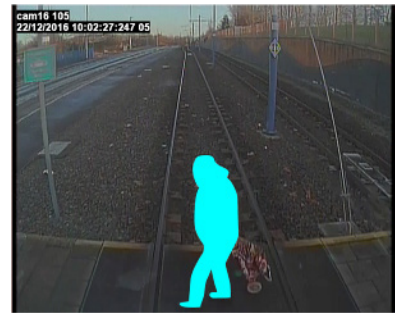
Time: 10:02:27.2 - Tram distance to collision: 2.0 metres

The tram reaches the front edge of the crossing with traction power applied. Its speed is between 11 and 13 mph (18 and 21 km/h).

The pedestrian is in the centre of the outbound track.

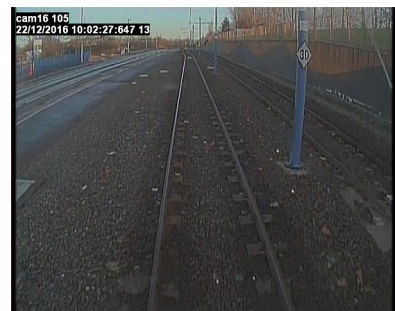
Time: 10:02:27.6 - Tram distance to collision: 0.0 metres

The tram collides with the pedestrian. Traction power is removed and braking is applied. Its speed is 13 mph (21 km/h).

The pedestrian is knocked to the ground in front of the tram.

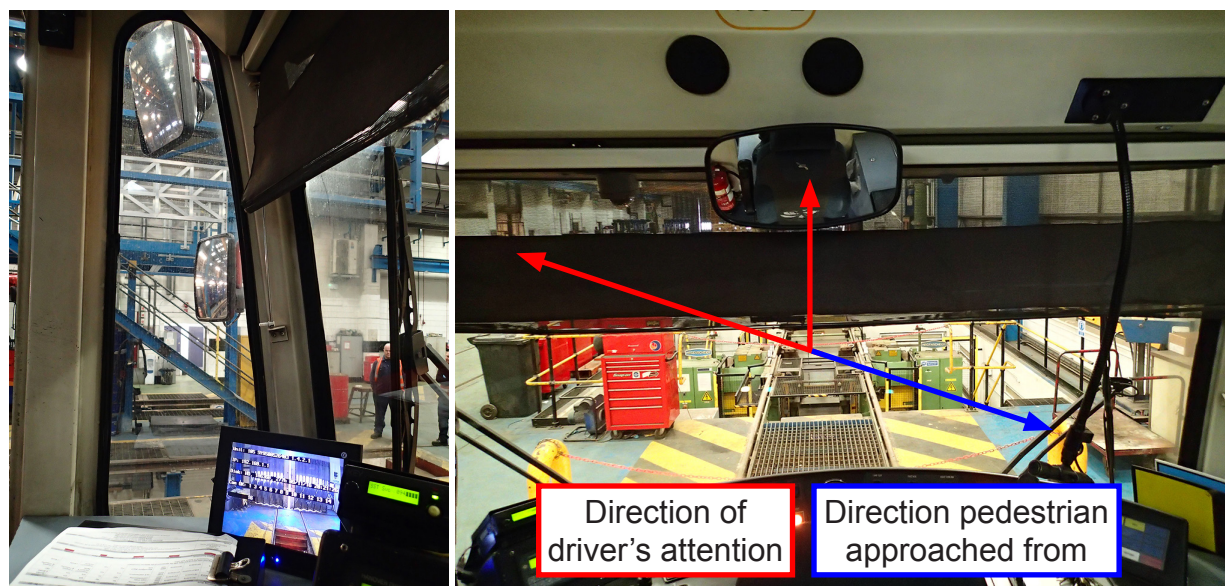
Figure 8: The location of the tram's mirrors

- 36 As the tram passed non-stop through the tram stop, and prior to seeing the pedestrian, the driver's attention was focused on the tram's mirrors. Stagecoach Supertram's *operational standards* define the rules that its tram drivers are required to follow and include a requirement for drivers to operate trams on line of sight. This means the 'driver must ensure that the tram can be stopped within the range of vision' and at all times drivers must 'control the tram so as to be able to stop short of any vehicle, pedestrian, or other potential hazard ahead'. However, instead of looking ahead, the driver reported that she was monitoring the external left-hand side mirror and the internal rear view mirror (figure 8).

- 37 The position of both these mirrors takes the driver's attention away from looking ahead, particularly the internal rear view mirror which is almost directly above the driver's head. Consequently, if using these mirrors the driver would not have seen the pedestrian in her peripheral vision as he crossed from the bottom right-hand corner of her view.

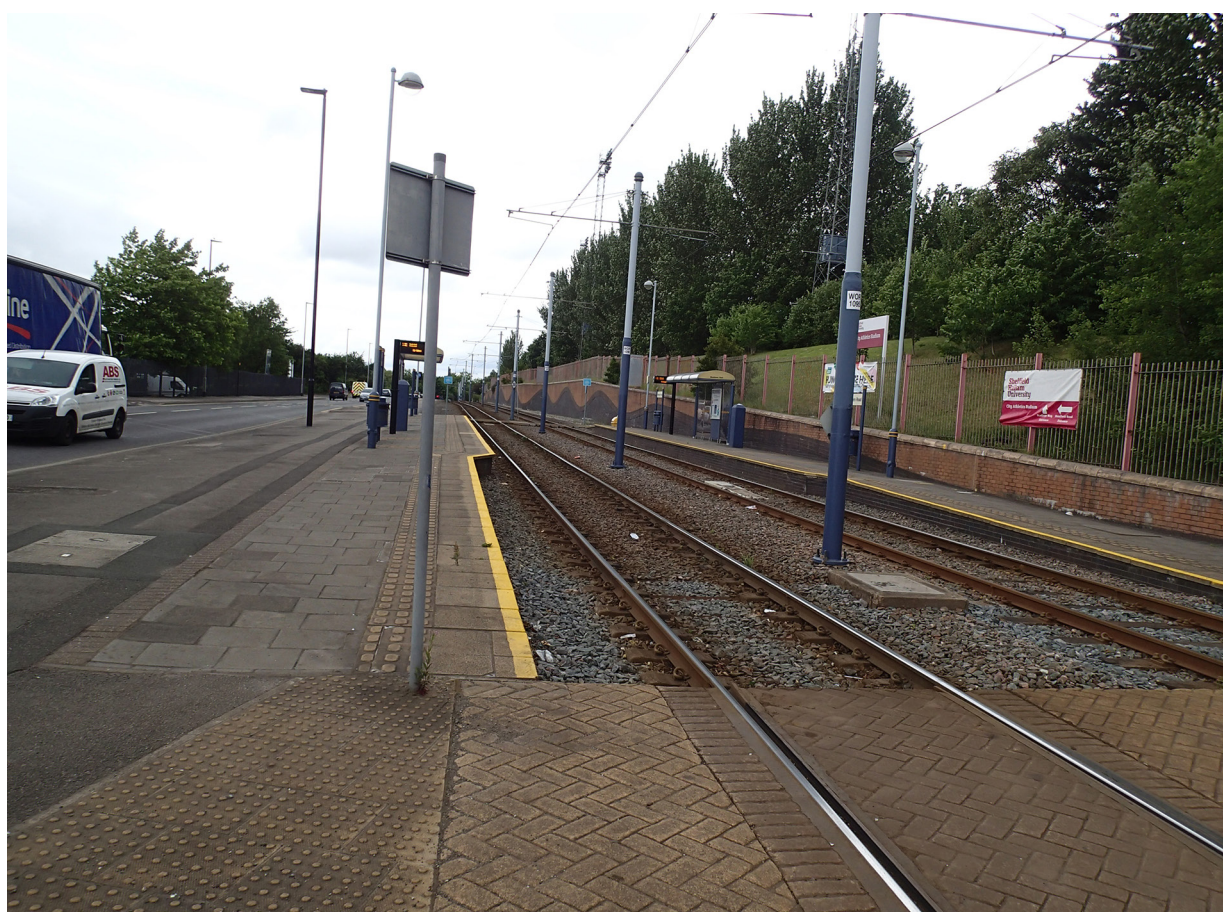
Figure 9: The position of the posts between the tracks through the tram stop

- 44 When the front of the tram entered the tram stop, the pedestrian was about 52 metres away and walking down the inbound platform ramp at the far end of the tram stop (figure 6). Posts that support the tramway's overhead electrification wiring are located between the tracks through the length of the tram stop and are likely to have interrupted the driver's view of the pedestrian (figure 9).

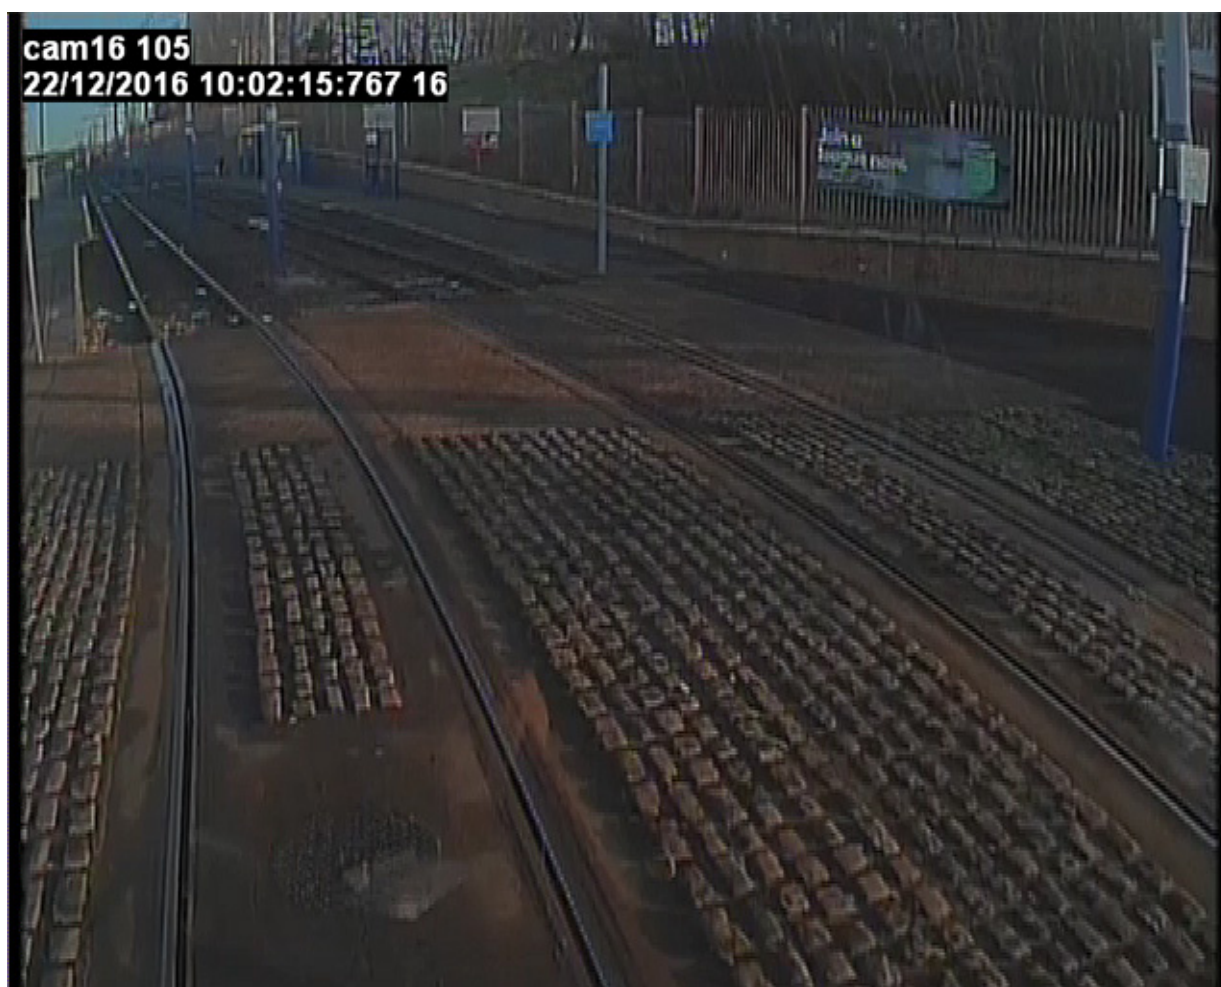
Figure 10: Forward facing CCTV images showing the approach to the tram stop in sunlight and parts of the tram stop in shade (courtesy of Stagecoach Supertram)

- 47 The low winter sun was casting long shadows that morning (paragraph 14). This meant the tram travelled through areas which were sunlit and others that were shaded and the driver's eyes would have needed time to adjust to the changes in light conditions. When the tram approached Woodbourn Road tram stop, the driver was in a sunlit area (figure 10). As she entered the tram stop, this changed to a shaded area which included the whole of the inbound platform, with the pedestrian at the far end of it (figure 6). The colour of the pedestrian's clothes did not stand out against the background of the tram stop and the wall behind it, which made him less easy to spot when in shade.

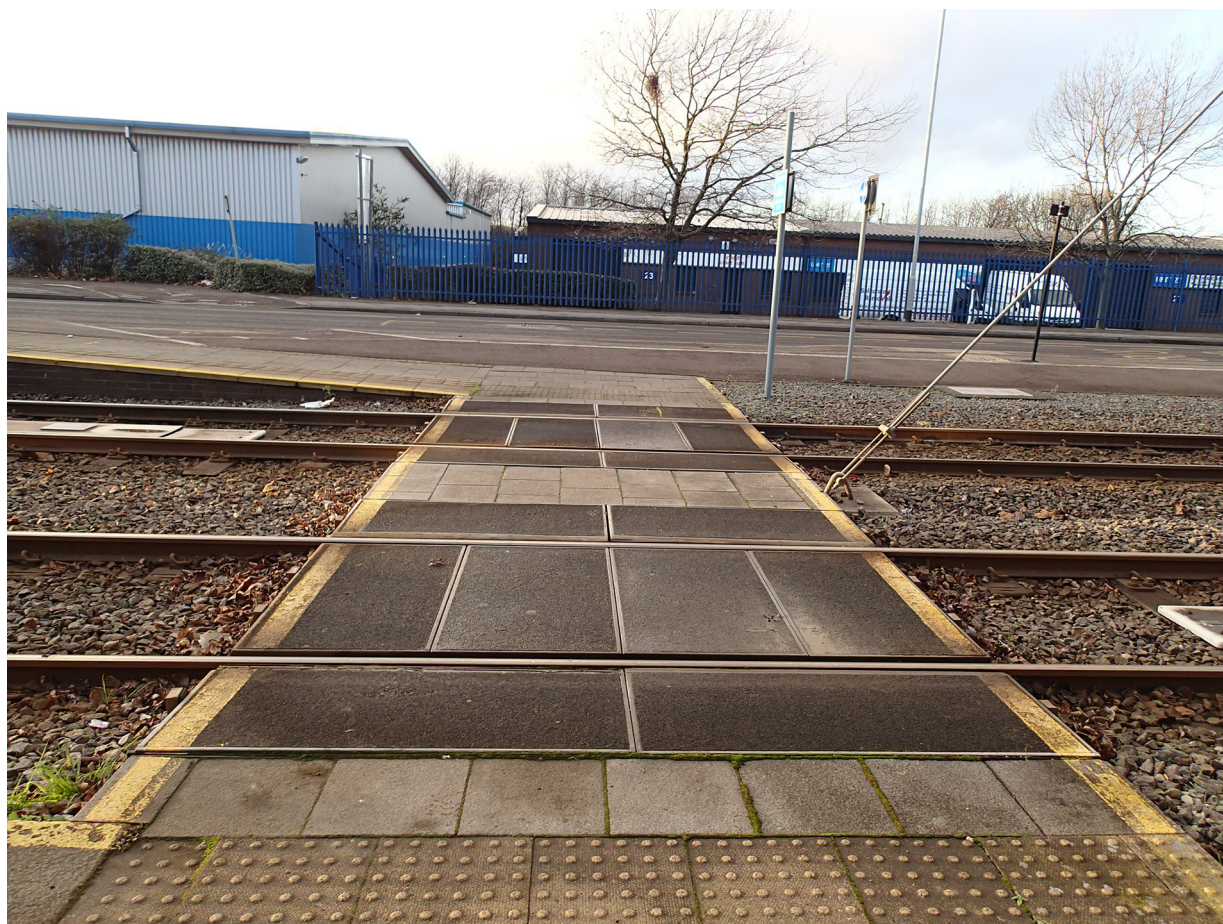
Figure 11: Photograph showing the surface over the crossing

- 85 The condition of the crossing, including its surface, was not a factor. Stagecoach Supertram's records show the tram stop was last inspected on 30 November 2016. The only defect noted during this inspection was graffiti on some of the signs which was removed that day. The crossing surface was reported in the inspection as 'ok' and no issues could be seen with it during a visual inspection after the accident. It was level throughout its length, at the same height as the head of the rail, and tactile paving strips were present at the outer edges, denoting the start and end of the crossing (figure 11).

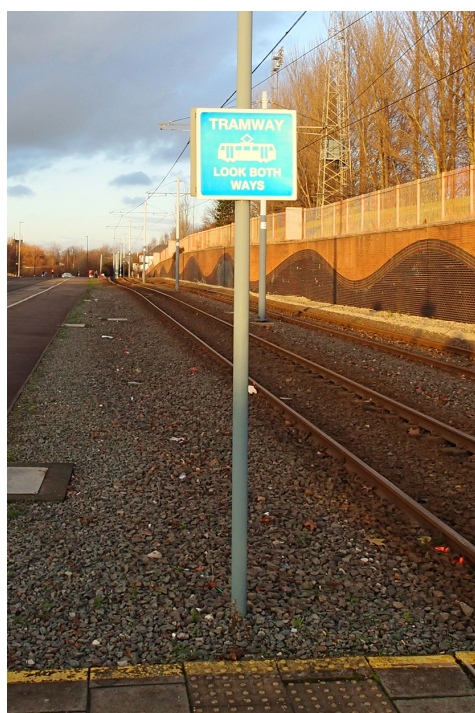
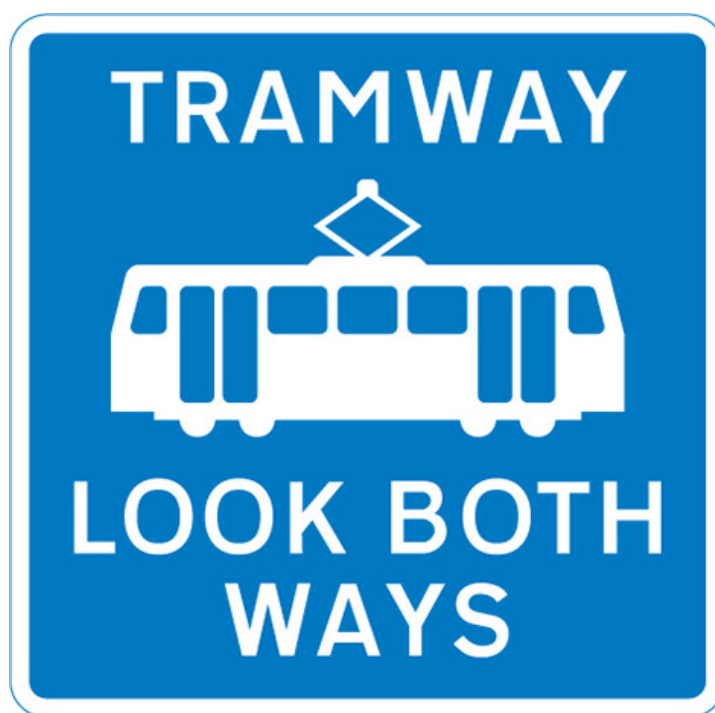
Figure 12: Example of the signage for crossing users

- 84 It is unlikely that the signage provided at the crossing was a factor. Four 'Tramway Look Both Ways' signs were in place on the northern crossing for its users (figure 12). These signs were the same as the 'Tramway Look Both Ways' sign shown in the Highway Code. When the pedestrian approached the crossing, one of these signs, located on the inbound side of the crossing, was in the pedestrian's line of sight. Stagecoach Supertram has since placed another of these signs on the outbound side of the crossing, which faces users crossing from the inbound side (paragraph 103 and figure 13). Guidance on tramways¹⁰ issued by the ORR mentions that these signs should be provided at pedestrian crossings but it does not state whereabouts on the crossing. It is unlikely that the presence of a second sign would have altered the way in which the pedestrian used the crossing because he had just got off a tram and had just walked past such a sign.
