Rail Accident Report

Derailment at Washwood Heath West Junction, Birmingham 23 March 2015

Report 01/2016
January 2016

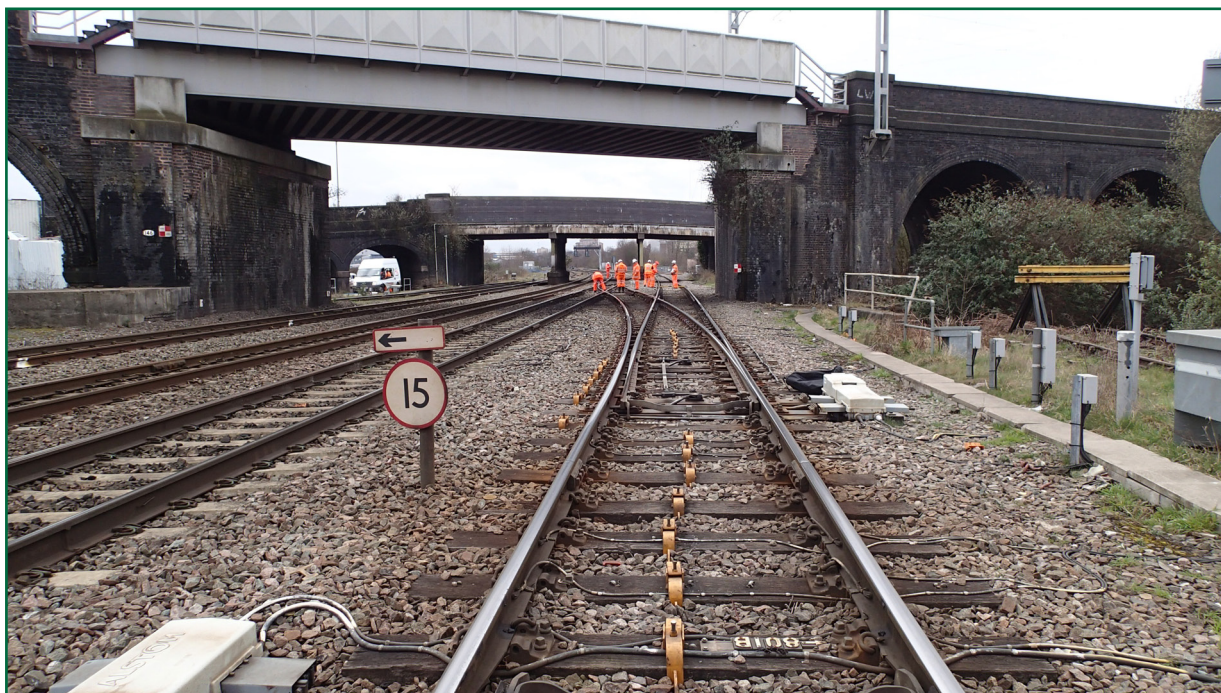
Figure 2: Site of the derailment, looking in the direction that the train was travelling

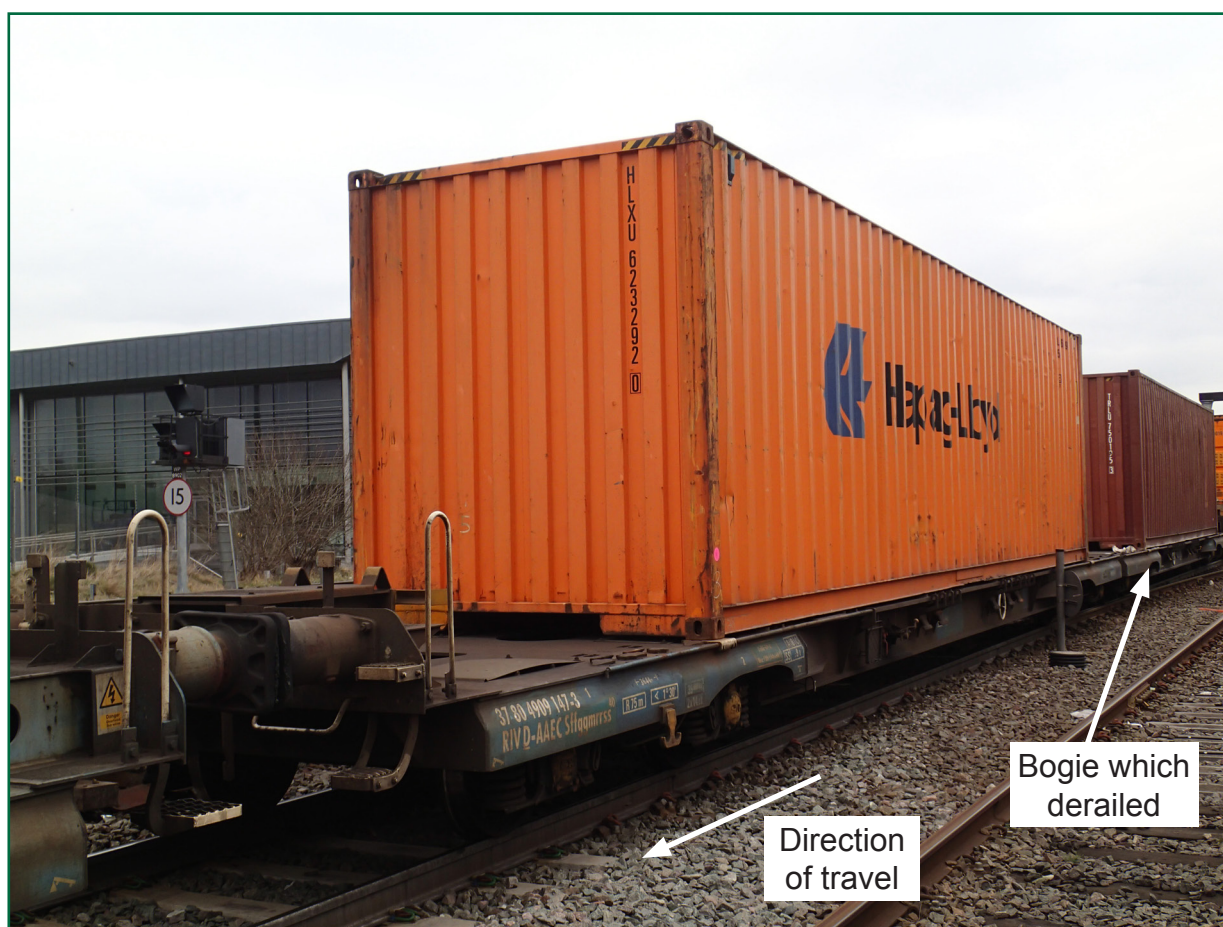
- 20 The wagon which derailed was number 37 80 4909 147-3, a 'Megafret' type (*TOPS* code IKA, UIC code Sffggmrrss). This was the tenth wagon in the train. The ninth wagon was also a Megafret, and these were the only Megafret wagons on the train.
- 21 A Megafret wagon consists of two semi-permanently coupled *platforms*, each of which has two bogies. The combination of the two platforms is regarded as a single wagon for operational purposes and is given one wagon number. Each platform of a Megafret can carry a container up to 45 ft¹ long. At the time of the derailment, wagon 37 80 4909 147-3 conveyed an empty 40 ft container on the leading platform and a 40 ft container loaded with scrap plastic chips on the trailing platform. The bogie which derailed was the leading bogie of the trailing platform (figure 4).

Figure 4: Wagon 37 80 4909 147-3 after the incident

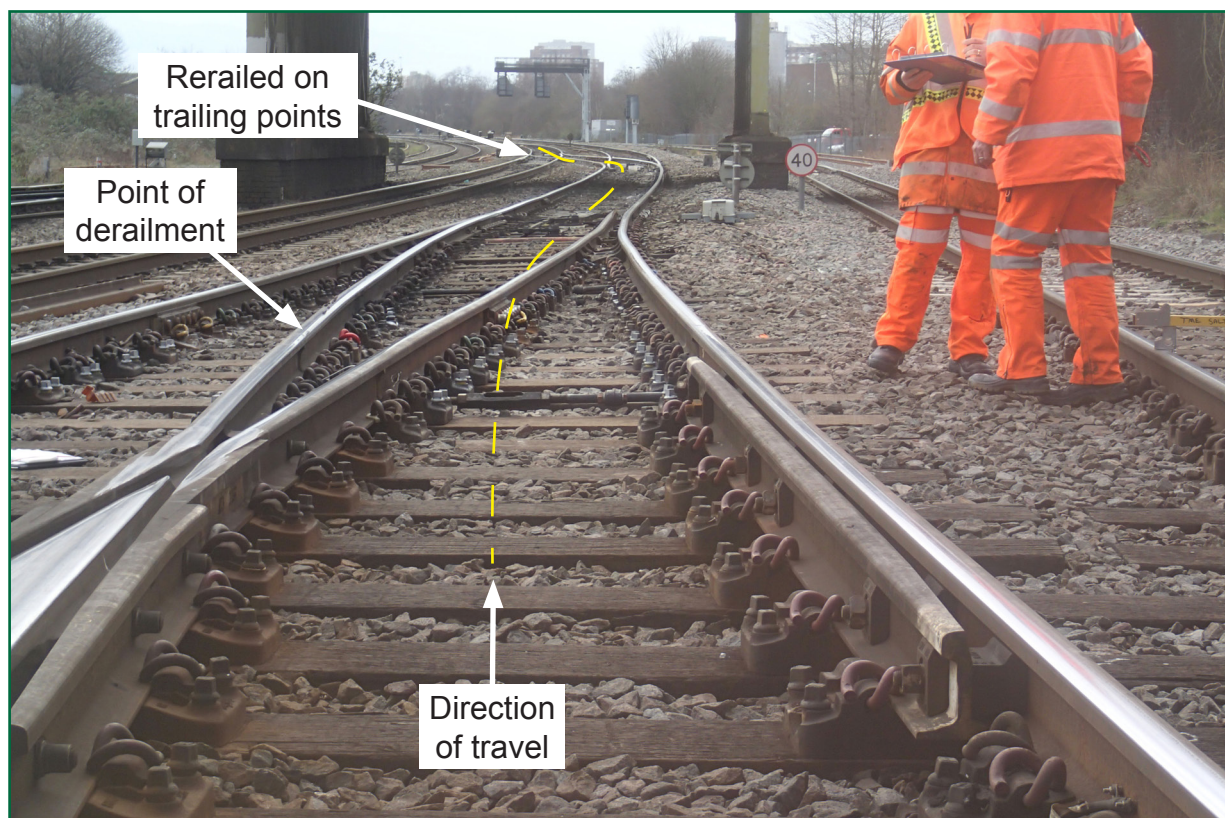
- 27 The bogie ran derailed through the *switches* of 802B points, the plain line between them and 805A points and through those points (figure 5). Significant damage was caused to 802B and 805A points and the track between them (figure 6).

Figure 5: Path of the derailed bogie

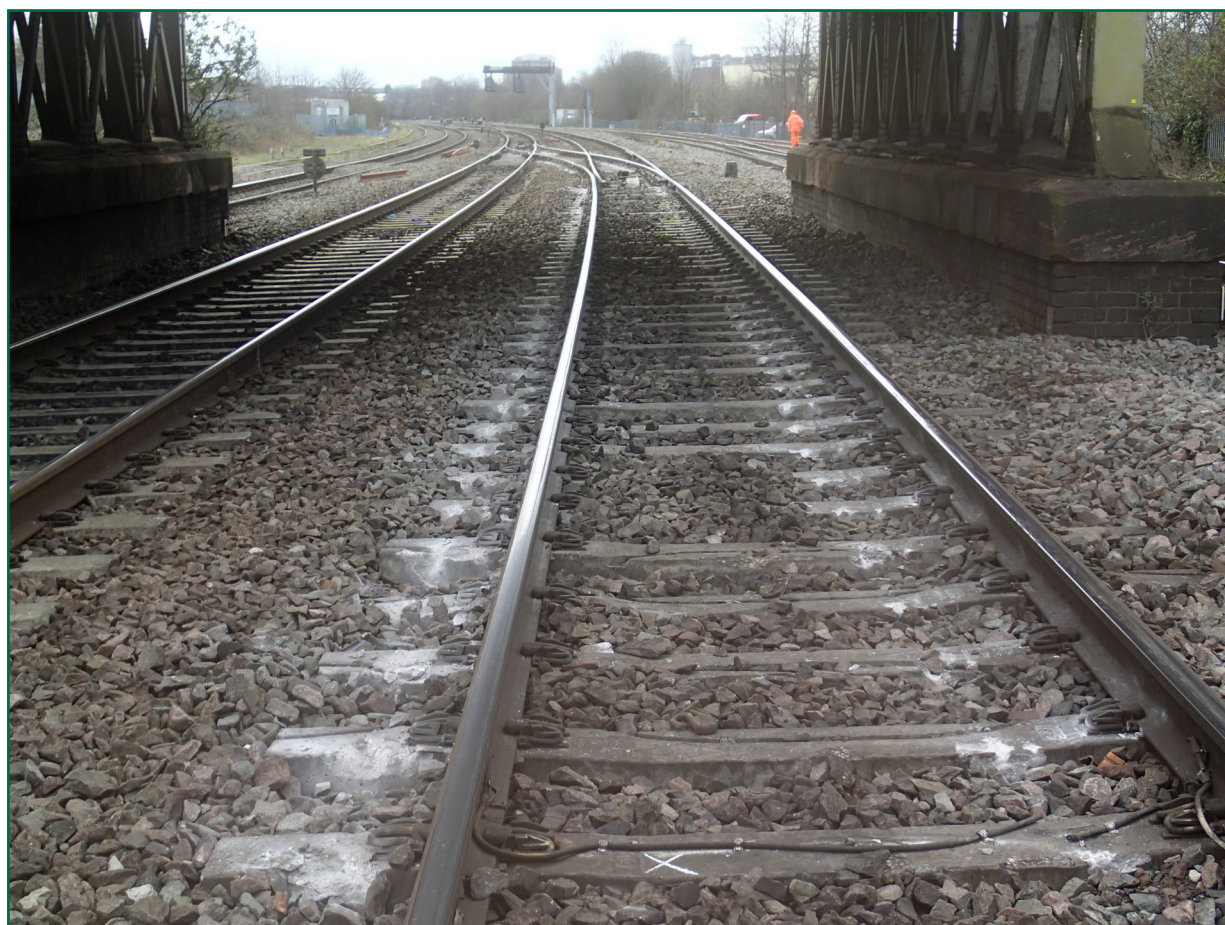
Figure 6: Damage caused to track by the derailed bogie

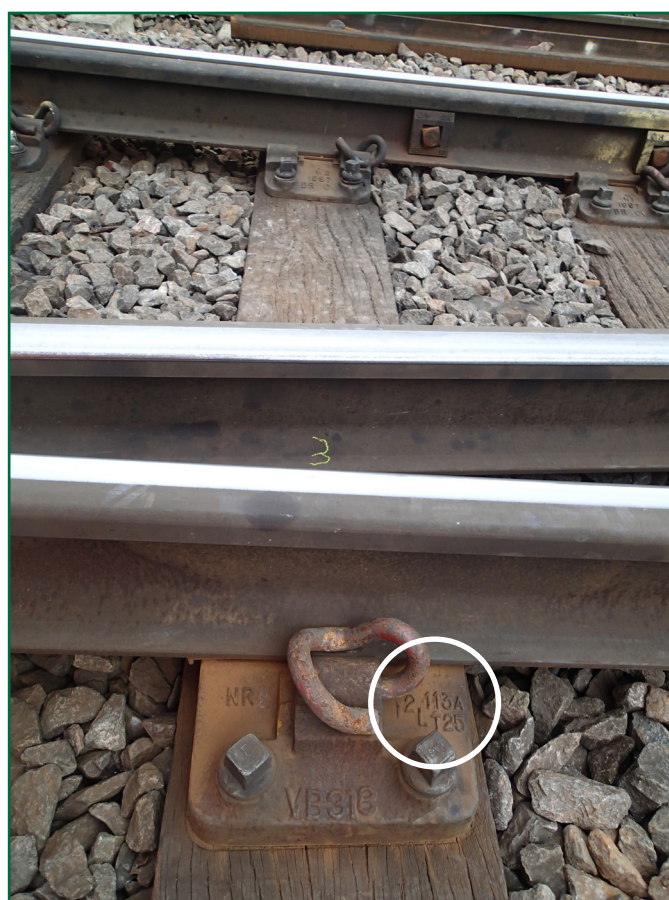
Figure 7: Two-levelled baseplate with marking (circled) to show it is 25 mm thicker than the standard baseplate

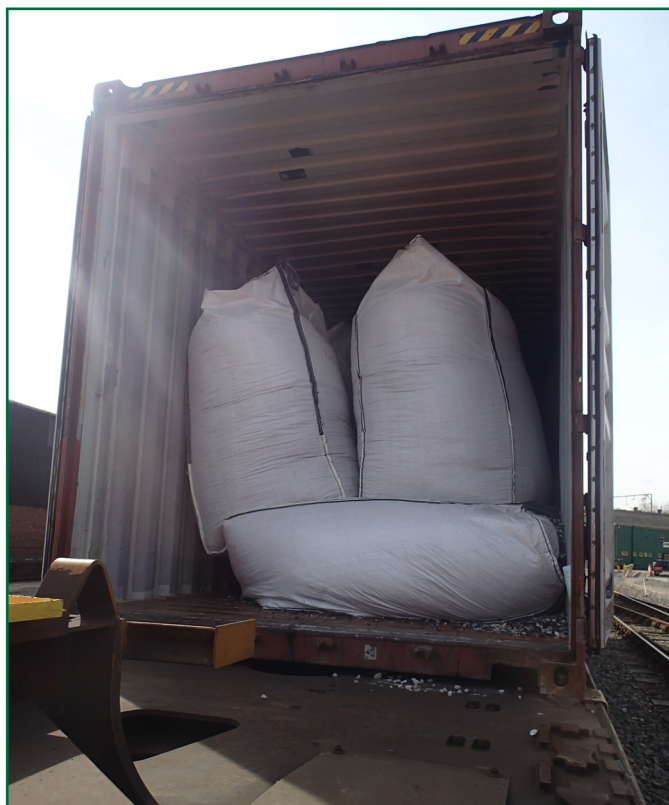
- 62 The container on the wagon was opened under RAIB supervision and its contents appeared to be reasonably evenly loaded (figure 8).
- 63 The RAIB arranged for the wagon to be tested on site, to measure the amount of wheel unloading on twisted track. The test method followed that specified in Railway Group Standard GM/RT2141 'Resistance of vehicles to derailment and rollover'. The two platforms of the wagon were separated and the trailing platform was tested with the loaded container in place. The loads on the leading wheels of the bogie which derailed were found to be reduced by 79% of their original value when the other wheels on the platform were jacked up by the amount specified in the standard. Standard GM/RT2141 specifies a maximum of 60% wheel unloading to minimise the risk of flange climb derailment on twisted track.

Figure 8: Contents of the container that was loaded on the trailing platform of wagon 37 80 4909 147-3

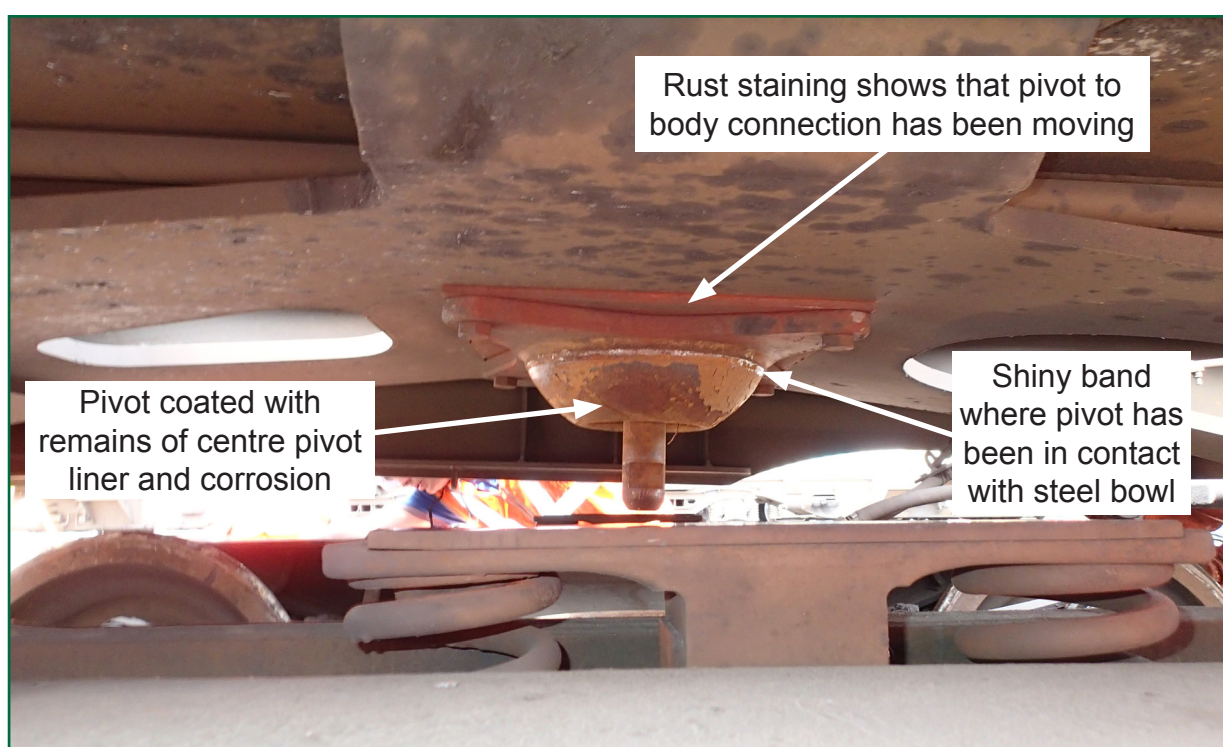
67 The bogie centre pivot liners were found to be worn well beyond their maintenance limits.

68 The wagon body was lifted from its bogies under RAIB supervision at Lawley Street Freightliner terminal. The centre pivot liners of all four bogies of the wagon were found to be worn to the extent that the steel centre pivot on the wagon body was in contact with the steel casting on the bogie. These plastic centre pivot liners are intended to prevent direct contact between the centre pivot on the body and the casting on the bogie. This is because the friction involved in direct steel to steel contact is much higher than the intended level of friction between the polished steel surface and the plastic liner. This increased frictional resistance would have prevented the bogies from rotating freely in curves. Figure 10 shows the centre pivot of another Megafret wagon whose liners had not worn so as to cause steel to steel contact. Figure 11 shows the centre pivot of the bogie which derailed.

Figure 11: Centre pivot of the bogie which derailed

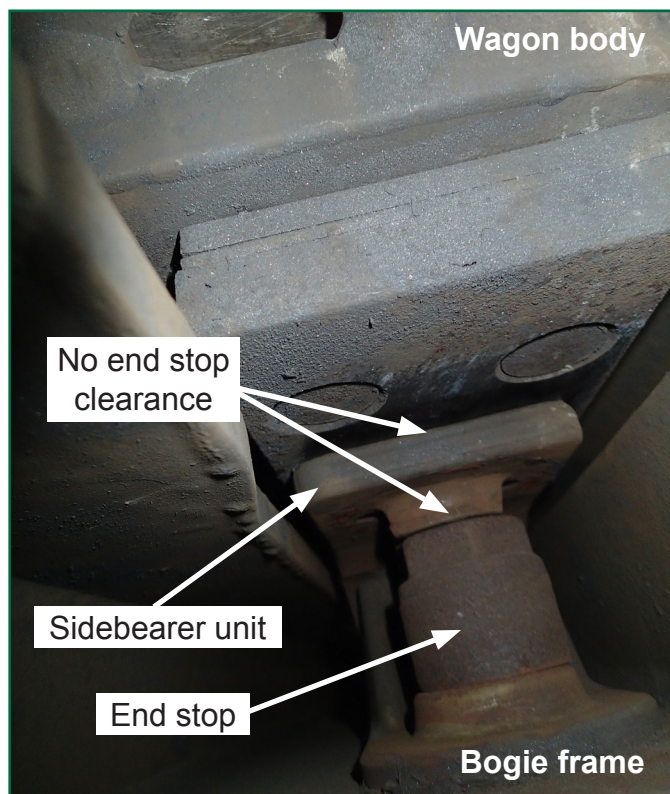
- 73 The worn centre pivot liner reduced the clearance between the steel sidebearer castings and their steel end stops (figure 9). The AAE TSO specified that this clearance should be 12 mm, with a tolerance of $-1/+2$ mm (ie an acceptable gap between 11 and 14 mm). Other maintainers' maintenance instructions for the Y33 bogie specified the same clearance but with a tolerance of $-0/+2$ mm. When measured during the wagon examination, this gap was found to be zero on one side of the bogie which derailed and 4 mm on the other side (figure 13).

Figure 13: Sidebearer on the left side of the bogie which derailed, showing no clearance between sidebearer casting and end stop (arrowed)

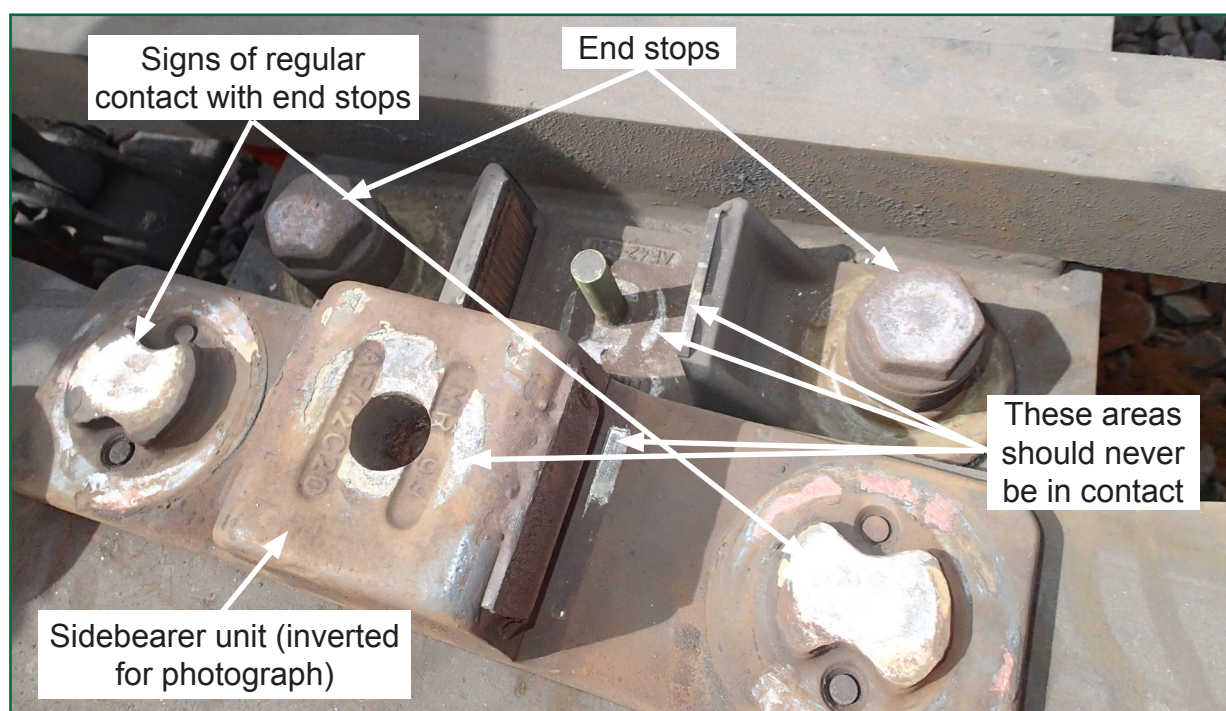
- 74 The reduction in end stop clearance had caused the sidebearer castings to come into contact with the end stops much more frequently than they were designed for. This caused wear of the castings and damage to the castings and the saddles in which they slide (figure 14).

Figure 14: Sidebearer on the left side of the bogie which derailed, showing where contact has occurred with the saddle (arrowed)

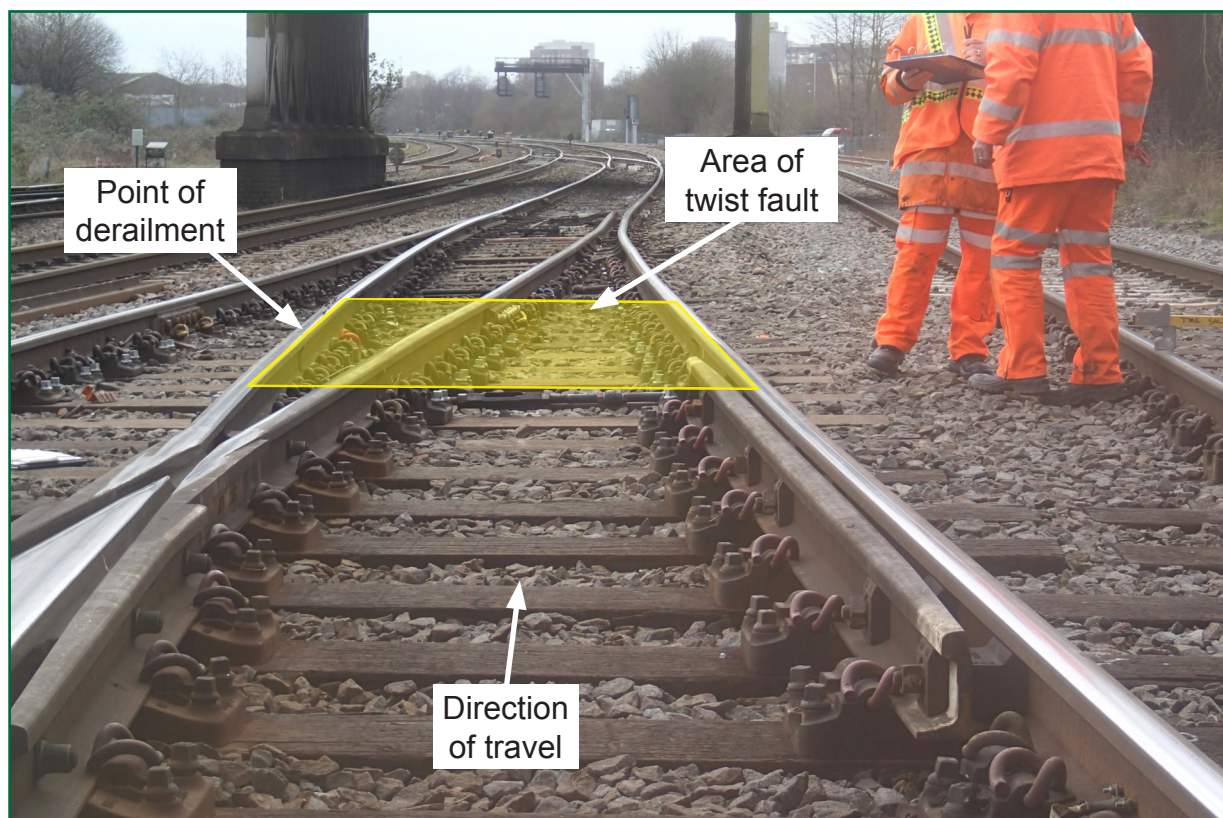
- 101 **The track contained a twist fault of such a magnitude that, once detected, Network Rail’s standard stated that it should be repaired within 36 hours.**

- 103 The RAIB surveyed the track after the derailment using an Amber trolley (paragraph 55). The data from this survey was supplemented by void measurements made using a class 66 locomotive. It was not possible to obtain a full set of void measurements as damage to the track caused by the derailment prevented the locomotive from travelling completely through the crossover. The survey showed that the track contained a static twist of 1 in 121 over 3 metres. The location of the twist was at the point of derailment (figure 16). The sense of the twist was such that the leading left-side wheel of a vehicle would see a reduction in load. Network Rail’s standard NR/L2/TRK/001mod ‘Track geometry - Inspections and minimum actions’ states that a twist between 1 in 91 and 1 in 125 requires remedial action within 36 hours of its discovery.

Figure 16: Location of track twist at the point of derailment

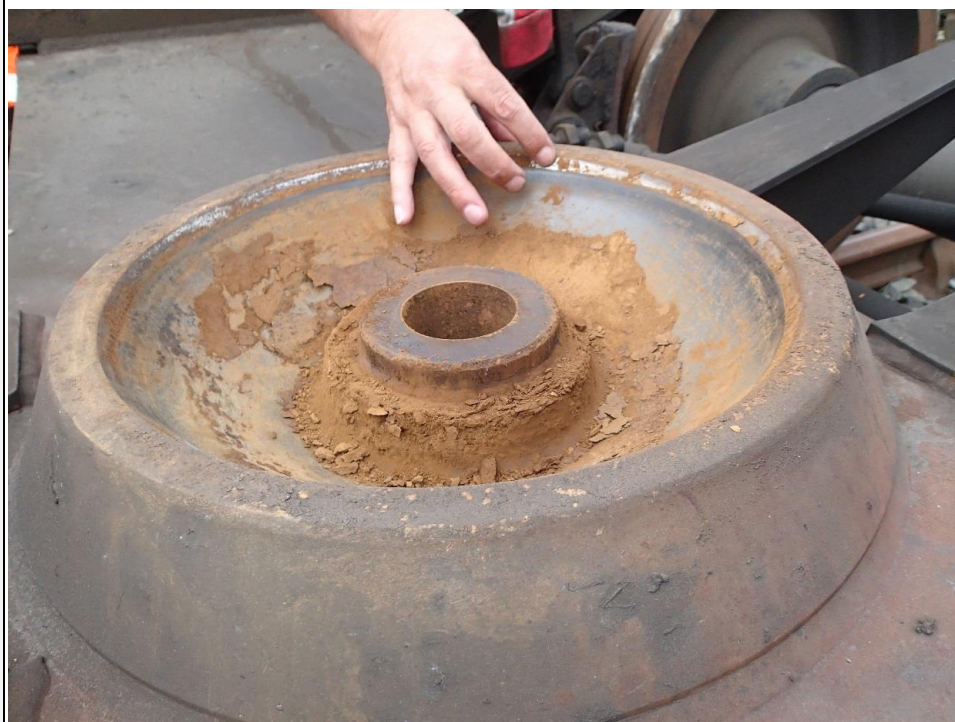
Figure 2: Centre pivot liner worn below level of steel rim, leading to contact between steel surfaces

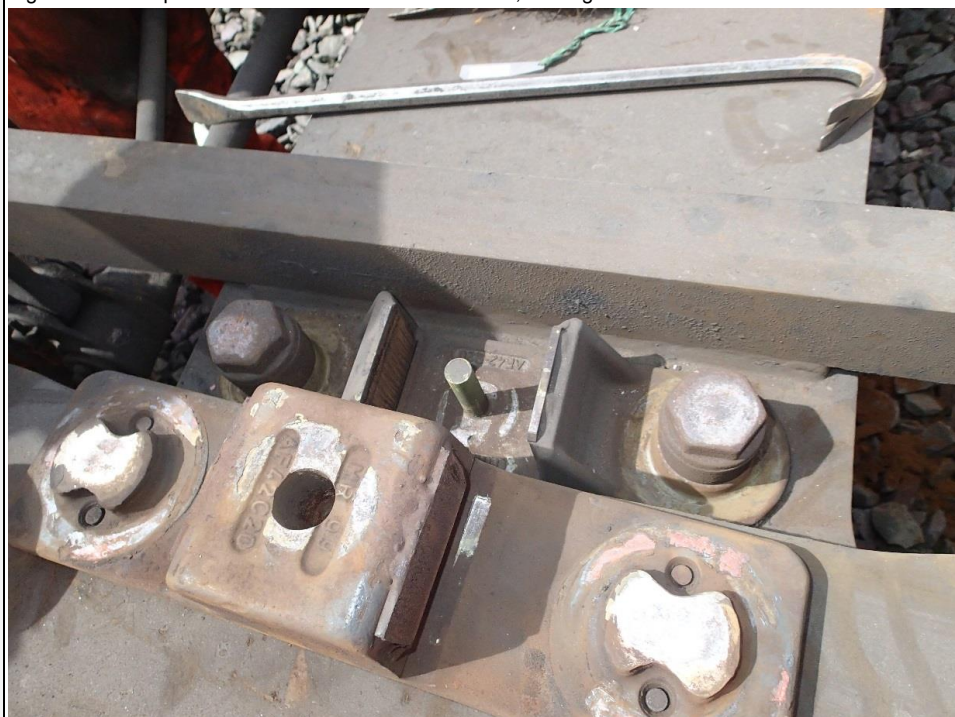
Figure 3: Sidebearer showing signs of frequent contact with end stops
