Rail Accident Report

Collision at Frognal Farm User Worked Crossing 23 October 2017

Report 12/2018
August 2018

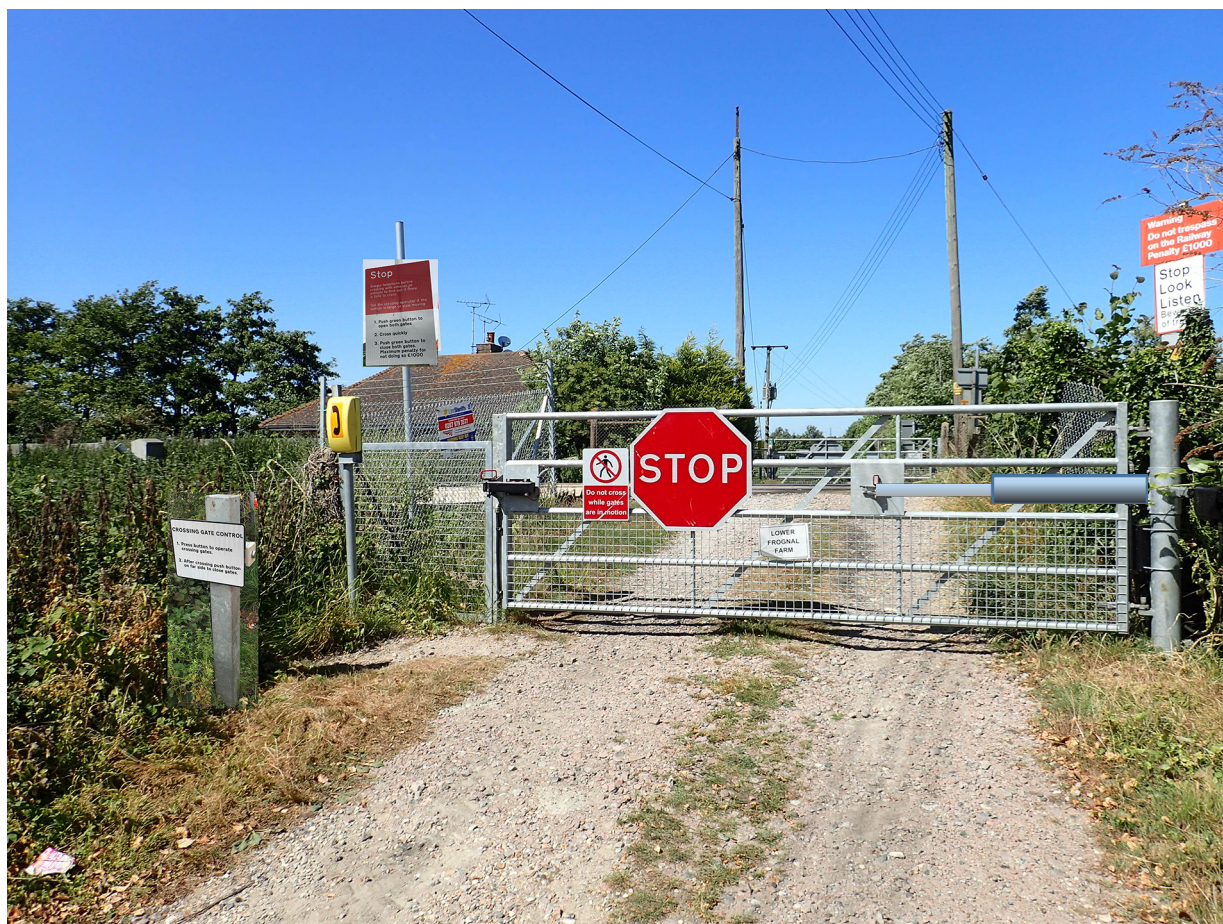
Figure 3: Reconstruction of the van driver's view of the crossing. It was not possible for the RAIB to photograph the crossing in this state in the aftermath of the accident because of the presence of recovery vehicles, and the signs were altered a short time later to reflect changes made to the crossing after the accident.

- 56 Users of Frogmal Farm crossing were presented with nine signs of differing size and prominence on their approach to the crossing (figures 3 and 4). The van driver, having pulled onto the crossing's approach road and clear of Lower Road, had already passed the first sign. The level crossing manager (see paragraph 142) realised that users of the crossing would miss the first sign when they pulled clear of Lower Road, and so she asked for it to be repeated closer to the crossing, shortly after the POGO equipment was commissioned. An additional sign was installed on 13 April 2017.

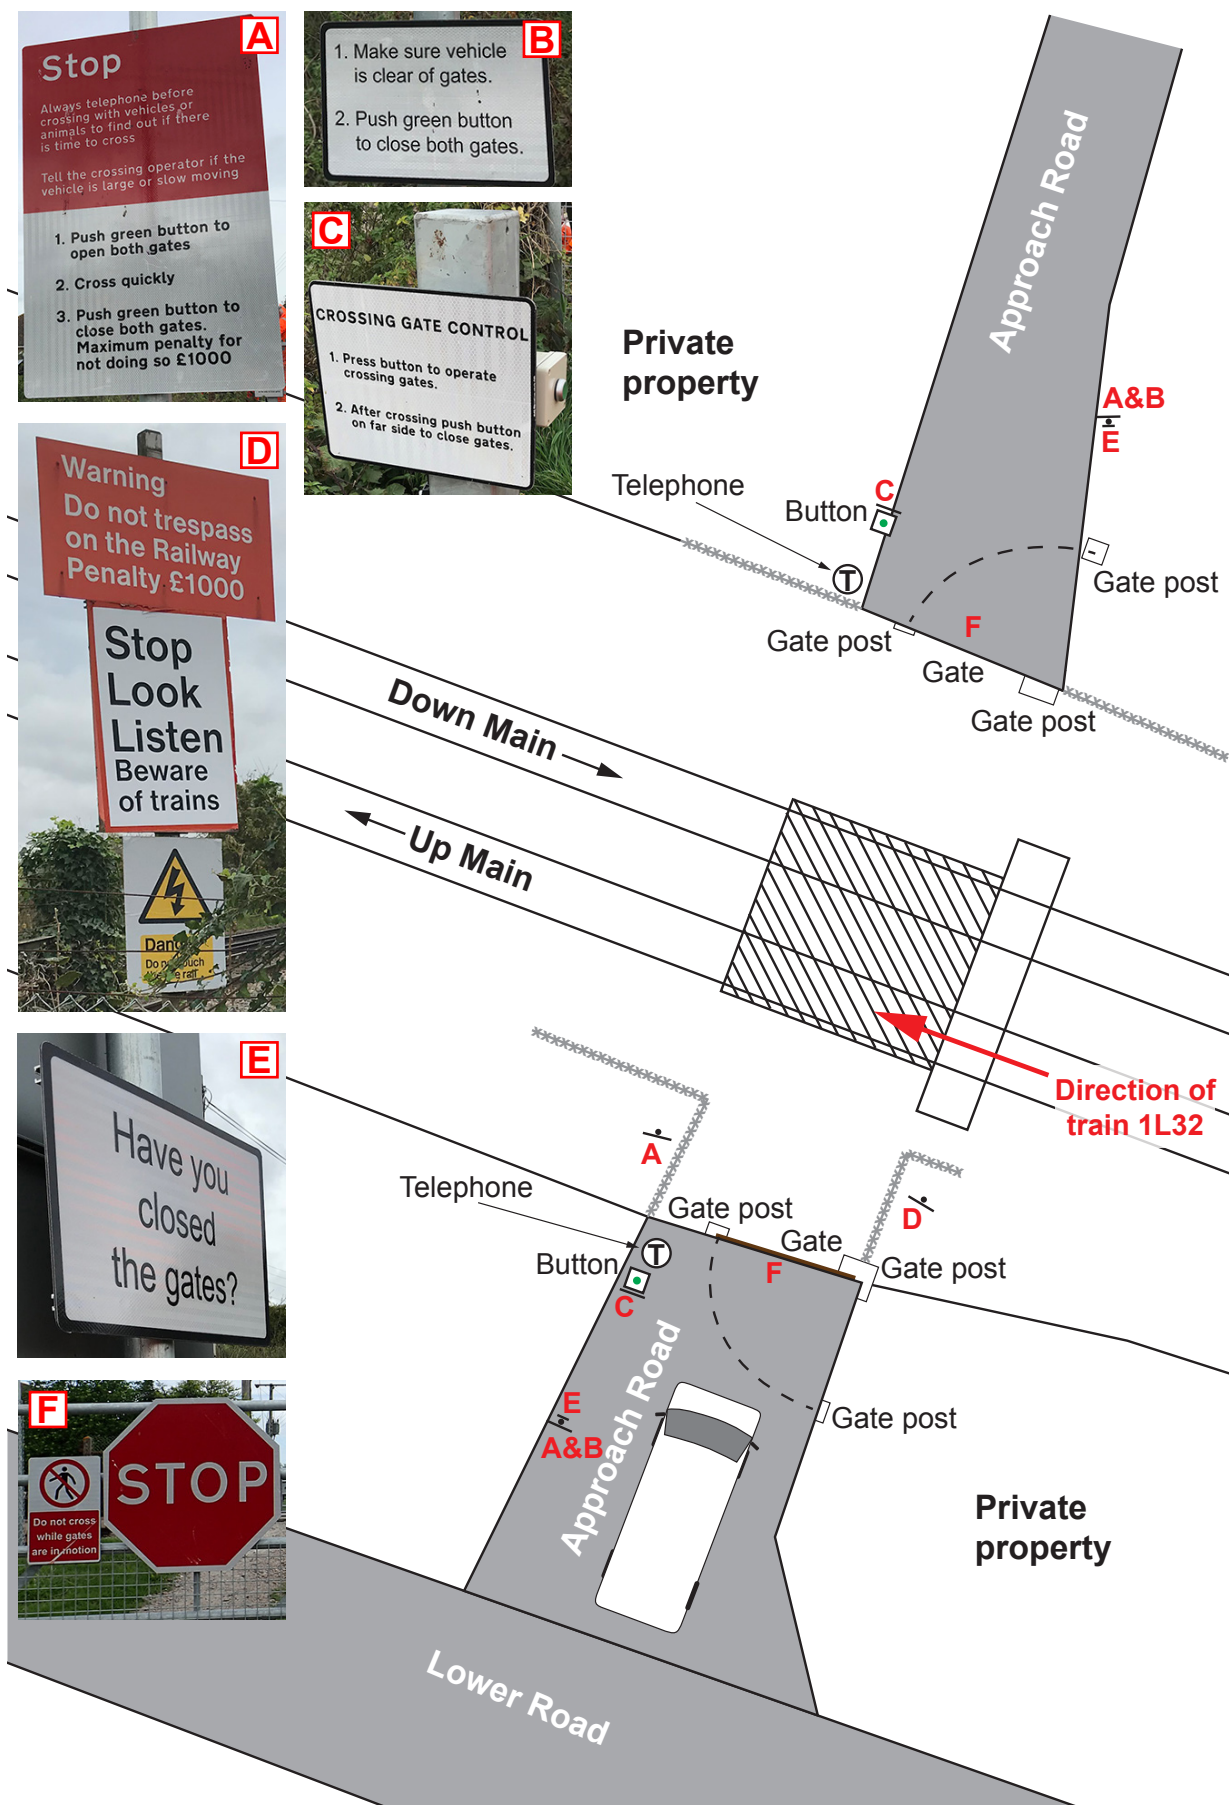
Figure 4: Frogmal Farm crossing layout showing signage placement and approximate stopping location of the van

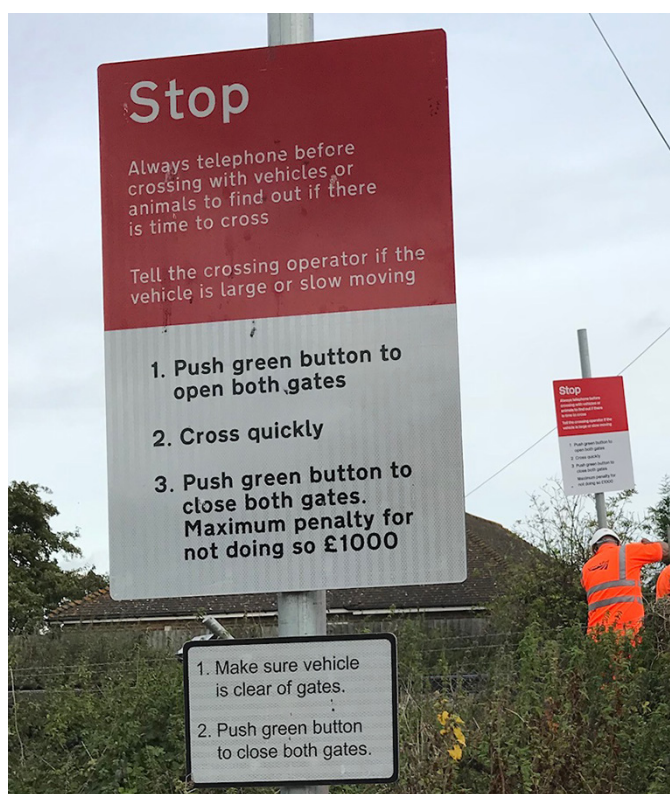
Figure 5: The duplicated signs explaining how to use the crossing

- 57 This sign (the sign on the right in figure 5, also visible above and to the left of the crossing gate in figure 3) explaining how to use the crossing correctly, was offset to the left of the road.
- 58 The van stopped on an incline clear of Lower Road. The signage to the driver's right, the bottom of which was partially obscured by vegetation, was the sign shown as sign D in figure 4.
- 59 There was a stop sign on the gate, and a sign warning people not to cross while the gates are in motion. These were mounted on the gate and so were immediately in front of a vehicle driver as they approached the crossing. There was a small sign on the button facing Lower Road, with two numbered instructions on it in small type.

- 83 Witness evidence indicates that the installers in March 2017 did their best to install the equipment in accordance with the intent of the 2014 design with the information that they had available, having collected all the signage required for POGO crossings from the central stores. Despite the error noted in paragraph 82, this included the instructional sign shown in figure 5.

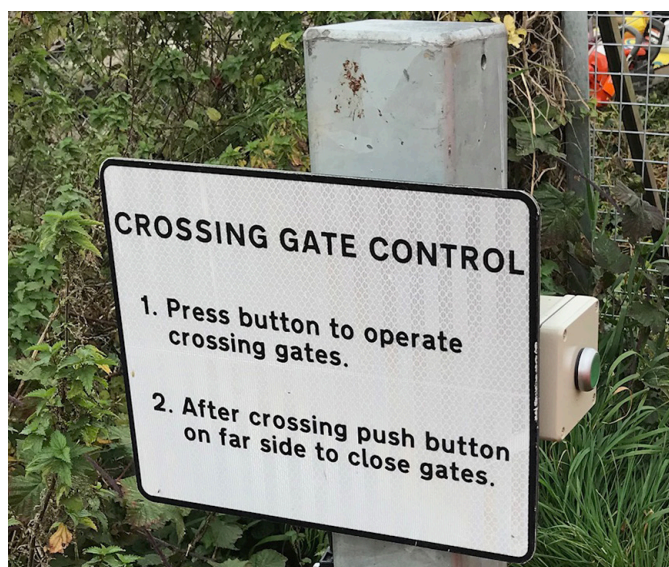
Figure 7: Sign and green push button

- 101 The two signs on the gate did not give any information as to how to use the crossing safely from a vehicle driver's perspective, and the three signs on the right, which were partially obscured by vegetation, also gave no instruction as to how to use the crossing safely.

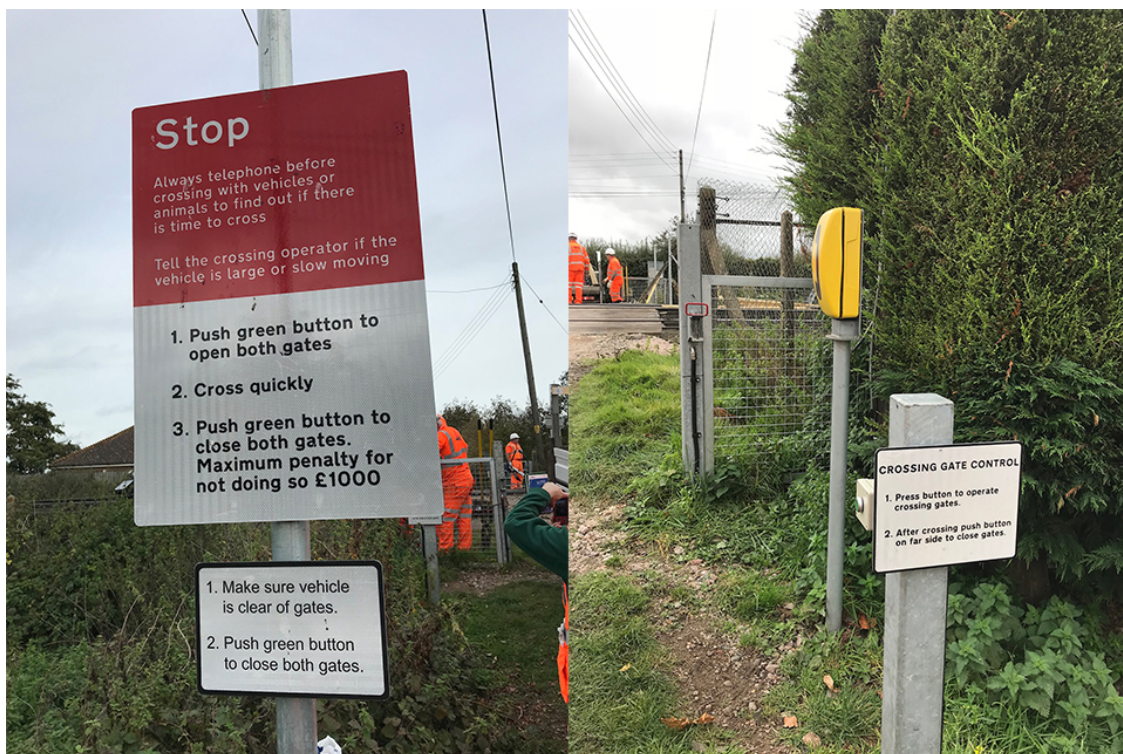
The signs at Frogнал Farm crossing, showing the instructions to vehicle users (left) and the telephone cabinet, gate operating button and subsidiary instruction sign (right)¹³

Signs for user worked level crossings are defined in the Private Crossings (Signs & Barriers) Regulations 1996¹. These regulations were made many years before POGO equipment came into use. There are currently no appropriate signs in the Regulations for crossings with new technology such as POGO equipment, and Network Rail has attempted to design its own signs to use in conjunction with the legally specified signs. Although the Office of Rail and Road (ORR) and the Department for Transport (DfT) are currently working on an updated and revised version of the Regulations, it is likely to be some time before this becomes law.
