# Rail Accident Report

**Freight train derailment at Lewisham,  
south-east London  
24 January 2017**

Report 04/2018  
February 2018

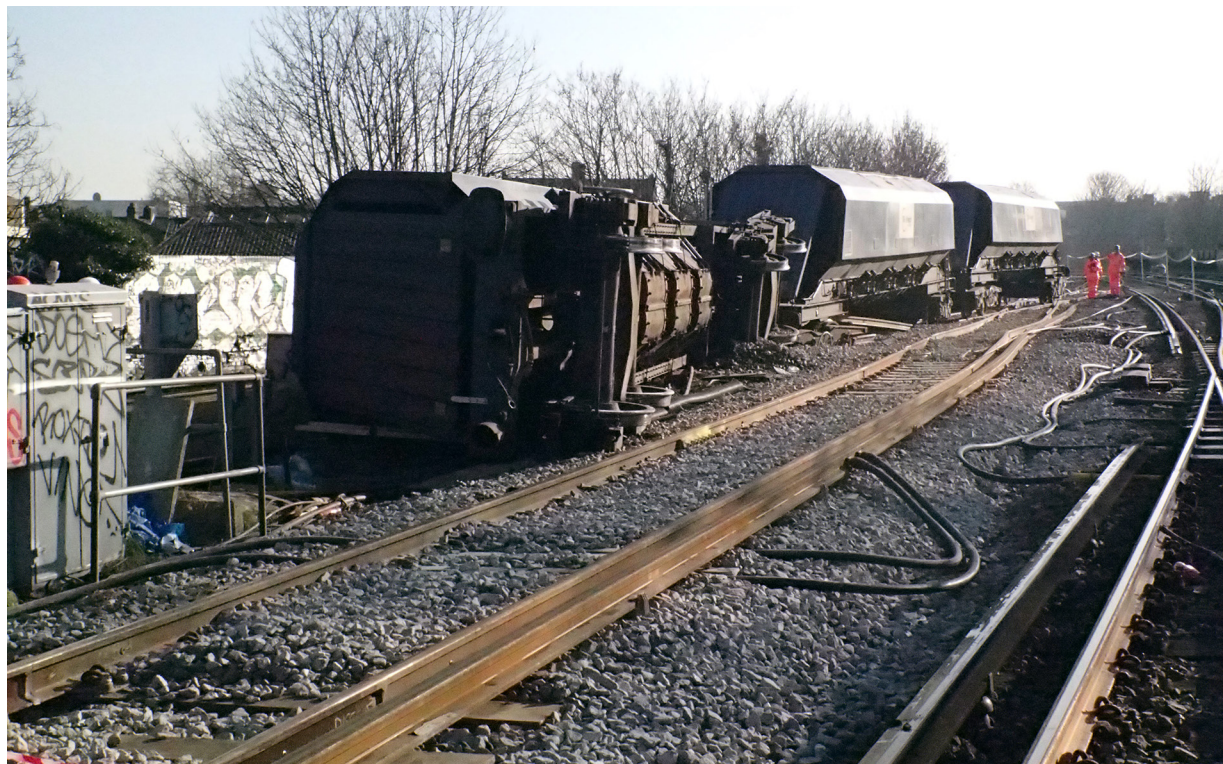
Figure 3: Location of the last three wagons of train 6M90 after the derailment

- 6 There was major damage to the track and the derailed wagons. No-one was injured. However, a derailment of this nature has the potential to foul adjacent lines open to traffic and came close to doing so in this case.

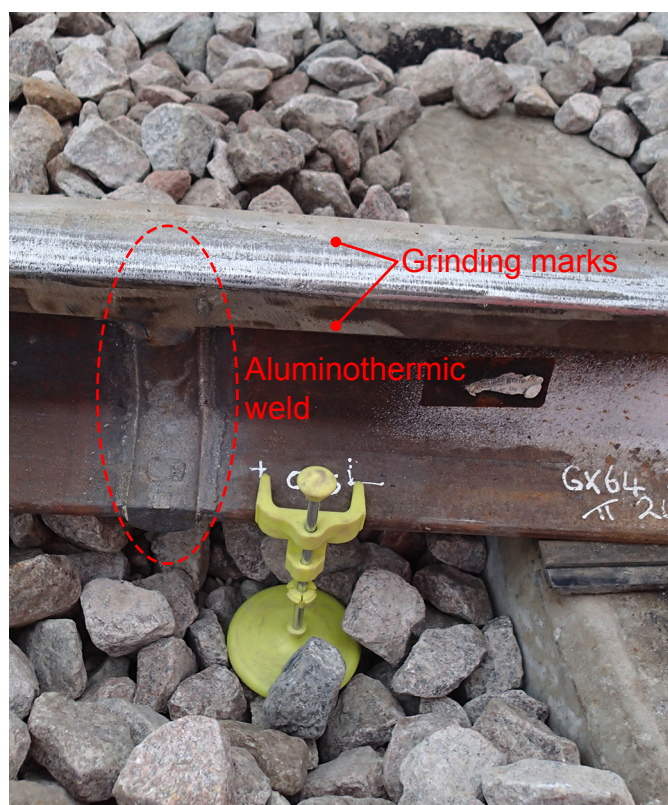
- 46 The *gauge face* and the rail head close to the area of the aluminothermic weld were relatively rough due to grinding work that had been undertaken to dress the weld (figure 7). Similar grinding work had been done to dress an aluminothermic weld around 800 mm further along the Up Courthill Loop line on the right-hand rail.

Figure 7: Aluminothermic weld on the left-hand rail of panel 13 (photograph shows a void meter used to measure track deflection)

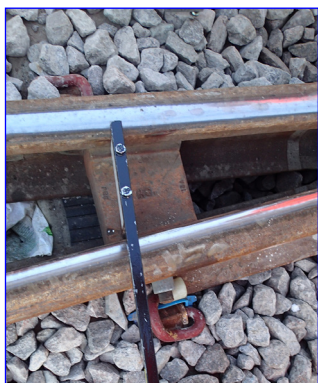
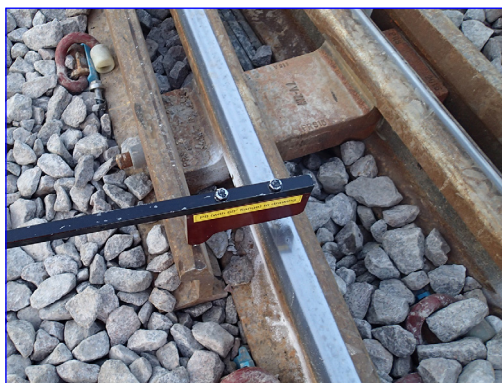
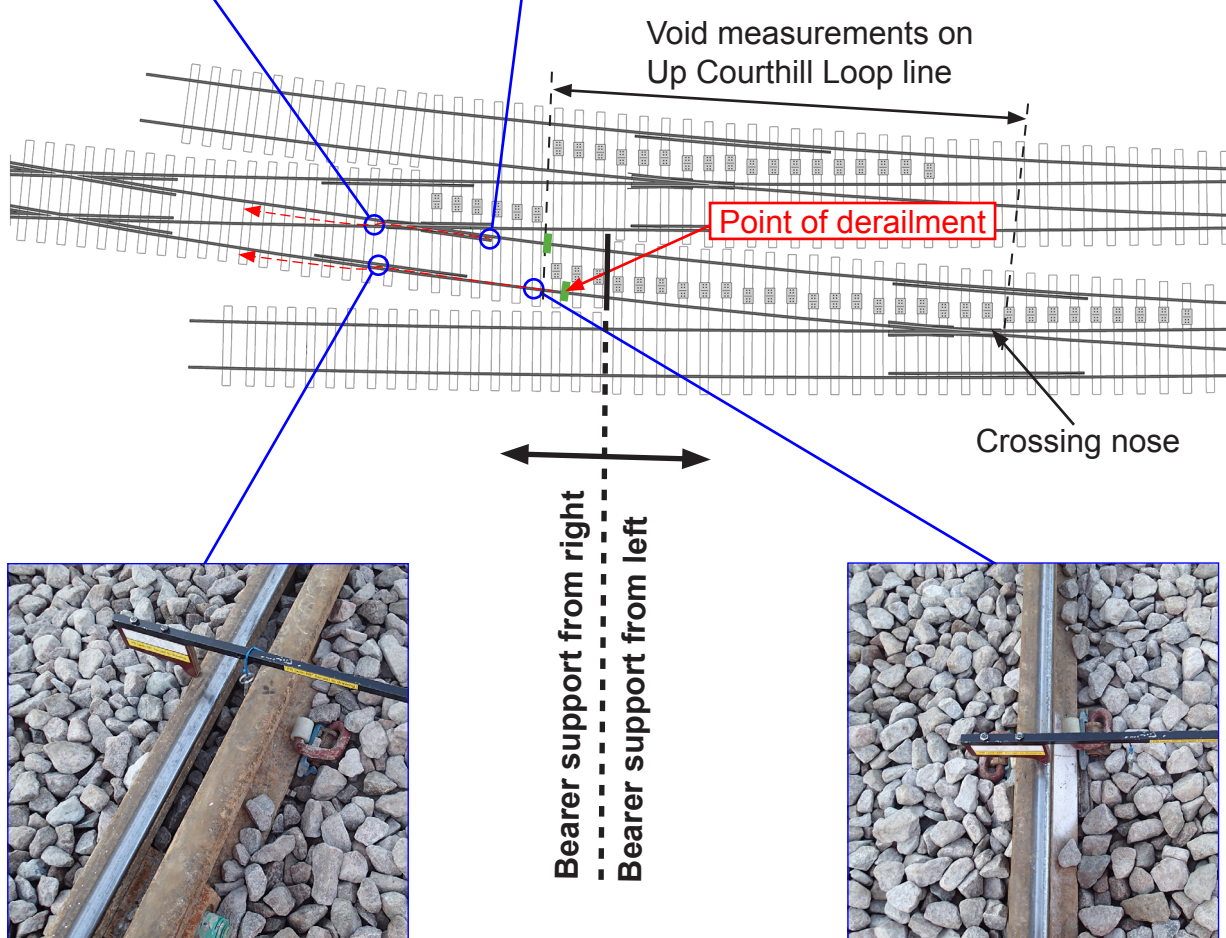
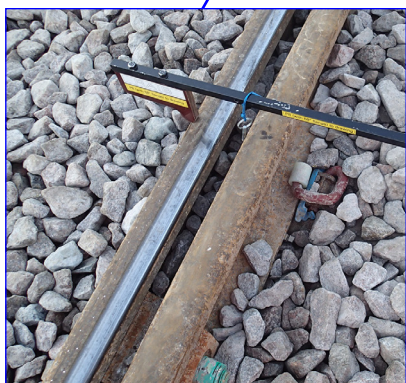
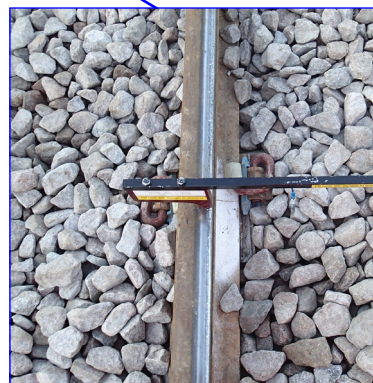
- 45 The RAIB inspected the track and found four sets of marks on the left-hand rail of the Up Courthill Loop line that were consistent with the flanges of the left-hand wheels of the four *wheelsets* of wagon 16 climbing on to the rail head, running along the top and then dropping into the *six-foot* between the Up Slow and Down Slow lines. The first mark started close to an *aluminothermic* weld located within the three short bearer sections on the left-hand rail of panel 13 (paragraph 36). The RAIB found complementary marks on the right-hand rail showing that opposite wheels of the wheelsets had dropped into the *four-foot* of the Down Slow line after the *crossing nose*, the flanges of two of the wheels having first run on top of the *wing rails*. Distortion of the track further along the Down Slow line, and other damage, indicated that the leading end of the first wagon to derail was then pulled to the right by the wagon ahead, which was correctly running on the Up Courthill Loop line. The forces involved would explain the separation of the train, between wagon 15 and 16, and wagon 16 overturning.

4. Right-hand wheel drops off rail head

2. Right-hand wheel flange contacts and runs along wing rail

3. Left-hand wheel drops off rail head

1. Left-hand wheel flange climbs on to rail head

Figure 8: Key features of the track in the vicinity of the point of derailment (photographs show wheelset template used to identify and match derailment marks)

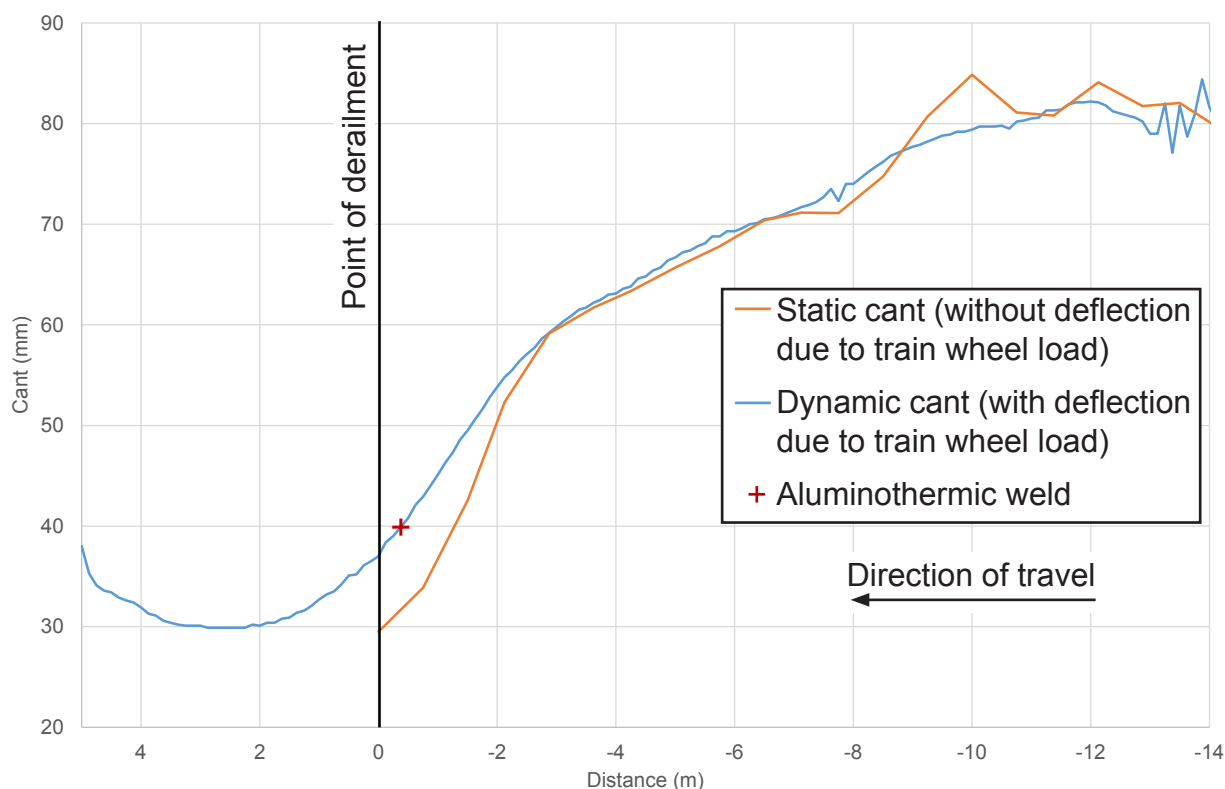
Figure 9: Static and dynamic cant measured on the Up Courthill Loop line after the derailment

- 52 The RAIB observed that both the static and dynamic cant on the approach to the point of derailment (figure 9) resulted in short and long base twists that were of the same sense and that would cause wheel unloading at the leading left-hand wheel.

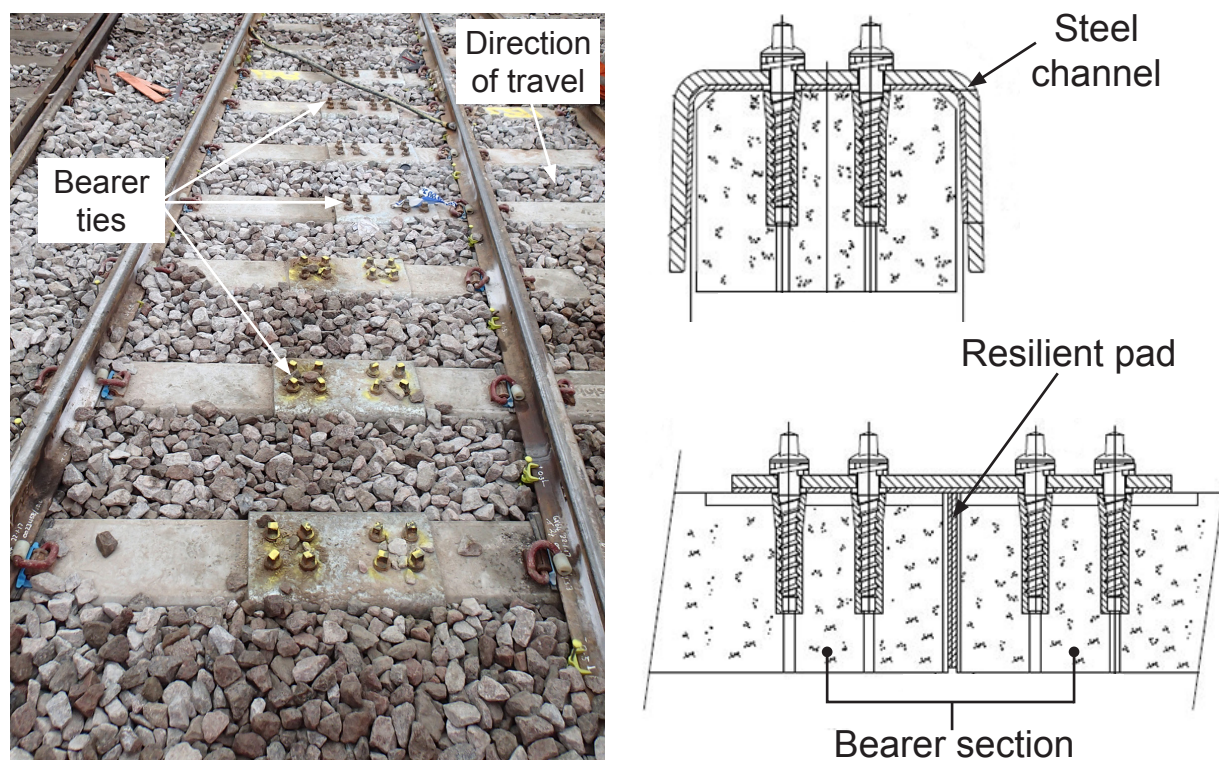
- 55 Conventional S&C uses relatively long continuous bearers to support the rails, particularly in areas where lines diverge, cross and come together. With modular S&C, the bearers need to be split into shorter lengths (bearer sections) so that the track panels can be made small enough to enable them to be transported to site. A significant task was to develop a means of joining the bearer sections together on site. Network Rail decided to seek an engineering solution from industry suppliers and issued a competitive tender. It selected a mechanical connector comprising an inverted U-shaped steel channel, designed to fit over the abutting bearer ends (separated by a resilient pad) and then screwed into place (figure 10). In responding to Network Rail's tender, the successful tenderer described the mechanical connector as being 'rigid'; suggesting that the connected bearer sections would behave like a single continuous long bearer.

Figure 10: Bearer ties on the Up Courthill Loop line (drawings courtesy of Network Rail)

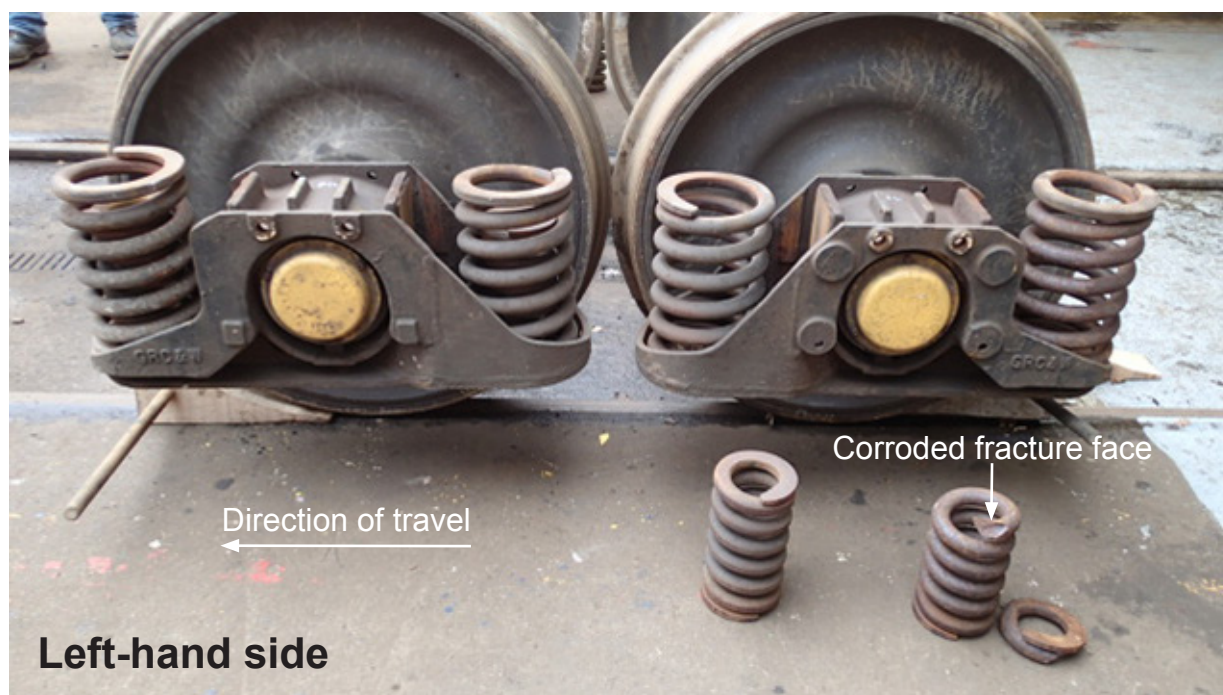
- 64 The RAIB examined wagon 16 after it had been re-railed and recovered from site and arranged for it to be partially dismantled to allow the bogie and suspension components to be inspected.
- 65 The RAIB found that one of the primary springs on the left-hand side of the leading bogie had fractured and that, given the degree of corrosion on the fracture face, the spring had been in this condition at the time of the derailment (figure 11).

Figure 11: Fractured primary spring found on leading bogie of wagon 16

<sup>9</sup> The vehicle dynamics study showed that the fractured secondary (side-bearer) and primary suspension springs that were found on the leading bogie had negligible influence on derailment risk. In fact the failed primary spring was actually found to slightly reduce the risk of derailment.

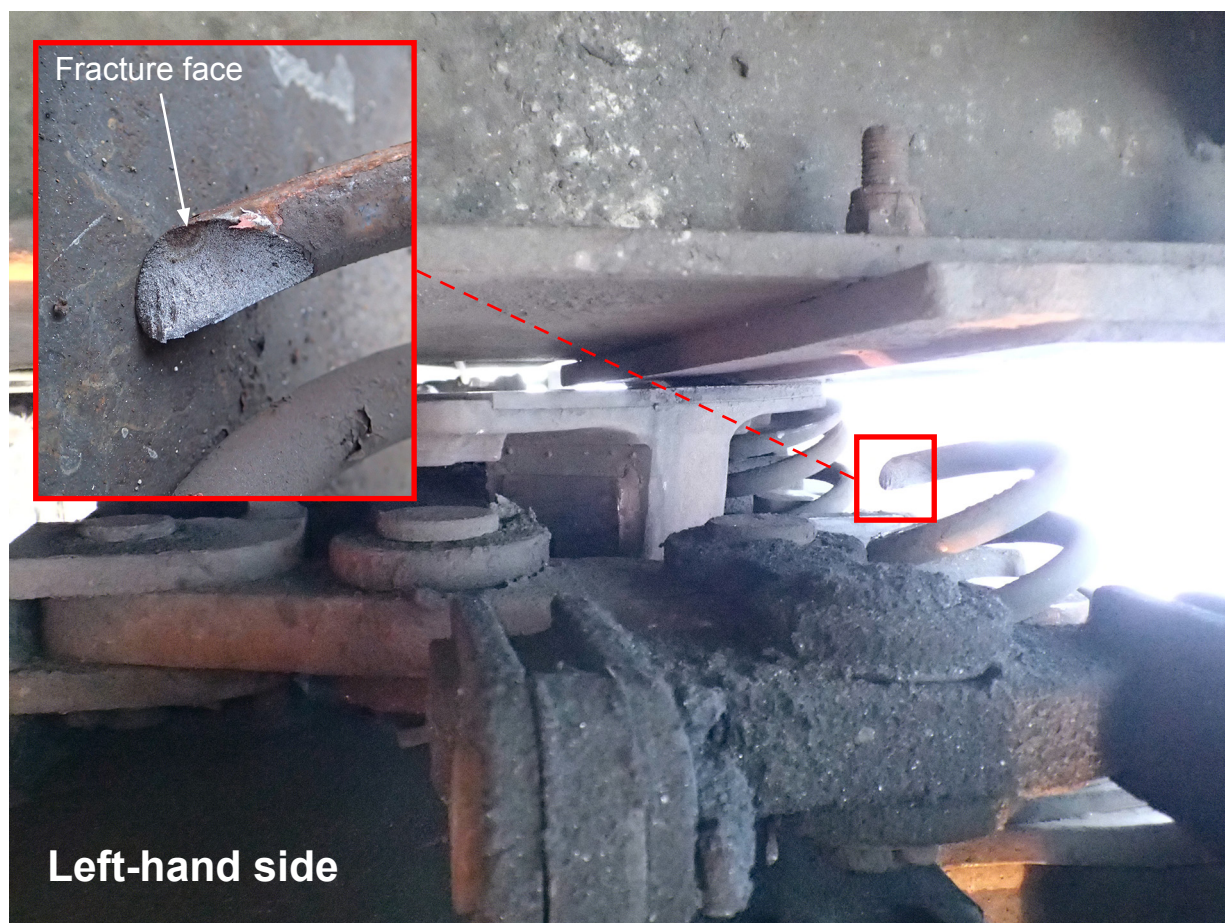
- 66 All the side-bearer units on the wagon had become dislodged, and a number of secondary springs had fractured, including one on the left-hand side of the leading bogie (figure 12). The dislodgement was almost certainly as result of the wagon running derailed or overturning. Although the fracture faces were bright and there was little corrosion, detailed examination revealed marks that indicated that the fracture had been growing progressively (figure 12 inset) and it is possible that the spring failed beforehand. The RAIB found a spring that had failed in a similar manner on wagon 18, one of the wagons that did not derail. A more detailed examination of side-bearer components revealed evidence that some guide posts had failed and shortened, and that some had been contacting the underside of the top plate (figure 13). While this suggested reduced side-bearer gaps that may, in certain circumstances present an increased derailment risk, more detailed examination discounted this as a factor in this derailment (paragraph 75).

Figure 12: Dislodged side-bearer and fractured secondary spring found on the leading bogie of wagon 16

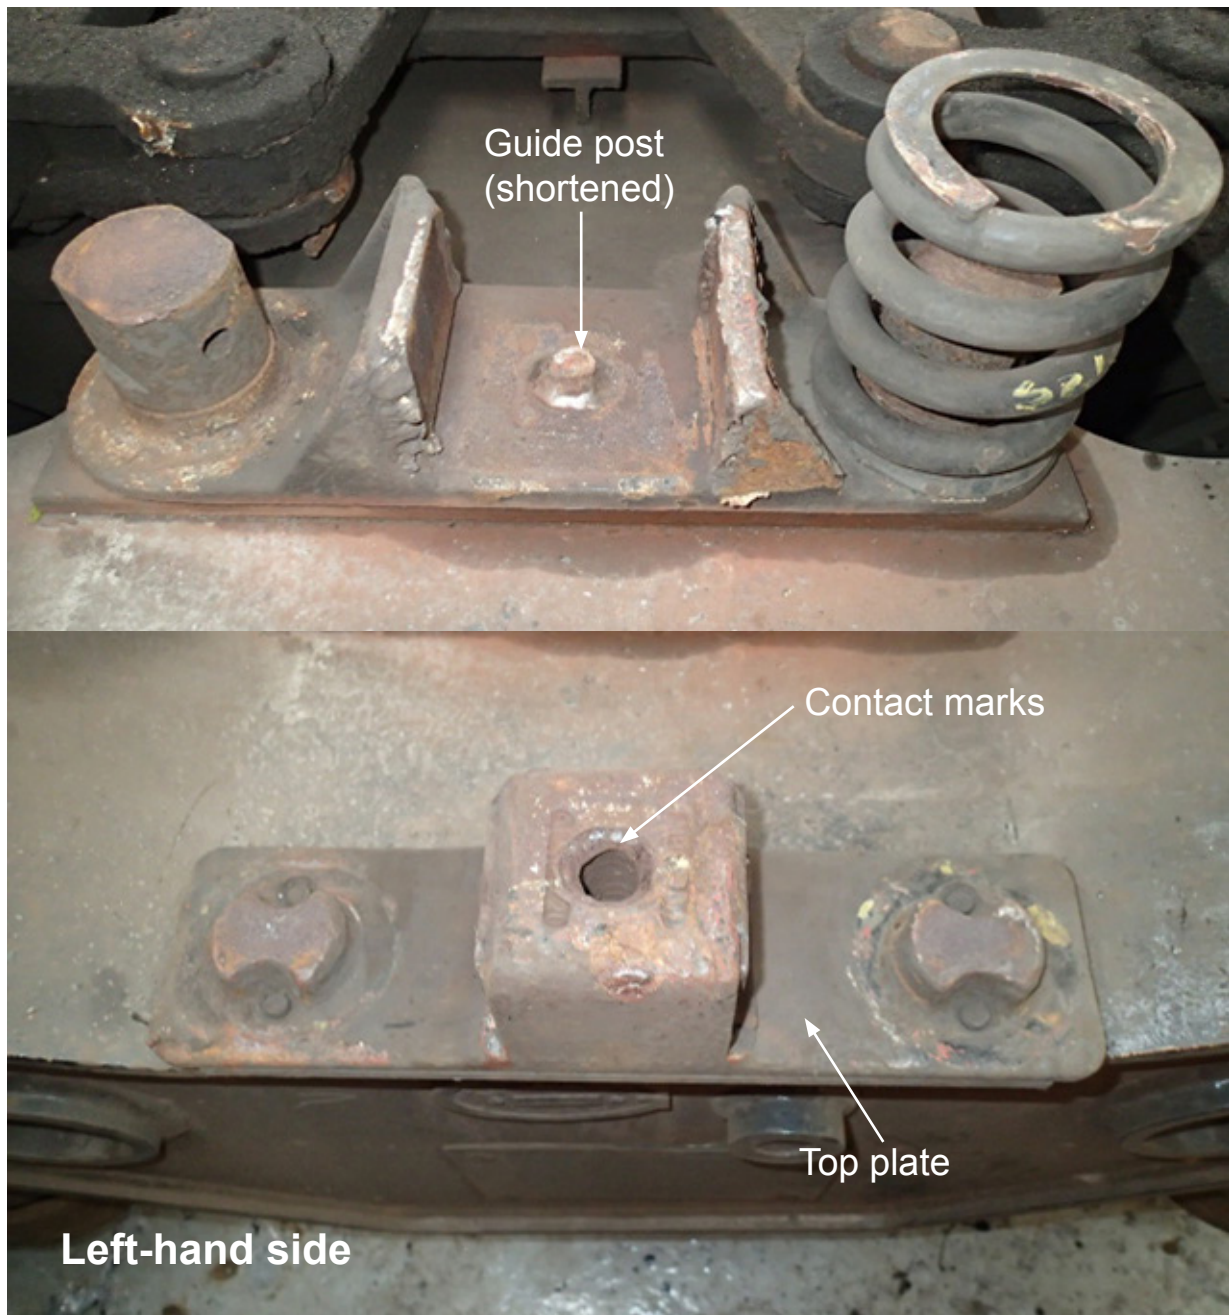
- 69 The RAIB retained wagon 18 for reference purposes. It observed that the sand was loaded to the right-hand side and that this had resulted in the side-bearer gaps closing on that side of the wagon (figure 14). It subsequently arranged for the wheel unloading behaviour of the wagon to be measured on the track twist conditions defined in Appendix A of GM/RT2141 (paragraph 51) and a simulation of that measured on the approach to the point of derailment (paragraph 47). These measurements were used to check the behaviour of the computer simulation model used to study the derailment mechanism (paragraph 72).

*Figure 13: Side-bearer components from the left-hand side of the trailing bogie on wagon 18, showing guide post damage and contact marks*

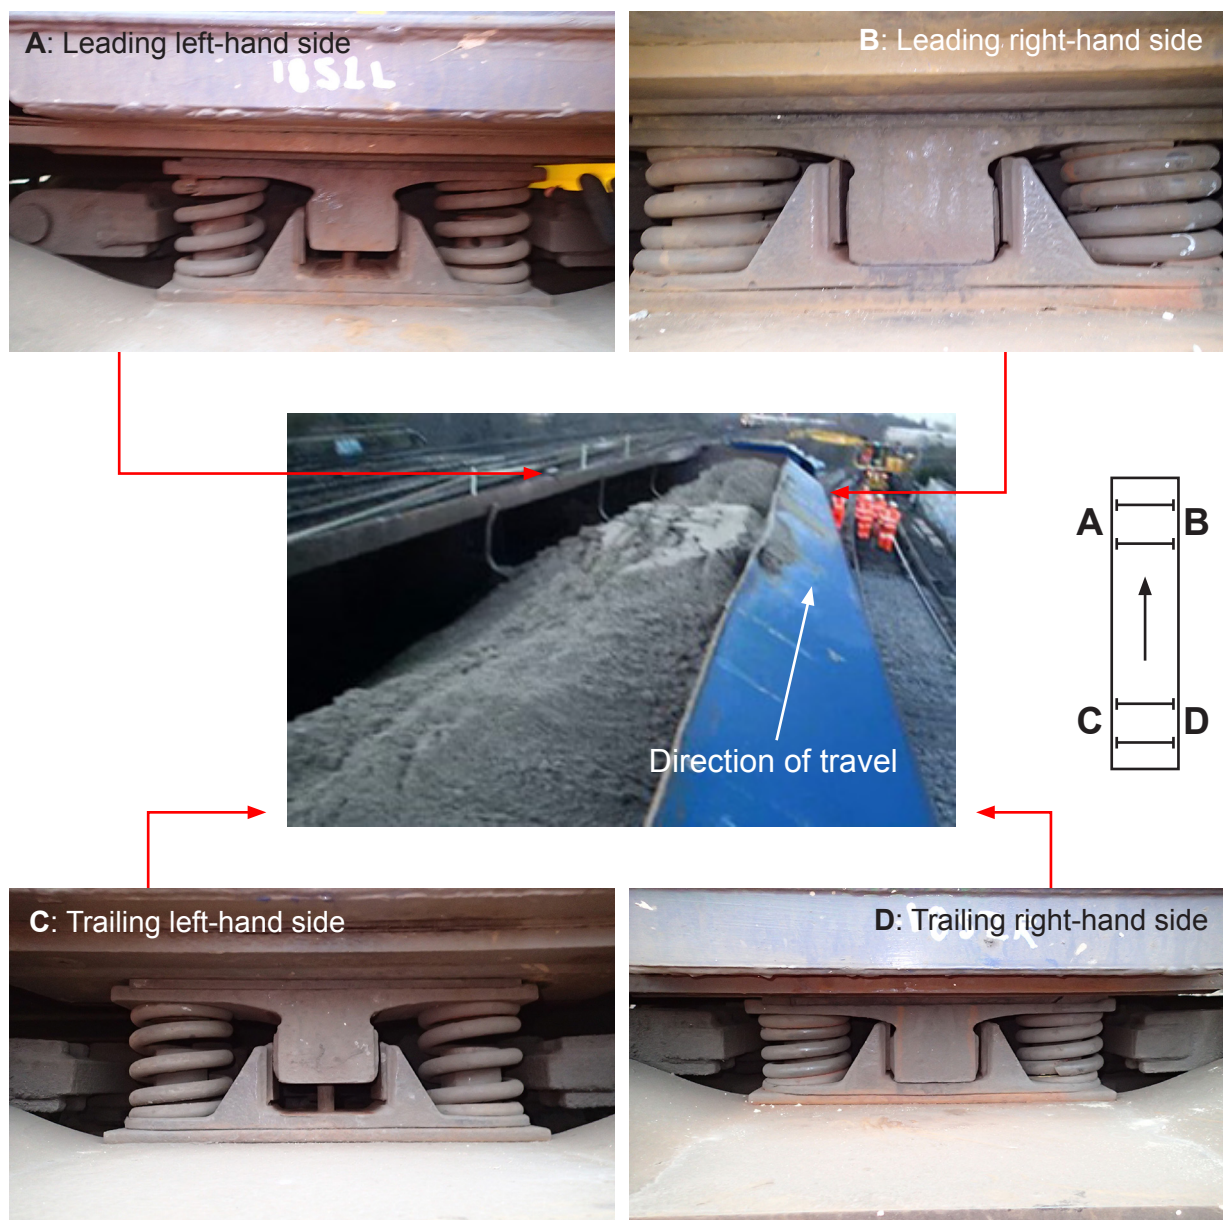
Figure 14: Sand payload in wagon 18 and the condition of the side-bearers

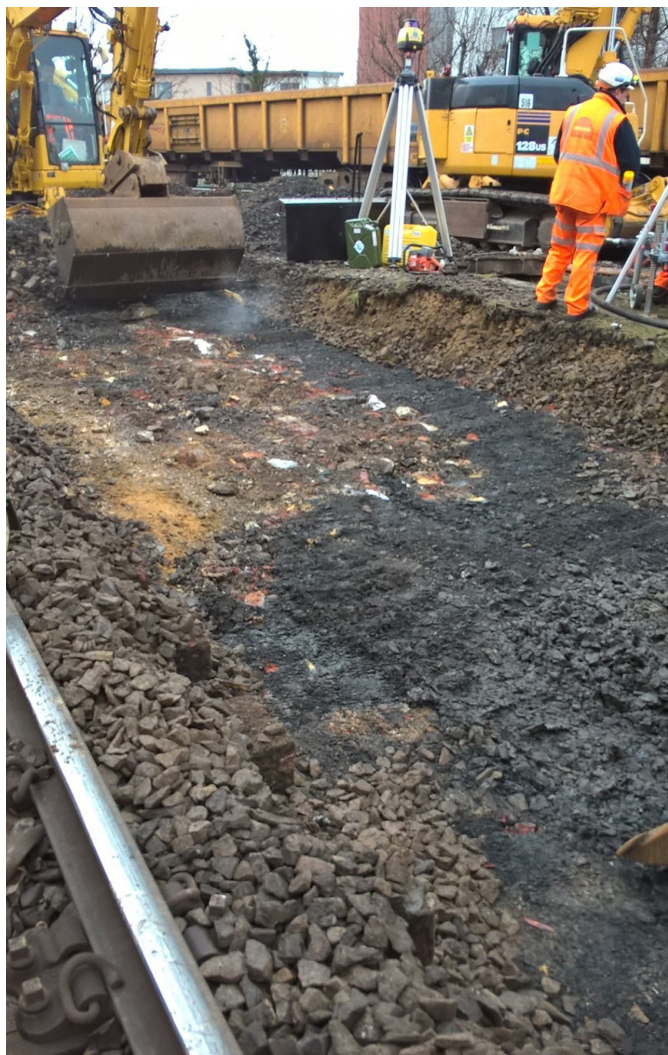
Figure 15: Excavation of the track bed close to the point of derailment on 14 January 2017 (photograph courtesy of Network Rail)

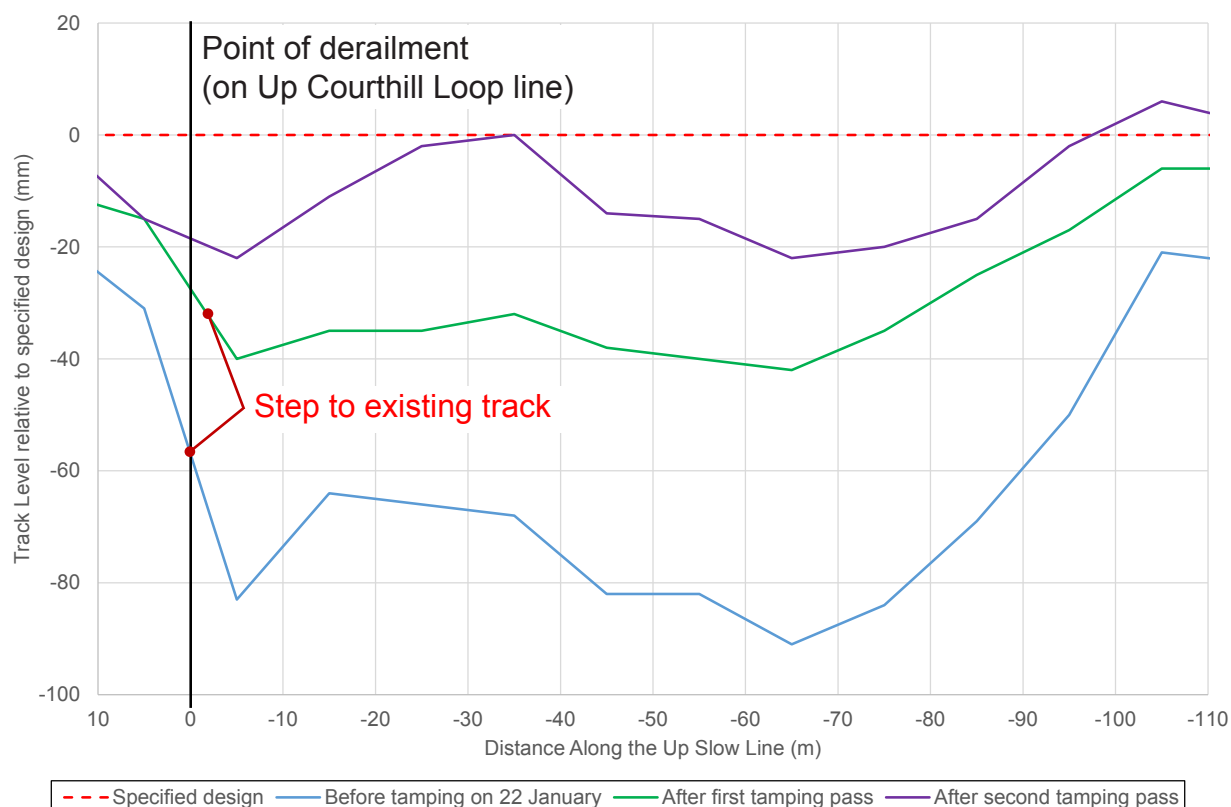
- 87 Machine DR 75502 started tamping the Up Slow line at 06:05 hrs. It was known that the track on the Up Slow line had been installed too low<sup>12</sup> (paragraph 31) and it had settled further over the intervening week. Unfortunately, it was not possible to achieve the amount of lift needed with one tamper pass (paragraph 34). The need for the second tamper pass meant that machine DR 75502 remained occupied until 09:30 hrs leaving no time for it to then tamp the Up Courthill Loop line before it was due to depart. Figure 16 shows the level of the track at the start of the tamping work, and that achieved after each tamping pass. It also illustrates the step at the transition to the existing track that witness evidence suggests was of concern to the lead engineer during the Core Works (paragraph 31).

Figure 16: Level of the Up Slow line prior to the tamping work on 22 January 2017, and after each tamping pass

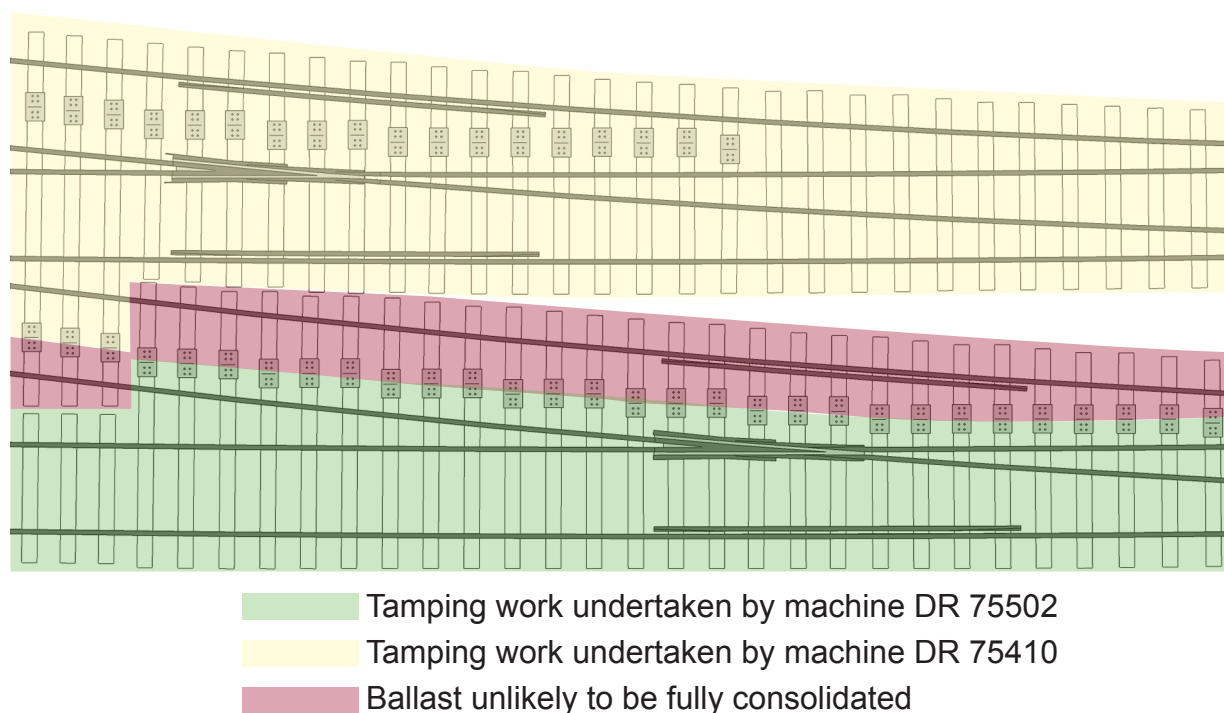
91 Figure 17 shows the areas on the Up Courthill Loop line where the ballast is unlikely to have been fully consolidated by the tamping undertaken on 22 January.

Figure 17: Areas of the double junction affected by tamping work on 22 January 2017

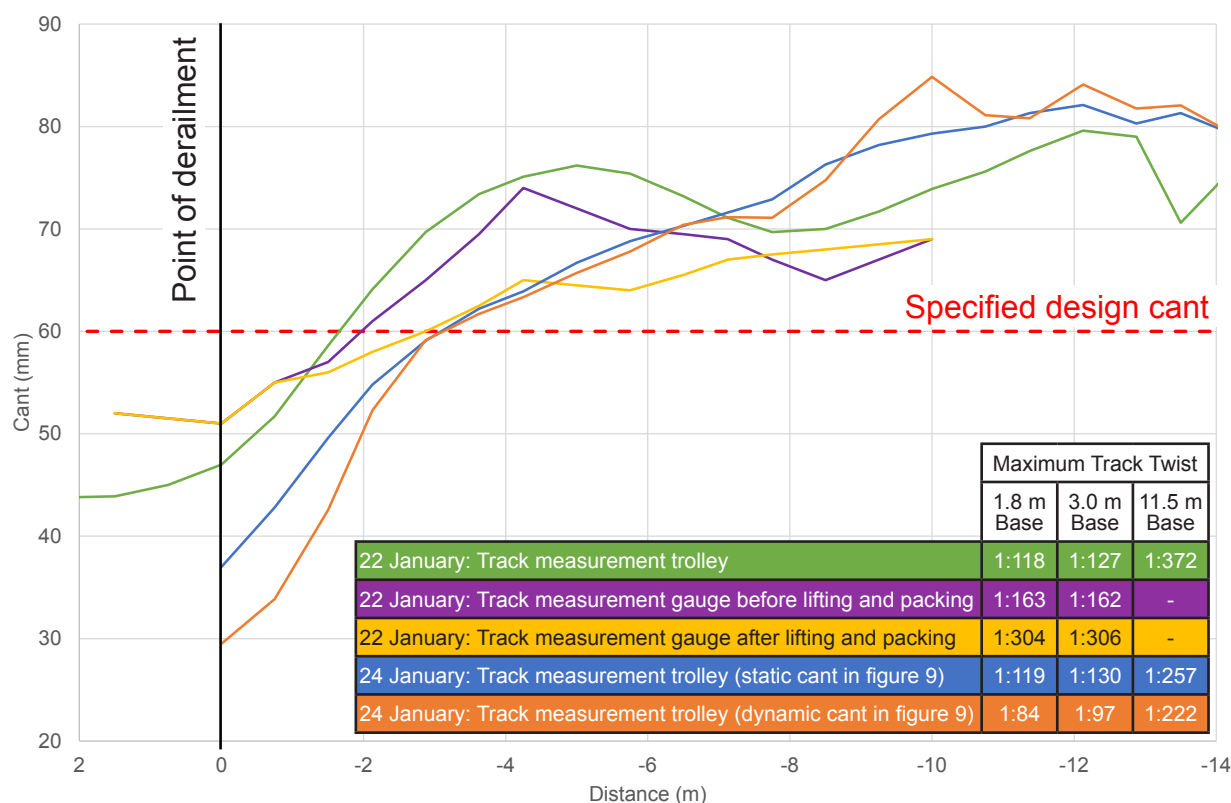
94 Figure 18 shows the cant levels that were measured on the Up Courthill Loop line to verify the manual repair undertaken during the follow-up work, and how this then deteriorated over 28 hours to form the track twist feature on which wagon 16 derailed. It also summarises the associated maximum twist levels on the immediate approach to the point of derailment: over three metres, and over the wheelbase (1.8 metres, short base twist) and bogie centres (11.5 metres, long base twist) of a JGA wagon.

Figure 18: Track cant on the Up Courthill Loop line

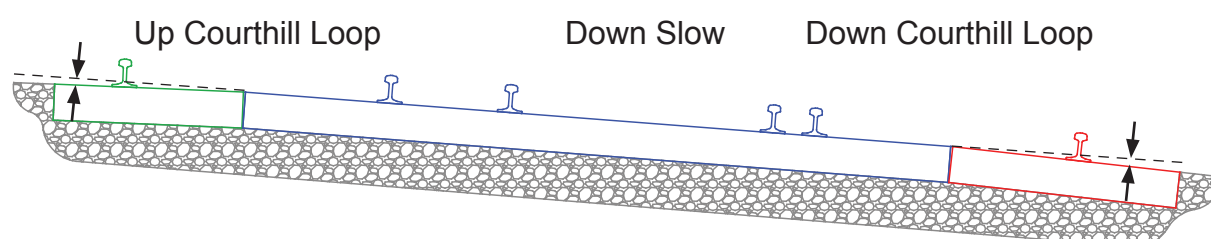
- 106 The bearer closest to the point of derailment supports three lines. It has a bearer tie in the four-foot of the Up Courthill Loop line as well as in the four-foot of the Down Courthill Loop line. The bearer section supporting the Down Slow line is continuous in between (figure 6). The RAIB analysed the track measurement trolley recordings made during the follow-up work (paragraph 35) and the void measurements and track measurement trolley recordings made after the derailment (paragraph 47). With reference to figure 19, it found that, at the time of the follow-up work, the cant on the individual lines on the bearer varied: the static cant on the Up Courthill Loop line was less than that on the Down Slow line (in the middle of the bearer), and the static cant on the Down Courthill Loop line was more. The different amount of cant on each line is explained by the fact that the bearer ties were acting as hinges, which allowed the bearer sections to rotate relative to one another. By the time of the derailment, the static cant on the Up Courthill Loop line had reduced considerably further. The dynamic cant was even less, evidencing how vulnerable the short bearer section under the left-hand rail was to inadequate track bed support.

Cant (mm)	Up Courthill Loop	Down Slow	Down Courthill Loop
At follow-up weekend	45	49	59
Post-derailment (static)	37		
Post-derailment (dynamic)	29.5

Figure 19: Track cant on the bearer closest to the point of derailment

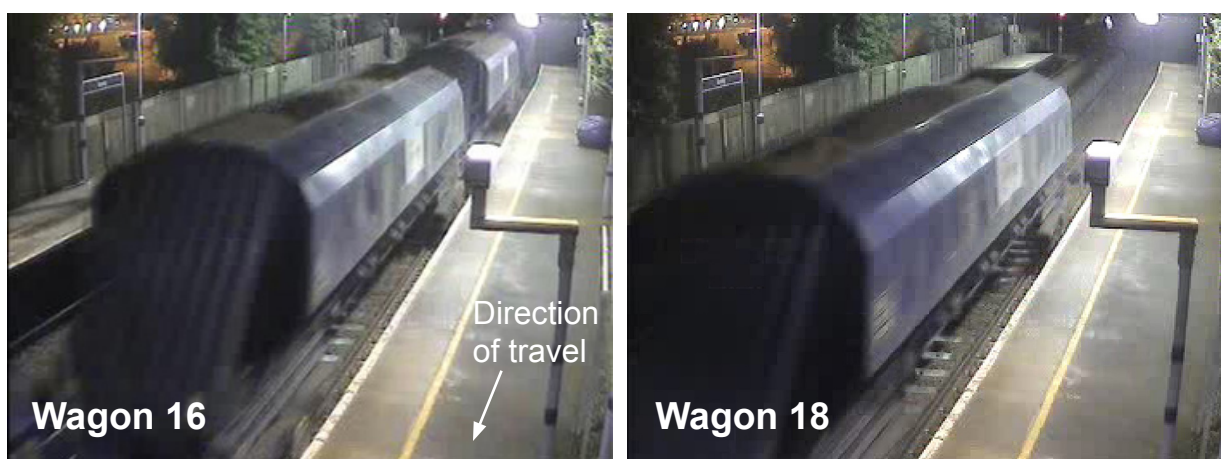
- closed circuit television (CCTV) images of train 6M90 passing Bexley station, which show the profile of the sand in wagons 16 and 18 was similar (figure 20); and
- that wagons 16 and 18 were loaded using the same process (paragraph 38).

Figure 20: CCTV images of train 6M90 passing through Bexley station on 24 January 2017 (images courtesy of London and South East Railway Limited)
