Rail Accident Report

Accident to a track worker near Redhill 24 June 2014

Report 06/2015
June 2015

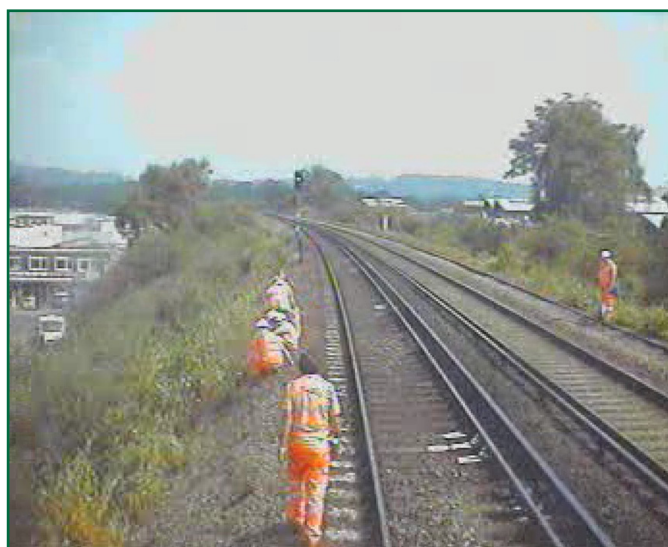
- 35 The COSS watched the approach of train 1U53. The section supervisor continued to walk north alongside the track, with his back to the approaching train (figure 2).

Figure 2: image from the train's forward facing CCTV, immediately before the accident, showing the section supervisor walking along the side of the line, the members of the gang sitting down on the embankment, and the site lookout on the extreme right of the picture

- 41 **The section supervisor was walking too close to the track with his back to the approaching train.**
- 42 The FFCCTV from train 1U53 shows the section supervisor apparently unaware of the approach of the train, walking steadily along with his back to it. He is unable to remember exactly what he was doing, but witness evidence indicates that he had taken one measurement of lengths of rail to be replaced and was on his way to mark up and measure the next section. He was carrying a spray can of white paint in his right hand when he was struck; this burst and provided an indication of the location of the point of impact.

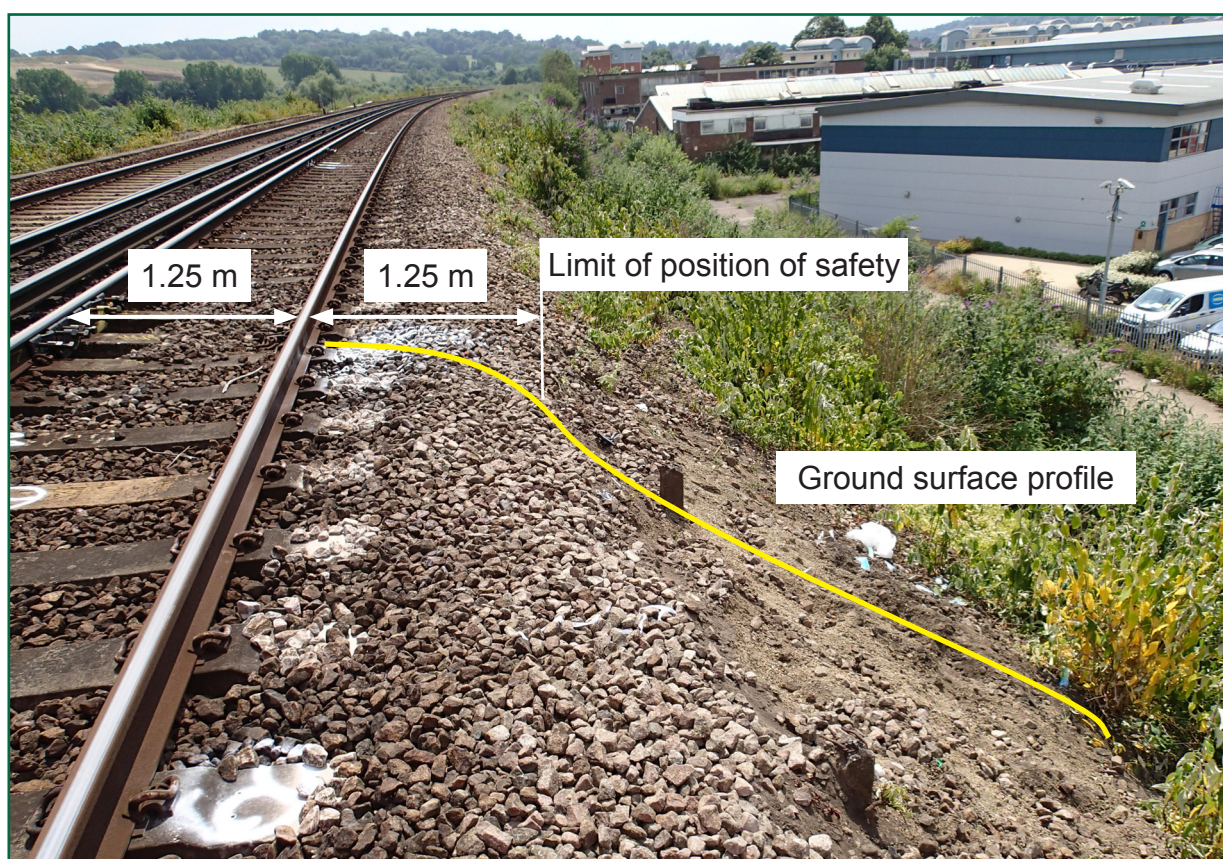
- 69 **The cess at this location is narrow and treacherous, and not suitable as a position of safety.**
- 70 To be clear of the track and in a position of safety, a person must be⁹ at least 1.25 metres from the nearest rail (on lines where trains run at up to 100 mph). At the location of the accident, the ground drops steeply away from the track, less than one metre from the sleeper ends, as shown in figure 3.

- 71 At this location, to reach a position of safety requires scrambling down the slope of the embankment. The surface consists of loose earth and ballast, making it treacherous and difficult to stand on. To walk alongside the track, it is necessary to be on or just beyond the ends of the sleepers. Walking along the slope is almost impossible (after the accident, the emergency services passed the casualty, on a stretcher, under the train that was standing at the site. This was because it was not possible to carry it safely along the cess to go round the front of the train (see figure 6)).

Figure 3: Location of accident, showing ground profile

- Review each section of line where work while trains are running is authorised, and assess the availability and suitability of the locations that are required to be used as a position of safety. Where these are found to be inadequate, Network Rail should prohibit work while trains are running.
- Ensure that staff responsible for establishing a safe system of work on site are explicitly prompted to consider potential hazards that might call into question the suitability of the position(s) of safety throughout the site (such as the number of people required to use it/them, and whether the ground is reasonably level, in good condition underfoot and free of obstructions) before permitting work to commence (paragraphs 115b, 115c).

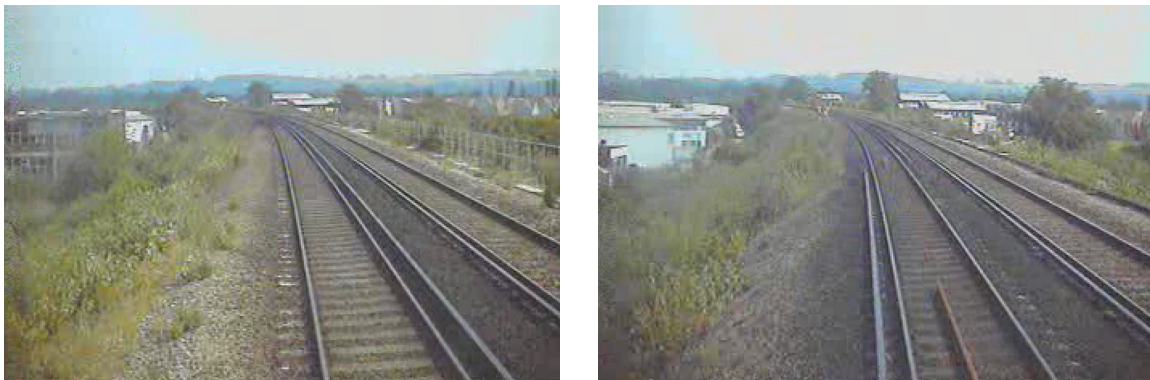
81 The train approached the work group round a left-hand curve. The group became visible to the train crew about seven seconds before the accident occurred (figure 4, left). The site lookout acknowledged the train's approach by raising his flag. From the FFCCTV evidence, it appears that only when the train was about four seconds' running time from the group did the position of the section supervisor, separate from the others, become visible to the trainee driver and the driver-instructor. The driver-instructor then realised that the person he could see to the right of the other figures was possibly too close to the track (figure 4, right).

Figure 4: FFCCTV images, seven seconds before the accident (left) and four seconds before the accident (right)

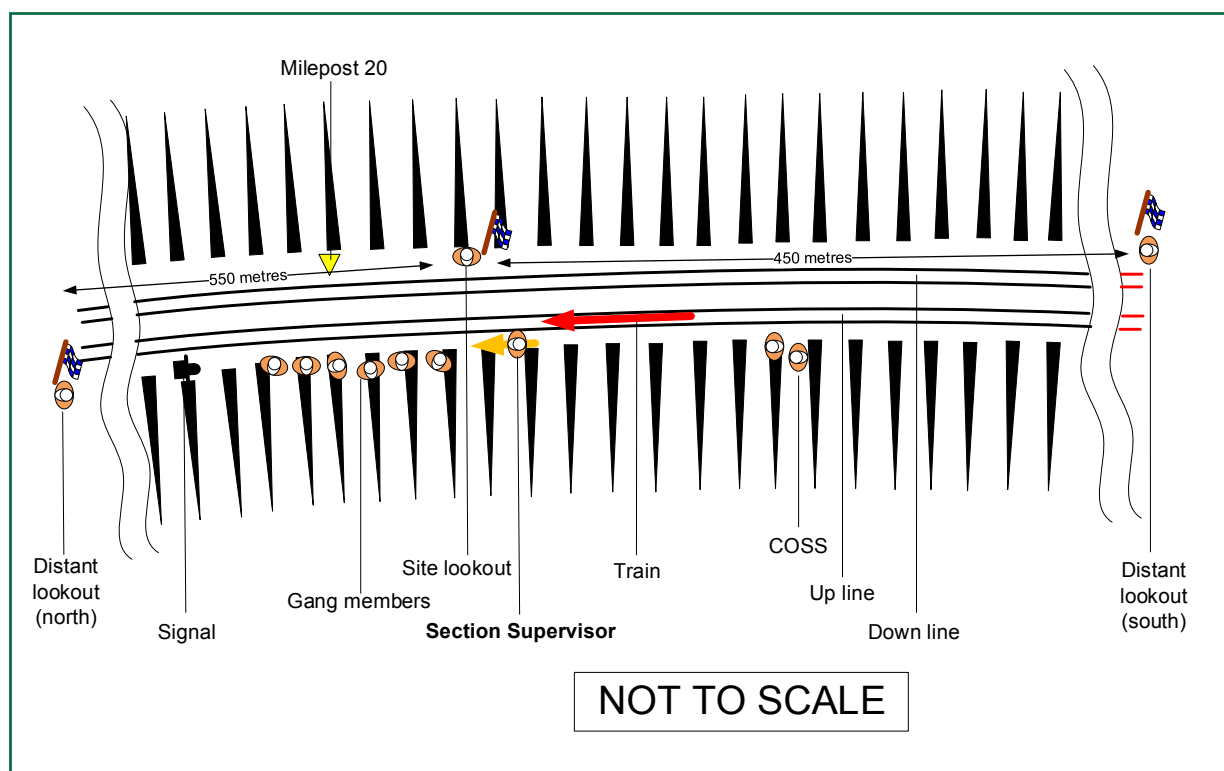
Figure 5: The accident site, showing the relative positions of the people involved

- 90 In this case, the site lookout gave the initial warning of the up train and saw that everyone was still in the position of safety after the passing of the previous down train. He says that he then turned towards the north to maintain visual contact with the distant lookout in that direction, in case another down train was approaching. He turned back towards the up train and raised his flag to acknowledge it as it came close. He states that he was not aware that the section supervisor was walking along the other side of the line. Even if he had noticed him, it would have been difficult for the lookout to tell how far the section supervisor was from the track because of the angle of vision, but he states that he would have given a further warning had he realised that the supervisor was in an unsafe position.

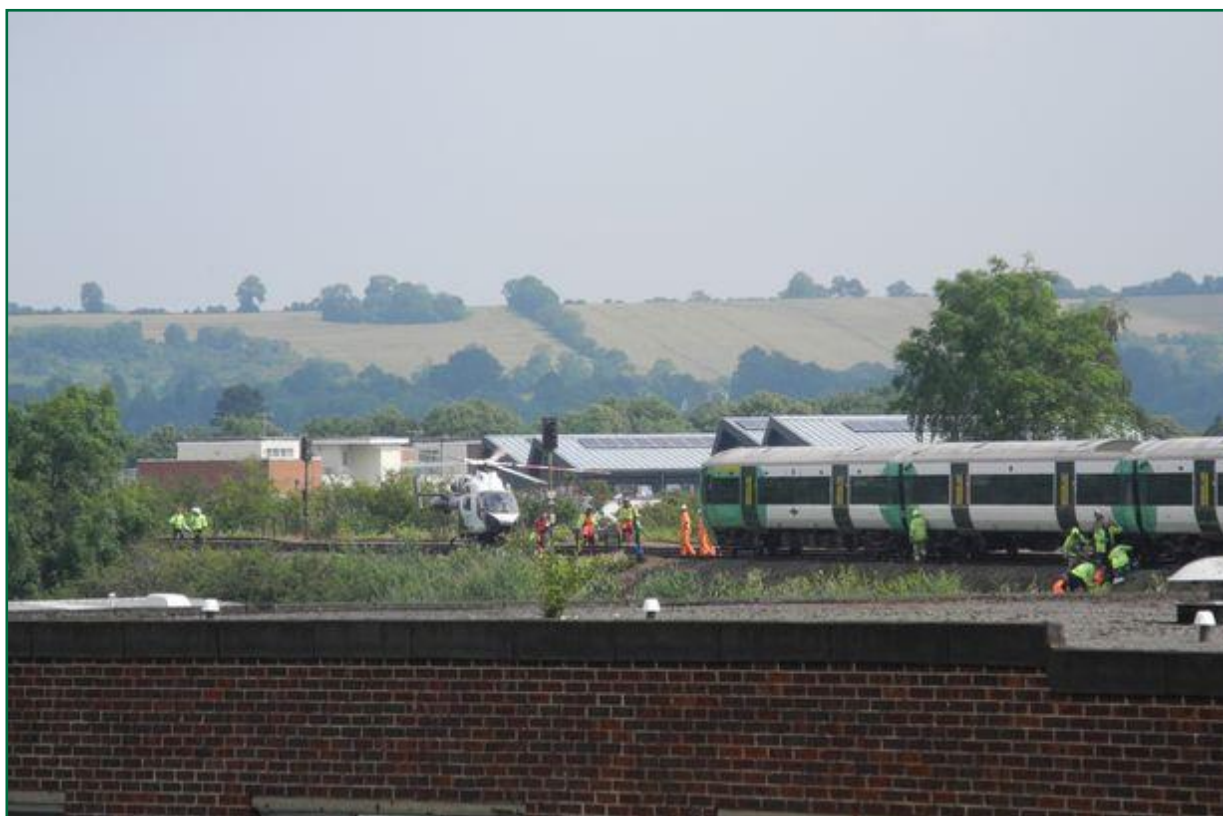
Figure 6: HEMS helicopter landing on the railway near the scene of the accident. Paramedics treating the casualty can be seen on the extreme right. The train in the picture was following the train that was involved in the accident, and had come to a stand at the signal visible in the photograph (reproduced with kind permission of the Surrey Advertiser ©Trinity Mirror group).

- 95 The helicopter landed on the track without permission from Network Rail. A railway line is a potentially hazardous place on which to land a helicopter. If trains have not been stopped, or if the electrical power to the conductor rails has not been cut off, there is the possibility of a serious accident. In this case, the power had been switched off soon after the accident. Even if these hazards have been taken into account, the tracks and ballast make up an uneven and treacherous surface, where there may be fragile troughing runs and drain covers which may not be able to support the weight of an aircraft. For these reasons, Network Rail strongly discourages helicopter ambulances from landing on or near railway lines.
