Rail Accident Report

**Near miss between a train and a track worker at
Shawford
24 June 2016**

Report 05/2017
March 2017

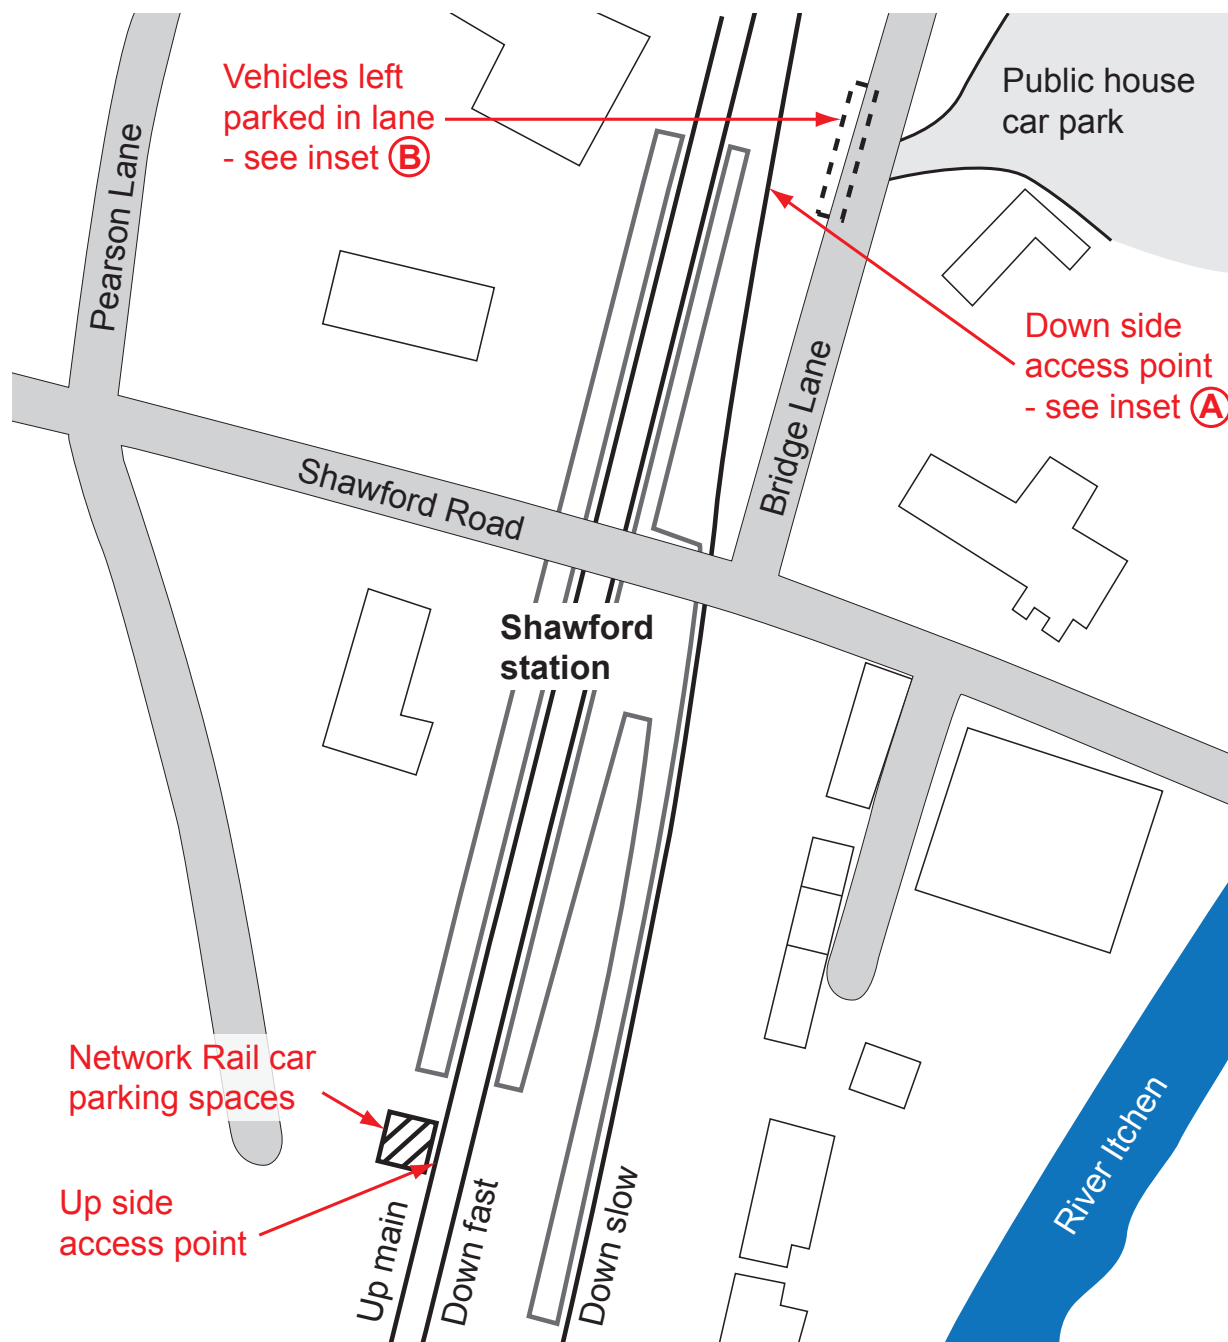
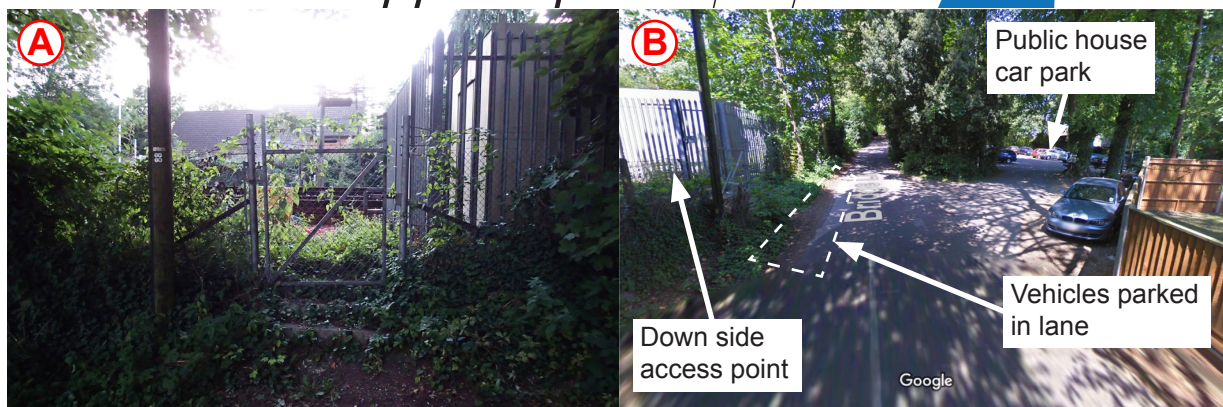
- 21 As the COSS and track worker went through the down side access gate (figure 6), they agreed to stay in the down cess as they walked. The COSS locked the gate behind him but then became distracted by checking that no other vehicles were coming along the lane. Meanwhile the track worker set off on his own, walking north along the cess, taking with him the global positioning system (GPS) coordinates for the reported rail defect and a handheld GPS unit.

Figure 6: Access points in Shawford station area

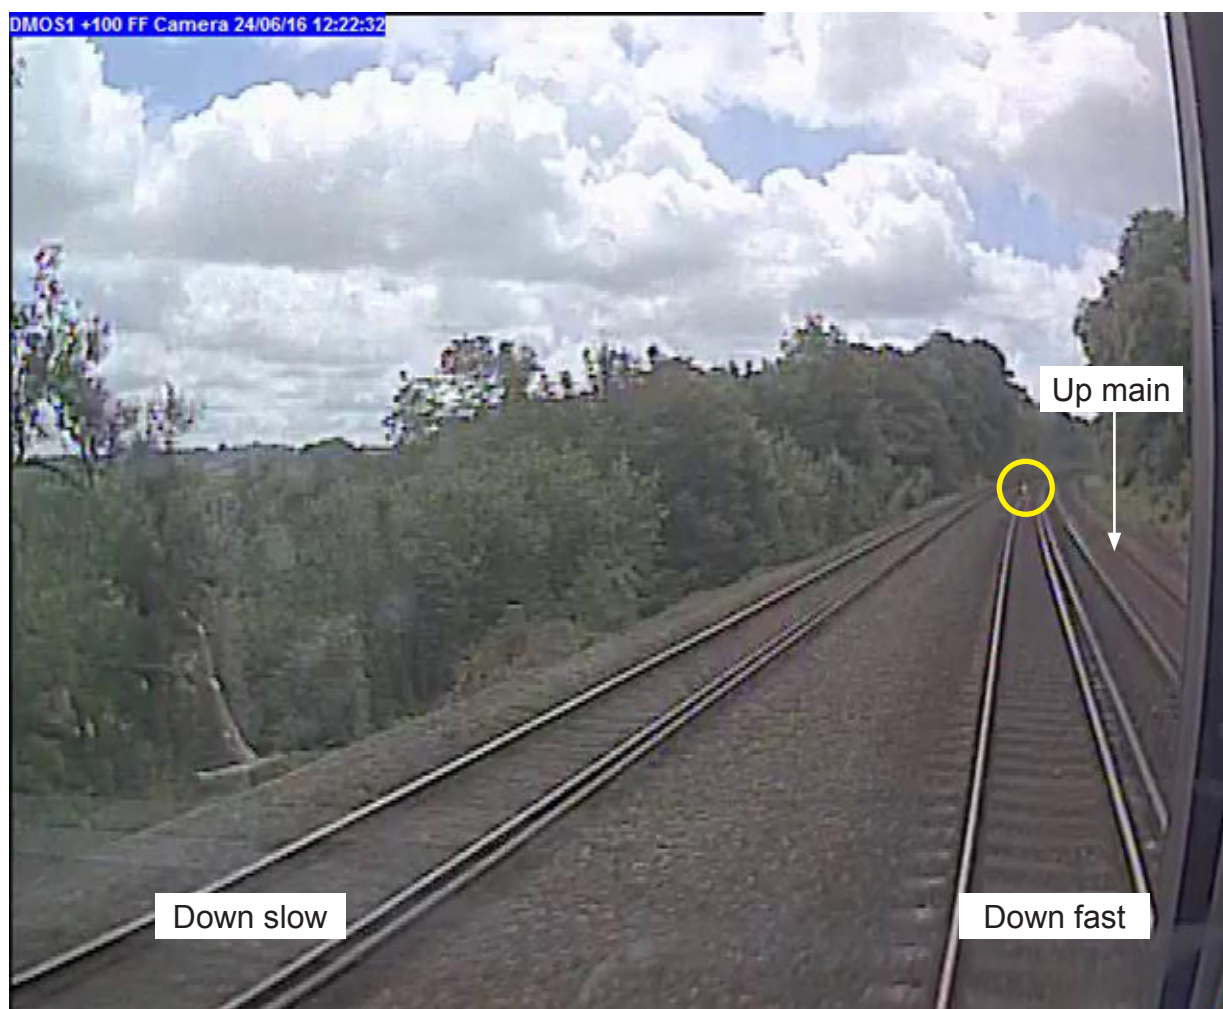
33 The forward facing CCTV footage recorded by train 1T29 shows that the track worker was standing in the down fast line as the train approached (figure 7). The track worker was stationary and was not looking up for approaching trains. This was because he was distracted by looking at the handheld GPS unit instead. The CCTV footage also shows the track worker did not respond at all when the train first sounded its horn. Witness evidence suggests that it would have been audible to him.

Figure 7: Forward facing CCTV image when train 1T29 was two seconds away from the track worker (courtesy of South West Trains)

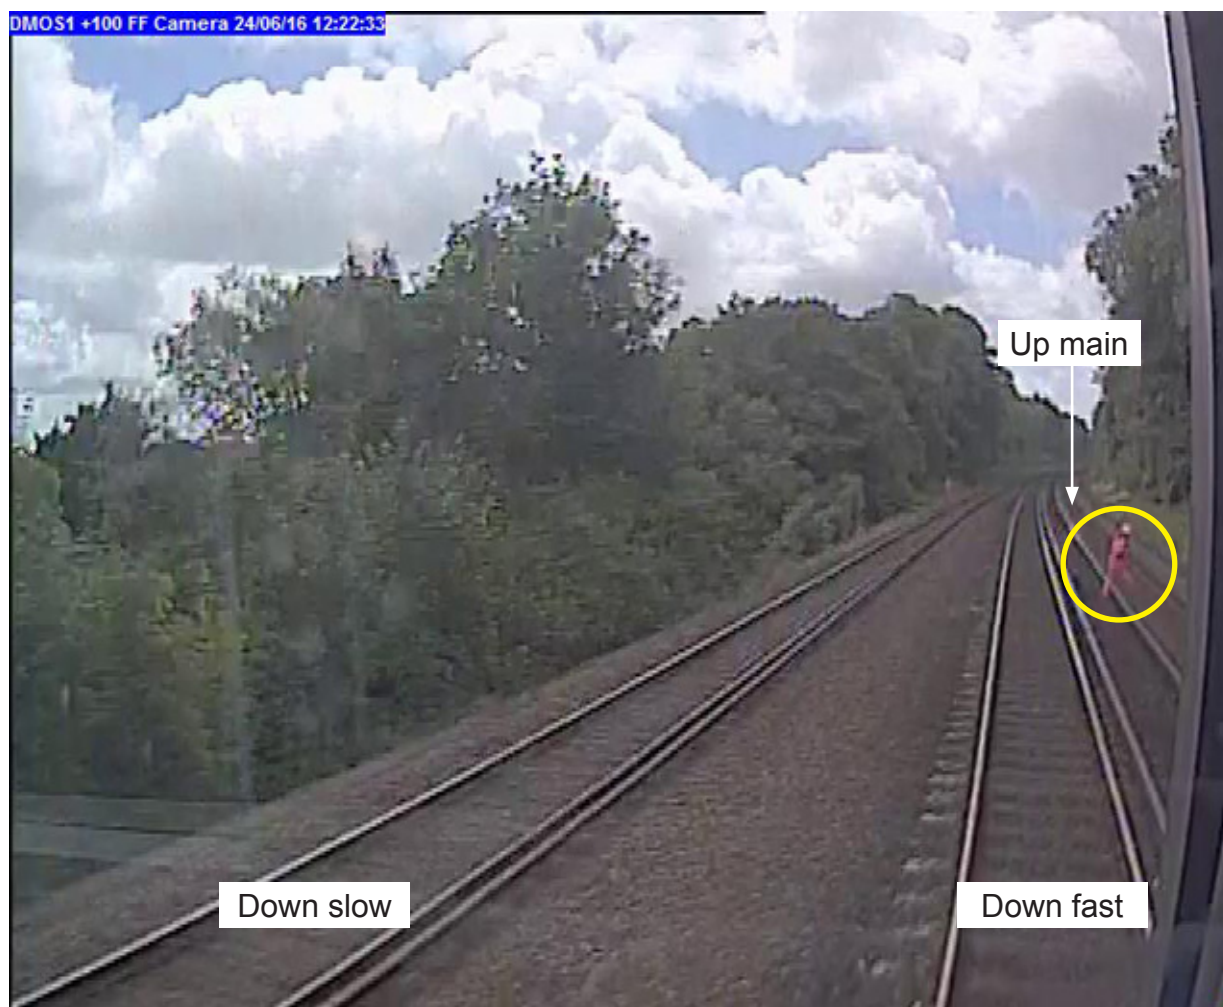
- 34 The footage shows the track worker moved clear of train 1T29 one second before the train arrived at his position, or about 35 metres in terms of distance (figure 8). When the track worker moved, he went towards the up cess. This meant he stepped over the live conductor rail for the down fast line, over a second live conductor rail into the up main line and then moved into the up cess. The up main line that he crossed was open to traffic; however, the nearest train on this line was a freight train that was about four minutes running time away.

Figure 8: Forward facing CCTV image when train 1T29 was one second away from the track worker (courtesy of South West Trains)
