## **Derailment of an empty passenger train at Paddington station 25 May 2014**

Report 03/2015  
April 2015

# **Derailment of an empty passenger train at Paddington station, 25 May 2014**

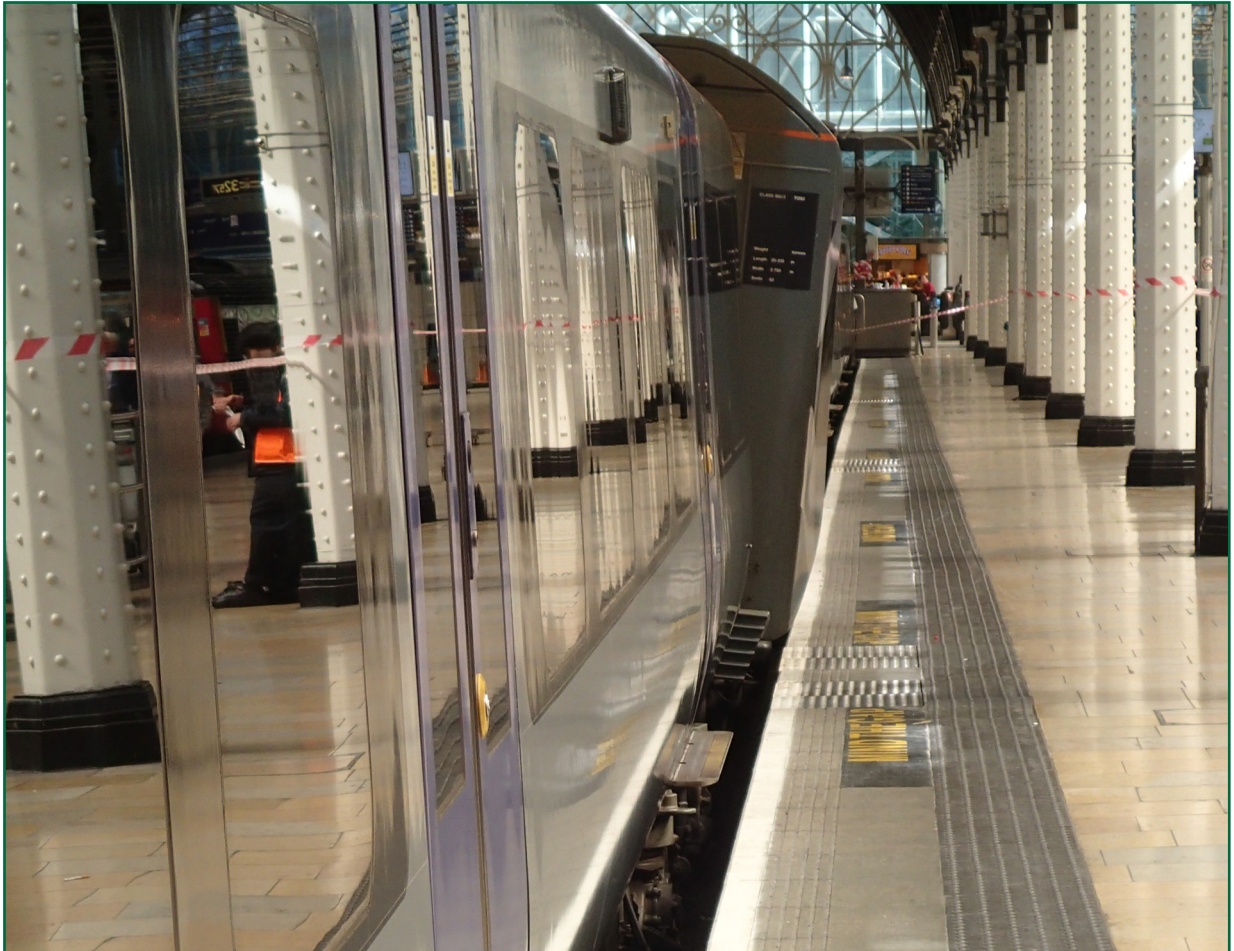
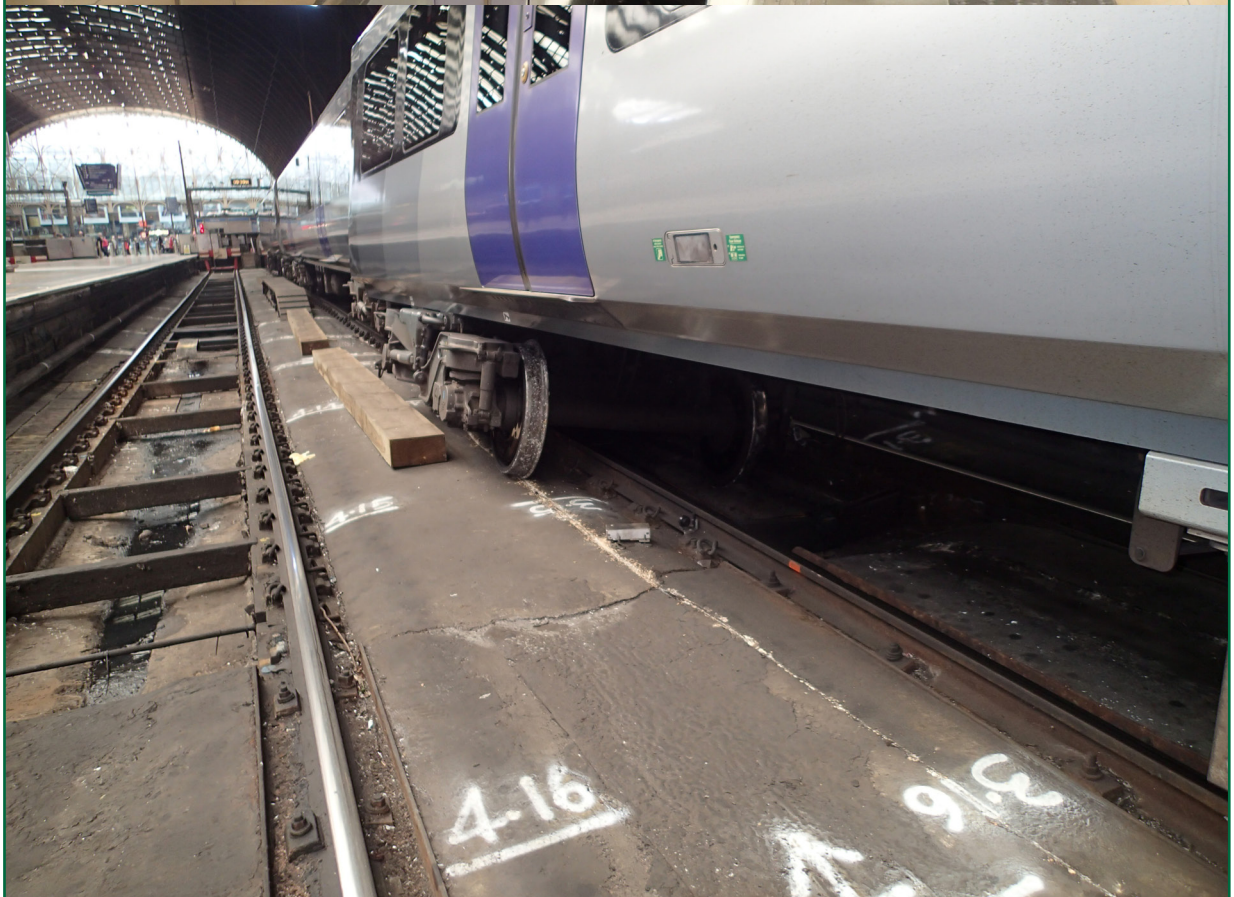
*Figure 2: Final resting position of derailed vehicle at Paddington station platform 3*

- 7 Train 5T08 was a five-car *electric multiple unit*. Both *wheelsets* on the leading *bogie* of the third vehicle derailed to the left, in the *six-foot*, on a right-hand curve (figure 2). The vehicle ran derailed for approximately 100 metres and damaged some track components in the process. There was only minimal damage to the vehicle itself.

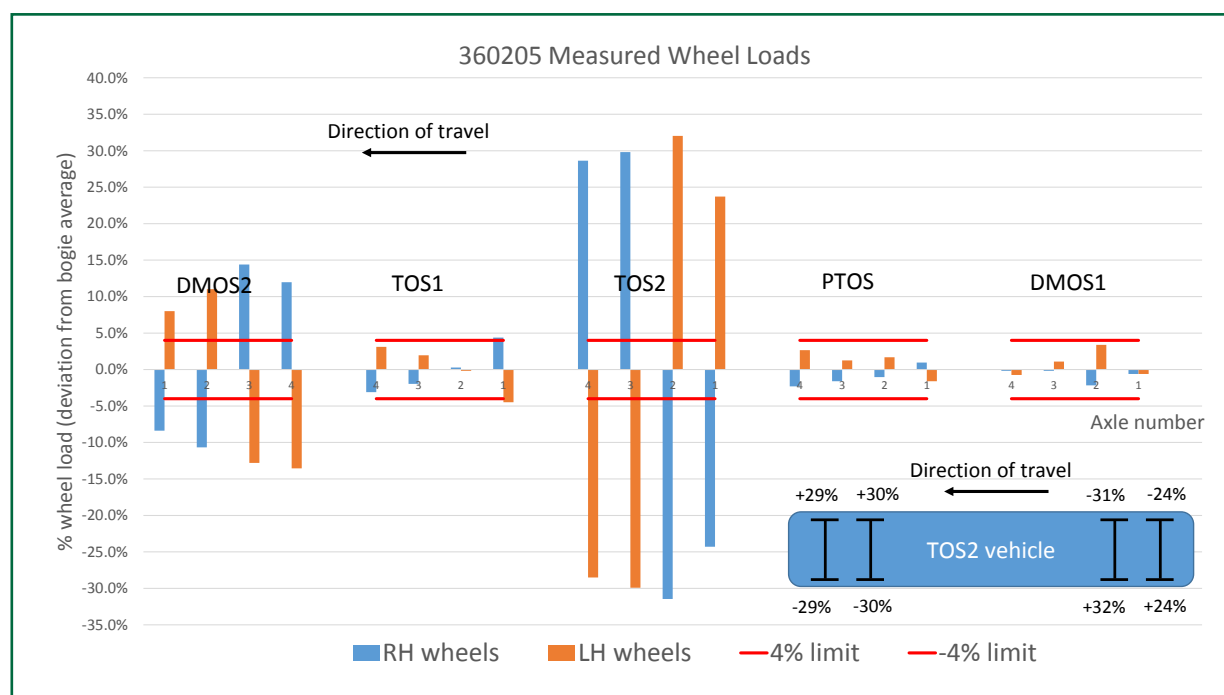
Figure 10: Wheel load distribution measured on unit 360205 after the derailment

49 **The wheels on the left-hand side of the leading bogie of the TOS2 vehicle were permanently unloaded beyond Siemens' manufacturing limits.**

50 Following the derailment, the RAIB commissioned a specialist company to measure the wheel load distribution on unit 360205 at Old Oak Common depot. The results of the measurements are shown in figure 10 as the percentage of wheel load variation compared to the average wheel load for each bogie. For reference, the acceptance criteria used by Siemens Germany when vehicles are first manufactured is also presented in figure 10 (maximum wheel load variation less than 4% of the average wheel load for the bogie – see paragraph 91).

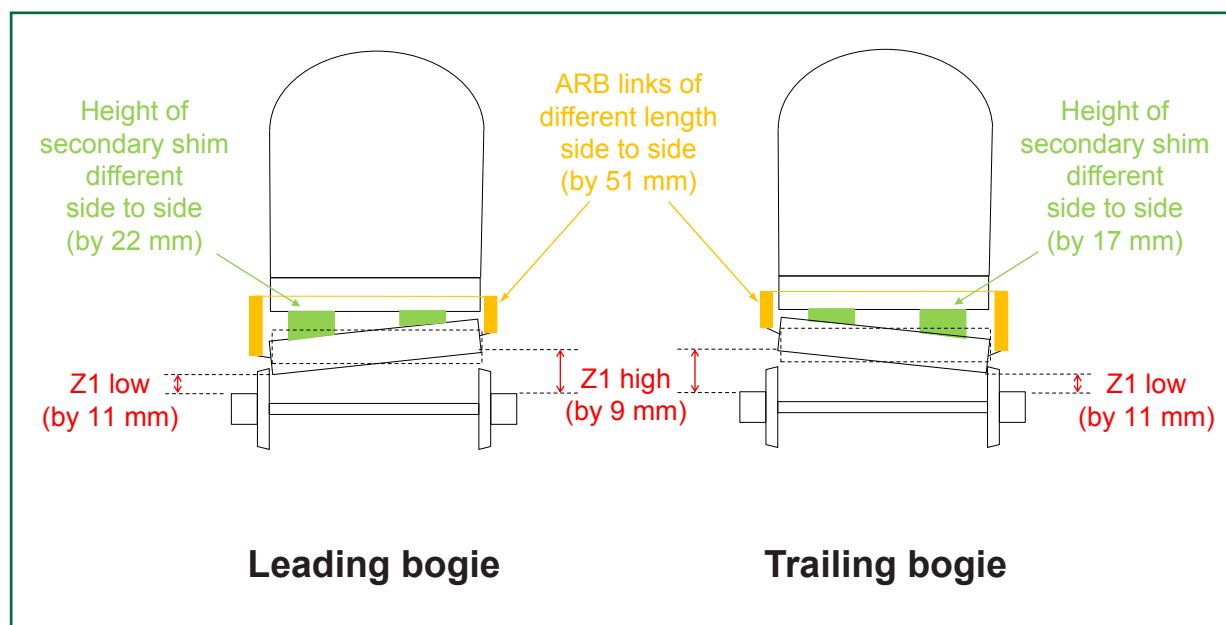
Figure 11: bogie setup as viewed from the front of the vehicle

Figure 11 schematically represents the setup on the leading and trailing bogies.

- 57 The model showed a good level of correlation with the real life situation as it predicted that the left-hand wheels of the leading bogie would be permanently unloaded by 1,200 kg (in comparison with the measured 1,250 kg). This confirmed that the setup of anti-roll bar links and shims had led to the leading left-hand wheel of the leading bogie being permanently unloaded. The analysis indicated that the dominant factor was the difference in anti-roll bar link length but the difference in shim height also contributed.

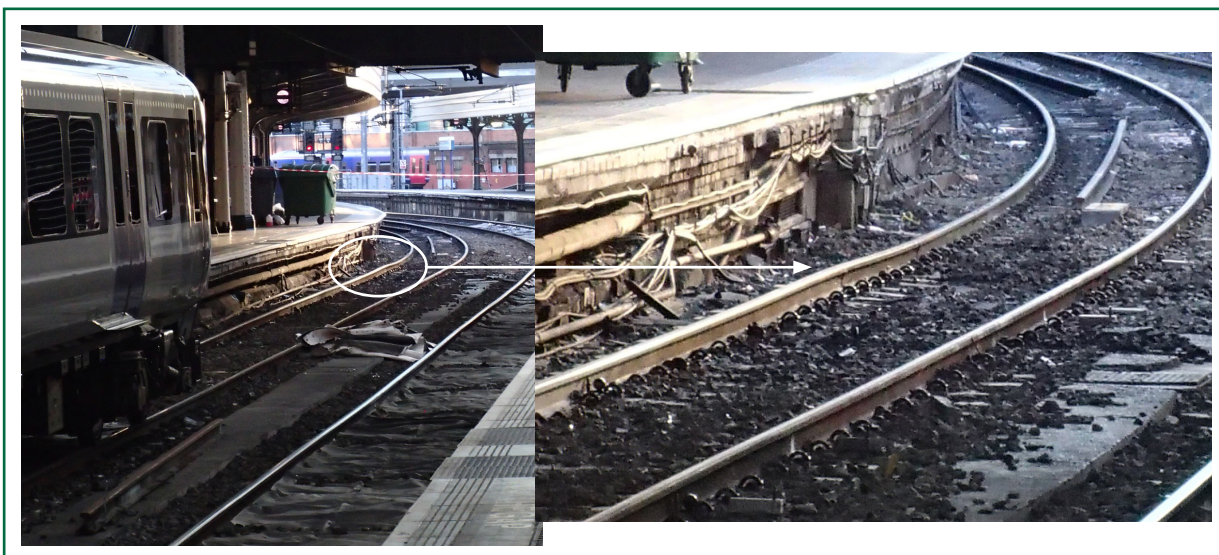
Figure 12: Track twist along platform 3

- 104 Following the derailment, the RAIB measured the track geometry on the approach to and along platform 3 using an *Amber trolley*. This identified a track twist in the immediate vicinity of the point of derailment (figure 12). The RAIB measured this track twist to be 22 mm over 3 metres. The RAIB also measured the *voids* at the derailment site to determine the dynamic track twist. Accounting for voids, the track twist became 24 mm over 3 metres.

- 105 The track twist (with or without voids) measured on site in the vicinity of the point of derailment was significantly in excess of the *intervention limit* (15 mm over 3 metres) set in Network Rail's standard NR/L2/TRK/001<sup>25</sup>. According to the standard, this level of track twist should have been attended to by Network Rail's maintenance team within 36 hours<sup>26</sup>.

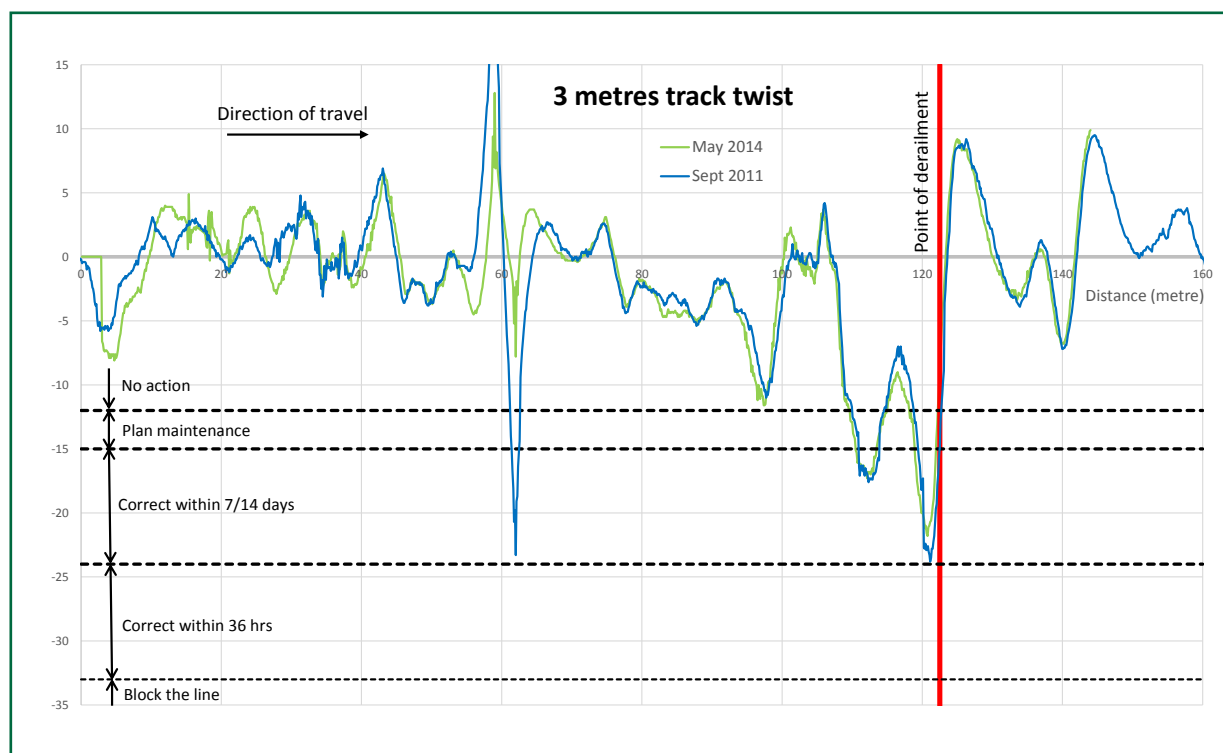
Figure 13: Comparison of 3 metres track twist in September 2011 and May 2014

108 Between September 2011 and the time of the derailment, the track at this location had been measured four times by the technical team (14 September 2011, 30 August 2012, 29 May 2013 and 26 November 2013 which was the last time the track was measured before the derailment). Since 2011, the frequency of these measurements had gradually increased to once every six months, which means that a measurement was due shortly after the date of the derailment<sup>29</sup>.

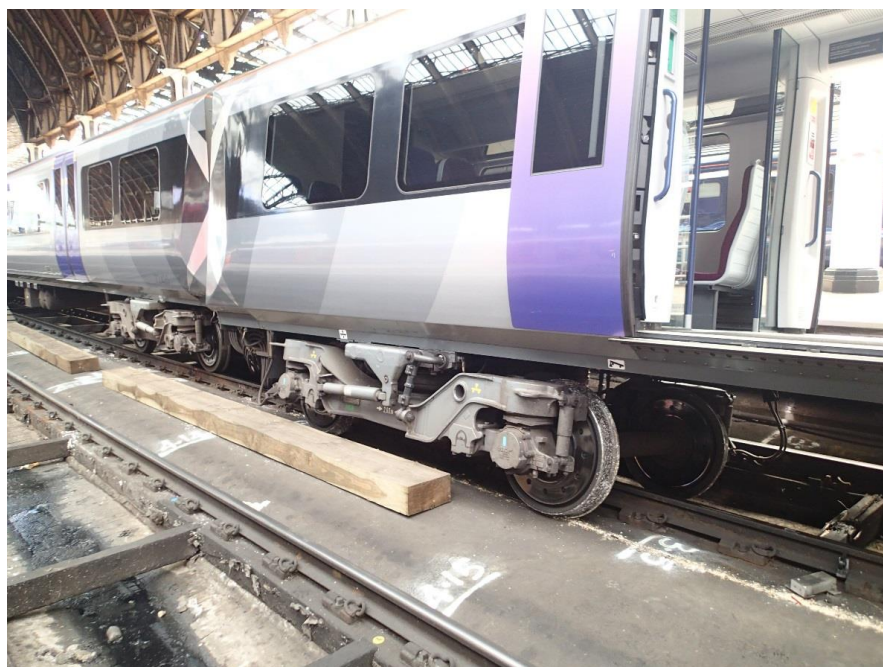
Figure 1 Unit 360205 standing at Paddington station immediately after the derailment
