Rail Accident Report

Derailment at Godmersham, Kent 26 July 2015

Report 05/2016
April 2016

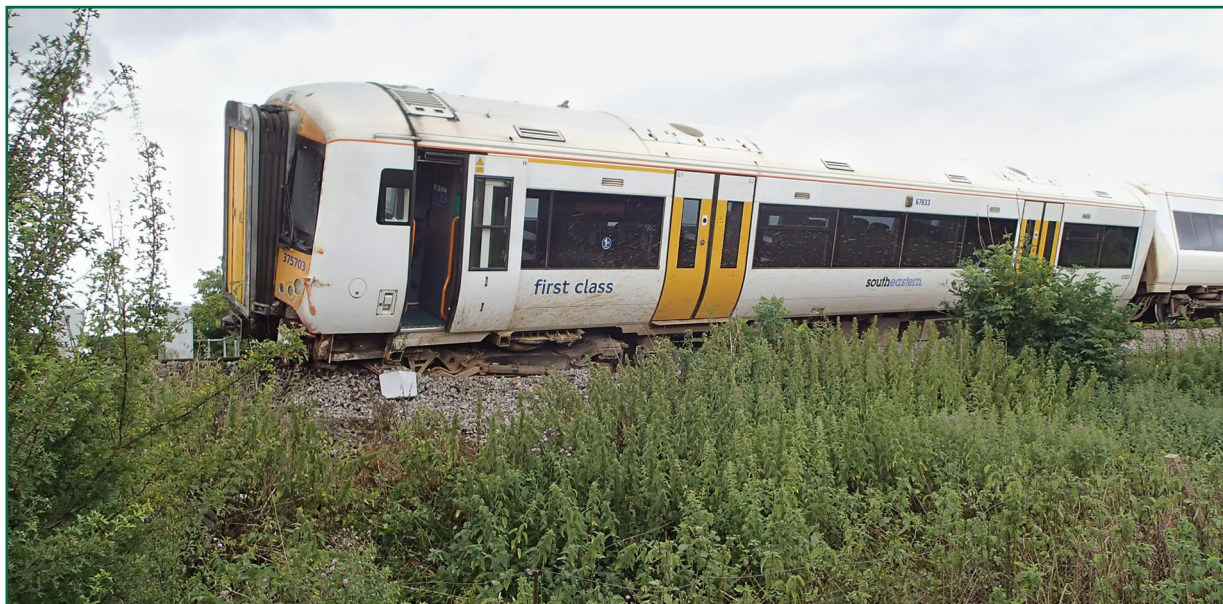
- 3 At around 21:40 hrs on Sunday 26 July 2015, train 2R66¹, the 20:10 hrs Southeastern service from London Charing Cross to Ramsgate, struck eight cows that had gained access to the railway at Godmersham in Kent, between Wye and Chilham stations (figure 1). The train travelled for approximately 365 metres after the first impact and stopped with the leading carriage, which had completely derailed, leaning about 20 degrees to the left above an embankment slope (figure 2).

Figure 2: The derailed leading carriage of train 2R66

- 13 Train 2R66 was formed of two class 375 *electric multiple units*, each of four carriages, with unit 375703 leading and 375612 trailing.
- 14 The train sustained substantial damage to the bogies and underframe equipment of the leading vehicle, as well as impact damage to the exterior of the driver's cab as a result of striking the bridge. In addition, a passenger saloon window was damaged towards the rear of the leading carriage on the right-hand side (in the direction of travel). Although the outer toughened glass pane had smashed, the inner laminated pane had not been penetrated.

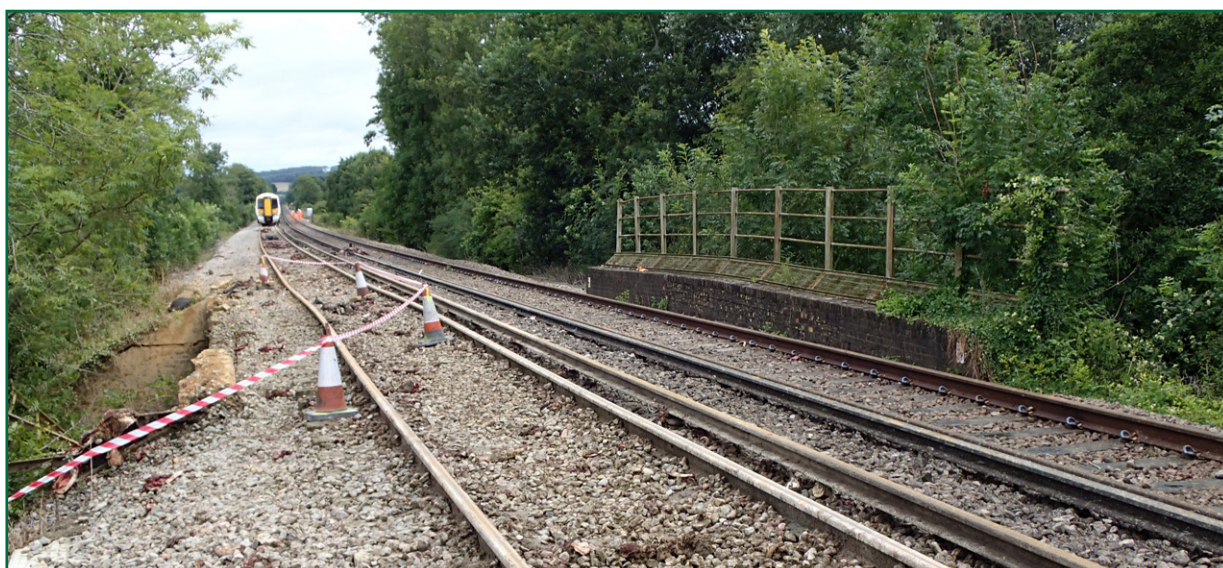
- 6 During the course of the derailment, the train struck a bridge parapet wall (known locally as Trimworth Bridge) on the *down* side of the railway, destroying the wall and its railings, and causing damage to the abutments. There was significant track damage, including deformation of the rails in the vicinity of the bridge (figure 3).

Figure 3: View of damage to the track and bridge as a result of the derailment

- 33 The derailed train was re-railed on the morning of 28 July 2015 and initially moved to Canterbury West, before being moved to LSER's depot at Ramsgate overnight on 29-30 July 2015. The damaged track was repaired and normal working was resumed on 30 July 2015 with a 50 mph (80 km/h) emergency speed restriction, which was lifted on 7 August 2015.

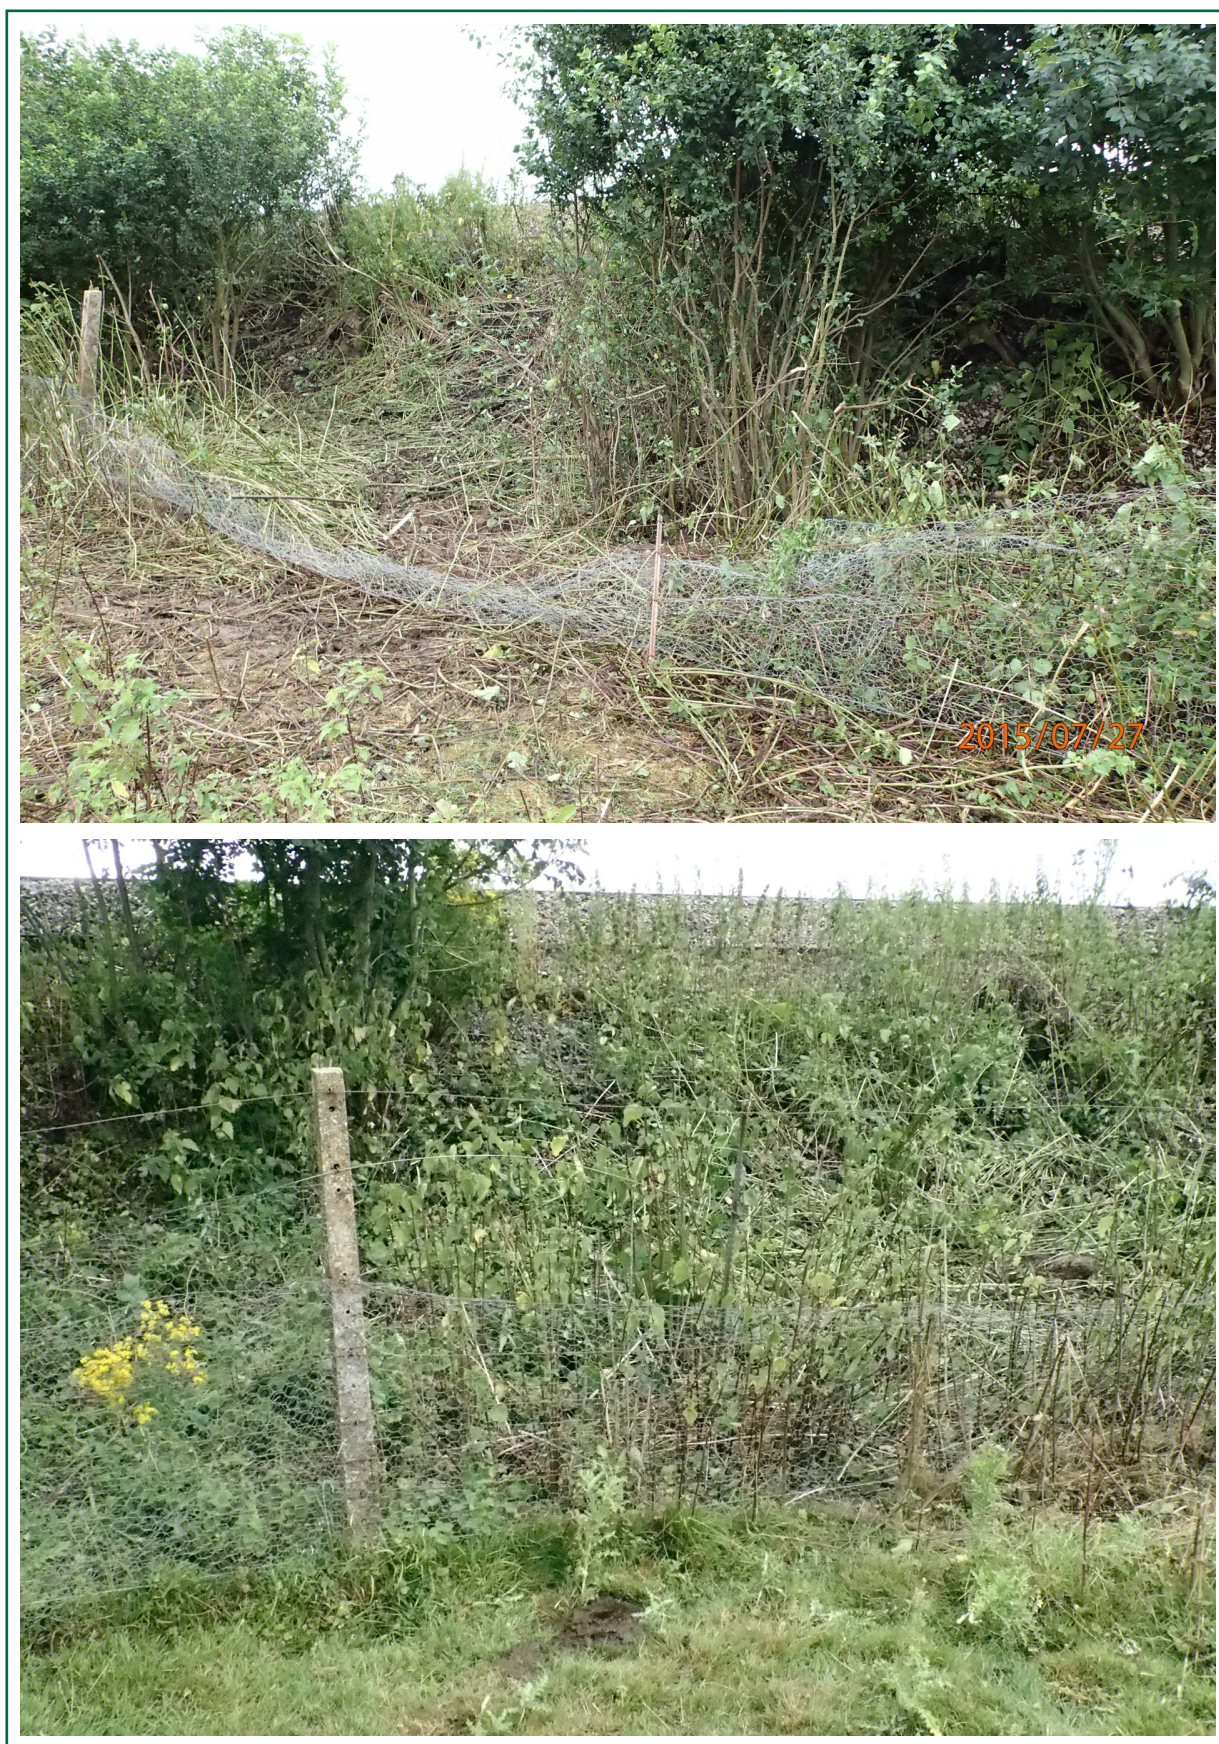
Figure 5: Sections of fence at Godmersham showing the site which was breached by the cows (top) and a representative area approximately 40 metres from the animal incursion (bottom)

- 111 Locally, the off-track section at Ashford DU has replaced around 1300 metres of boundary fence at Godmersham, which includes the site of the cow incursion, with chain link fencing. In terms of Network Rail's company standard (NR/L2/TRK/5100), this represents an upgrade to a class II barrier (see paragraph 37).

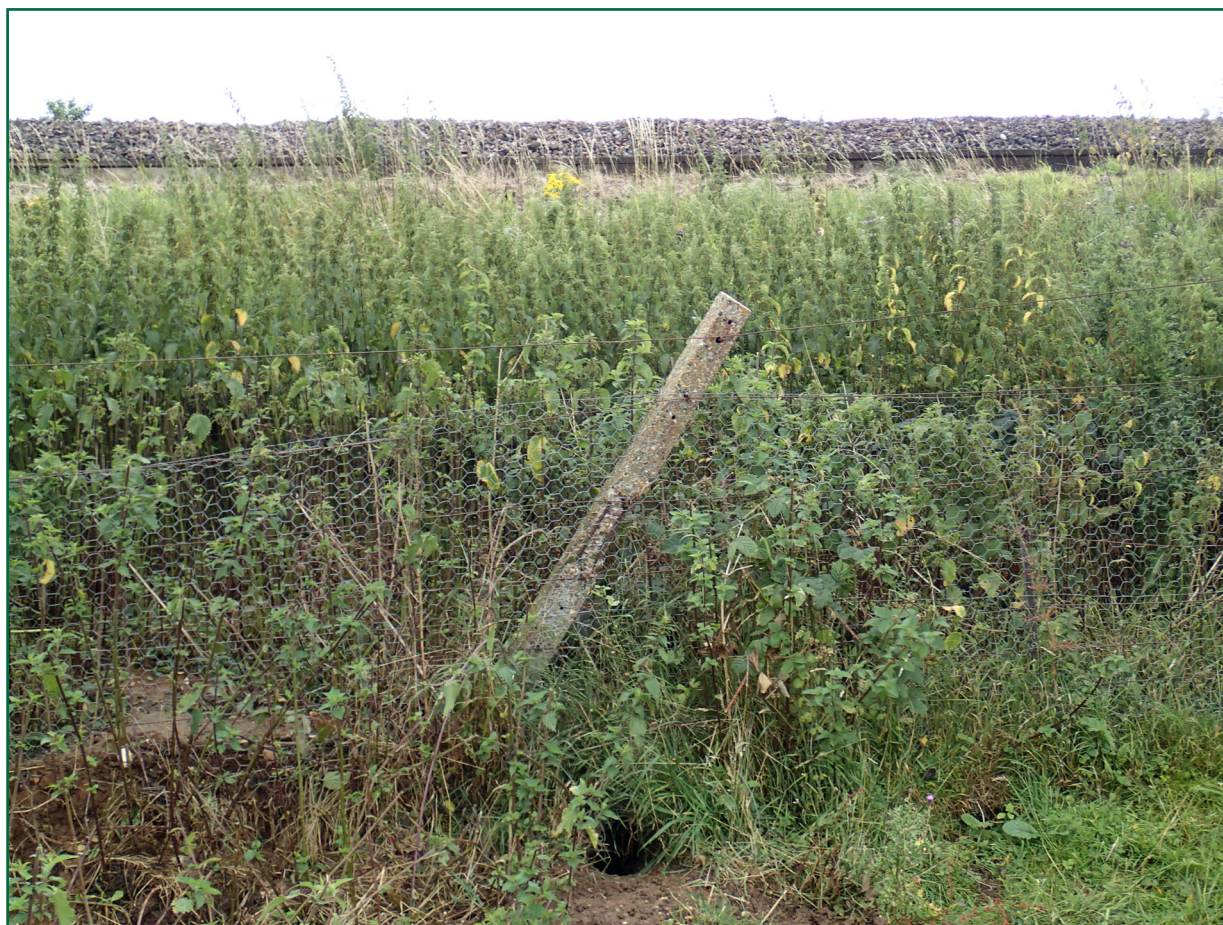
- 51 However, site observations after the accident found evidence of leaning posts, low wire tension and wire corrosion (figure 7).

Figure 7: Degraded section of fence at Godmersham (unaffected by the animal incursion)

- 52 There is no formal competence standard for fencing inspectors within Network Rail, nor is there any guidance to benchmark the condition score for a section of fence against objective criteria. In 2012, Network Rail introduced a training course on boundary inspection, which includes instruction on applying condition scores. However, to date, only a small proportion of relevant staff has completed the course; nobody in the off-track section within Network Rail's *delivery unit* (DU) at Ashford, which is responsible for this area, was aware of the course and the fencing inspector at Godmersham had not attended it. Knowledge is otherwise acquired on the job and through experience, leading to the potential for inconsistency in the ratings given by different inspectors. Similarly, there is no cross-checking or compliance reporting regarding the consistency between different fencing inspectors' assessments.

- 53 Witnesses were critical of the nominal categories available for condition ratings, with no intermediate score between 'good' and 'poor'. The system used in NR/L2/TRK/5100 is derived from earlier company standards that offered a wider scoring range, but the range was compressed when separate standards were combined into one; Network Rail has been unable to explain why the scoring system was changed in this way. The RAIB also noted the apparent ambiguity in the definition of 'poor' condition (fit for current use, but maintenance required).

- 54 The risk rating system provides little sensitivity to discriminate between maintenance priorities in an area such as Kent, where the prevalence of third rail electrification means that most of the risk scores are calculated to be of high priority (paragraphs 38 and 50). Consequently, the off-track section within Ashford DU relies heavily on subjective reports from its fencing inspectors in order to determine which fences need to be prioritised for repair or renewal. The fence at Godmersham was not identified as requiring repair or renewal.

- 112 Fencing inspectors at Ashford DU have been re-briefed to use a condition score 2 (ie poor – paragraph 38) only if the fence requires maintenance. Otherwise, the condition score 0 (ie good) should be used when no work is required.

- 113 The Ashford off-track section has also instigated a process to review its boundary risk assessments and, where necessary, accelerate the programme for repairs or renewals at high risk sites. It has also been trialling the use of additional measurement tools to quantify the condition of the fence (such as wire diameter and tension).

- 1 *The intent of this recommendation is to improve the fence inspection process such that potentially substandard fences are properly identified for repair or renewal. This might be accomplished as part of the Business Critical Rules review of standards.*

- a) the design of the fence and its appropriateness for the adjacent land use; and
- b) condition ratings based on objective and relative (benchmarked) criteria.

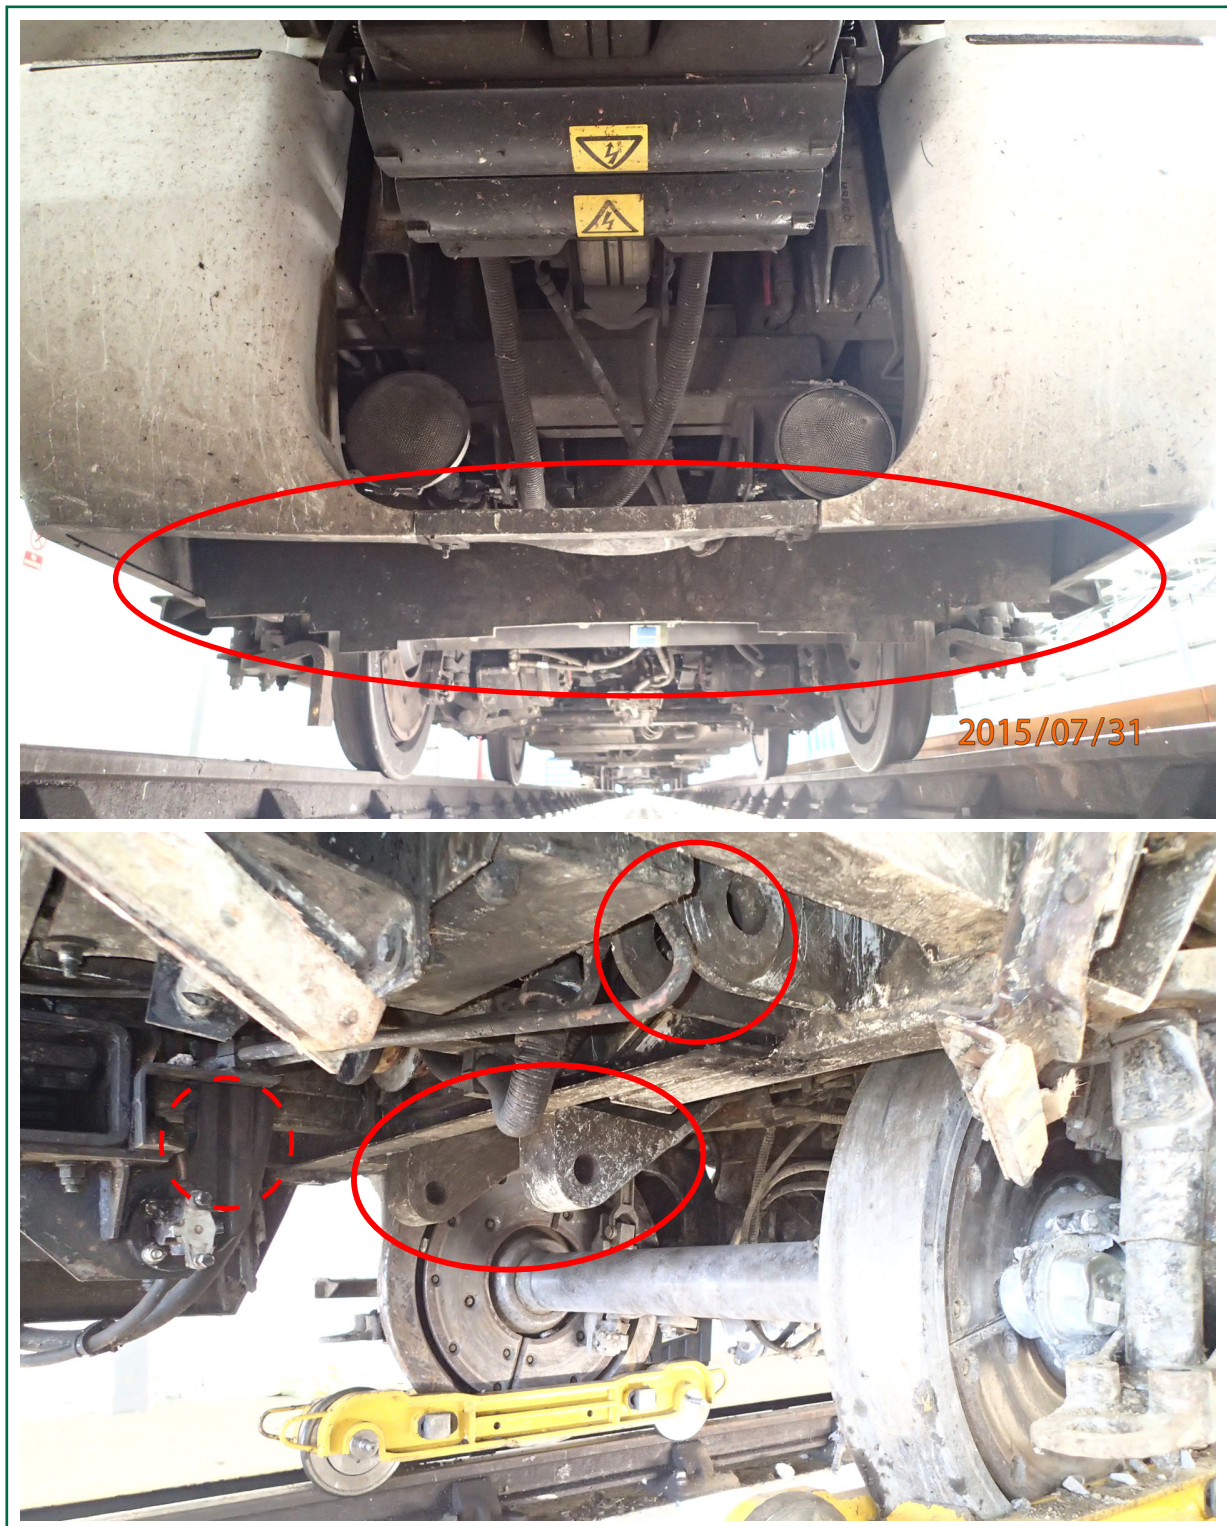
- 62 The leading unit of the train, 375703, was not fitted with obstacle deflectors, whereas the trailing unit, 375612, was equipped with them.
- 63 Obstacle deflectors are designed to shield the leading wheels and remove large obstacles (ie cars, trees and large animals) from the path of the train. Their benefit is primarily in preventing derailment as a result of such a collision. RSSB research project T189 ('Optimal design and deployment of obstacle deflectors and lifeguards') found, based on data from 1991 to 2000, that the relative derailment rate (per mile) for trains without obstacle deflectors involved in such collisions is about 75% higher than that for trains with obstacle deflectors.

- 66 Class 375 units are part of a family of units known as Electrostars, and were built between 1999 and 2005. The vehicle standards in force at the time⁸ specified requirements for obstacle deflectors in line with the Polmont recommendations (paragraph 45). These stated that obstacle deflectors should be fitted to vehicles with operational speeds of 145 km/h (90 mph) and above, unless their axleload was above 170 kN, or if they operated only on third rail lines. In the latter case, obstacle deflectors should be fitted to vehicles with operational speeds above 160 km/h. The class 375 units were specified with a maximum operating speed of 100 mph which, for the purposes of the standard, was deemed to be equivalent to 160 km/h.

- 67 According to the associated guidance note⁹ to the vehicle standard, the rationale for the easement in speed above which obstacle deflectors must be fitted to vehicles operating only on third rail lines (ie from 145 km/h to 160 km/h) is that trackside fencing on third rail lines is considered to be more secure than on other lines. Furthermore, the presence of the third rail was thought to discourage trespass (and hence reduce damage to fencing). These conclusions are drawn in a number of historical documents, including the Polmont inquiry report, and are supported by RSSB research (under project T189, using accident data for the year 2000) which found that only a small proportion of total animal strikes occur on lines with third rails.

- 68 However, RAIB's review of these historical documents concludes that the requirements for better fencing on third rail lines are primarily intended to protect against the risk of trespass by (and potential consequent electrocution of) people, especially children, rather than animals. As paragraph 37 explains, Network Rail's standard allows a lower barrier class on third rail lines when only livestock occupy the adjacent land. Analysis of data from RSSB's *Safety Management Information System* (SMIS; see table 1) covering the period 2005-2015 found no evidence that the proportion of animal strikes in the south-east region (which consists primarily of third rail lines) was significantly lower than that for the rest of England or Wales when normalised for passenger train mileage over the same period (the data suggest relatively low rates of collision across England and Wales while Scotland accounts for a disproportionately high number of animal strikes). These findings do not support the assumption that the boundary fence is more secure in the south-east, at least as far as animal incursions are concerned.

Figure 8: Comparison of the leading end of unit 375612 (top) and the leading end of unit 375703 (bottom), showing the presence or absence of obstacle deflectors respectively (obstacle deflectors and mounting brackets circled in red; one mounting bracket not visible in bottom image). Note that the unit in the bottom image is mounted on wheel skates for recovery purposes.

- 3 *The intent of this recommendation is to reduce the risk of derailment arising from collisions with obstacles for electric multiple units operating exclusively on third rail lines.*

London & South Eastern Railway Limited, in conjunction with Govia Thameslink Railway, Porterbrook Leasing Company Limited¹⁷ and Eversholt Rail Group should develop, and then implement, a programme for retrofitting obstacle deflectors to Electrostar units that are not currently fitted, but are equipped with mountings for such deflectors (paragraph 91c).
