# Rail Accident Report

## **Derailment of a freight train at Stoke Lane Level Crossing, near Nottingham 27 August 2013**

Report 02/2015  
April 2015

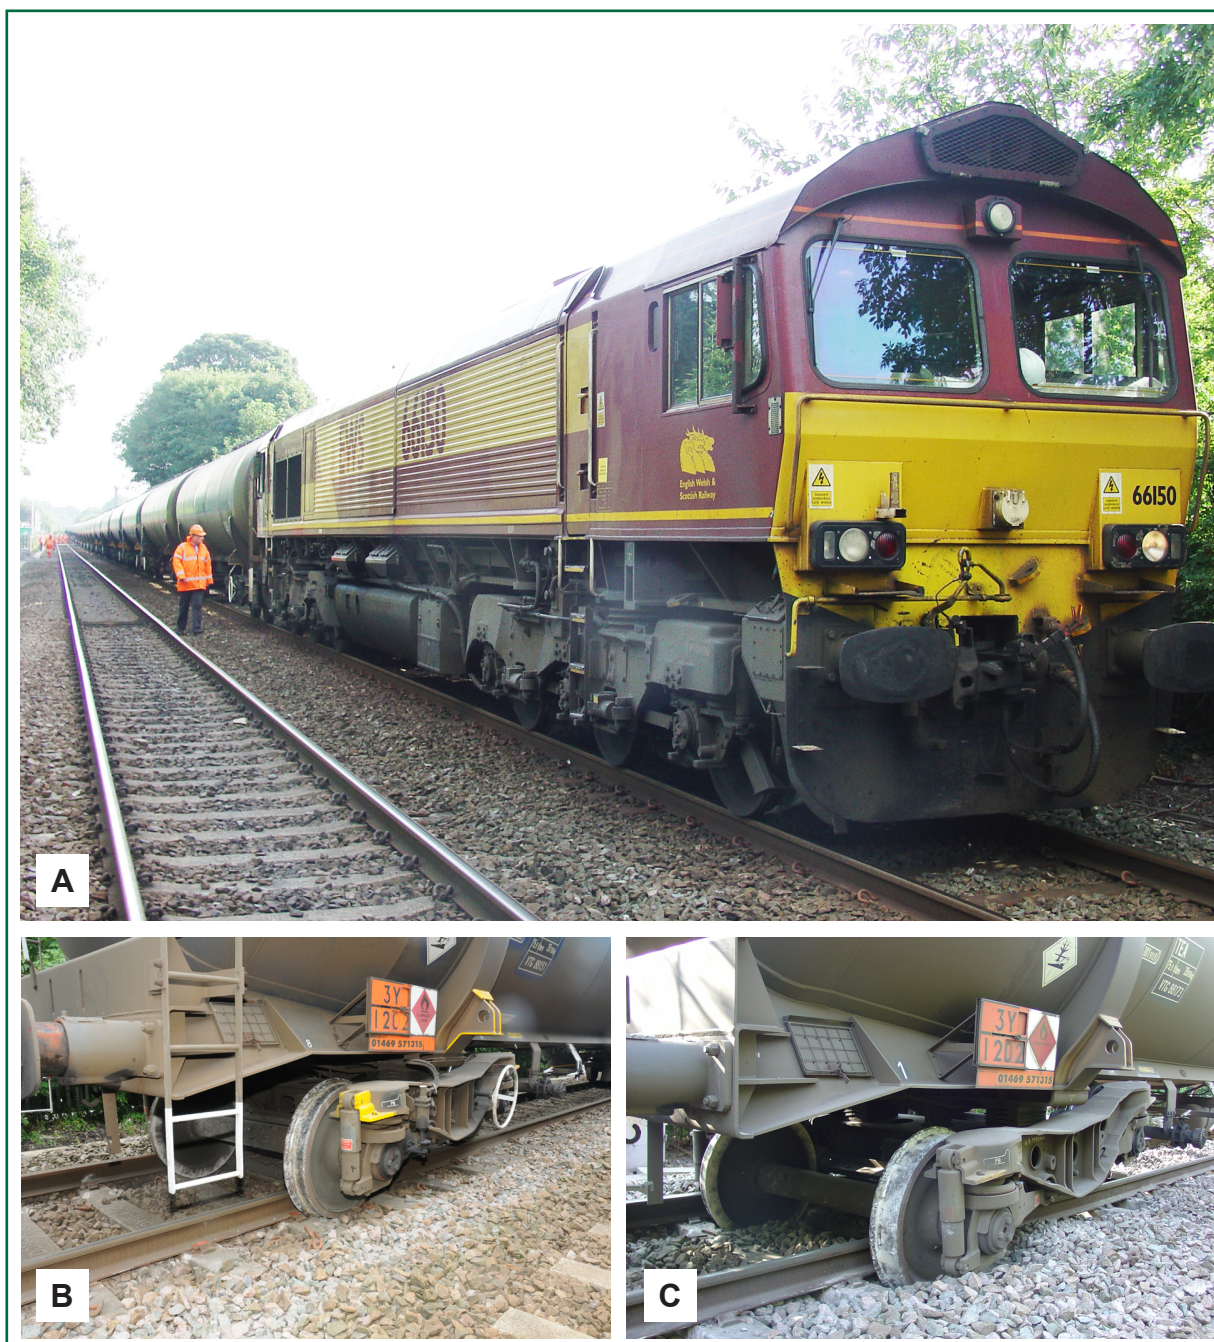
- 8 After informing the signaller of the automatic brake application, the driver went to investigate. He found the trailing axles of the 26<sup>th</sup> and 28<sup>th</sup> wagons had derailed toward the *six foot* (figure 2). The wagons had remained upright and in line and had not fouled the adjacent running line. There was no leakage of diesel fuel from any of the tank wagons, but the buffers on some had been damaged. The track was damaged by the derailed wheelsets for a distance of around 800 metres. The driver was not injured.

Figure 2: Train 6M35 (a) and its derailed wheelsets on 26th wagon (b) and 28th wagon (c)

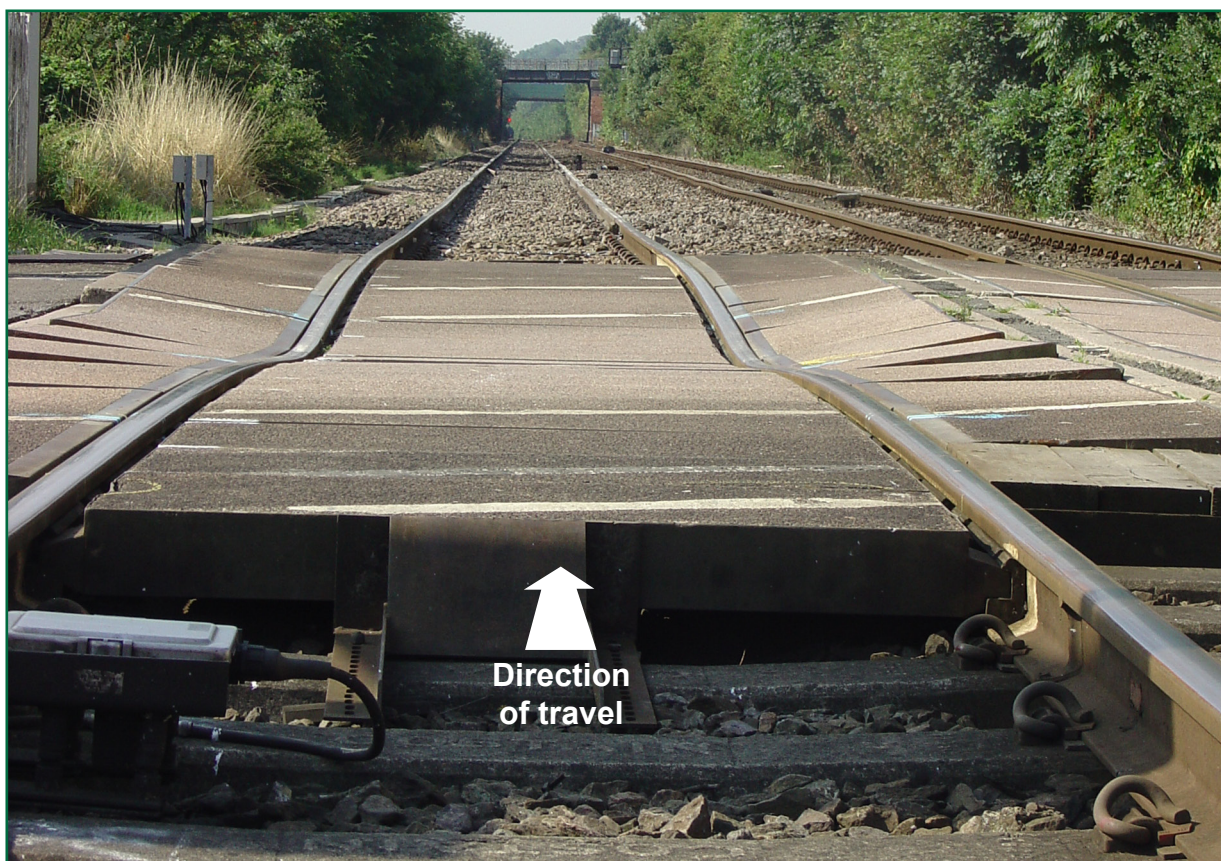
- 9 Examination of the site revealed severe dips of about 100 mm in both rails of the up line at Stoke Lane level crossing (figure 3). The rails had deformed over a void in the ground. Because of this void the track was not supported over a length of around 3 metres (figure 4). The railway remained closed for repairs until 15:30 hrs on 8 September 2013.

Figure 3: The dip in the rails at the point of derailment

- 45 The severe distortion in the rails of the up line (figure 3) was found at around 06:00 hrs. Later that day, the *level crossing panels* were removed and this revealed the large voids below both railway lines around the centre of the road (figure 4). In the following days, a significant amount of ground investigation and repair work was carried out by Network Rail and Morgan Sindall Underground Professional Services, in consultation with the RAIB, to document the voids and repair the track before the line was reopened to traffic on 8 September 2013.

- 48 **The immediate cause of the derailment was a severe dip in the track which had developed rapidly under the leading portion of train 6M35 and caused the 26<sup>th</sup> and 28<sup>th</sup> wagons to derail.**
- 49 After the derailment the maximum track dip was measured at 98 mm on the cess rail and 97 mm on the six foot rail. The actual amount of track dip that the last eight wagons of train 6M35 experienced would have been greater, due to additional deformation caused by elastic bending of rails under the weight of the wagons.

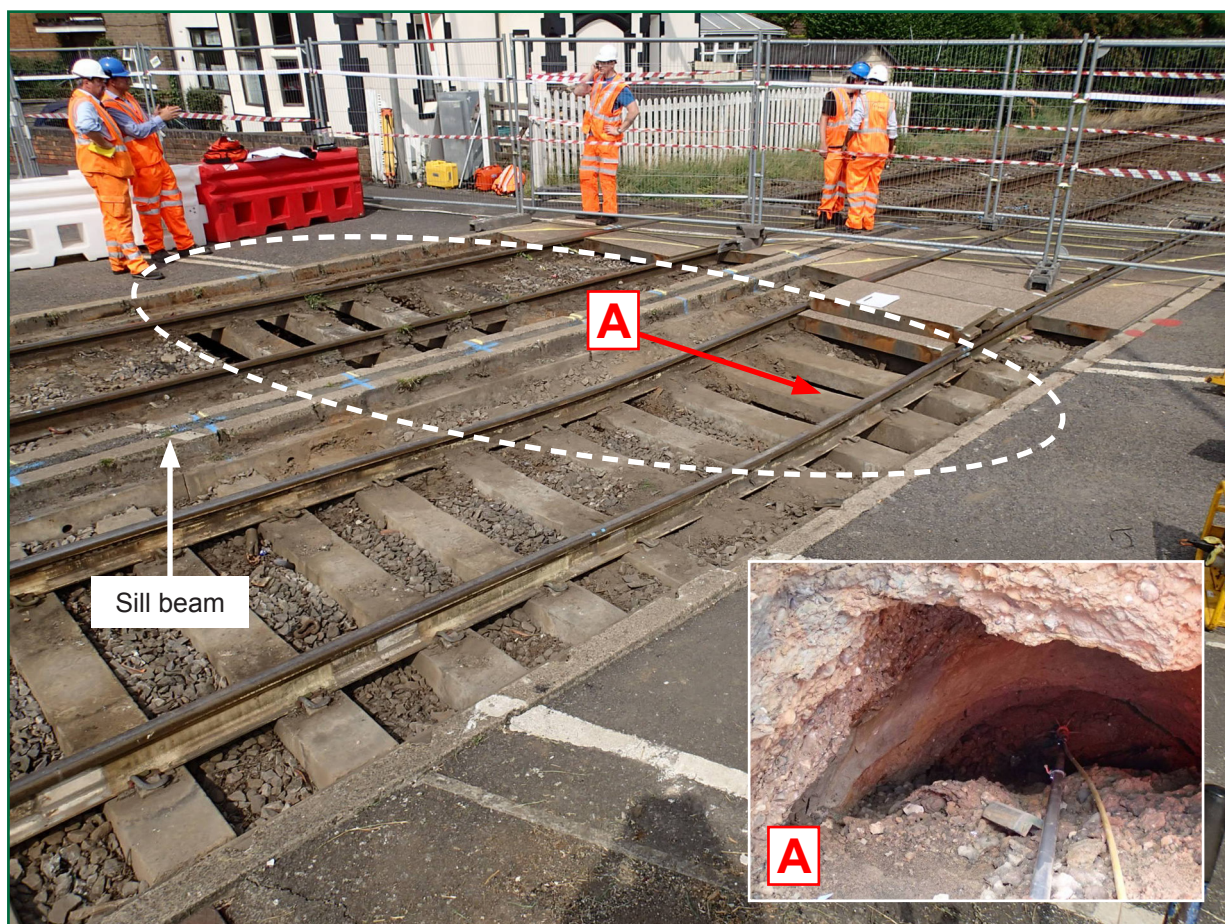
Figure 4: Extent of voiding below the track at the crossing

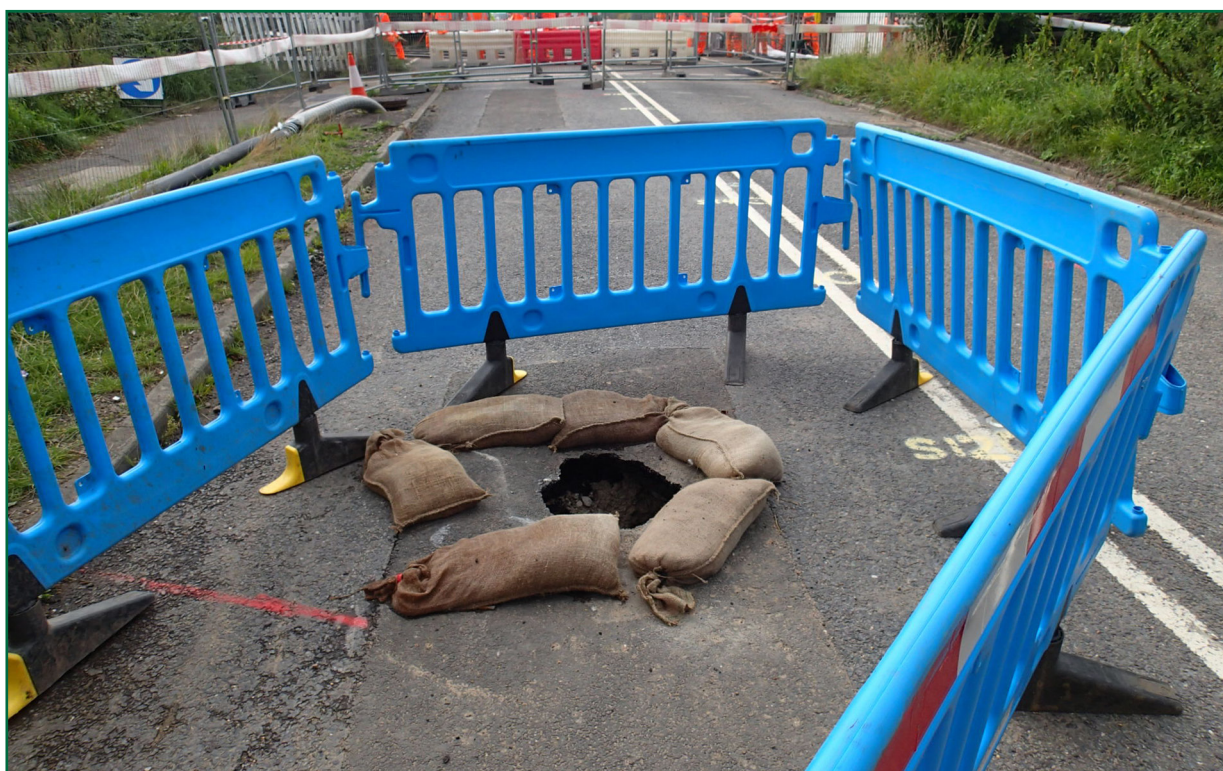
- 37 On 8 August, Bridgeway Consulting staff found a hole in the road located at one end of the trial excavation (paragraph 29) over the twin siphon closest to the launch shaft (figure 8). The position of the hole in relation to the siphons is shown in figure 5. On closer examination, the Bridgeway Consulting staff found the hole had loose material inside it which appeared to come from the reinstated road sub-base material and that there was a void below the surface which sloped downwards and toward the centre line of the road. Bridgeway Consulting called a site meeting the same day with representatives from Morgan Sindall Utilities and Nottinghamshire County Council, to examine the hole and determine the likely cause of the defect. The opinion of the two contractors' representatives at the meeting was that the hole had originated at the trial excavation due to inadequate reinstatement of the excavation and that both the hole and the void were not linked to the tunnelling activity. Nottinghamshire County Council's representative was uncertain as to the cause of the hole and subsequently sought further views from the involved parties. However no party accepted responsibility and the matter was unresolved when the derailment occurred. Severn Trent Water and F&B Tunnelling Solutions were informed of the hole. Network Rail was not informed and remained unaware of the hole until after the derailment.

Figure 8: Hole in the road found on 8 August 2013 (photograph taken on day of accident)

- 71 There were two other factors which affected the decisions made by the involved parties about the severity of the settlement problem:
- a) The hole that was discovered in the road on 8 August (paragraph 37) was not reported to Network Rail by either Morgan Sindall Utilities or Bridgeway Consulting, despite the joint meeting on 1 August to discuss Network Rail's concerns about the settlement. Interview evidence indicates that the reason it was not communicated to Network Rail was because it was considered by the parties at the site meeting of 8 August, that the hole had been caused by poor reinstatement of the trial excavation carried out prior to the tunnelling work and because it was quite far from the crossing. Examination of the hole after the derailment revealed that the trajectory of the void was steeply downward towards the centre of the road and the tunnel and not into the remainder of the trial excavation. Had more rigorous consideration been given to the cause of the void, a possible link to the tunnelling operation should have been apparent. This was a missed opportunity to provide potentially valuable information to Network Rail about what was happening at Stoke Lane almost three weeks before the derailment. Had Network Rail been informed about the hole in the road, and the trajectory of the void below, it may have led to lifting the level crossing panels sooner than the planned 9 September possession.

- f) Where there is an unexpected event such as the appearance of a surface hole in the vicinity of a tunnel, this should be investigated immediately and thoroughly, to identify the cause and any associated risks.

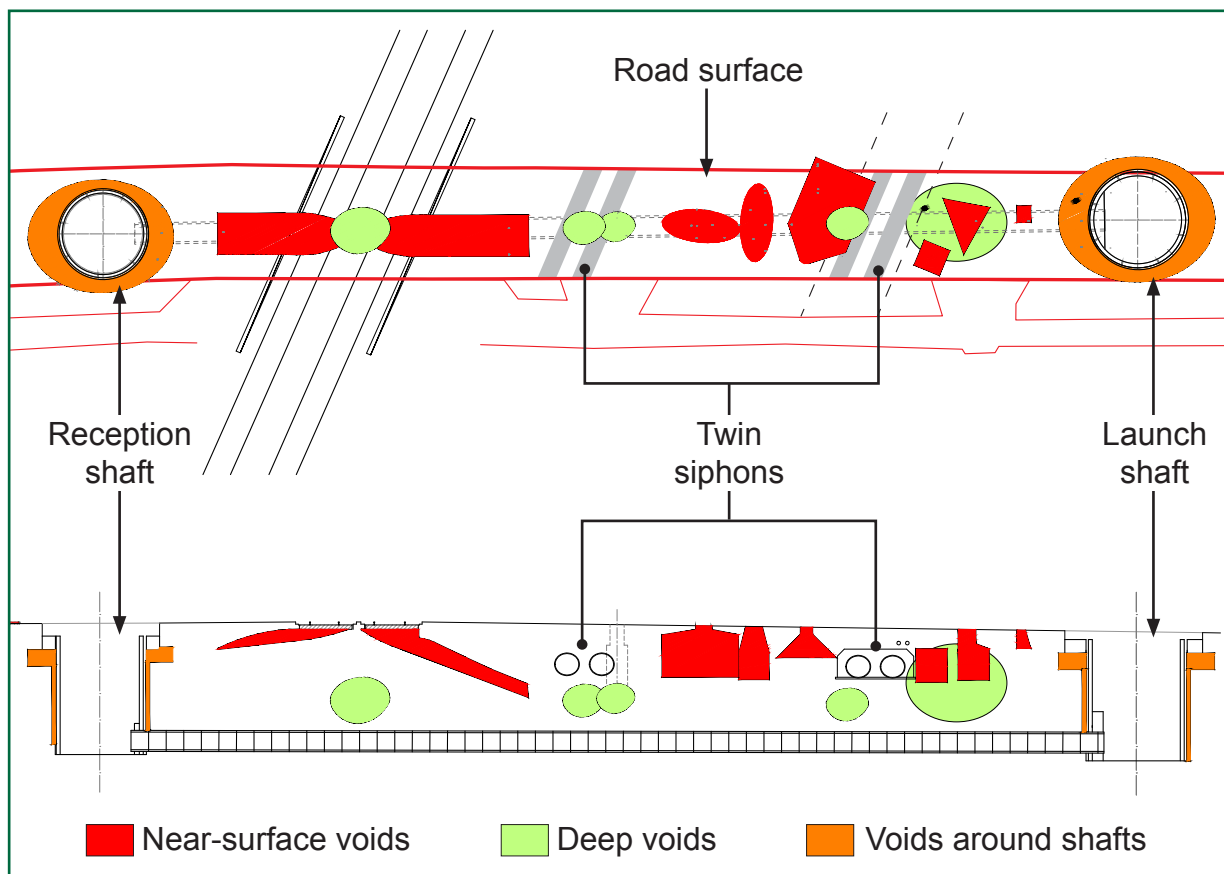
53 Ground investigations carried out following the derailment revealed that the voids under the railway were not isolated but were part of a series of voids which ran between the launch and reception shafts of the UTX, generally along the centre line of the road as shown in figure 9. Most of the voids were just below the road surface, but there were also voids found under the railway and the twin siphons and around the shafts. The volume of each void was estimated by Morgan Sindall Underground Professional Services from the amount of grout that had to be pumped into them during the remedial work. The combined total volume of the voids was estimated at around 63 m<sup>3</sup> comprising:

- a) Voids near the surface (shown in red): 46 m<sup>3</sup>
- b) Deep voids below the railway and twin siphons (shown in green): 8 m<sup>3</sup>
- c) Voids around the launch and reception shafts (shown in orange): 9 m<sup>3</sup>

Figure 9: Map of voiding found during ground investigations undertaken by Morgan Sindall

- 58 The positioning of the voids above the path of the microtunnel (figure 9) is the strongest indication that the voids had been caused by overmining of the ground during the tunnelling activity. Most of the voids along the road and across the railway between the launch and reception shafts had migrated from the depth of the tunnel to a level just below ground level. Normally such voids would be expected to break through the surface soon after the tunnelling had been completed but the road and its foundations effectively bridged the voids, except for one hole which appeared in the road on 8 August (paragraph 37). The deep voids found below the railway and each of the twin siphons do not appear to have risen higher because they were bridged by those structures.

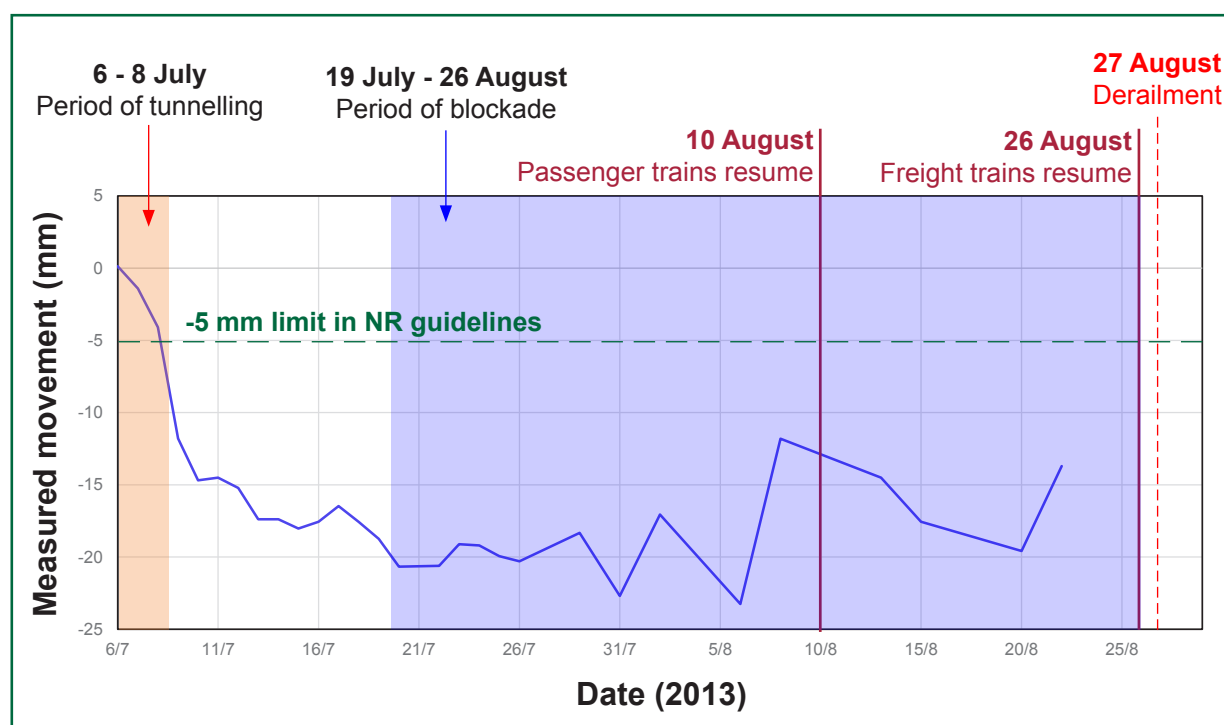
**68** As detailed at paragraphs 34 to 38, monitoring of the railway showed a trend of increasing track settlement from 9.5 mm on 8 July when the tunnelling operations finished, to around 23 mm on 31 July. A graph of settlement against time from the start of tunnelling (6 July) for the six foot rail of the up line at the road centre line (which generally showed the greatest amount of settlement) is shown in figure 11. After 31 July, this measurement position and some others around it indicated some fluctuation<sup>7</sup> between 23 mm and 12 mm. The last measurements taken before the derailment were on Thursday 22 August when the settlement recorded for position LX5 was 14 mm and those at other rail measurement positions at the centre of the level crossing were similar. The next set of readings were due on the day of the derailment. By 29 July, the monitoring had been reduced in frequency to three times per week (paragraph 34). The Nottingham station blockade, which had started on 19 July and continued until 26 August, had resulted in reduced rail traffic over Stoke Lane level crossing. Despite the reduced rail traffic flows there had been a further increase in settlement up to 31 July.

Figure 11: Movement of rail during and following tunnelling (on six foot rail of up line at road centre line)

<sup>7</sup> The precise reasons for the fluctuation are not known, but the RAIB considers it is unlikely that the ground level itself fluctuated by the amount indicated in the measurements. Other factors which could have contributed are the passage of a trains around these dates, natural expansion/contraction of the rails due to temperature changes and measurement errors (estimated by the surveyors to be around +/- 3mm).
