# Rail Accident Report

## **Trains struck platform at Moston, Manchester 28 January 2015**

Report 17/2015  
October 2015

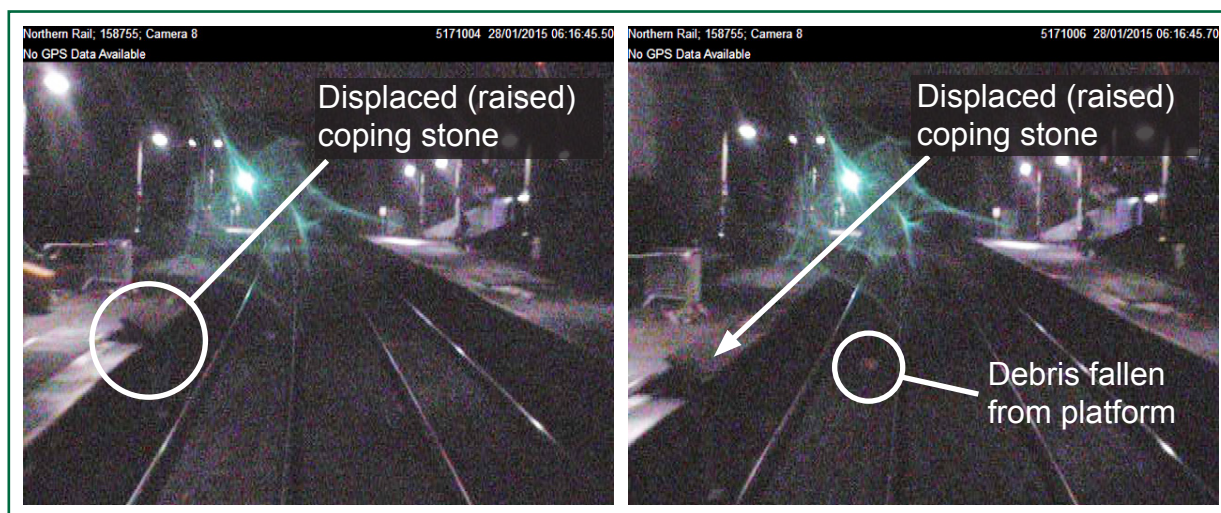
Figure 4: Images from CCTV fitted to front of passenger train (2E33)(courtesy Northern Trains)

- 13 Train 2E33 comprised a class 158 *diesel multiple unit* (158755) and left Manchester Victoria on time at 06:12 hrs. No-one was aware of the damage at Moston station until, at about 06:17 hrs, the driver of this train saw the displaced coping stones seconds before his train struck them (figure 4). The train suffered minor damage to the driver's cab step, suspension and other equipment (figure 5).

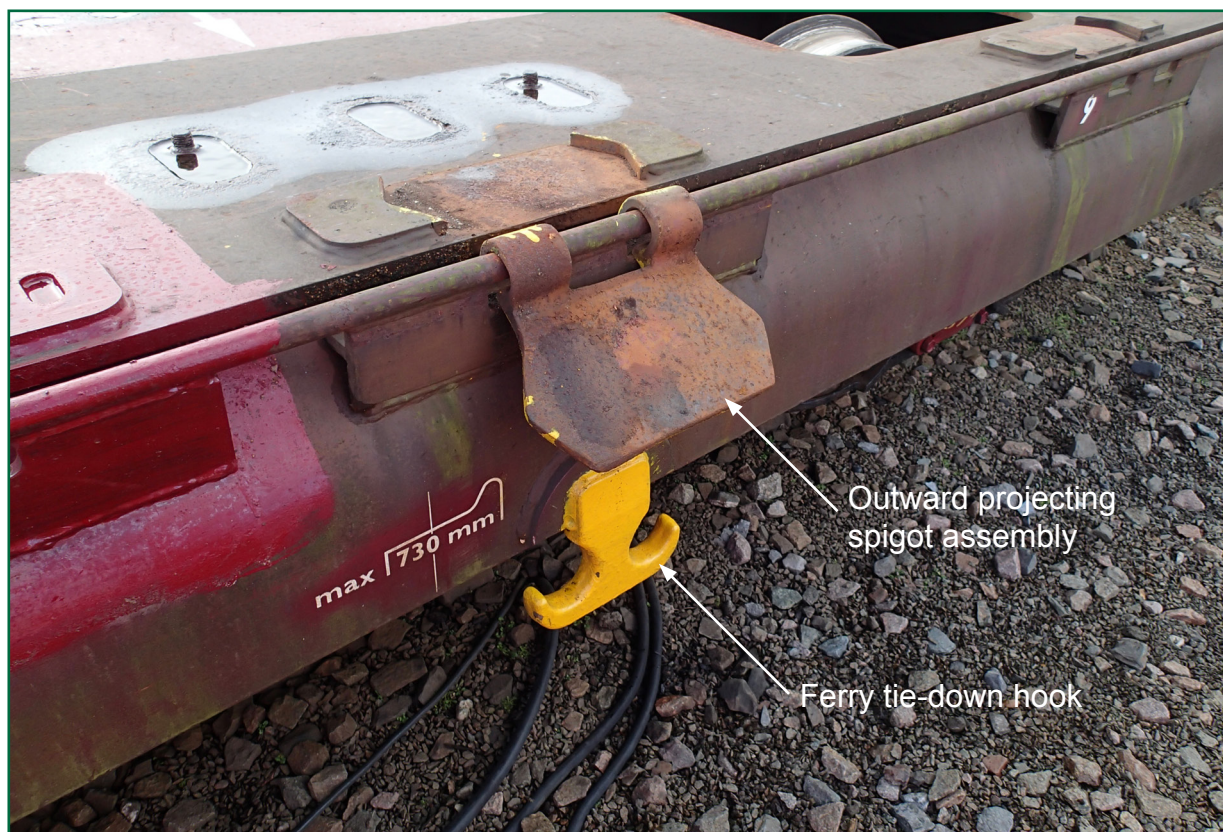
Figure 7: Outward projecting spigot assembly

- 15 **Spigots, left out of their pockets on the FKA wagon that formed part of train 6E33, struck platform supports and dislodged coping stones from the Down platform at Moston.**
- 16 FKA wagons comprise two semi-permanently coupled elements, each intended to carry one container secured by four spigots on the wagon which engage with sockets located at the bottom corners of the container. Each vehicle is therefore provided with four spigots, including two which slide along rods to accommodate containers of varying length. The spigots hinge about the rod allowing them to be rotated into, and out of, pockets on the top surface of the wagon. They can also be rotated outwards so that they rest against the outer side of the wagon in a position where they project outwards, and extend further from the centre of the track than any other part of the wagon (figures 6 and 7).

- c. Outward projecting spigot assemblies were difficult to see because only the underside of the assemblies were exposed and these were the same colour as the wagon side (figure 7).

- 1 *The intent of this recommendation is to minimise risk from hinged spigots being left in positions where they project beyond the vehicle gauge and thus present a risk of collision with structures. If a paint based solution is adopted, the benefits of painting wagon sides, rather than spigot assemblies, should be considered (paragraph 75).*

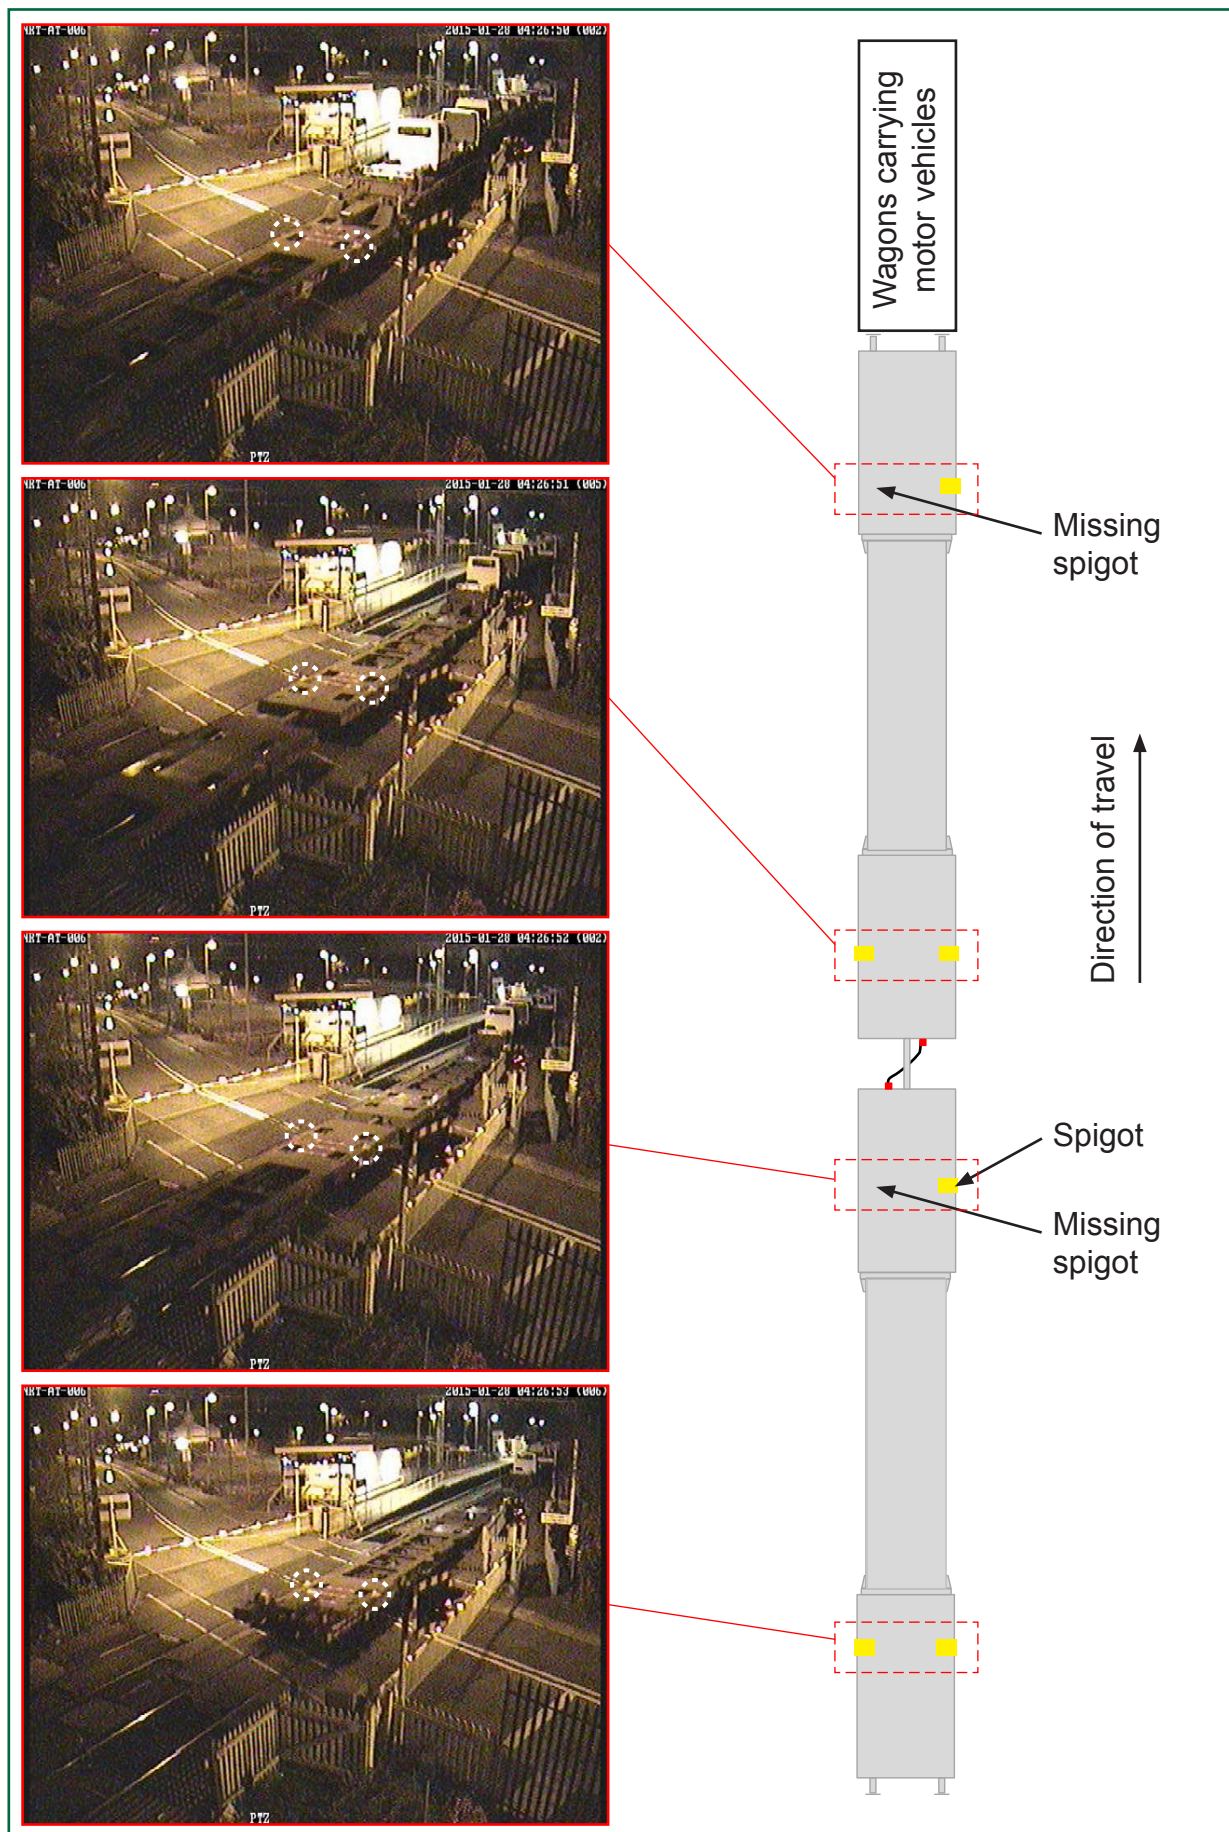
Figure 8: FKA wagon at Navigation Road

- 17 The FKA wagon passed Navigation Road level crossing before reaching Moston. Images obtained by a temporary closed circuit television (CCTV) system at this crossing show spigots located in six of the expected eight positions (figure 8). These correspond to locations where spigots were found in their correct positions when the wagon was inspected at Doncaster. The CCTV images show that spigots are absent from two expected positions, both on the wagon side furthest from the CCTV camera where an outward projecting spigot would be hidden by the wagon. These positions correspond to the locations where spigots were found to be missing at Doncaster and the RAIB has concluded that the two spigots found at Moston were attached at these positions, but projecting outwards, as the train passed Navigation Road level crossing.

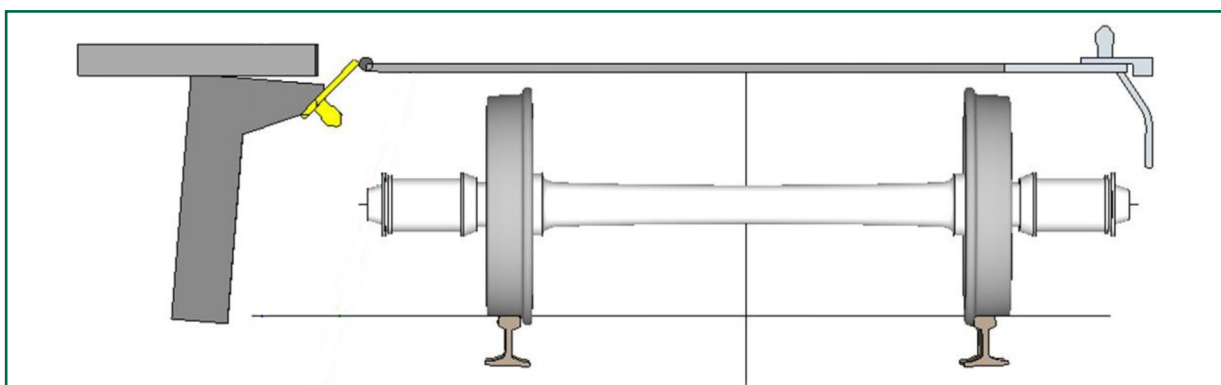
Figure 9: Outward projecting spigot position relative to platform

- 18 The outward projecting spigots struck the platform supports, causing coping stones to be displaced. This is evidenced by a comparison of the measured position of the spigot relative to the platform (illustrated in figure 9 using measurements described at paragraphs 20 and 34) and the following witness marks made as the train travelled northwards through the station:

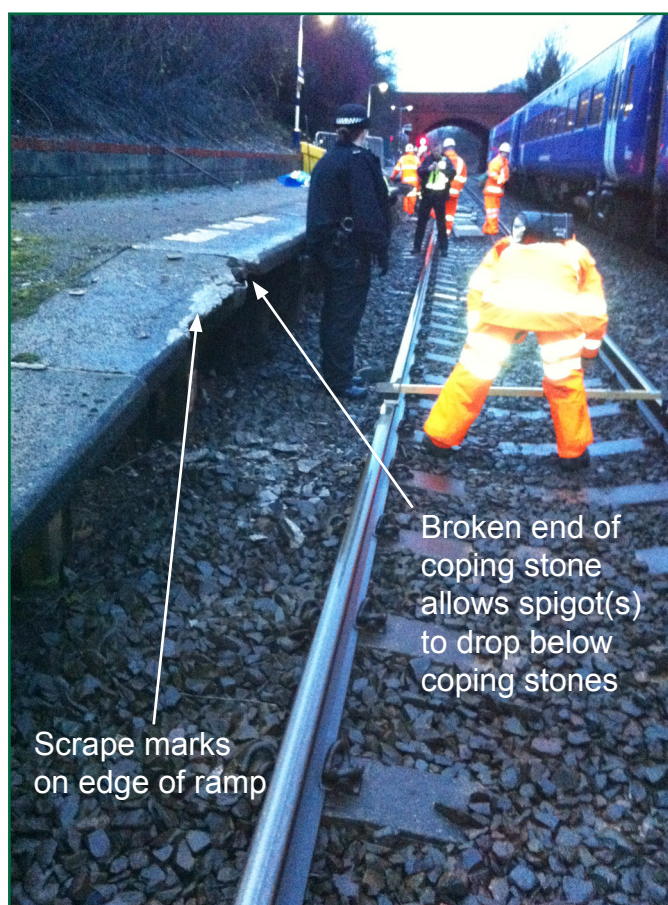
Figure 10: Witness marks on southern ramp

- a. Scrape marks on the edge of coping stones near the top of the ramp at the south end of the platform, which show that the spigots contacted, and slid up, the top surface of these stones (figure 10).

- b. A broken coping stone<sup>2</sup> immediately beyond the top of the ramp providing a route for the spigot(s) to pass beneath subsequent coping stones (figure 10).

- c. The absence of scrape marks on the top of the next few coping stones. (figure 10).
- d. Impact marks on platform supports (figure 11).
- e. Coping stones displaced in a manner consistent with impacts from spigots beneath the coping stones and/or the effects of platform supports being struck by spigots. This occurred in two areas, both within 20 metres of the top of the southern ramp (figure 4).
- f. The absence of damage further along the platform, observed during a post-accident inspection by the RAIB (consistent with the *spigot assemblies* having been pulled from the wagon by the impacts described above).

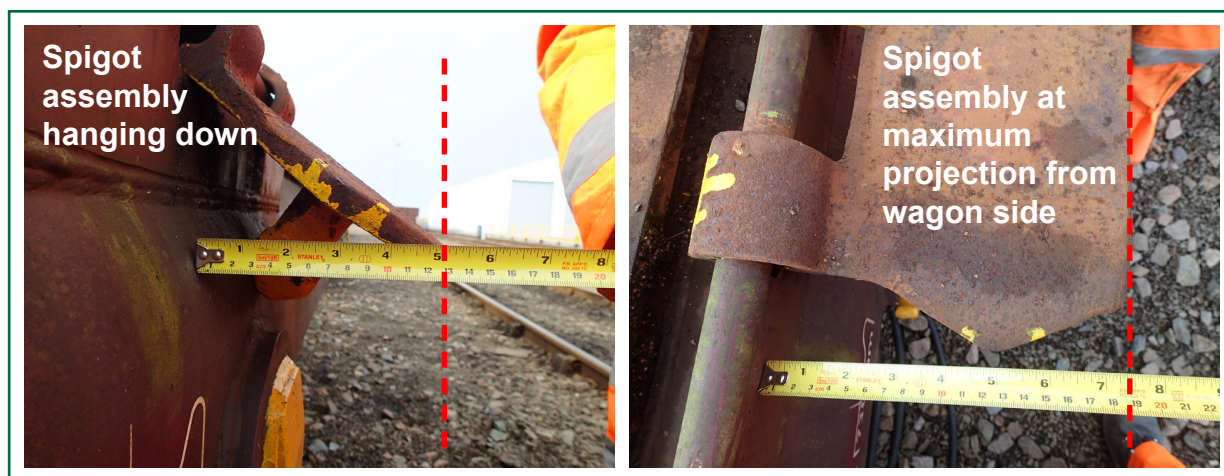
Figure 13: Outward projecting spigot assembly positions

- 24 Analyses based on data taken from wagon construction drawings and measurement of *spigot assemblies* recovered from Moston station show that an outward projecting spigot extends about 58 mm beyond W6a wagon gauge when resting against the wagon body. As W6a gauge projects 1350 mm beyond the track centre-line, the 58 millimetre projection beyond W6a gauge equates to 690 mm overhang beyond the rail<sup>4</sup>. The manufacturer's gauging drawings show that 12 mm of lateral movement should be considered when assessing wagon compliance with W6a wagon gauge and so a spigot hanging down projects 70 mm beyond this wagon gauge. The amount of projection increases by up to about 70 mm as the spigot is raised.

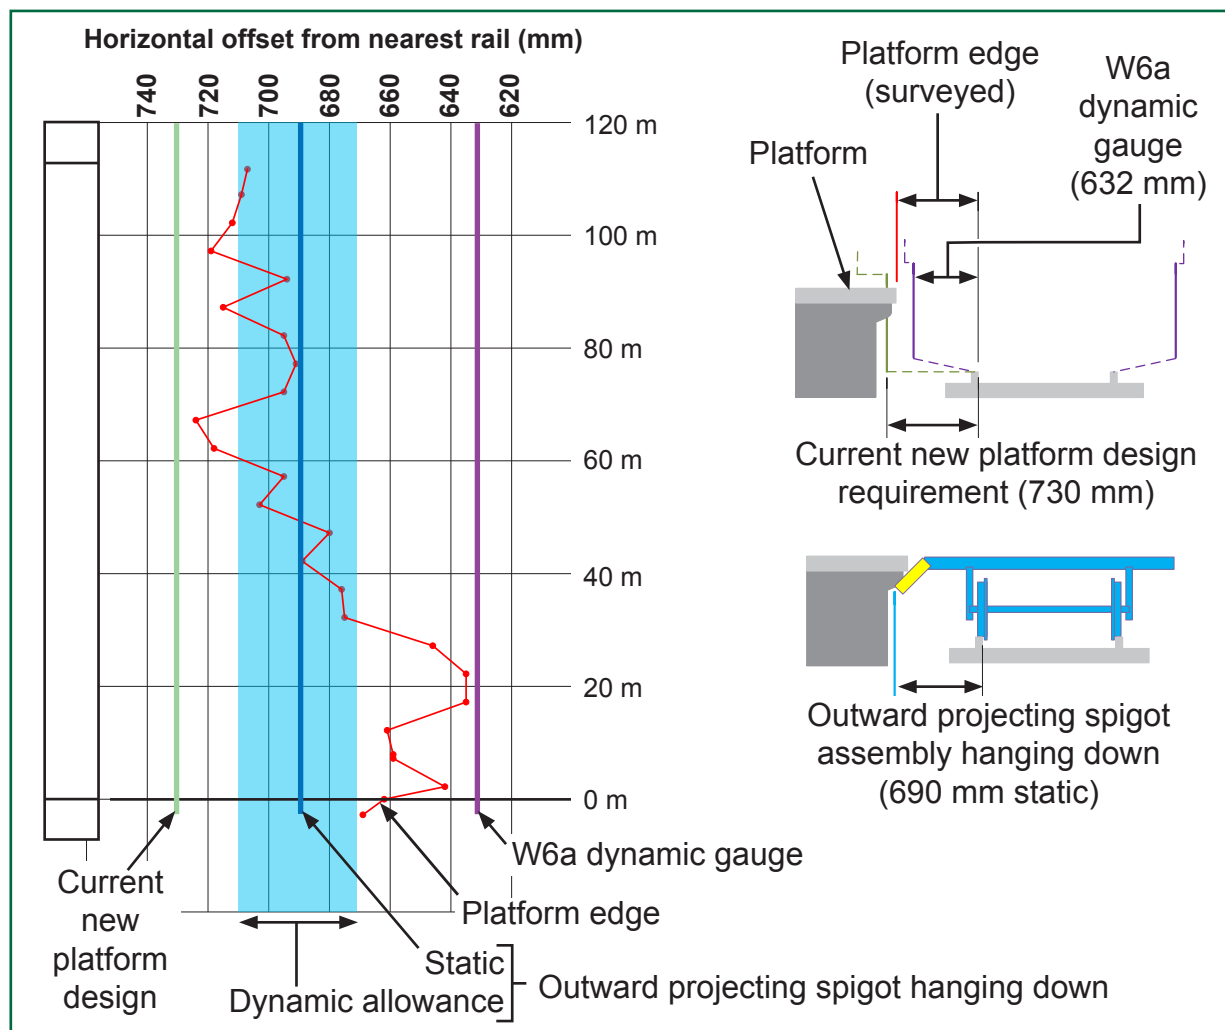
Figure 15: Platform edge distance from track (July 2014)

- 40 The outward projecting FKA spigot data plotted on figure 15 takes account of:
- the *static* offset of 690 mm beyond the nearest rail applicable to a spigot hanging downwards (paragraph 24);
  - lateral sway effects due to intended suspension movement and suspension wear;
  - lateral movement of wagon wheels between the rails due to wheel/rail clearances, flange wear and rail sidewear; and
  - measurement inaccuracies.

- 41 Figure 15 includes an allowance of  $\pm 20$  mm for the effects of sway, lateral wagon movement and measurement inaccuracies. This is considerably less than the  $\pm 35$  mm included for the same effects in railway industry calculations of clearance between structures and trains<sup>8</sup>. The industry values are intended to model the extreme combination of conditions which must be considered in order to demonstrate a very low, and acceptable, risk of trains striking structures. The RAIB has applied a subjective reduction to these values in order to illustrate likely wagon behaviour. The reduction takes account of the FKA wagon passing through Moston station at a speed of 36 mph (58 km/hour), significantly less than both the 60 mph (96 km/hour) maximum speed applicable to FKA wagons, and the 70 mph (113 km/hour) maximum speed for all trains at this location.

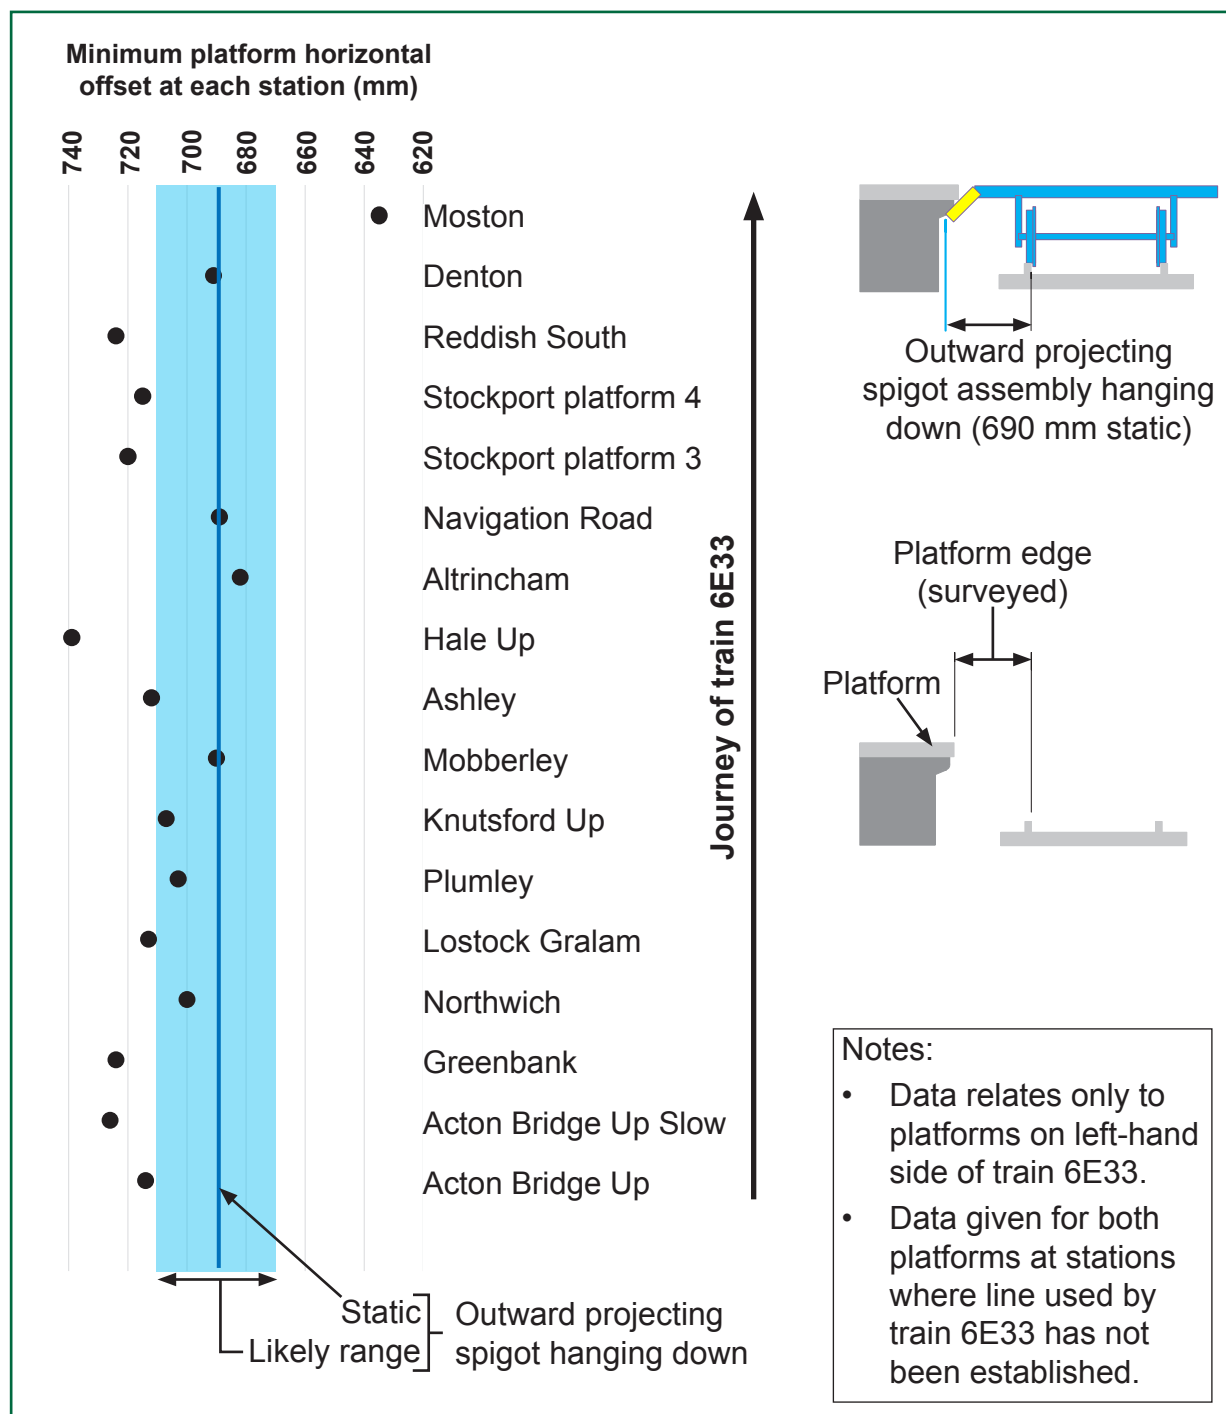
Figure 16: Minimum track to platform offsets on journey of train 6E33

- 44 Network Rail's Gauging Engineer's team use the measured distances between platforms and the adjacent track to determine the level of risk, and thus the management strategy, applicable to each platform. The team compare the measured survey data with *dynamic gauge* profiles applicable to the rolling stock permitted to use the adjacent track. Their calculation for theoretical horizontal separation between the platform and the track includes allowances for measurement inaccuracies ( $\pm 11$  mm), track movement (typically  $\pm 25$  mm), flangewear and wheel/rail clearance (combined allowance of  $\pm 12.5$  mm), rail sidewear (typically  $\pm 4.5$  mm) and cross level error ( $\pm 6$  mm at platform level for 10 mm cross level error).

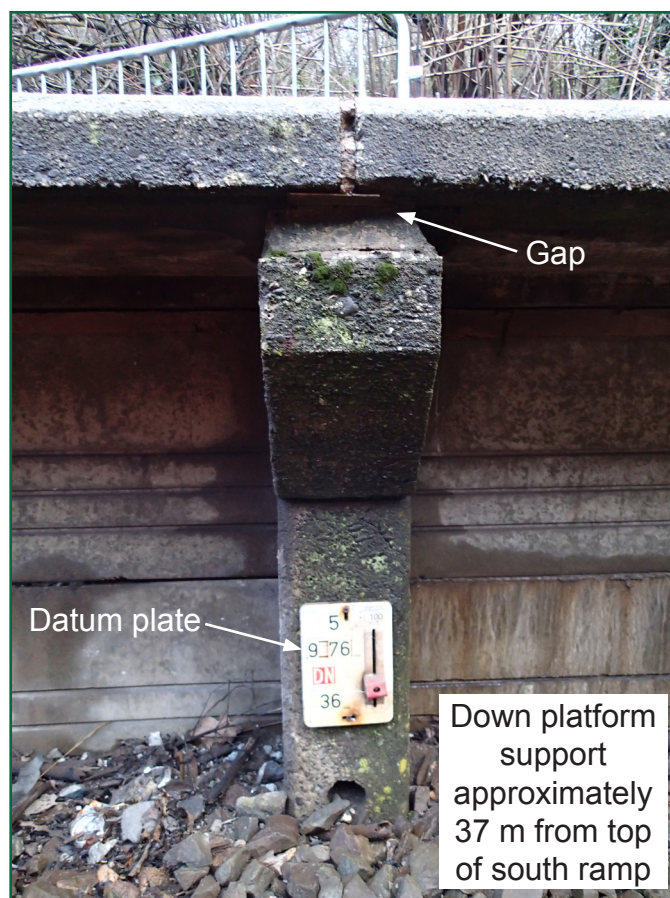
Figure 20: Gap between support and coping stone

- A gap between the coping stones and a platform support observed by the RAIB, outside the accident area, about 40 metres from the southern ramp (figure 20); and

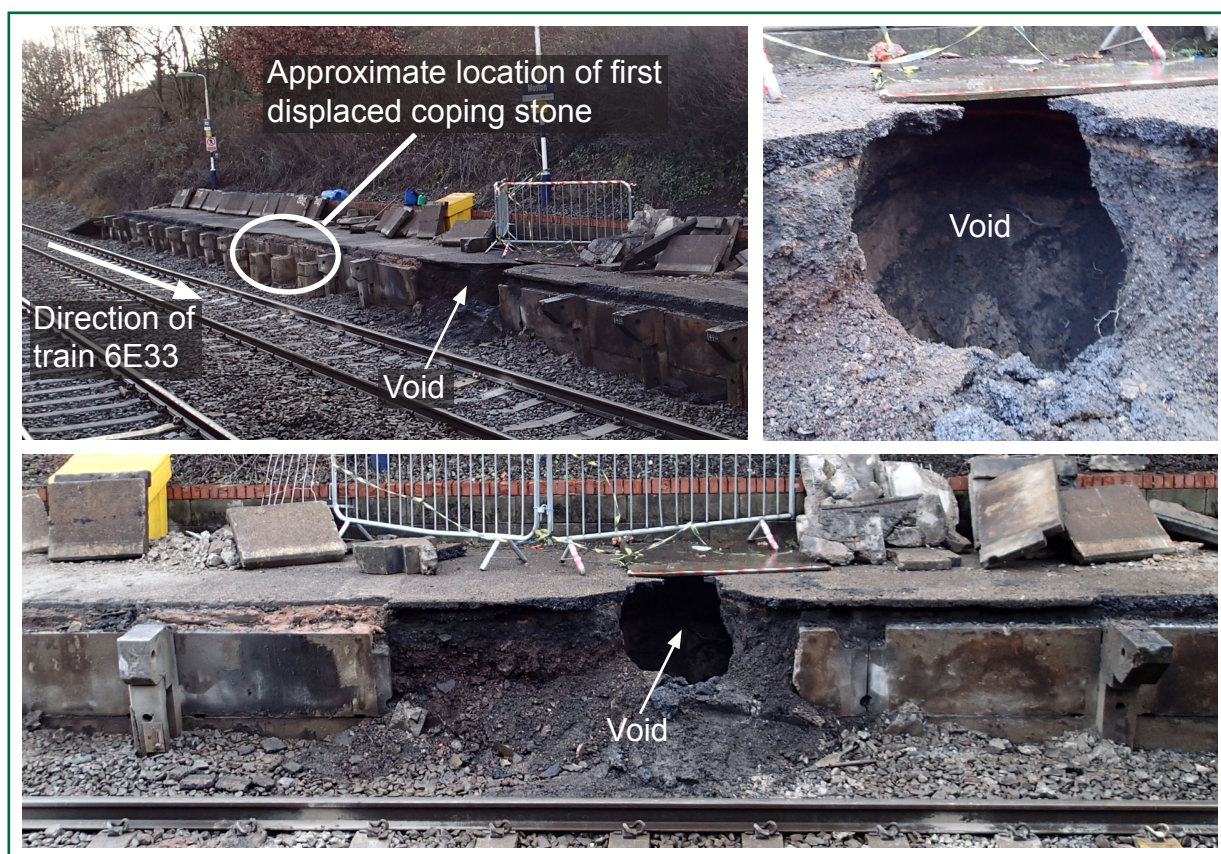
Figure 21: Void in fill beneath platform

- A void beneath the Down platform which had been recorded by Network Rail before the accident but, although near the accident area, is located after the area of impact and so is not considered to be related to the accident (figure 21).

- 53 The cause of these movements is uncertain, but is probably at least partly due to inadequate drainage to deal with water flowing down the cutting sides which rise up from the back of the platform<sup>11</sup>.

<sup>11</sup> The cause of the void as suggested in Network Rail's London North Western Building Asset Management's 'Response to RAIB investigation' dated 20 March 2015.

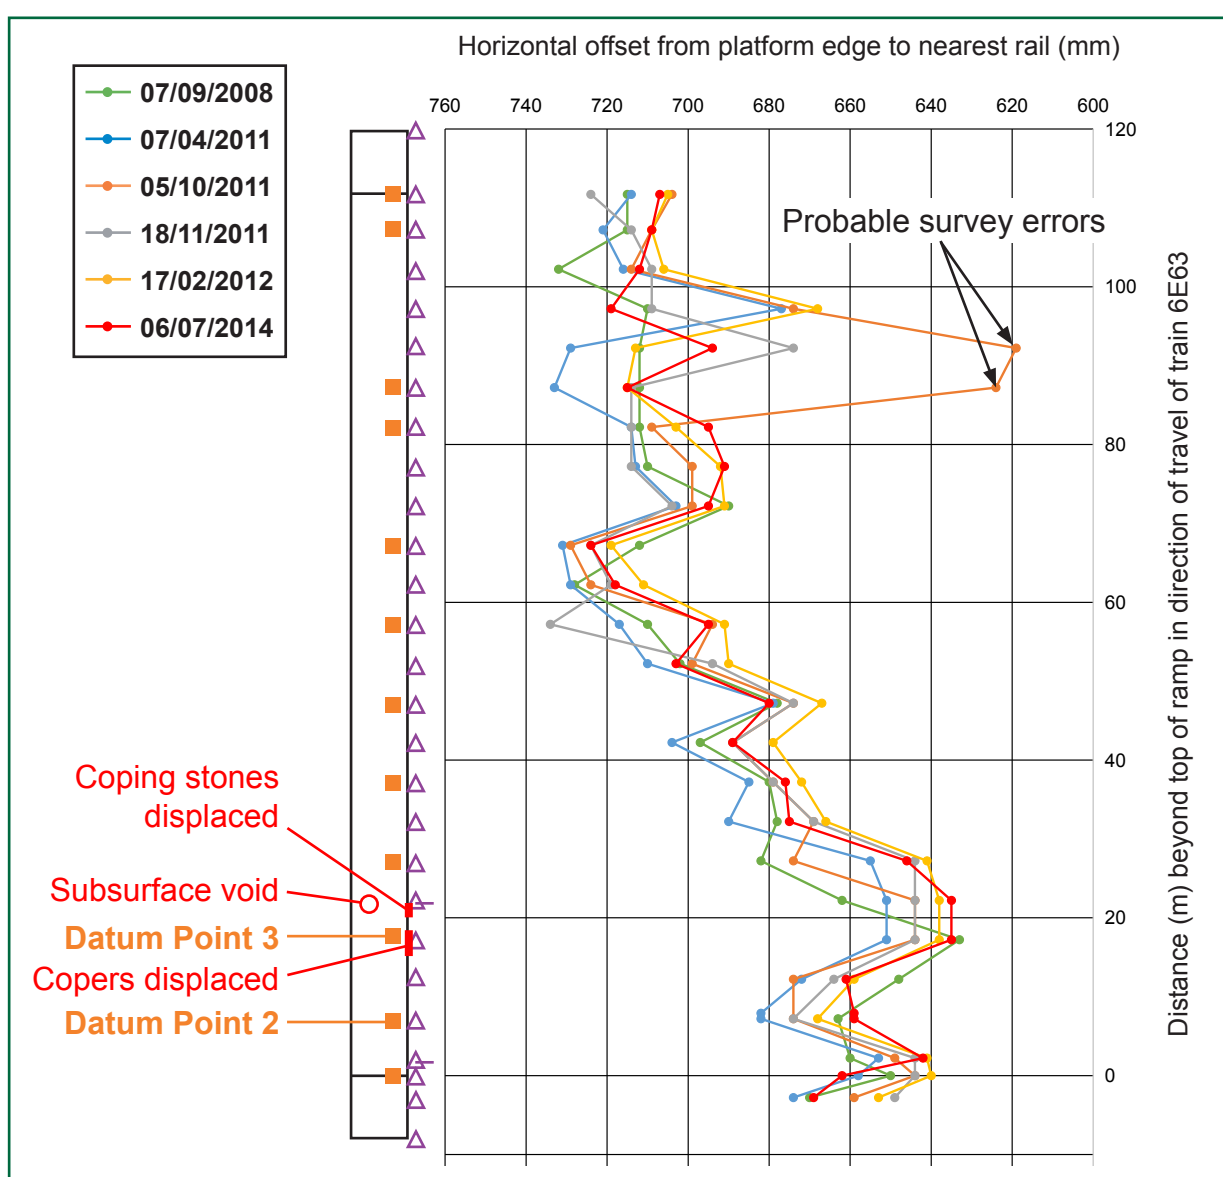
Figure 22: Platform edge positions 2008 to 2014

- 57 Platform edge survey data recorded by Network Rail since 2008 was analysed by the RAIB and shows no evidence of the platform-track spacing reducing significantly since January 2009 (figures 22 and 23). It is possible particularly tight offsets in the area of the accident (figure 22) are a consequence of historic platform movements, but it is also possible that they are a consequence of deliberately positioning the track to achieve a good track alignment.

- 2 *The intent of this recommendation is to provide Network Rail staff with clear guidance, and practical methodologies, for recognising long term reductions in clearances at platforms. Where clearances are managed by comparison to a reference datum (eg the position of a platform in January 2009), the process should facilitate this comparison. Documents referenced in Network Rail standard NR/L2/TRK/3201 should be checked to ensure that the current version does not have a potential to mislead staff involved in management of clearances at platforms.*
