# Rail Accident Report

**Partial collapse of a wall onto open railway  
lines, Liverpool  
28 February 2017**

# Partial collapse of a wall onto open railway lines, Liverpool, 28 February 2017

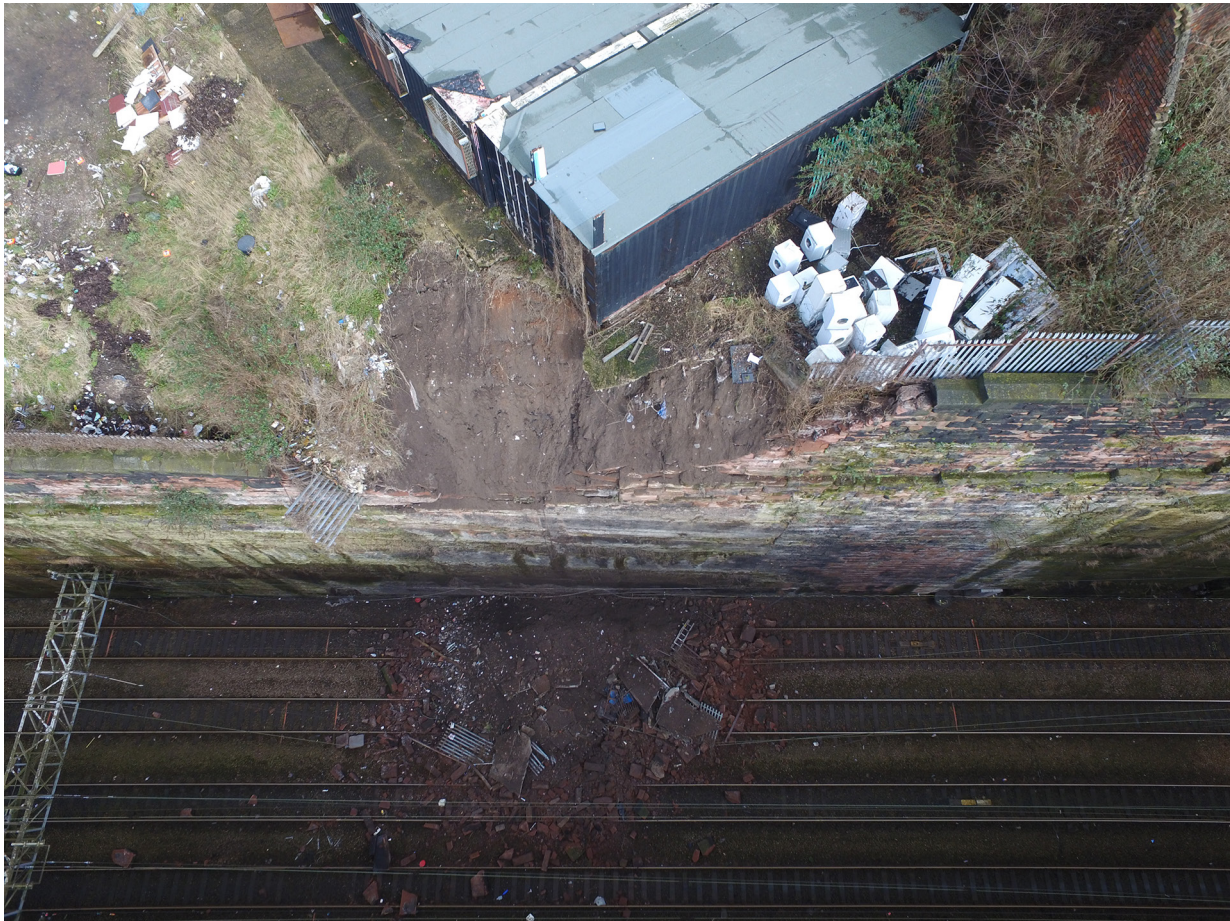
Figure 2: The cutting following the collapse of the retaining wall

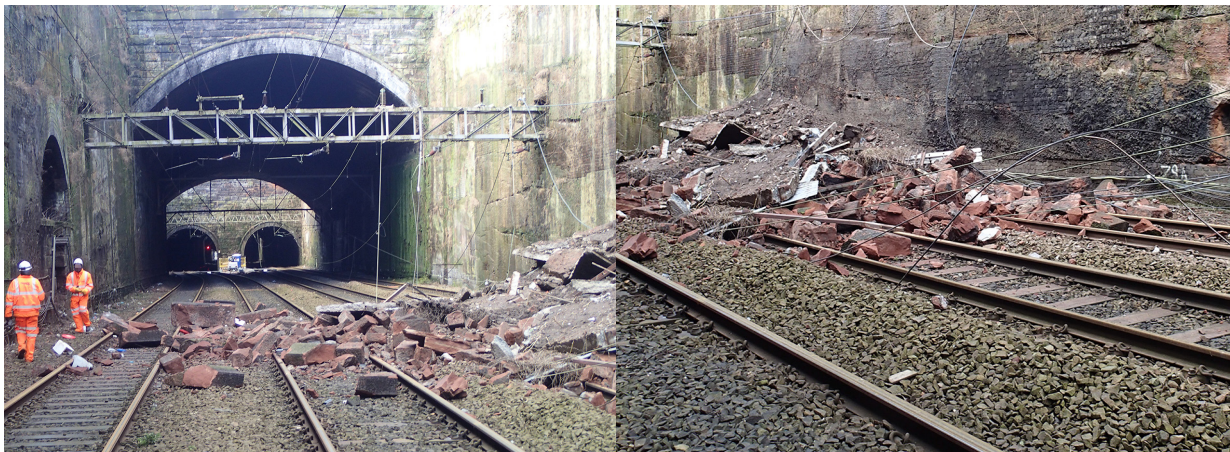
Figure 3: The debris on the track following the wall collapse

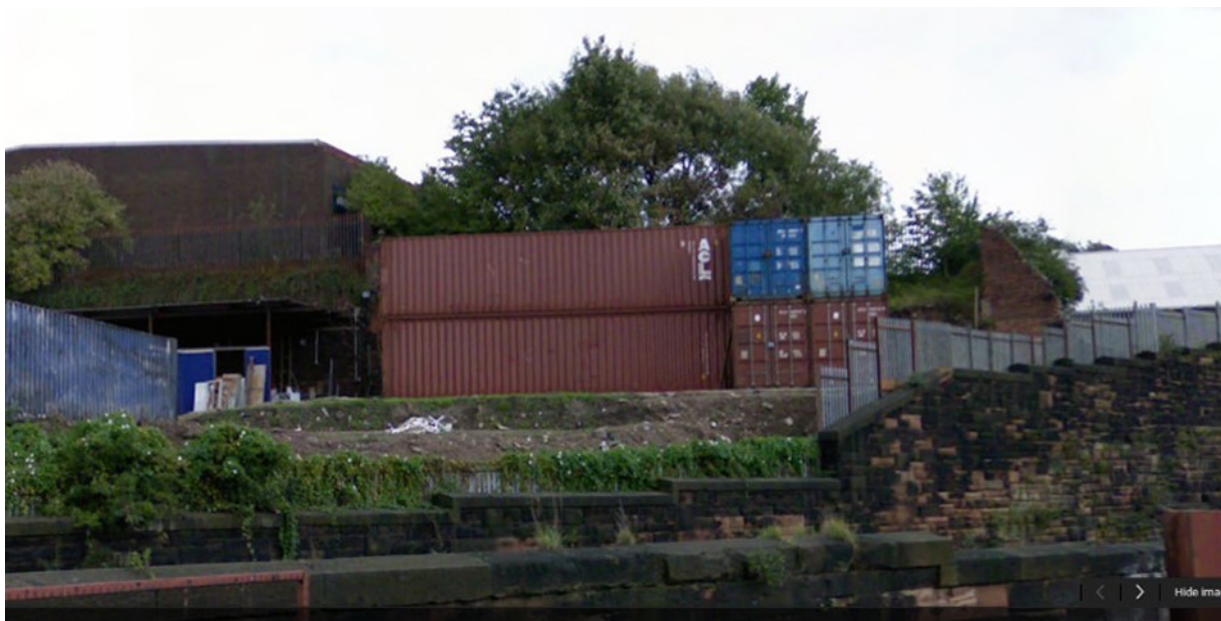
- 29 By June 2009 there were six containers on the property, rearranged and double stacked (figure 9). The containers had been placed on a concrete slab approximately 100 mm thick which was supported by an earthwork that had been built out from the terrace wall towards the west of the property (figure 10). The concrete slab also extended beyond the footprint of the containers to meet the railway retaining wall (figure 11) which by this time was additionally surcharged. Also by this time, the lease holder had erected additional palisade fencing against this eastern section of the wall.

Figure 9: Google Street view image of the double stacked containers, the raised supporting earthwork and additional fencing (photograph dated on Google Street View as September 2008, but date is approximate)

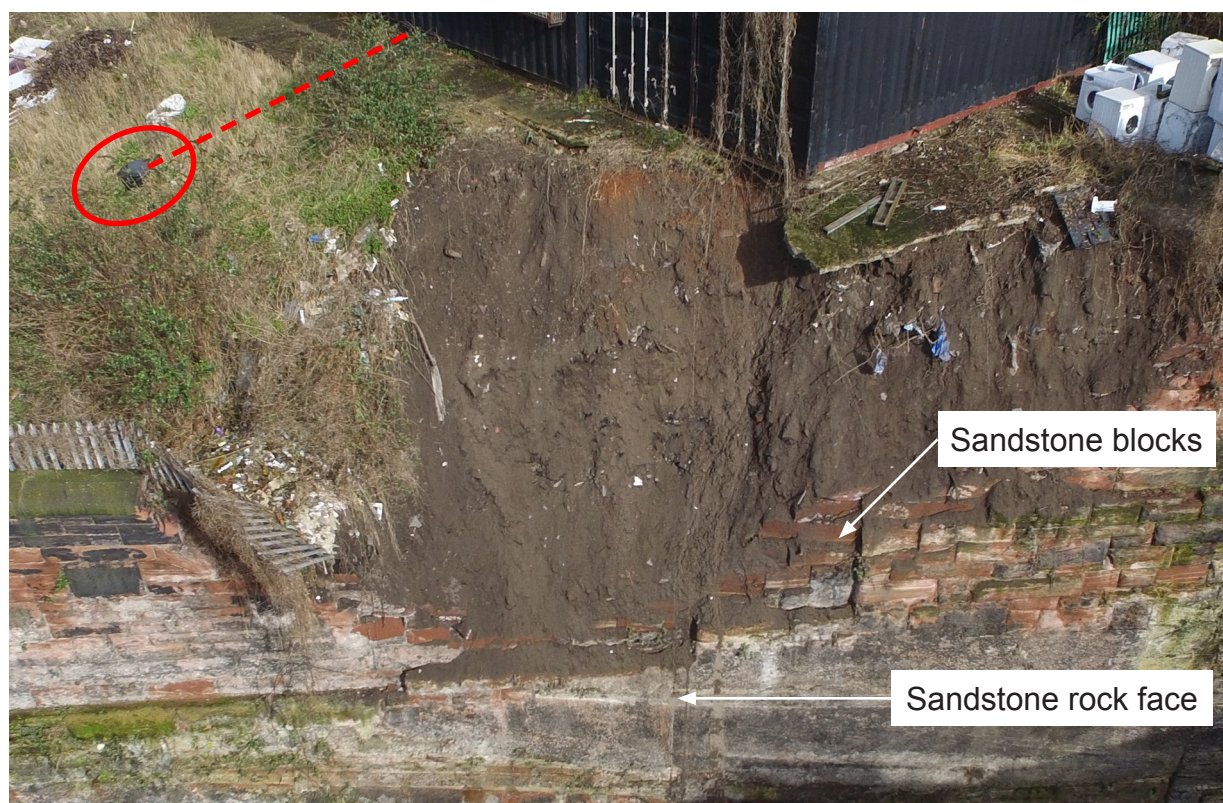
- 32 **The wall collapsed because it could not withstand the loads from the additional surcharge.**
- 33 The disposition of the fallen masonry blocks, including many capping stones, on the two tracks furthest from the north side retaining wall (figure 3, left-hand image) indicates that the wall failed by overturning (or toppling). In this action, the wall rotated about a pivot point just above the interface between the wall and the sandstone rock (figure 12). The estimated weight of the blocks, soil and concrete that fell into the cutting is around 170 tonnes.

Figure 12: The upper part of the cutting wall following the collapse (red circle indicates a drain chamber - see paragraph 39)

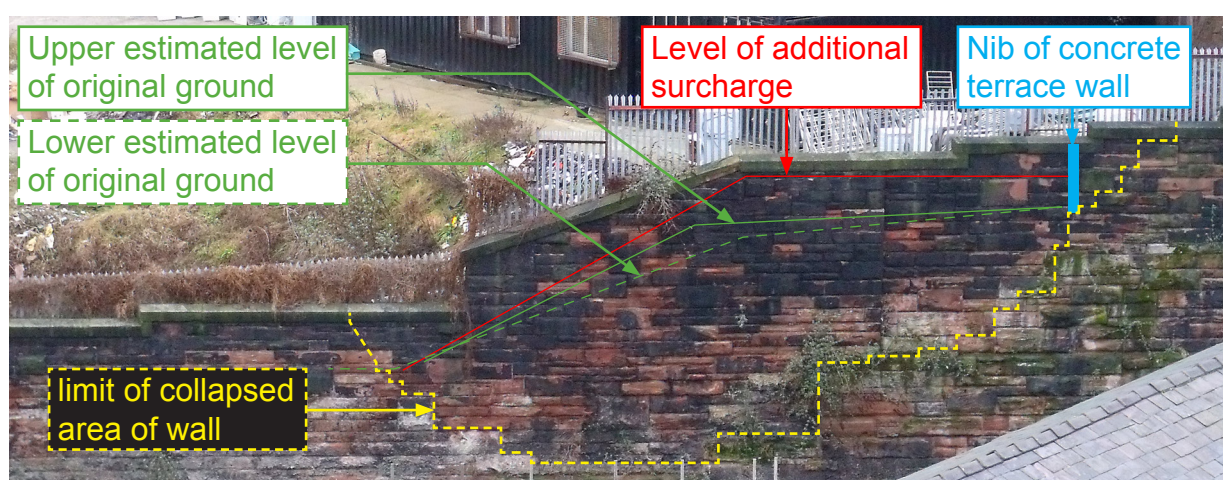
- 35 The wall had been in place since the 1880s and for it to have overturned and collapsed, there must almost certainly have been a change in the forces acting on it. The RAIB has assessed the change in horizontal loading to the wall from the additional surcharge resulting from the regrading work undertaken on the adjacent land (paragraph 29). The increase in ground height at the point where the concrete slab met the retaining wall, is estimated to have been between 0.9 metres and 1.5 metres (figure 13). This range in values is due to the uncertainty surrounding the actual level of the ground at this point before the surcharge was added (paragraph 26). This range of surcharge results in an increase of between 160% and 237% of the overturning moment about the base of the masonry wall (ie its interface with the sandstone rock) due to the additional soil weight. This loading does not take into account any effects from the recent rainfall that fell in the area, discussed later at paragraph 37.

Figure 13: Photograph of the wall taken around 2011 overlaid with estimated change to the wall surcharge and the area of wall that collapsed (photograph courtesy of Williamson Tunnels Heritage Centre)

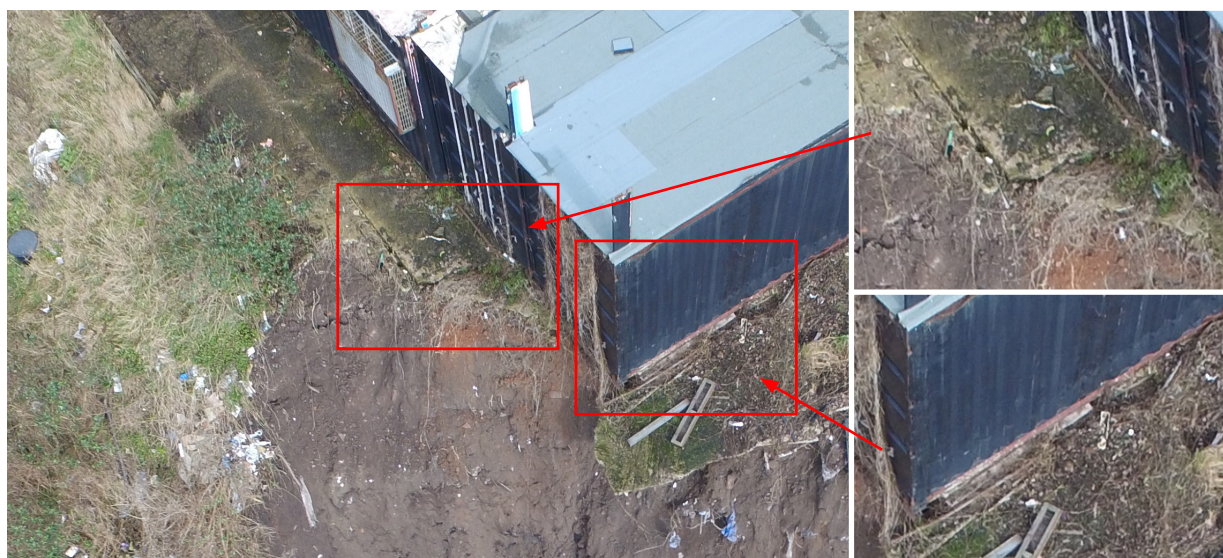
- 36 There were cracks in some areas of the remaining concrete slab following the collapse (figure 14). The discolouration of the cracked edges of the concrete slab and the vegetation growing through the cracks indicate that the ground had previously experienced some movement from settlement of the soil. Any previous settlement was likely to have been due to the soil's own weight, together with additional loads from the containers and the concrete slab. The lease holder reported to the RAIB that he had not noticed this cracking prior to the collapse.

Figure 14: The soil embankment following the collapse showing pre-existing cracks in the concrete slab

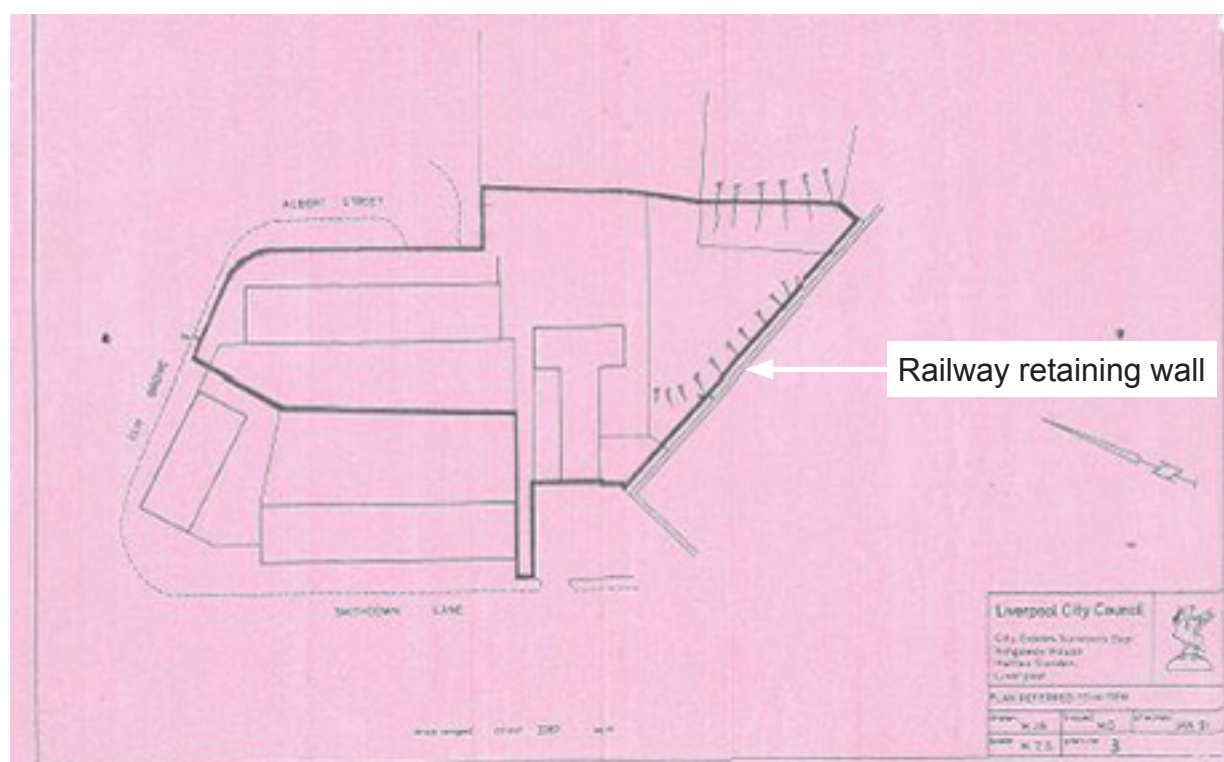
- 50 The land plan referred to in the property lease (figure 15) shows a strip of land immediately behind the retaining wall which was outside the boundary of the lease holder's property. Although the land plan is not sufficiently detailed to give an accurate measurement of the width of the strip of land, it shows that the property's boundary is not at the face of the railway wall. The lease holder has stated that the boundary of his property was 1 metre from the railway wall. Therefore the part of the raised earthwork adjacent to the wall, which caused additional surcharge to it, was built on land owned by Network Rail.

Figure 15: The land plan associated with the lease showing a space between the property boundary and the railway wall
