Rail Accident Report

**Trailer runaway near Hope, Derbyshire
28 May 2017**

Report 03/2018
February 2018

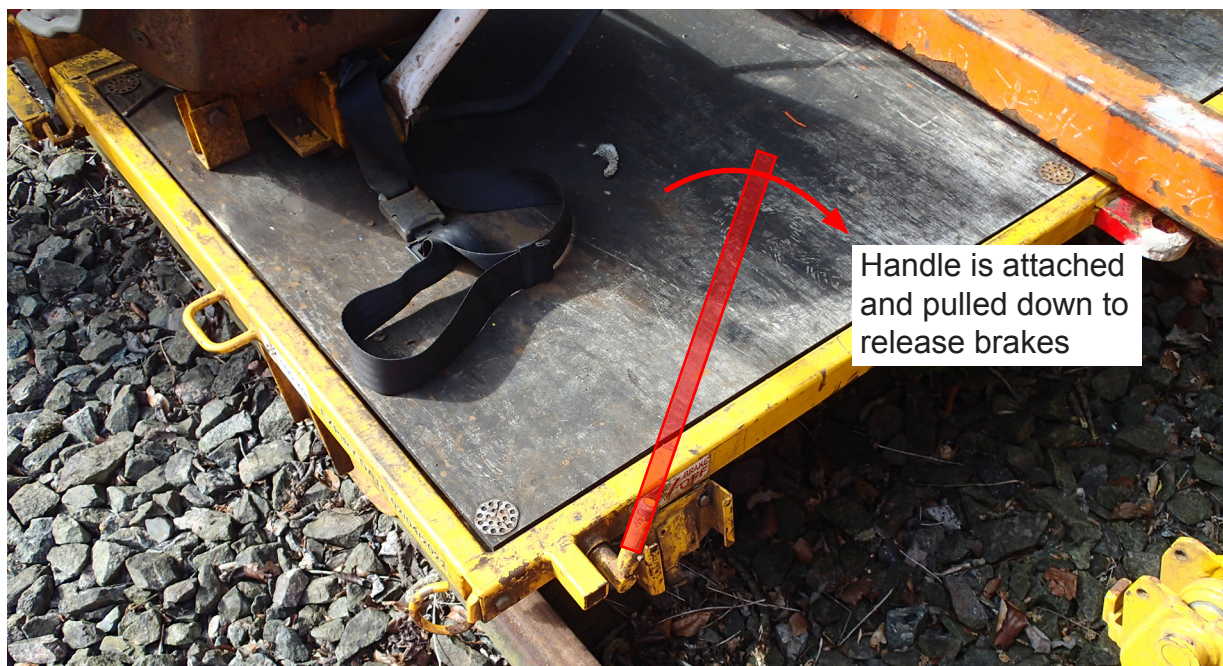
Figure 4: Manual brake release

- 73 The track worker and supervisor attempted to hold the brake handles over while riding on the trailer. They found this difficult to maintain and instead used a webbing strap which had been stored in the rear of the gator, to tie the brake release handles down. This was contrary to the operating manual for the trailer, which said that mechanical means should not be used to hold off the brakes. This action released the trailer brakes and allowed it to be moved freely. The gator then pushed the trailer out of the tunnel. At Edale, staff and equipment were unloaded, but the webbing strap was left in place for the machine operator to make the rest of the journey to Bamford, alone (paragraph 32). The trailer brakes were still disabled, with no mechanism available to apply them in the event of a breakaway from the gator.

- 74 The machine operator was conscious of the absence of trailer brakes, and reported that he attempted to apply some braking by loosening off the strap when he stopped to answer the first telephone call (paragraph 33). However, RAIB testing demonstrated that when the brake release handles are operated, there is a large range of movement over which the brakes are in the released state. This means that a partial loosening of the strap would have almost certainly left the brakes still fully released.

Network Rail should provide clear instructions and training to users of rail mounted trolleys and trailers on its infrastructure, on the procedures to be followed in the event of failures, such as of braking systems, that require them to be recovered (paragraph 98b).

- 1 It is important that users of rail mounted trailers and trolleys do not disable the operation of brakes, unless alternative mitigation to prevent a runaway condition has been put in place.
- 2 It is important that users of rail mounted trailers and trolleys carry out the full set of prescribed brake tests, including testing that brakes are releasing correctly, as well as applying correctly, prior to use.

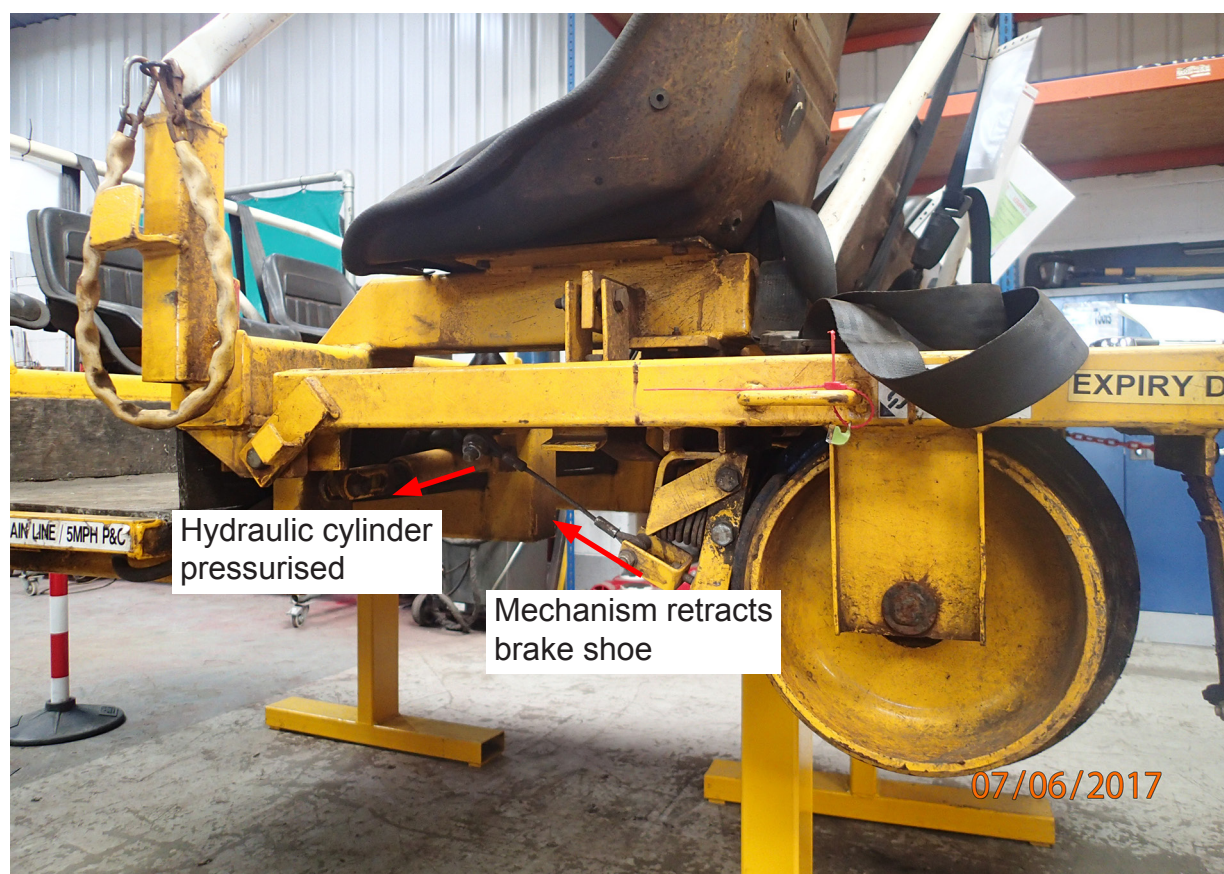
Figure 6: Trailer brakes

- 40 When the personnel carrier trailer is coupled to the gator, the braking on the trailer is spring applied and hydraulically released. A hydraulic pump on the gator pressurises oil in a sealed system, which is used to operate brake cylinders on the trailer which compress the springs, retracting the brake shoes and releasing the brakes (figure 6). This system is binary, in that the system is either fully pressurised, to release the brakes on the trailer, or depressurised, in which case the brakes are spring applied. RAIB testing was unable to identify a condition where partial braking could be present.

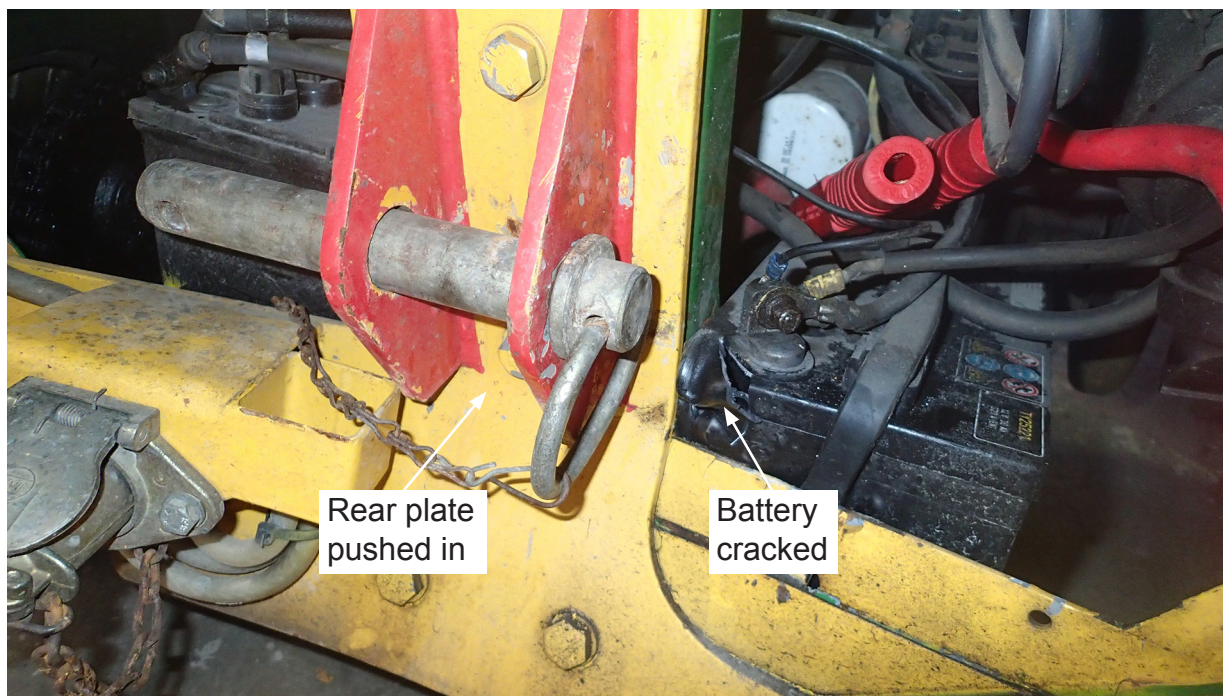
Figure 9: Rear end damage to the gator

- 49 After the runaway, the rear of the gator was found to have damage consistent with an end-on impact to the towbar (figure 9). No evidence was found to explain how this damage had occurred. The gator was able to operate correctly after the runaway, with this damage in place, and so it is possible that the damage was present prior to the incident.

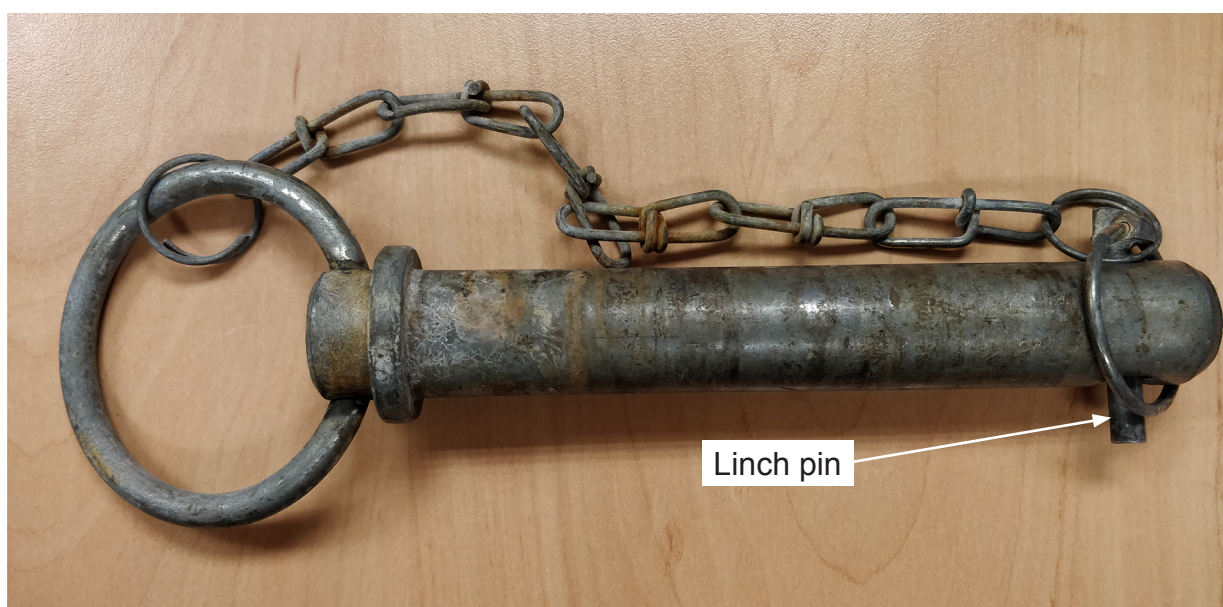
Figure 11: Towbar pin

- 57 The coupling pin at the trailer end of the towbar had fallen out.**
- 58 The towbar consists of a horizontal steel bar which is connected between coupling points on the gator and on the trailer. Each end of the towbar has three vertical fins, which interleave with two vertical fins that are mounted on the vehicle's coupling point (figure 10). A towbar pin is inserted horizontally through holes in the five vertical fins, securing the towbar to the vehicle (figure 11).

- 59 Near the end of the towbar pin, there is a hole to allow fitment of a linch pin (figure 11) that is intended to prevent the horizontal towbar pin from vibrating out of the coupling. The linch pin consists of a metal pin with a ring in the end that snaps securely into position. The ring is intended to be snapped over the end of the towbar pin and rest hard against one side of the linch pin. In that position, the ring prevents the linch pin from falling out, in any orientation, which in turn prevents the towbar pin from falling out.

- 102 Network Rail has issued a safety bulletin describing the circumstances of the towbar separation and the importance of fitting the linch pin in the correct orientation. This was distributed to users in Network Rail and to its contractors.
- 103 Permaquip has updated the user and maintenance manuals for plant that it supplies that uses this design of towbar. The changes include clarification that there is a correct and an incorrect way of securing the linch pin, showing photographs of both conditions. The maintenance regime has also been amended to include an inspection of the linch pin condition.

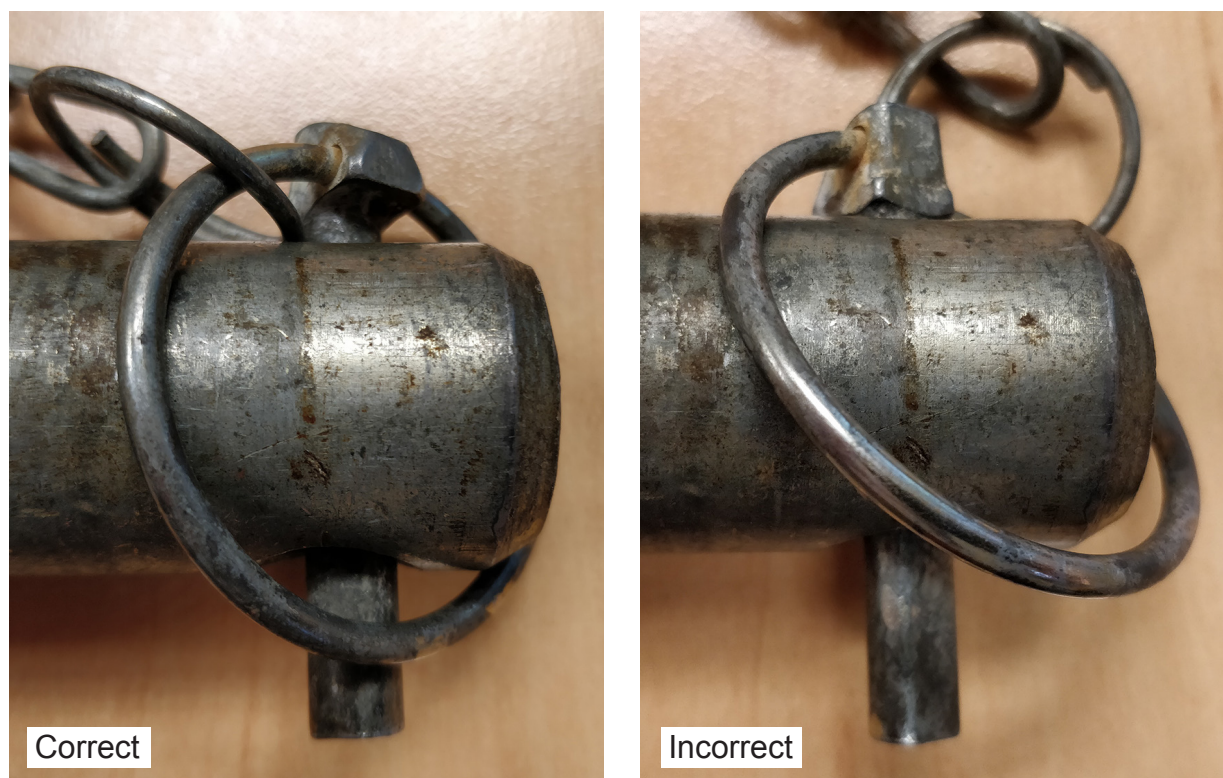
Figure 12: Linch pin in correct and incorrect orientations

- 60 The RAIB identified that it was possible to snap the ring on the linch pin in two orientations. The ring snaps into position against the linch pin in only one of these orientations. In the other orientation, the ring remains at an angle to the linch pin, potentially allowing it to fall out, while still looking as if it has been snapped in place correctly (figure 12). If the linch pin has fallen out, the horizontal orientation of the towbar means there is nothing preventing the towbar pin falling out under vibration and the towbar becoming detached.

- 61 After the runaway, the towbar pin was found on the rear deck of the trailer, adjacent to the coupling. The linch pin was attached to it by a chain but was not inserted in the hole in the towbar pin. This is consistent with the towbar pin having vibrated its way out.

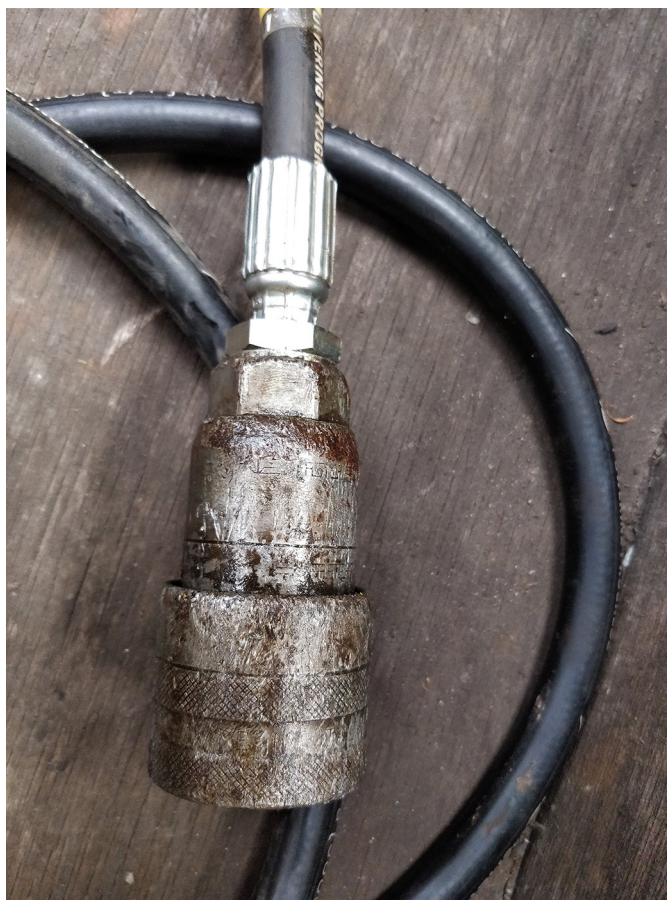
Figure 13: Hydraulic hose coupling

- 64 **The hydraulic hose between the gator and the trailer was not correctly connected at the time that the towbar coupling pin fell out.**
- 65 When the trailer came to a stop at Earles Sidings, the bayonet fitting at the end of the trailer's hydraulic brake hose was not connected to the gator. The fixed coupling at the trailer end of the hose had snapped and the hose was found on the track close to where the trailer came to a stop. The outer surfaces of the hydraulic hose bayonet coupling were covered in scratches and marks consistent with it having been dragged along the track, although it is possible that some of these were present prior to the incident (figure 13).
