Rail Accident Report

**Train ran onto a washed-out embankment near
Knockmore, Northern Ireland
28 June 2012**

Report 14/2013
September 2013

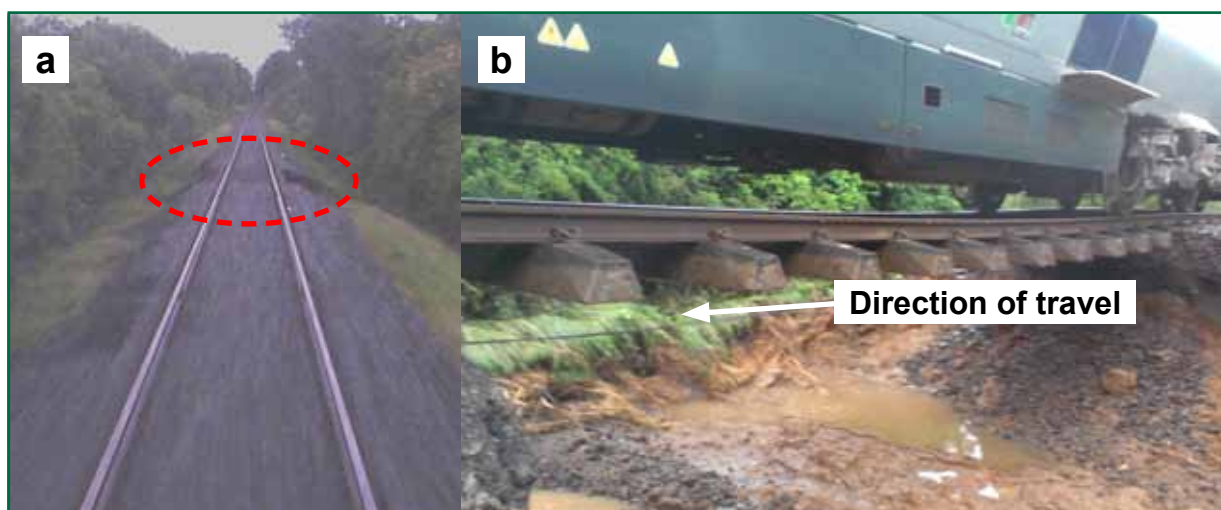
- 7 A *pilotman*, who was in the cab, saw the washed out embankment ahead (figure 2a) and warned the driver who applied the train's emergency brake. The train ran onto the unsupported rails and the leading vehicle came to a stand with one bogie on each side of the unsupported track (figure 2b).

Figure 2: (a) cab view of the washed out embankment and (b) the leading vehicle stopped over the washout (images courtesy of NIR)

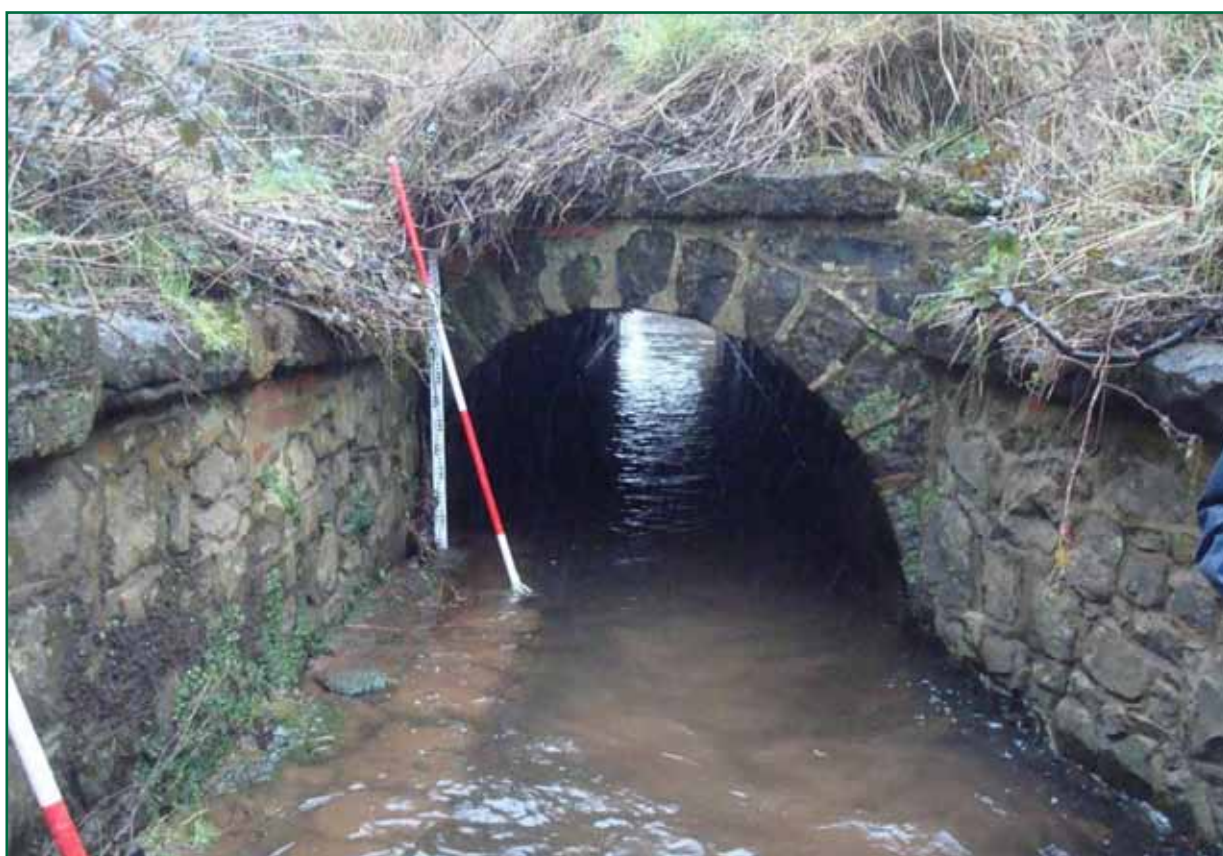
- 50 **The culvert system on the Brokerstown stream was unable to cope with the water flows generated by the heavy rainfall, causing water to back up behind the railway embankment.**
- 51 The brick arch culvert structure, UB1, is 38 metres long, with cross sectional dimensions, 1.8 metres high by 2.25 metres wide (figure 7). The Brokerstown stream flows from UB1 through a 40 metre long open section, to another culvert at the CCHBC plant, which is 390 metres long and has a series of bends in it (figure 4). This culvert has an inlet which is almost perpendicular to the watercourse and is protected by a *trash screen* (figure 8). Water then flows under the Belfast to Dublin main line through another culvert, (NIR bridge reference 02.278, shown as C8 in figure 4), before flowing through three other culverts and into the River Lagan.

Figure 7: Culvert UB1 inlet under Antrim branch line (image courtesy of URS)

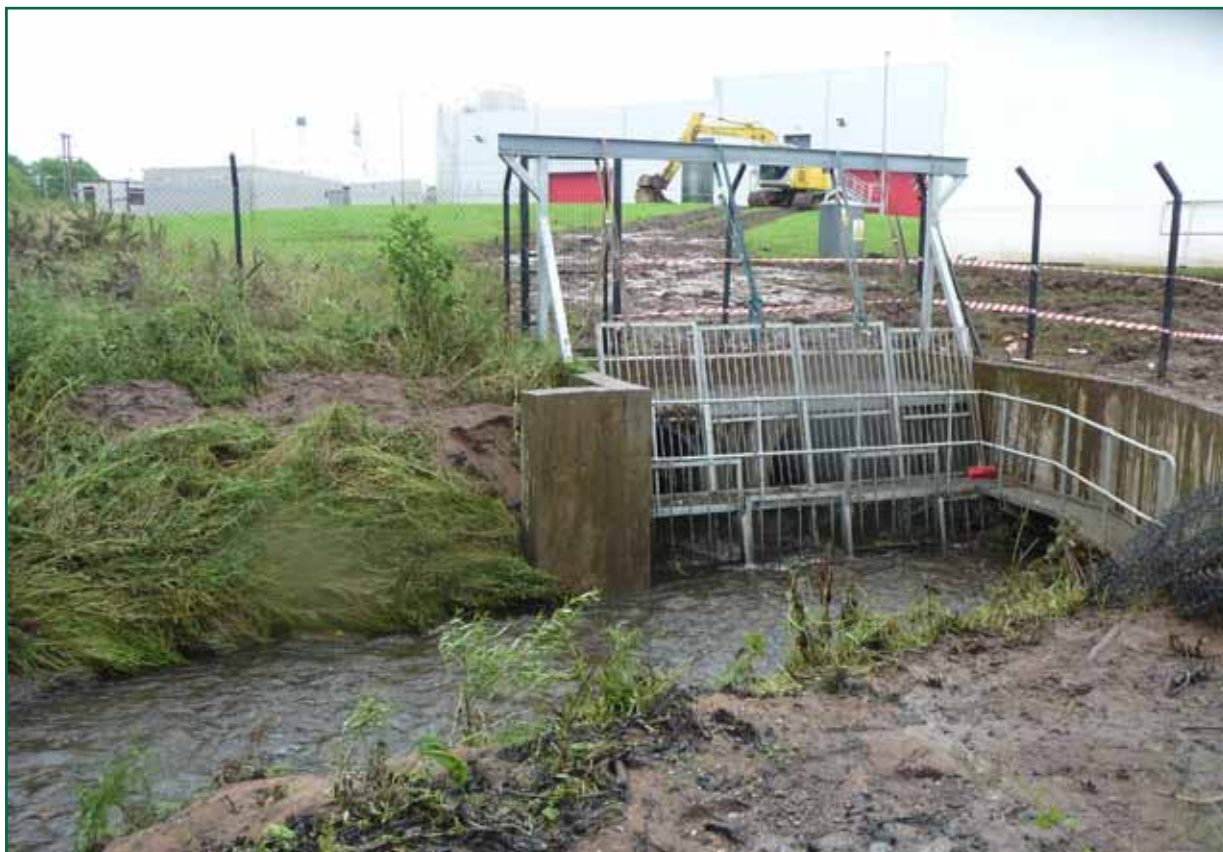
Figure 8: CCHBC culvert inlet with trash screen (image courtesy of URS)

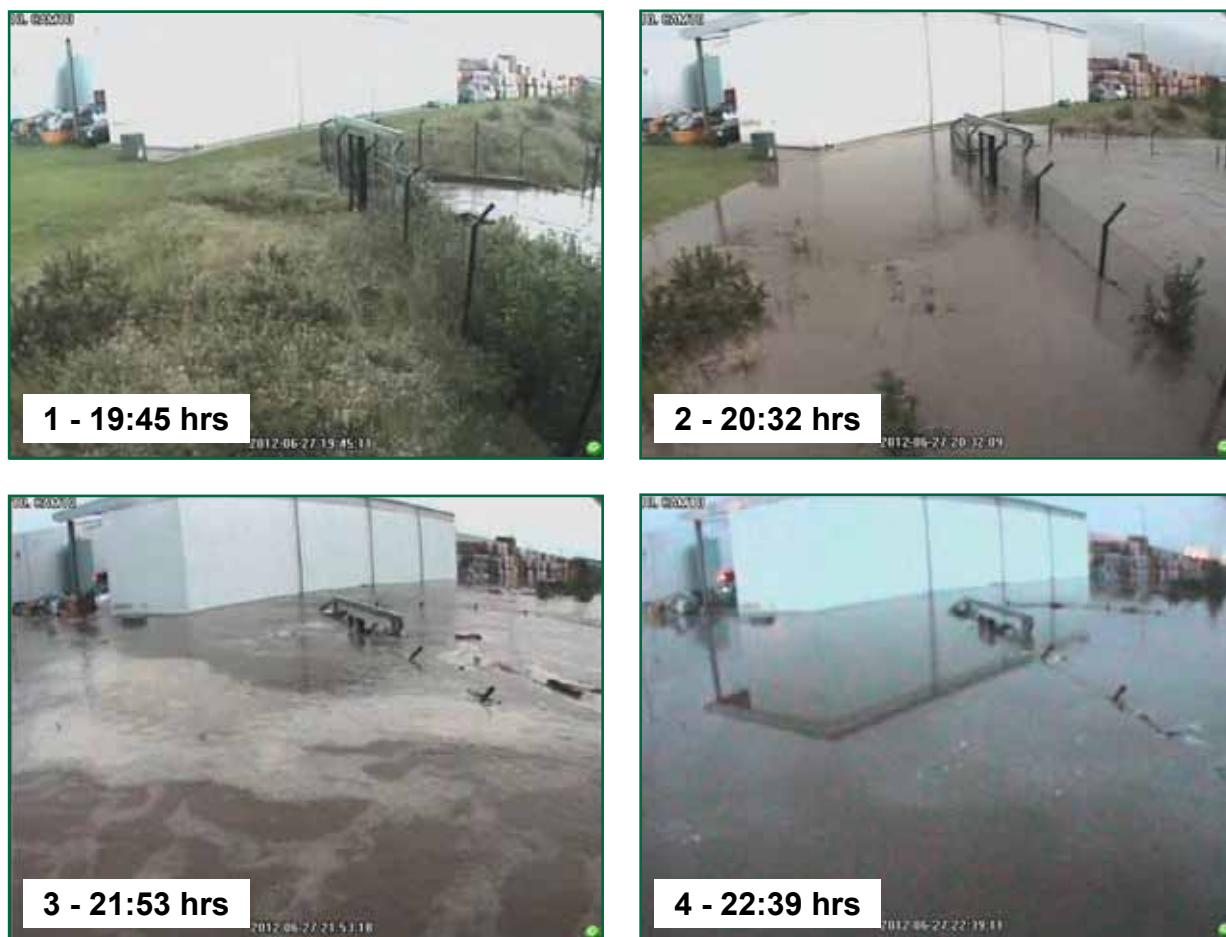
- 52 CCTV footage from a CCHBC camera aimed at the inlet to its culvert, showed the flood event developing on the CCHBC side of the boundary fence, between the plant and the downstream side of the railway embankment. A series of four still images taken from the footage are shown in figure 9.

- 53 By 19:45 hrs the inlet to the CCHBC culvert was completely submerged (ie the water level was higher than the top of the culvert inlet). By around 20:32 hrs, water had spilled over onto the adjacent land and had reached the plant itself. There is no CCTV footage which shows what was happening on the upstream side of the railway embankment at this time, but water would have been impounding on that side (figure 10) and its level would have been higher than on the downstream side in order to push water through UB1. Figure 9 shows that at around 21:53 hrs there was a sudden change in the pattern of water flow within the camera's field of view, and the simultaneous arrival of floating debris and an oily sheen. This was probably when the breach of the railway embankment occurred, releasing a large amount of water from the upstream side. The mechanism of embankment failure is discussed later at paragraph 62.

Figure 9: Flooding sequence at the adjacent CCHBC plant (images courtesy of CCHBC)

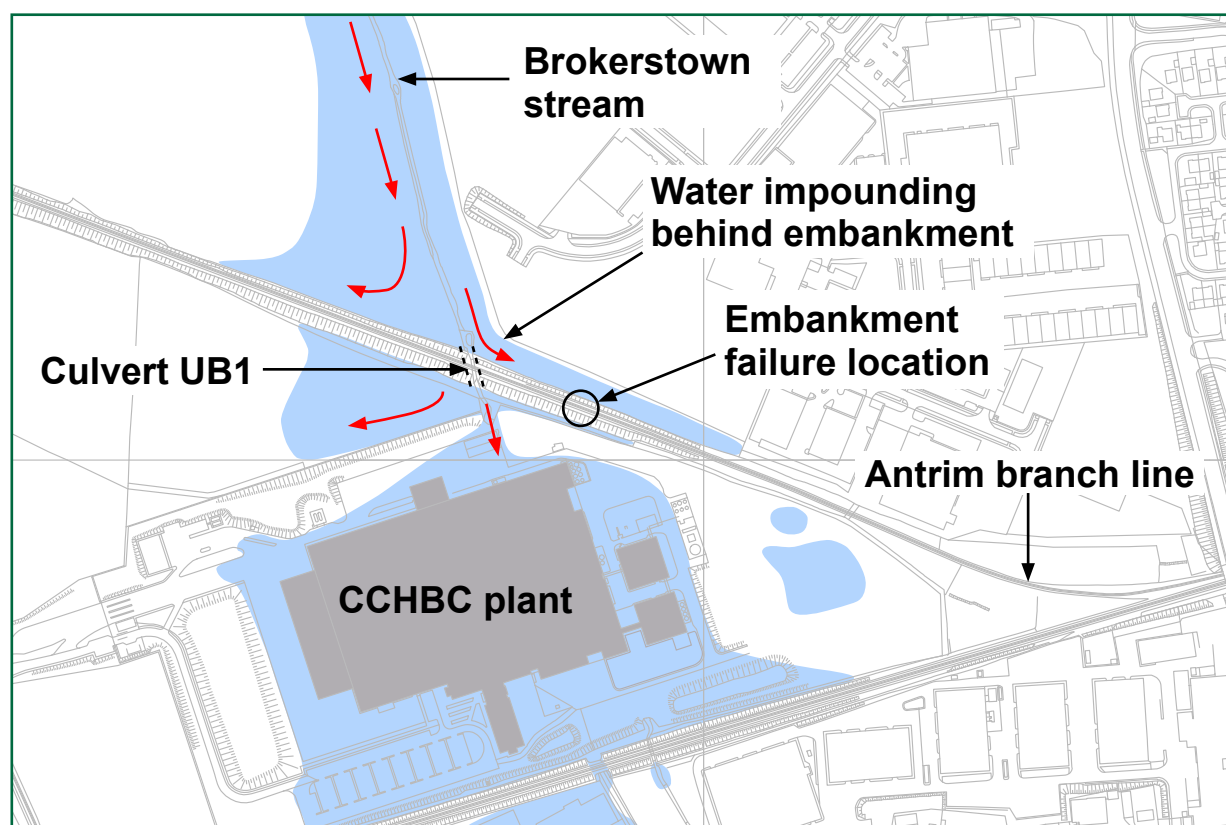
Figure 10: Schematic of water impounding behind the upstream side of the railway embankment

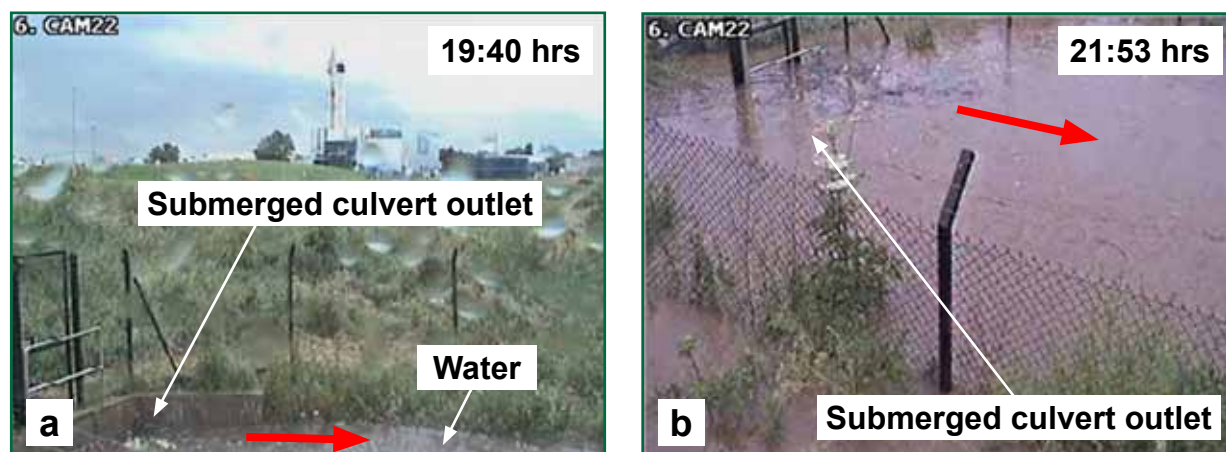
- 54 The CCTV footage from a camera aimed at the outlet from the CCHBC culvert shows that from around 19:40 hrs it was also completely submerged (figure 11). This indicates that culverts downstream of the CCHBC culvert were restricting flows through it. This in turn would have caused water levels to increase at the upstream end of the CCHBC culvert.

Figure 11: CCTV images of the CCHBC culvert outlet (images courtesy of CCHBC)

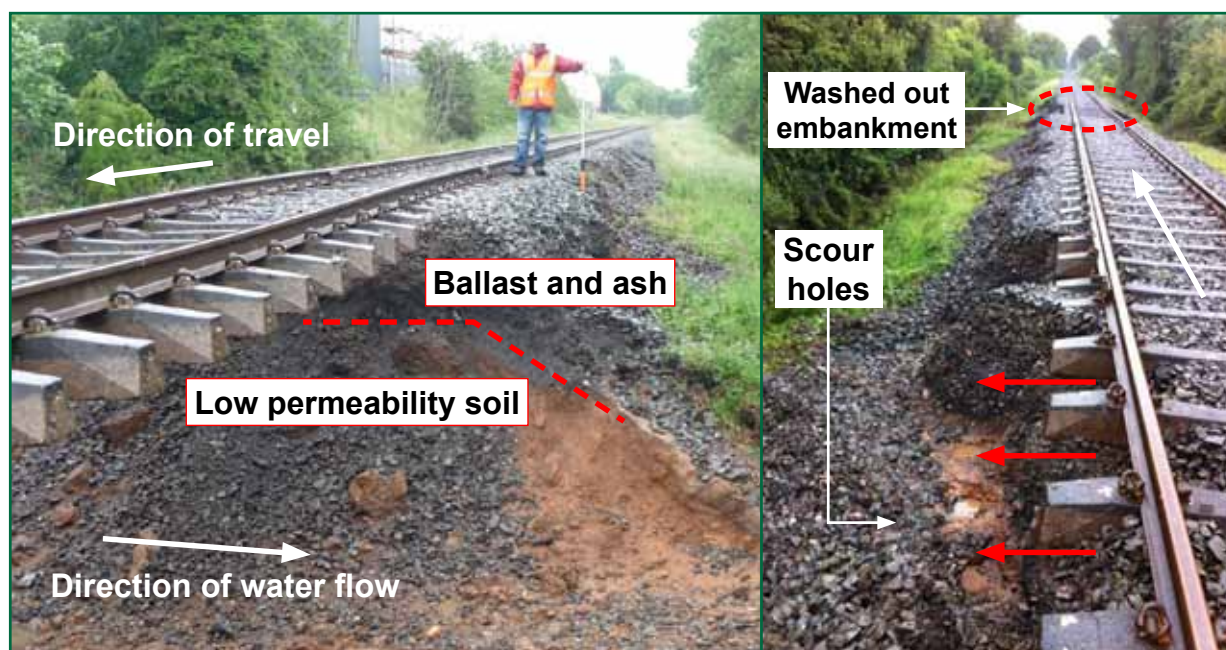
- 65 The photographs also recorded *scour holes* on the downstream side of the railway embankment, on the approach to the washout. These were formed as water seeped through the permeable upper layers of the track formation. The position of these scour holes provides an indication of the maximum water level on the upstream side of the embankment, which was around 1 metre below rail level.

Figure 12: Washed out embankment and scour holes on approach to the site (images courtesy of URS)

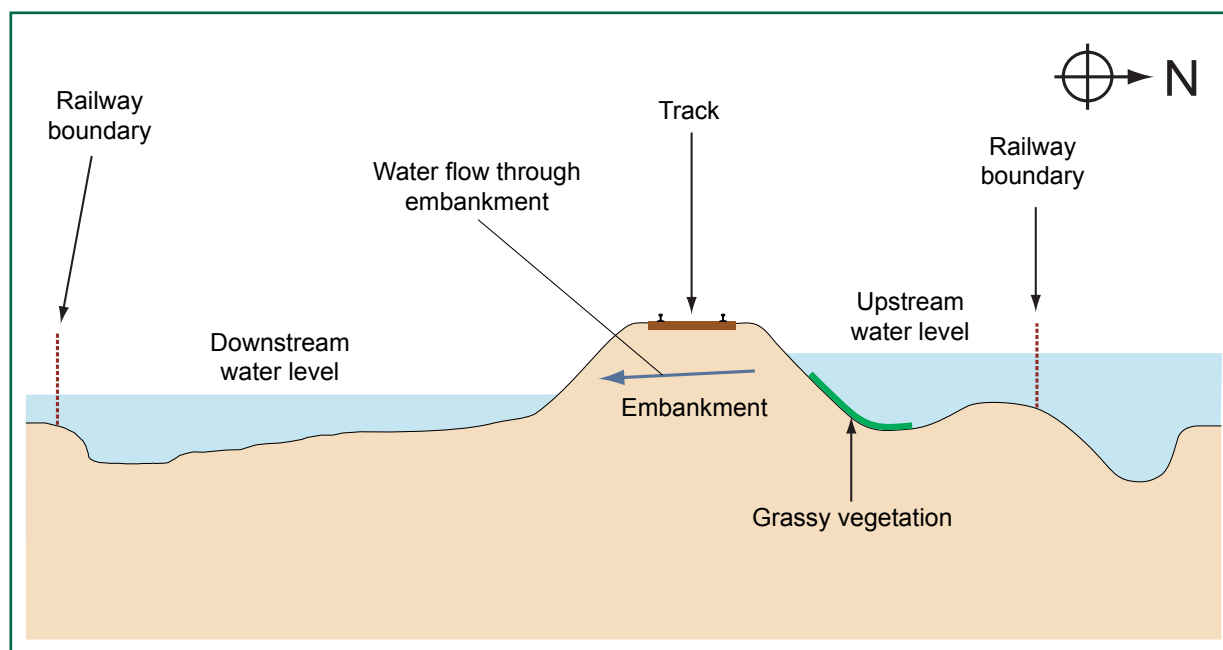
- 67 The difference in water levels across the embankment was caused by a greater flow of water arriving at the upstream side of UB1 than could be passed through the combination of UB1 and the downstream culverts, causing water to build up on the upstream side (figure 13). This water level difference would have provided a driving head to force water through the permeable upper layers of the embankment. When water levels were relatively low, it is likely that the embankment was effective as a dam because the embankment was relatively wide near its base, the grassy vegetation on the upstream face strengthened this surface, and the brown embankment core material offered a greater resistance to water seepage than the upper layers of ash and ballast.

Figure 13: Schematic cross section through embankment at the failure location, showing difference in water levels across it

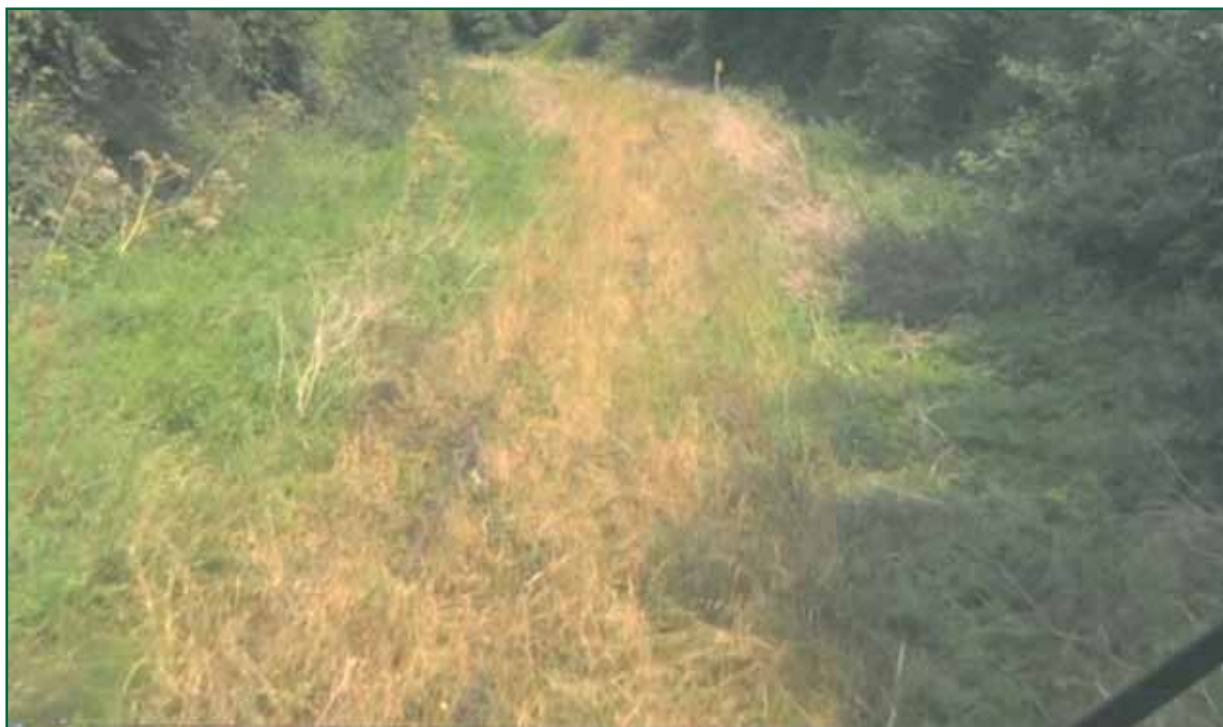
- 106 On 12 September 2012, the RAIB carried out a cab ride in a Class 4000 train along the Antrim branch line. It was noted that some short sections of the track were severely overgrown with weeds and in some locations one or both rails were not visible to the driver (figure 14).

Figure 14: A section of the Antrim branch line with excessive weeds and lack of visibility of the track, September 2012

- c. Some short sections of the Antrim branch line had been allowed to become severely overgrown with weeds, to the extent that one or both rails would not have been visible to track patrollers and drivers; (**paragraph 106, Recommendation 4**).
