Report 15/2017
October 2017

Serious irregularity at Cardiff East Junction, 29 December 2016

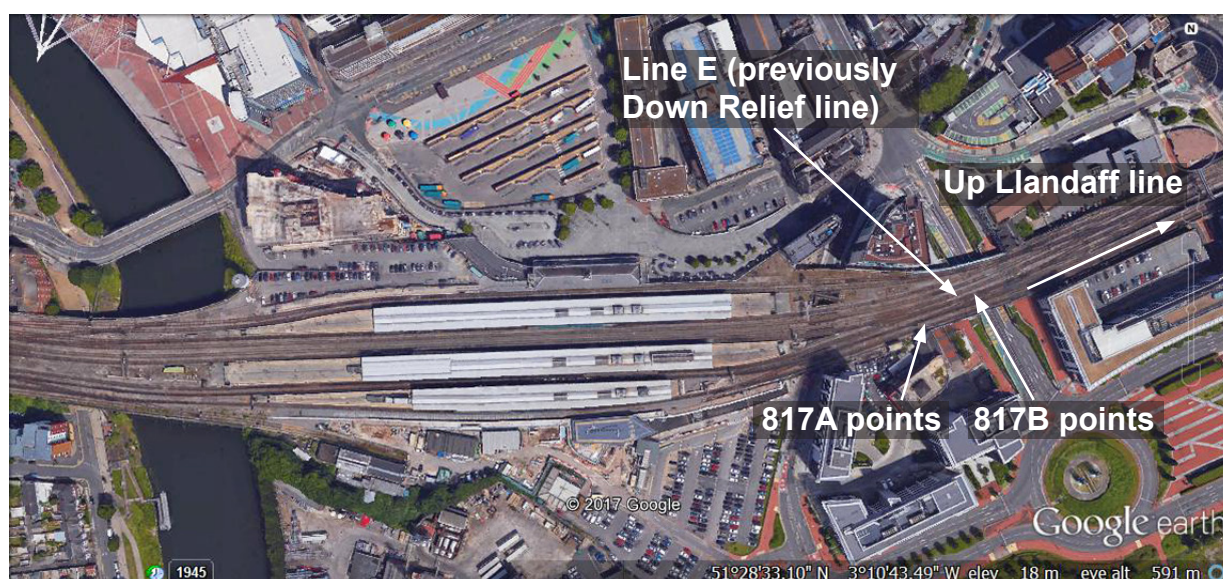
Figure 2: Overview of the lines out of Cardiff Central station showing the location of 817 points

- 7 817A points had been left unsecured, *undetected* and in the wrong position at the end of the works, earlier on the same day. They were due to be removed as part of final project works taking place during the Easter period in 2017. In the position in which the points were lying, train 2T08 would have been routed onto the former down relief line, which became line E as part of the works, and will be referred to as line E throughout this report.

- 8 817B points at the other end of the same *crossover* (figure 3) had also been left unsecured and undetected in the layout. However, this end of the crossover had been left set in the correct position for trains to pass along line E. 817B points were to be removed as part of the works carried out by 3 January 2017.

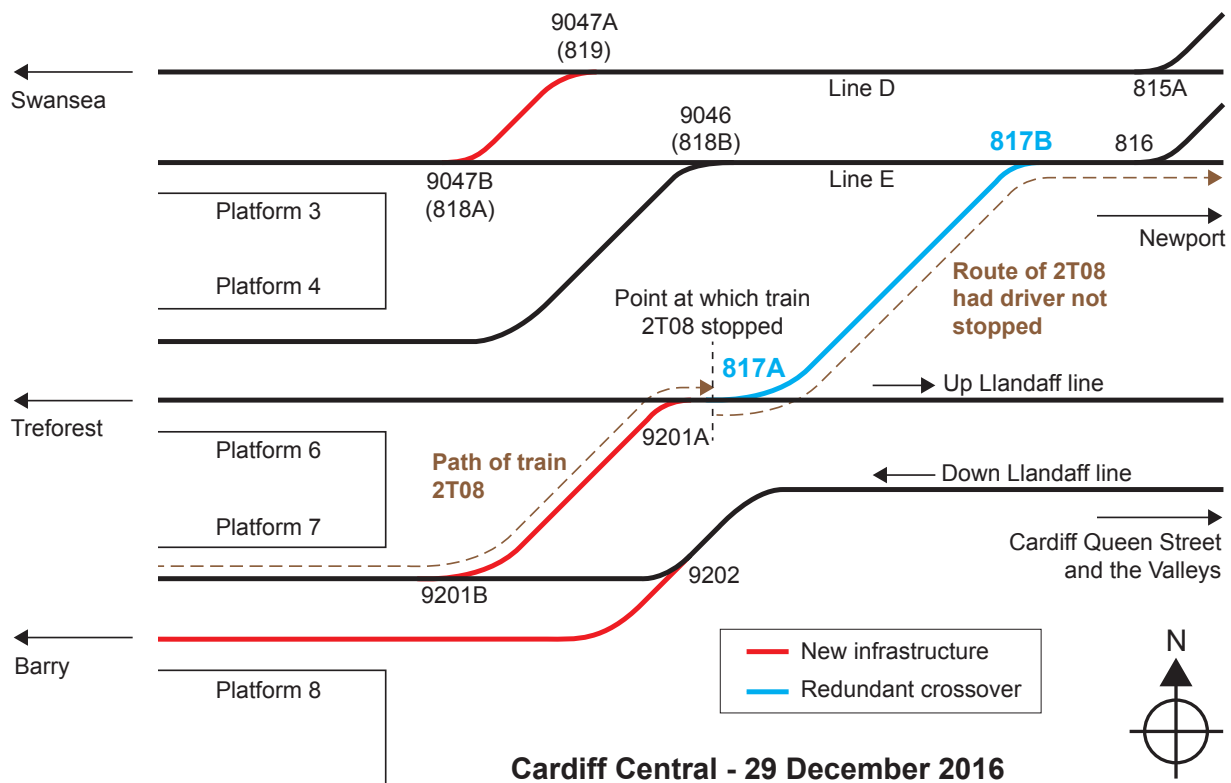
Figure 3: Simplified track layout showing the area and the location of 817 points

- 23 817A and 817B points formed a crossover between Line E and the Up Llandaff line. They were power operated and had been controlled from Cardiff power signal box, which was decommissioned at the beginning of the Christmas blockade. These lines were due to close again on 31 December for further works to be completed, after which all the lines would be re-opened through the area and a number of temporary speed restrictions would be lifted.
