# Rail Accident Report

## **Electrical arcing and fire under a train near Windsor & Eton Riverside 30 January 2015**

Report 18/2015  
October 2015

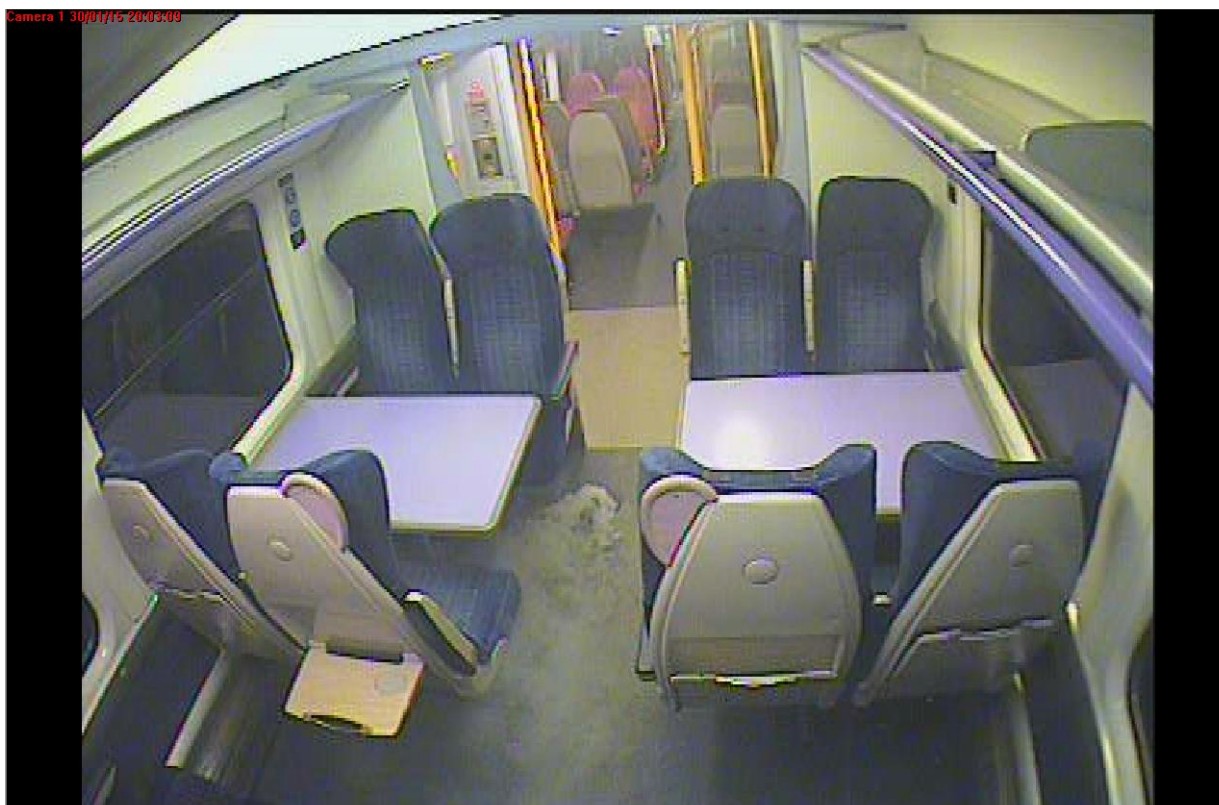
Figure 3: smoke breaks through the floor of carriage 67601

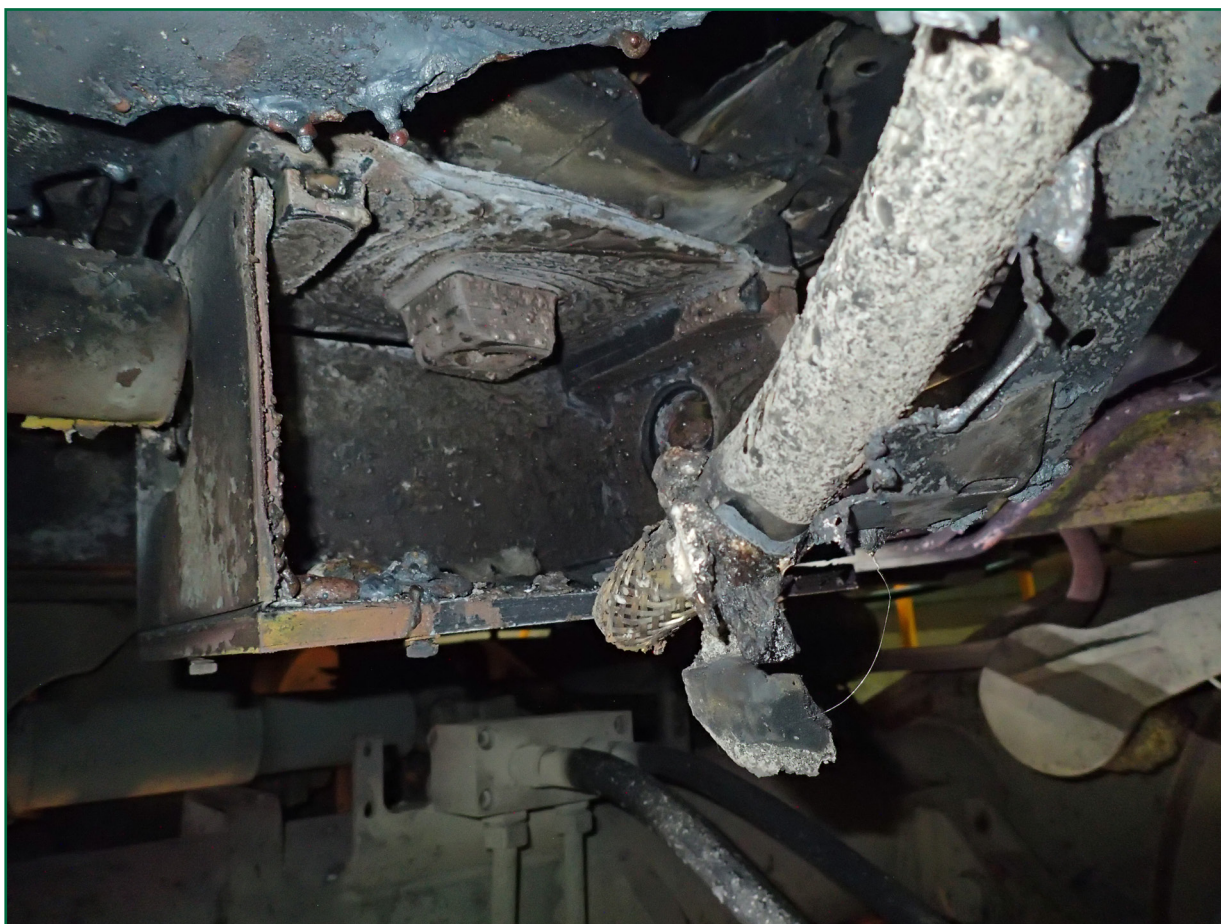
*Figure 5: the area where the arcing took place, showing damage to the junction box, cables and structural members*

- 48 Although, because of the nature of the event, much of the evidence had been destroyed, the origin of the arcing was almost certainly the joint where the two power cables from the collector shoes on each side of the carriage (the shoe cables) are connected to the cable which carries traction current through the unit (the bus line). The joint is mounted under the vehicle floor, close to the bogie on which the collector shoes are mounted. The construction of this joint is shown in figure 6b. It consists of a single zinc plated steel M16 hexagon head setscrew, 45 mm long, which passes through holes in the ends of the lugs which are crimped to the three cable ends, and is screwed into a through tapped hole in a boss which is welded to a plate, forming a bracket assembly. The joint also includes a plain washer and a helical spring washer. Alstom document FMI J06 ALST 0078 specifies that the setscrew should be tightened to 173 Nm.

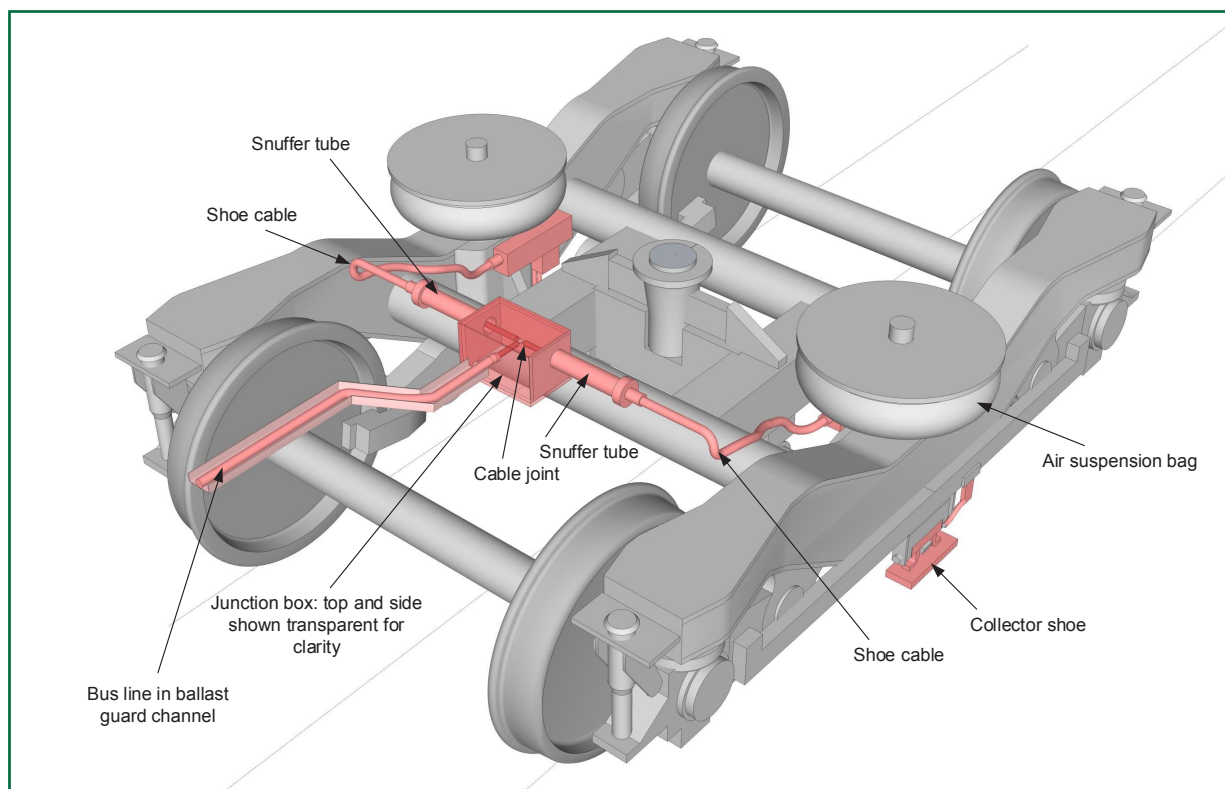
Figure 6a: Class 458/5 bogie, showing power cable arrangement

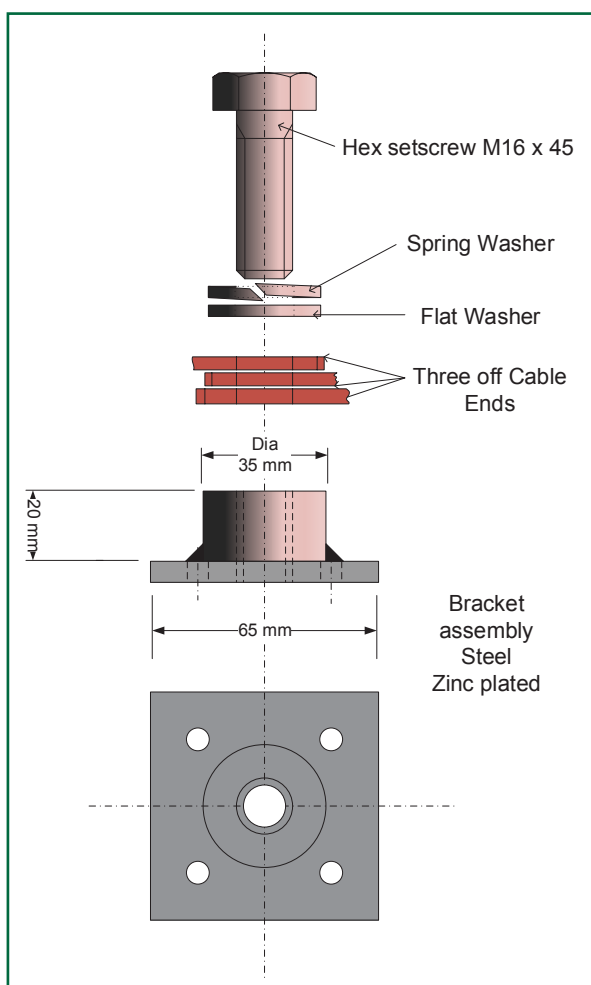
Figure 2: Track and signalling layout, showing route of train

Figure 6b: details of the cable joint

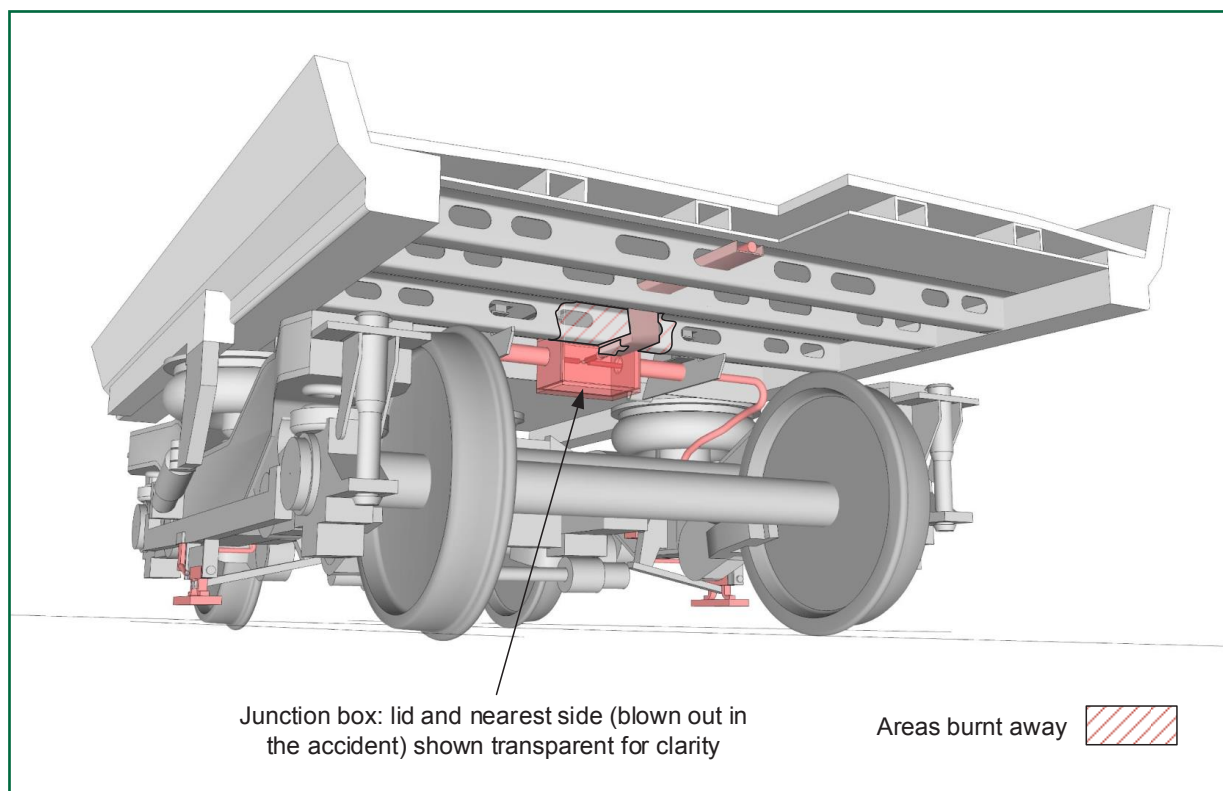
- 51 In the damaged junction box on vehicle 67601, the side through which the bus line passed had been blown out and was retrieved from the track under the train after the accident. The lid was still in place. The sides and top of the junction box had lost some thickness, but were substantially intact (figure 5 and figure 8). The bracket, washers, cable ends and securing bolt had been totally consumed by the arcing. The shoe cable on the right-hand side (in the direction of travel) had burnt back to the wall of the junction box, and the shoe cable on the left-hand side had burnt further back, some 70 mm beyond the wall of the junction box. The bus line cable was burnt back to approximately the point where the junction box wall had been.

- 52 The *snuffer tubes*, which protect the shoe cables outside the junction box, were intact, although the tube on the left-hand side had come away from the wall of the junction box. The shroud which is intended to protect the bus line cable from physical damage was burnt back about 150 mm from the junction box and displaced.

Figure 8: Damaged area under carriage 67601

- 53 The arcing burnt a hole about 300 mm by 100 mm through the outer skin of the vehicle, and destroyed longitudinal and lateral steel structural members in the vicinity of the junction box, compromising the strength of the vehicle body structure in this area. Figure 9 shows the extent of the damage, looking from above. The mineral wool and glass fibre insulation material between the outer skin and the floor was destroyed. The floor itself was affected over an area about 500 mm in diameter, with its lower skin (of aluminium) melted away, and the plywood core heavily charred and penetrated in one area.

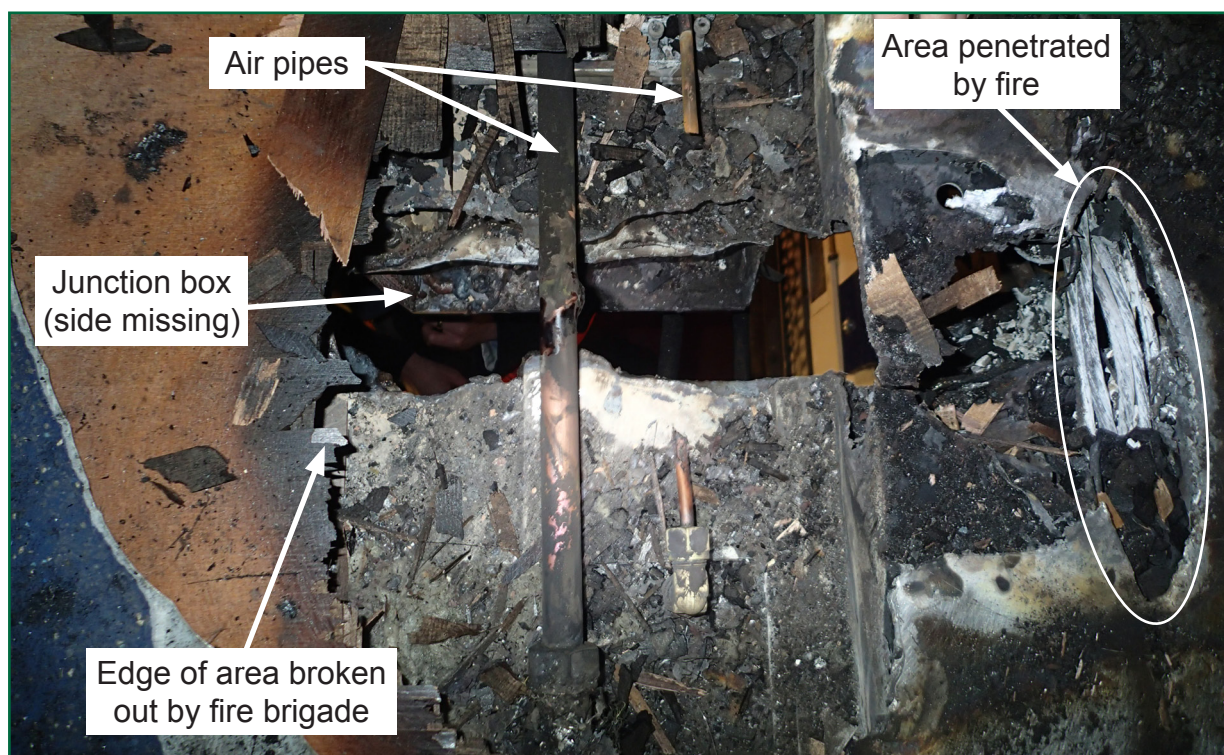
- 54 It was not possible to be certain exactly how much of the upper surface of the floor, and floor covering, had been burnt through by the arcing or by the subsequent fire, because of the action taken by the Fire Brigade to expose any smouldering areas. However, it seems likely that a large area was heavily charred and an area at least 150 mm by 30 mm was fully penetrated (figure 9).

Figure 9: Damaged area of floor, viewed from above

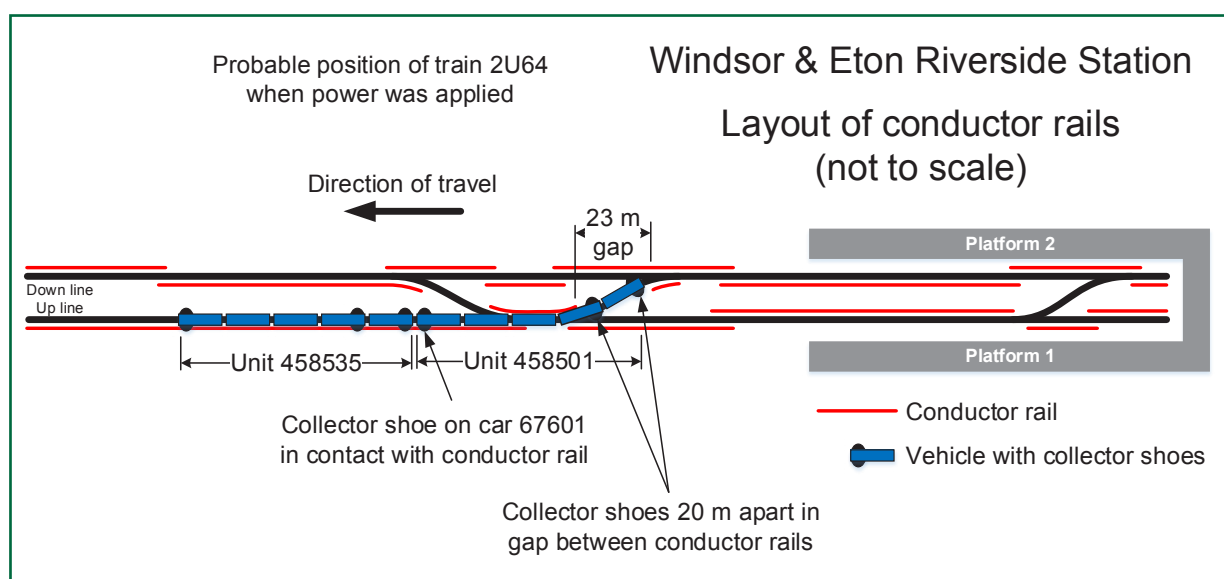
63 The initiating event for the violent arcing almost certainly occurred when the driver of the train applied power as the rear of the train was passing over the crossover from platform two to the up line. Because of the presence of the crossover, there is a gap of about 23 metres in the conductor rail for trains taking this route. The collector shoes on the rear two cars of the train are 20 metres apart. Therefore, for a short period, the only collector shoe on unit 458501 in contact with a conductor rail was the left-hand shoe on the leading vehicle, car 67601 (figure 10).

64 This meant that, for about half a second, a current of about 1900 amps (supplying all the traction motors on the unit) was probably passing through the loose joint. This initiated a powerful arc within the junction box, which burnt away the cable ends, creating heat and gas which raised the pressure inside the box, leading to an explosion and subsequent visible arcing (paragraph 22).

Figure 10: Layout of conductor rails and position of train at start of arcing
