Rail Accident Investigation Branch

Rail Accident Report

**Derailment of a freight train near Langworth,
Lincolnshire
30 June 2015**

Report 11/2016
June 2016

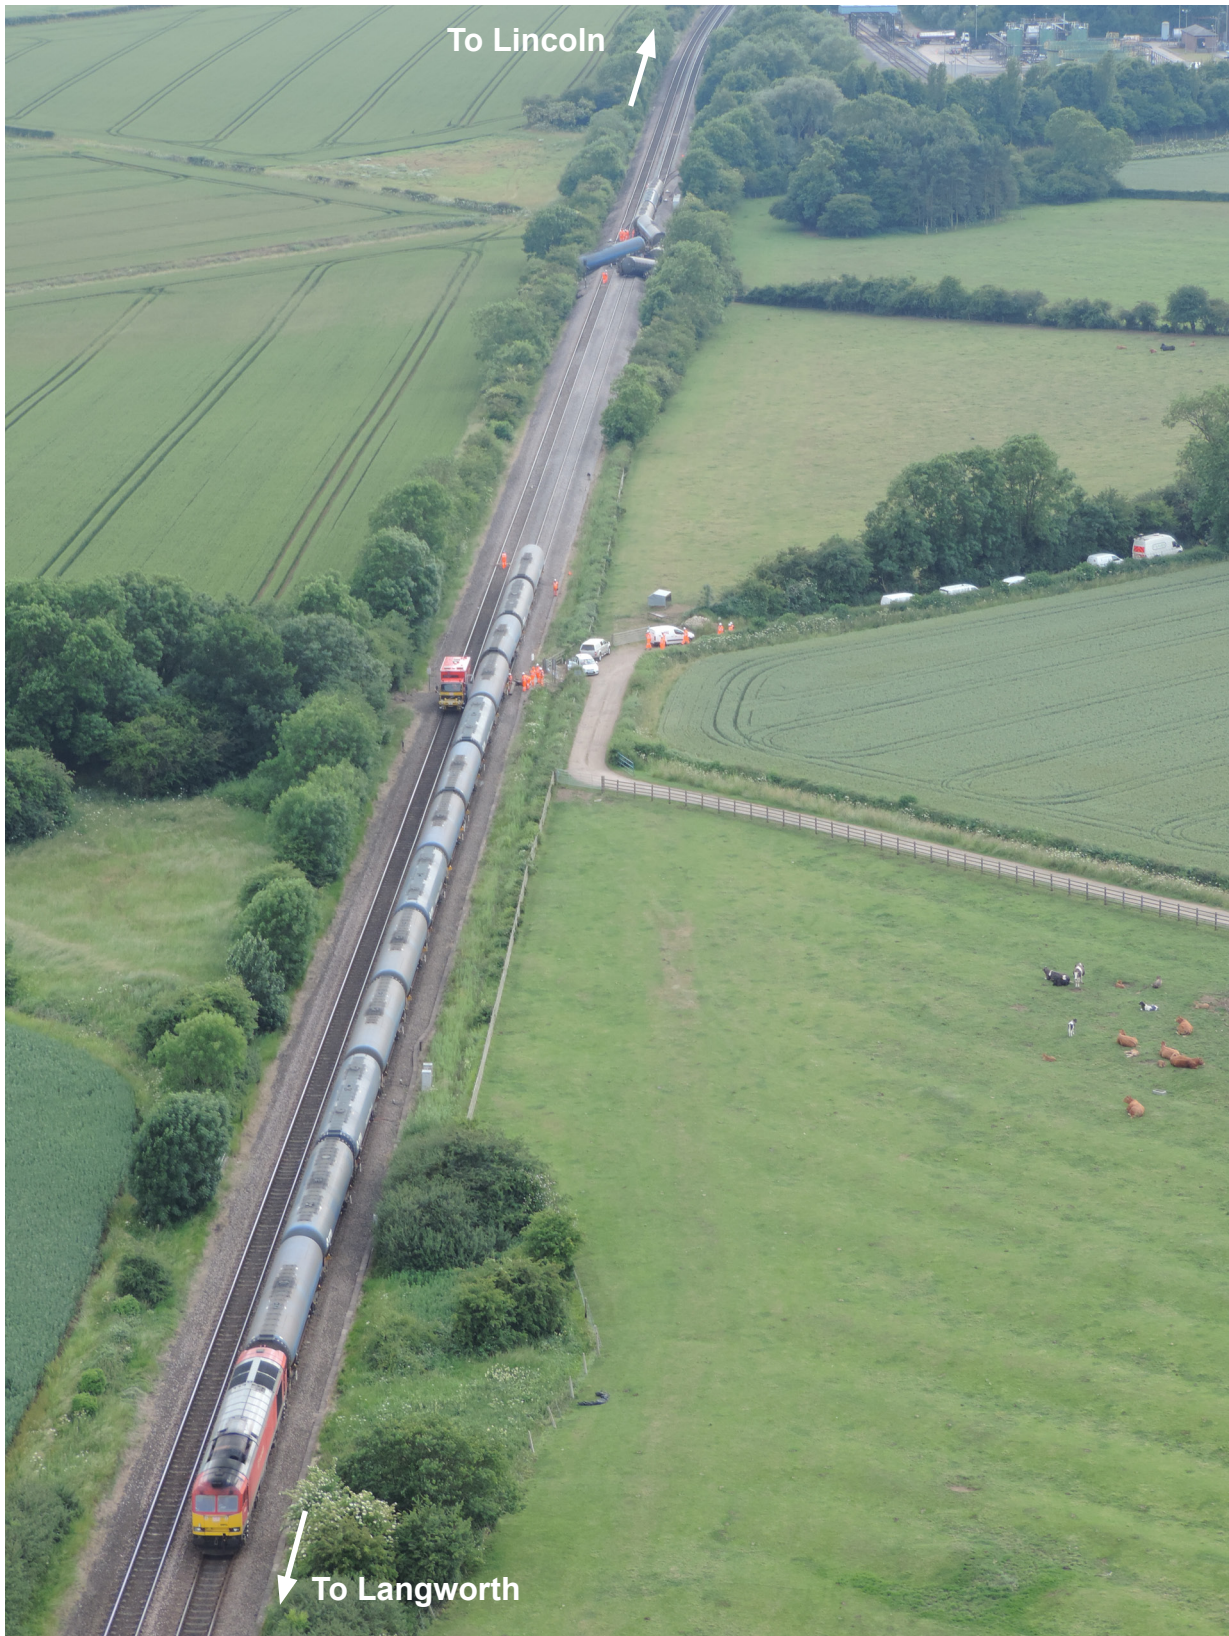
- 5 Wagons 11, 12 and 13 (from the leading end) derailed but remained upright. The train then separated between wagons 13 and 14, which caused the train's brakes to apply. The front part of the train came to rest about 250 metres from the rest of the train. Wagons 14 to 20 left the track with four wagons rolling over and one slewing across both tracks (figure 2). Wagons 21 and 22 did not derail.

- 6 Although no-one was injured, substantial damage was caused to the train and to the infrastructure over approximately 400 metres. Wagons 14 to 19 had to be recovered by crane which required the building of a temporary road. The remaining derailed wagons were railed and recovered by rail. There were no reports of any leakage of diesel fuel residue from the tanks.

Figure 2: Overview of the accident site (image courtesy of Network Rail)

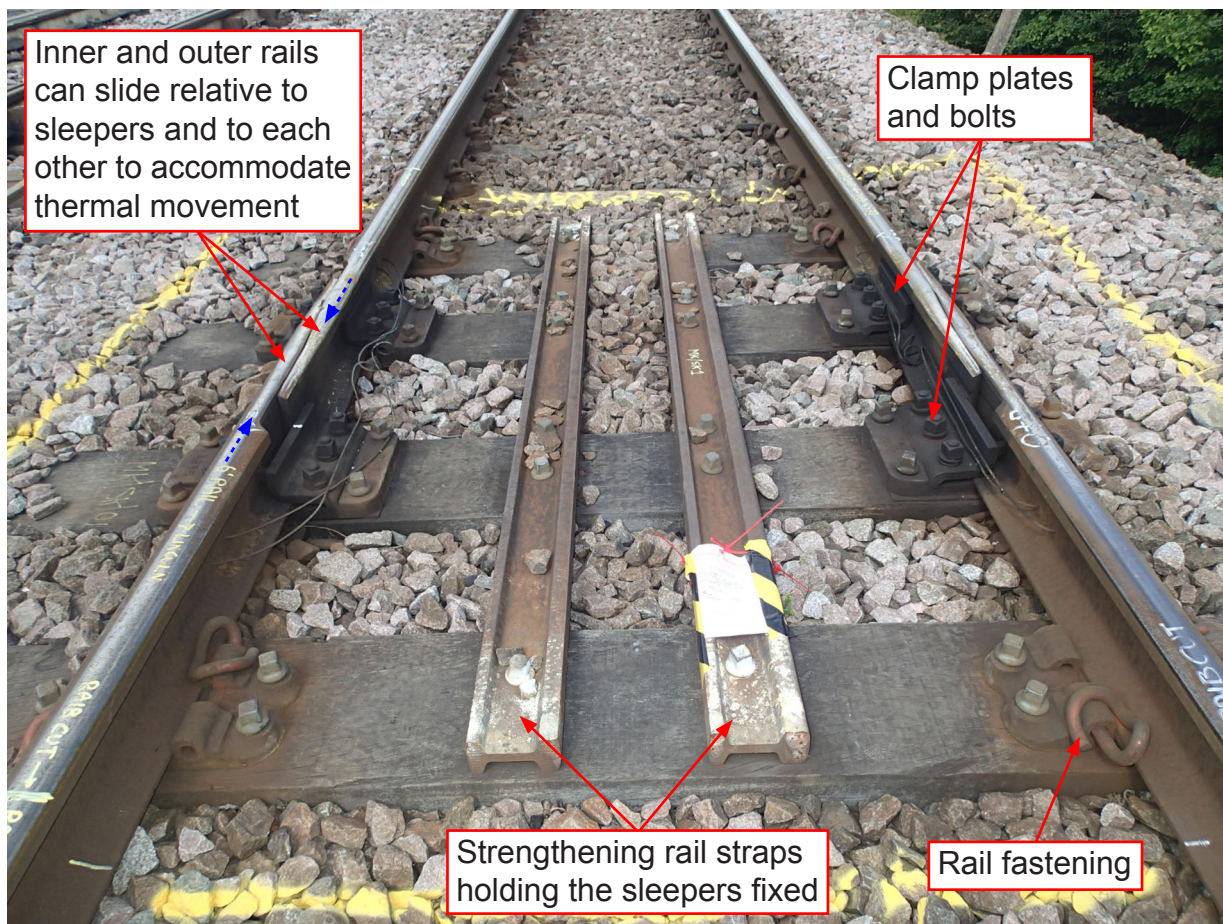
Figure 5: Adjustment switch on the down main line at the Lincoln end of 101A points

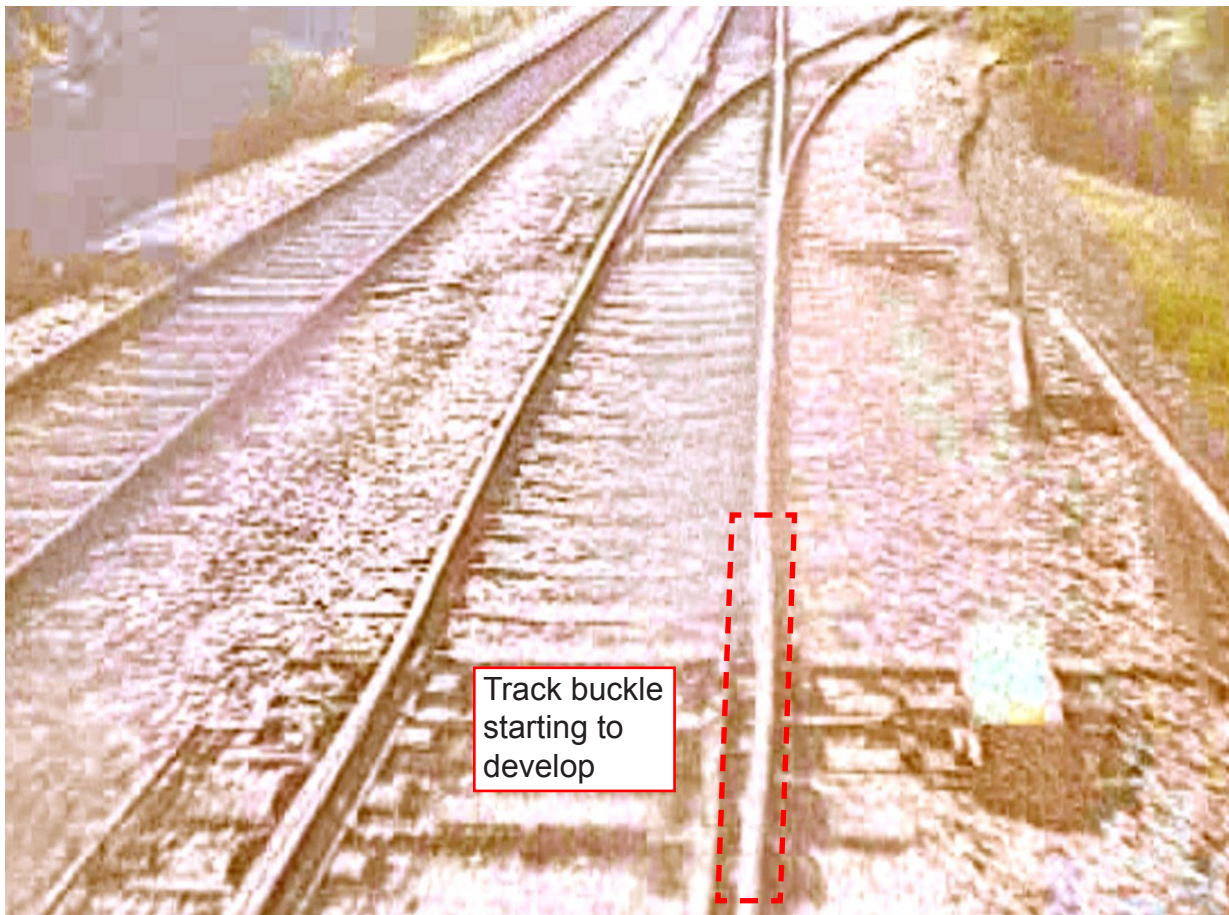
- 23 Train 6E54 discharged its load of diesel fuel at Kingsbury Oil Terminal and departed on its return journey to Humber Oil Refinery at 10:25 hrs. The driver reported an uneventful journey up to the derailment.
- 24 At 12:44 hrs an East Midlands Trains (EMT) passenger service from Lincoln to Grimsby, formed of a single vehicle, passed over the site. Although the driver reported that he did not see or feel anything amiss with the track, images from the forward and rearward facing CCTV cameras show there was a track buckle starting to develop around the toe of 101B points (figure 6). It is possible that the size of the buckle developed further under the train.

Figure 6: Image from rear facing CCTV camera on previous train at 12:44 hrs (image courtesy of East Midlands Trains)

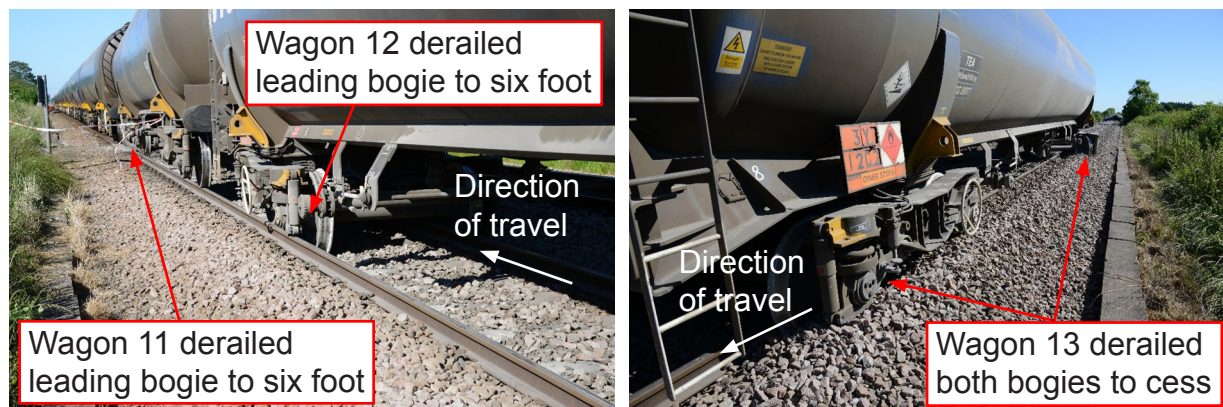
- 26 The locomotive and the first ten wagons had passed over the track buckle before the leading bogie of wagon 11 derailed to the *six-foot*, ie to the right, followed similarly by wagon 12. Wagon 13, however, derailed by both bogies to the *cess*, ie to the left (figure 7).

Figure 7: Wagons 11, 12 and 13

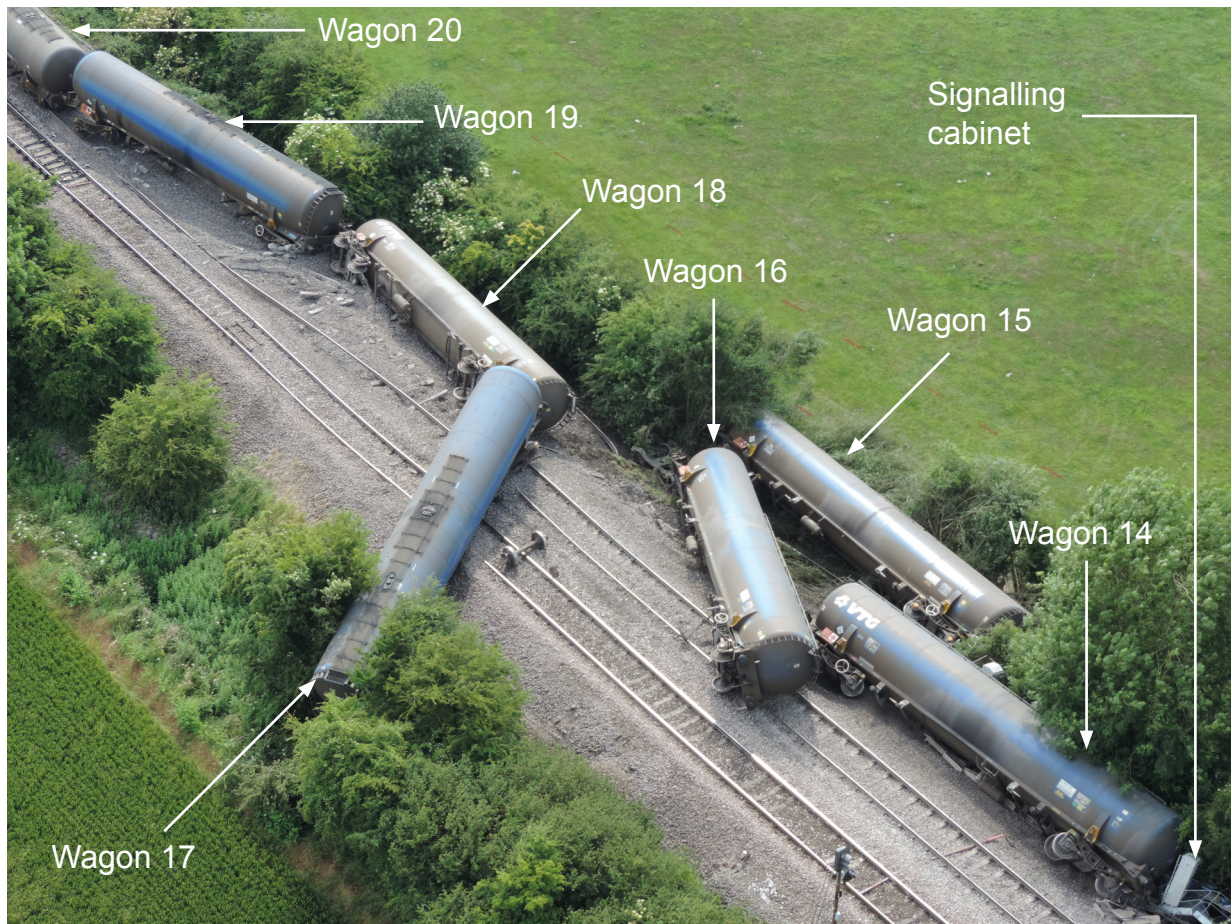
- 28 From the stopping position of wagon 13 there was a gap of approximately 250 metres to the rest of the train. The derailment marks suggest that wagons 14 and 15 (following the path of wagon 13) derailed to the cess and overturned, most likely when wagon 14 collided with a cabinet containing signalling equipment (figure 8). The leading bogie of wagon 16 also derailed to the cess but the trailing bogie moved towards the six foot with the result that wagons 16 and 17 jack-knifed and wagon 17 came to rest across both tracks. Wagons 18 to 20 derailed to the cess with wagon 18 overturning. Wagons 21 and 22 passed over the buckle without derailing, probably because of the slow train speed at this point, and came to rest with the rear of the train just beyond the toe of 101B points.

Figure 8: Wagons 14 to 20 (image courtesy of Network Rail)

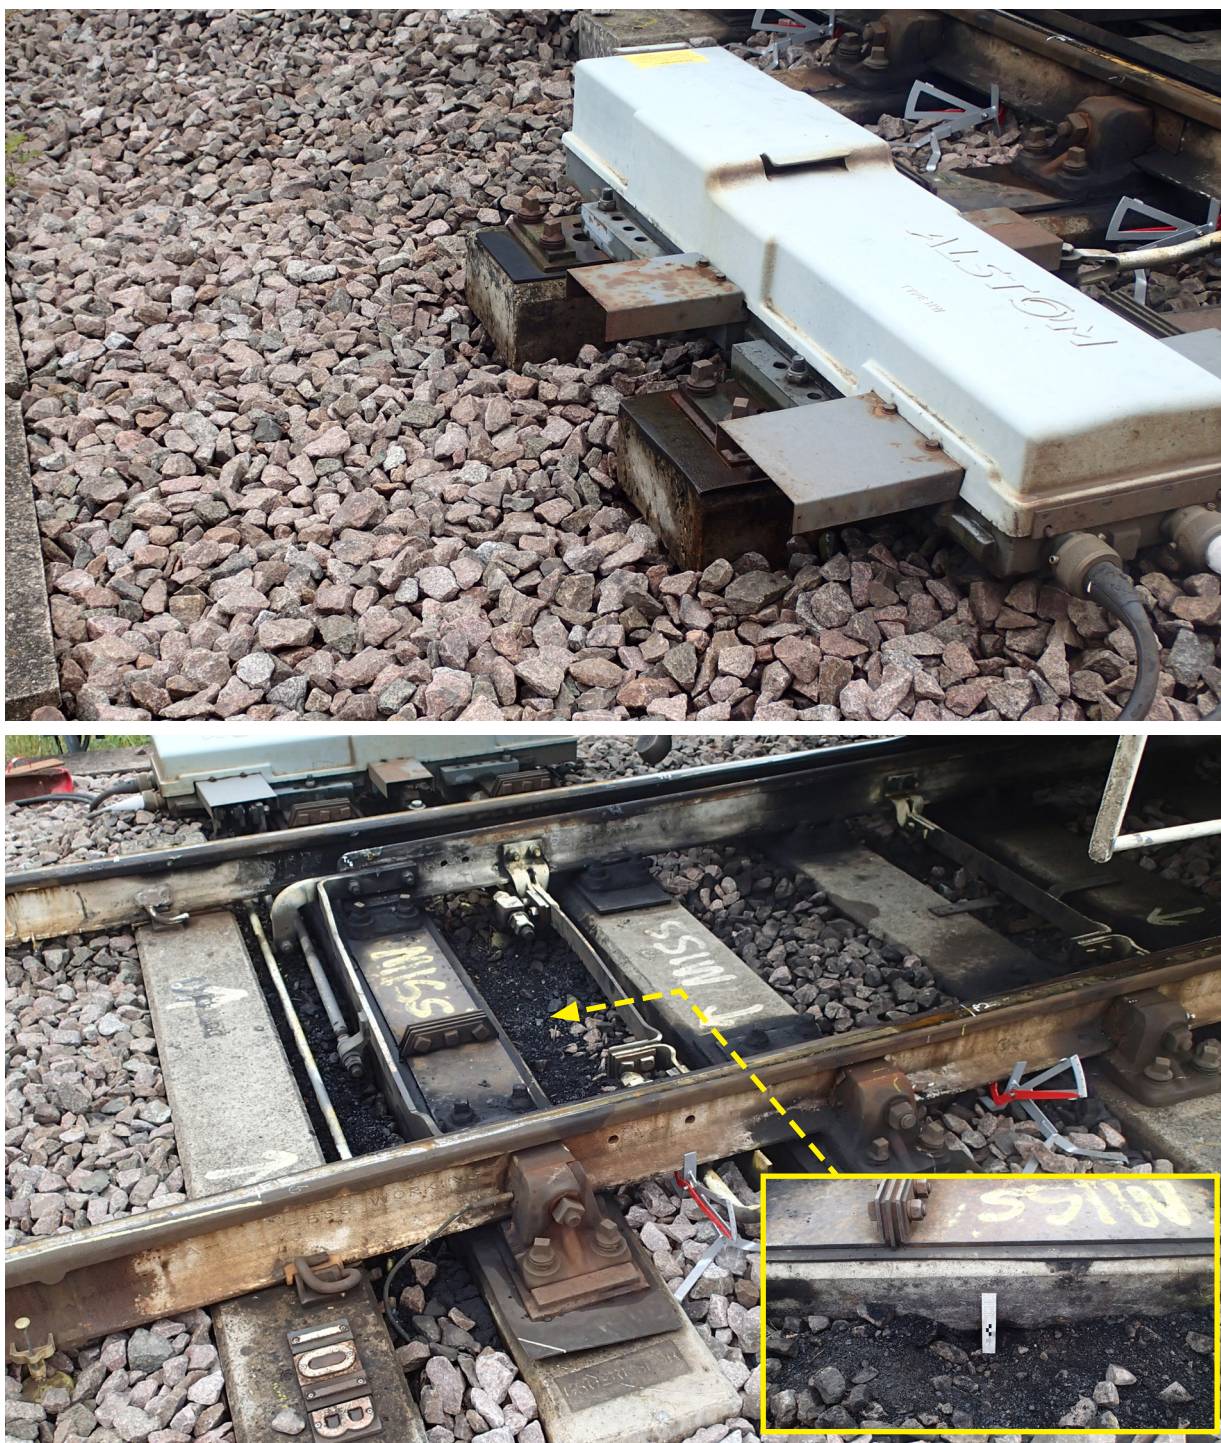
- 53 After the accident the RAIB observed that there was an absence of ballast in the cress at the ends of the bearers for 101B points on which the point motor was mounted (figure 9). The bearers for 102A points were similarly exposed. There was also a minimal *ballast shoulder* on the cress-side ends of the sleepers between the closely abutting toes of 102A and 101B points (figure 10) and the ends of the sleepers adjacent to the toe of 101B points were above the level of the ballast (figure 11). However, the spaces between sleepers within the rails (known as 'cribs') were mainly full of ballast.

Figure 9: Ballast support at the ends of 101B point motor bearers and in the 'cribs' at the toe of the points

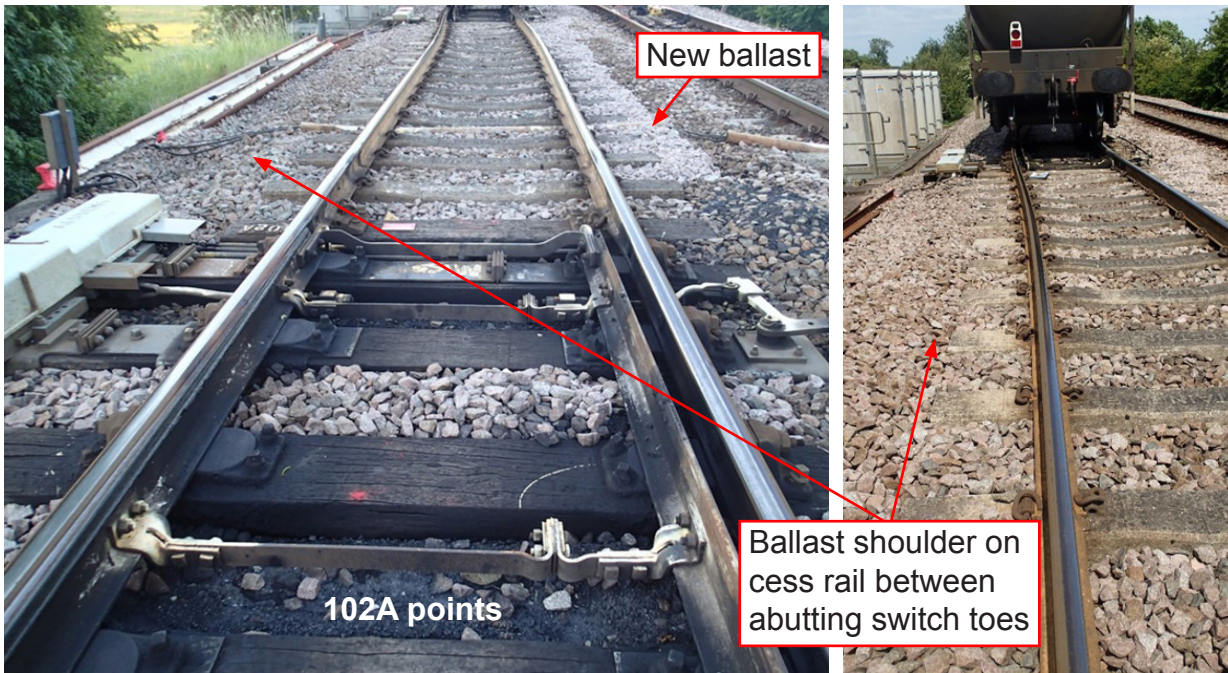
Figure 10: Ballast shoulder in plain line section between 102A and 101B points

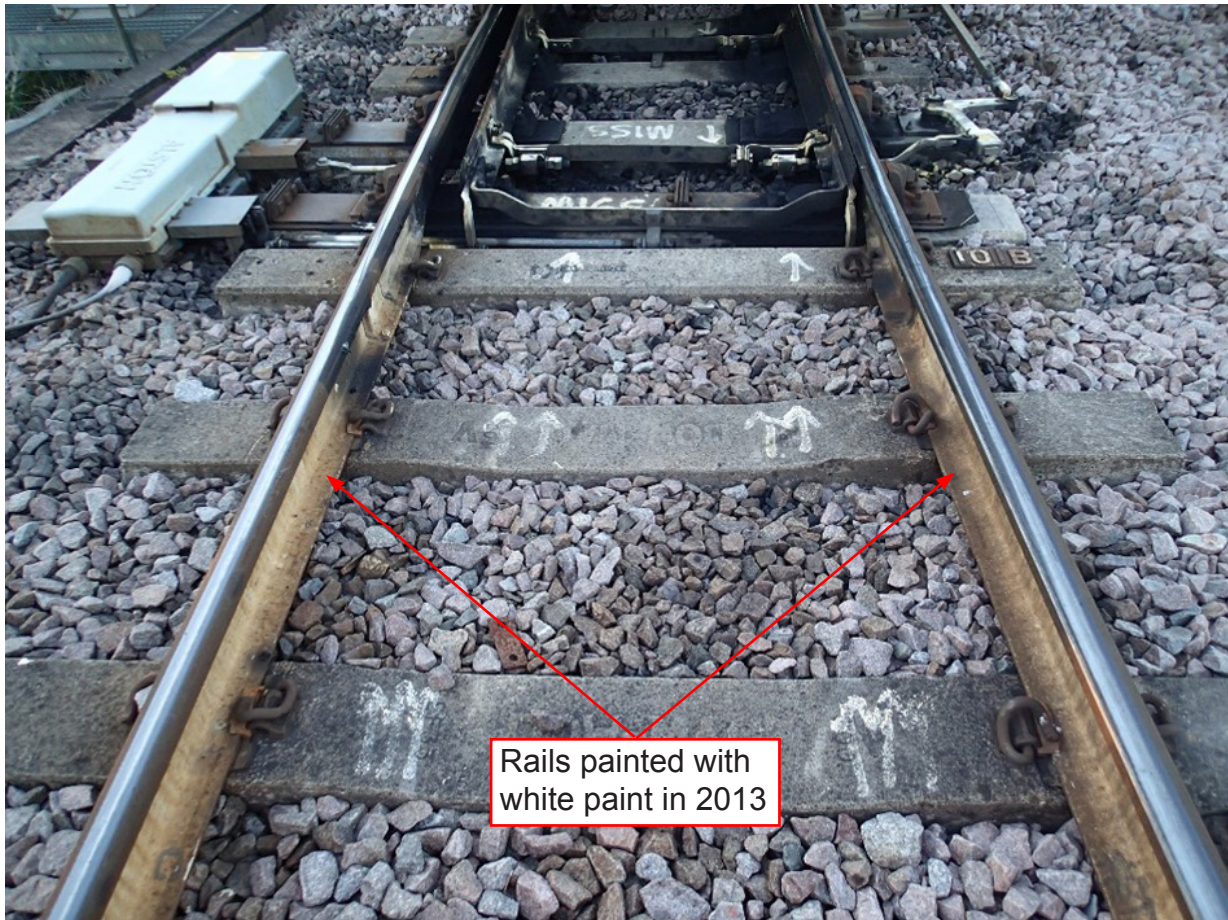
Figure 11: Sleeper tops above ballast at toe of 101B points

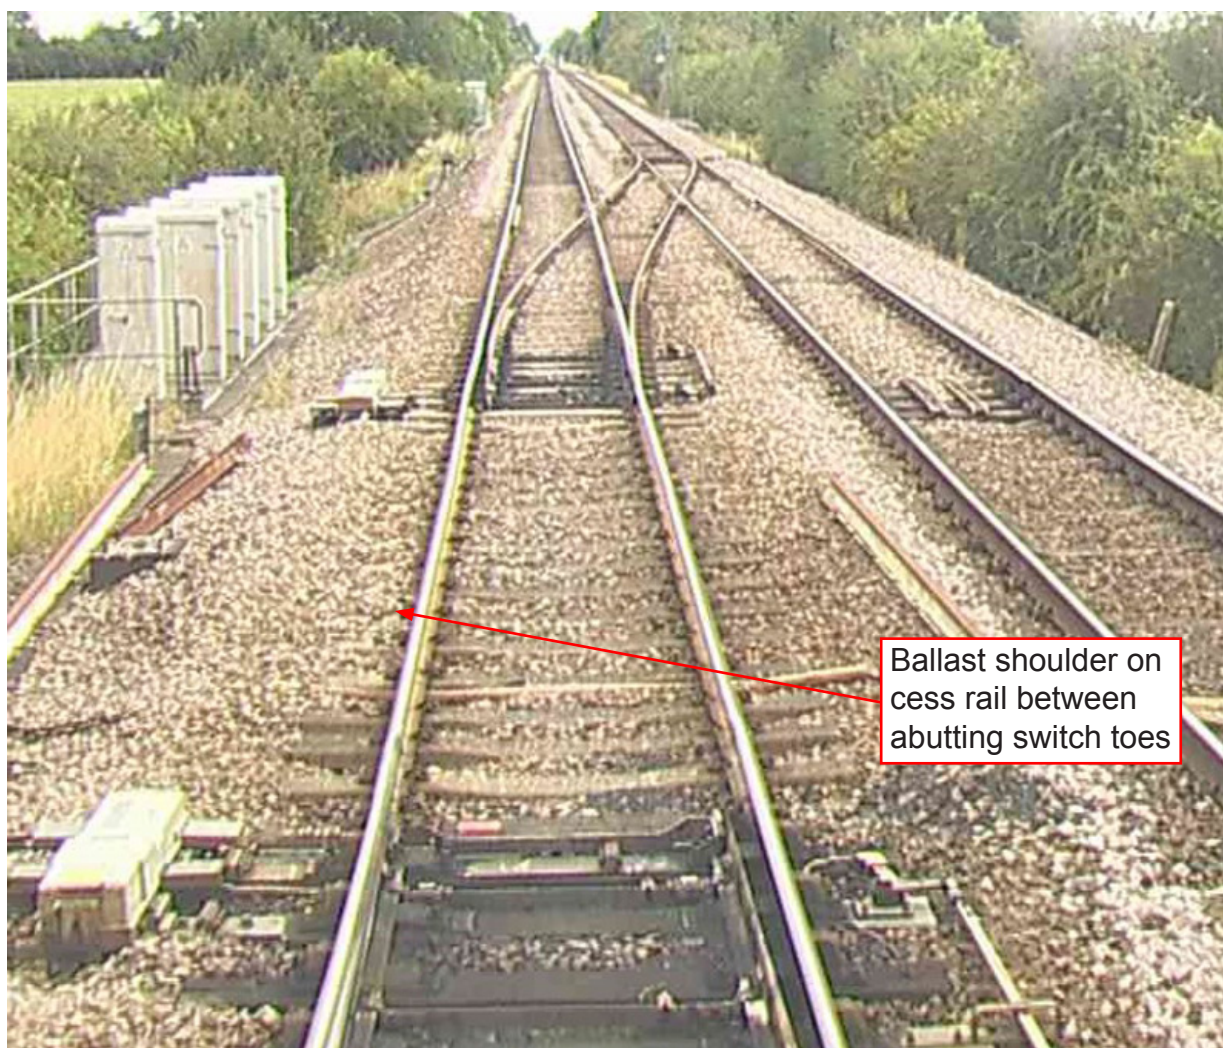
- 55 This ballast deficiency had existed for some time. A recording made by the forward facing CCTV on Network Rail's track recording train (which measures track geometry) in August 2014 showed that the ballast profile on the cress-side of the track was very similar to that at the time of the derailment with little or no ballast shoulder, and some sleeper ends and sides exposed (figure 12).

Figure 12: Ballast shoulder in plain line section between 102A and 101B points, captured by the forward facing CCTV camera on Network Rail's track recording train, August 2014 (image courtesy of Network Rail)

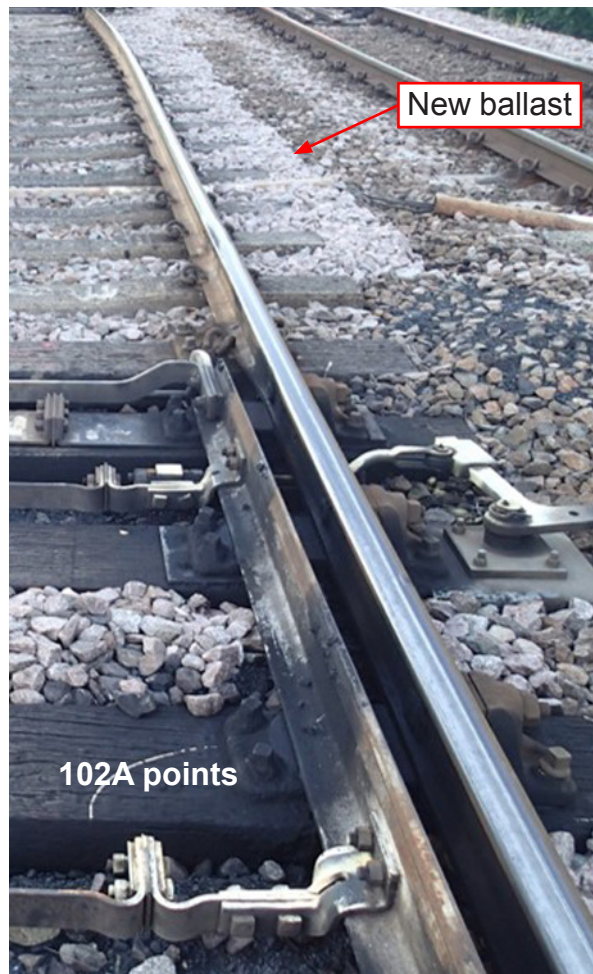
- 57 On 08 April 2015 the work order was cancelled by the SM(T). The SM(T) thought he might have cancelled it because he believed that new ballast had recently been dropped at the site. A comparison with the ballast profile recorded in August 2014 shows that there had been some dressing of the ballast on the six-foot (right-hand) shoulder on the approach to 101B points (figure 13).

Figure 13: Area of ballast dressing in the six-foot between 102A and 101B points

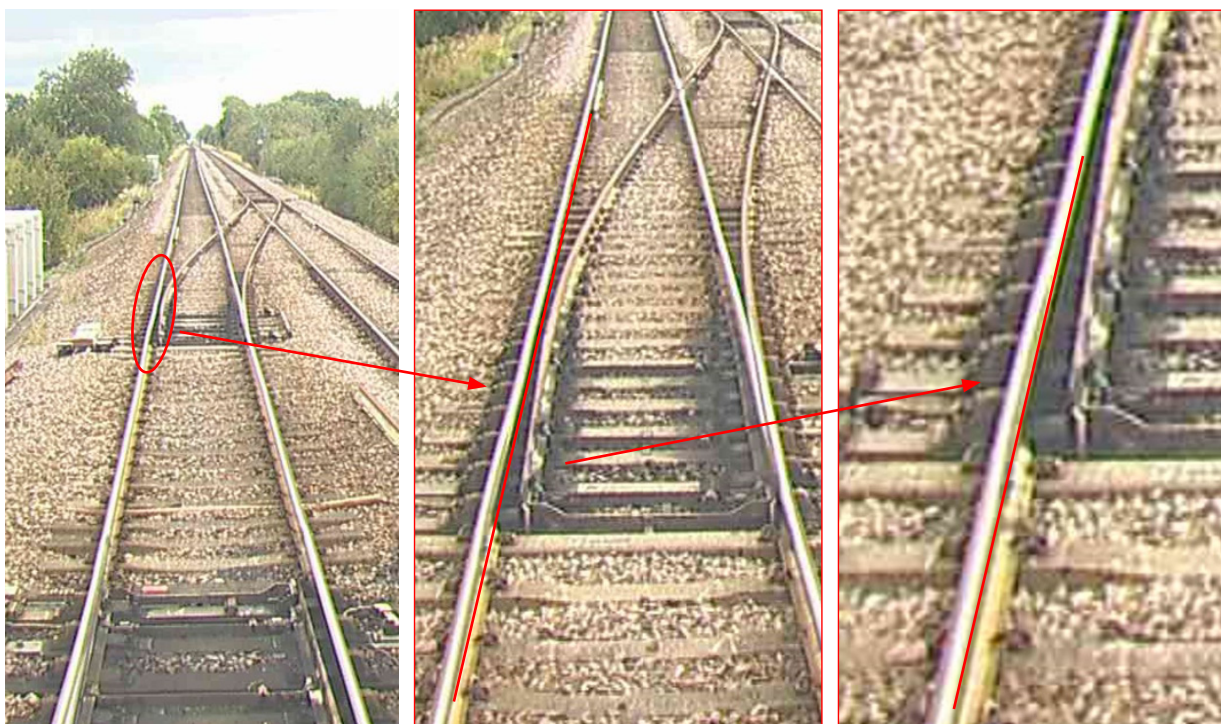
60 The track buckle that formed coincided with a lateral misalignment on the cess rail which was present in August 2014. Images from the forward facing camera on the track recording unit taken in August 2014 showed an apparent deviation in the rail at the toe of 101B points in the same place as the buckle occurred (figure 14).

Figure 14: Pre-existing misalignment on LH rail at 101B toes, captured by the forward facing CCTV camera on the Network Rail's track recording train, August 2014 (image courtesy of Network Rail)

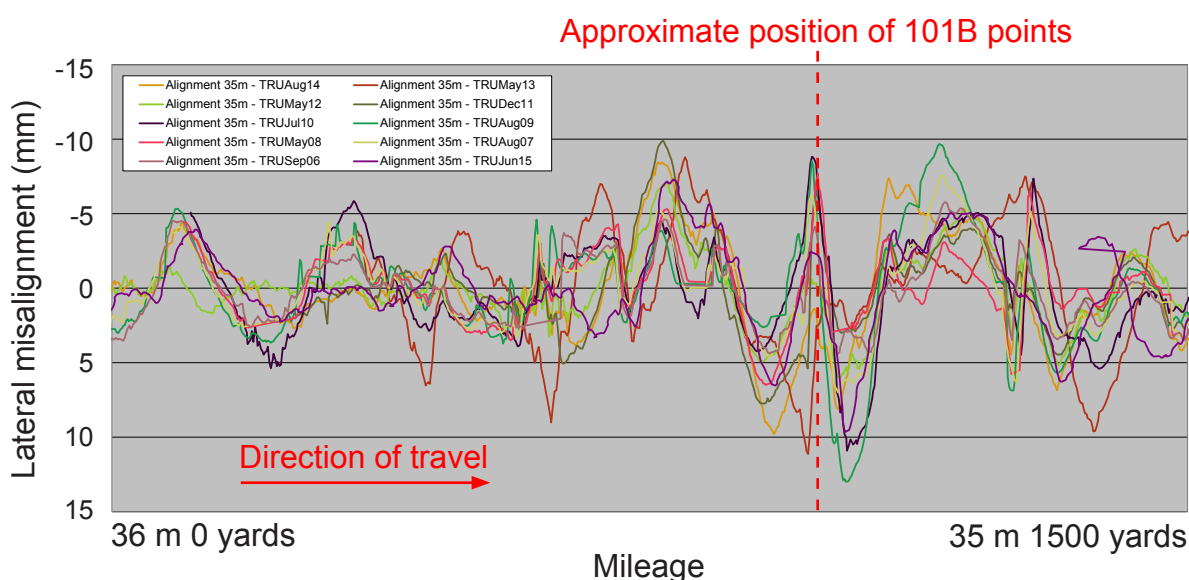
62 The switches and crossings at this location (Welton Oil Terminal) have had a history of problems with the horizontal and vertical alignment of the track, generally referred to as 'line' and 'top' respectively. Recordings of track geometry from Network Rail's track recording train going back to 2006 show that there were persistent problems with top in the area of the switches and crossings and, from about 2009 onwards, there were increasing issues with line (figure 15).

Figure 15: Traces of track alignment 2006 to 2014 for up line at 35 miles 1500 yards to 36 miles 0 yards
