# Rail Accident Report

## **Extensive track damage between Ferryside and Llangennech, Carmarthenshire 30 October 2017**

Report 17/2018  
October 2018

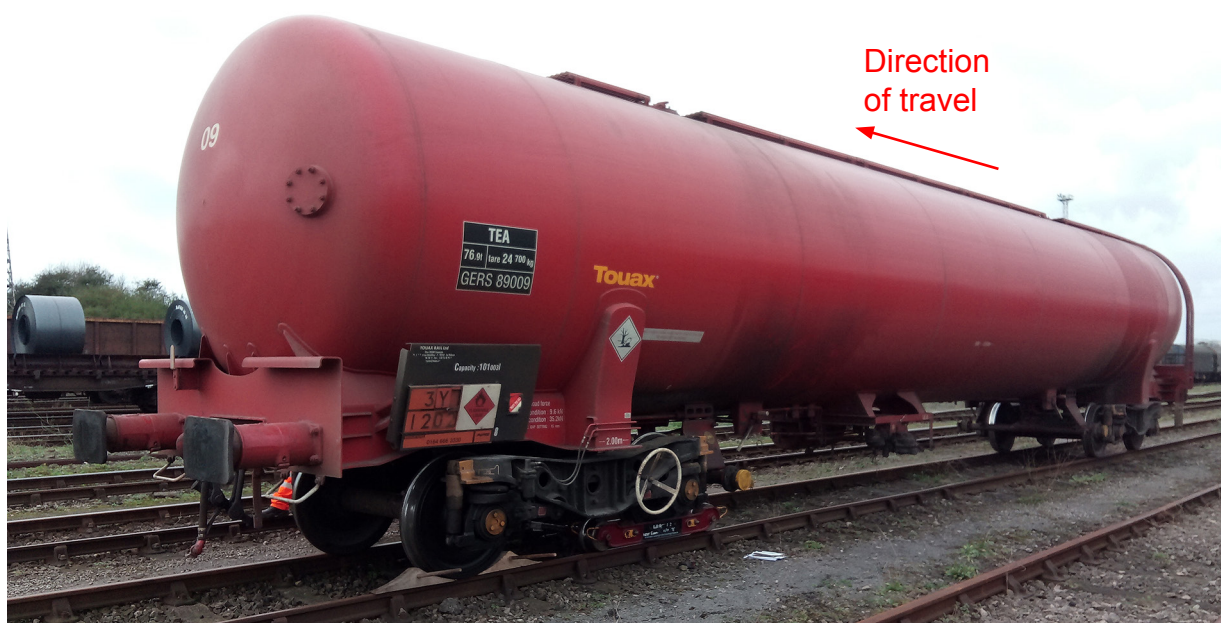
Figure 3: Wagon GERS89009 at Margam after the accident (courtesy DB Cargo)

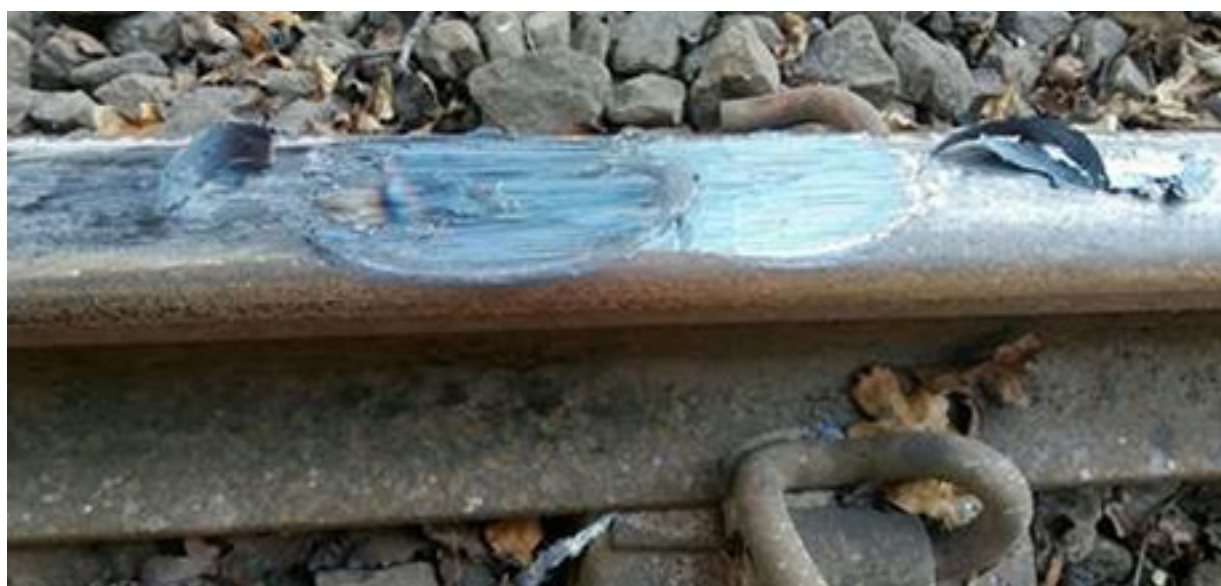
Figure 7: Damage to the rail head 67.2 miles (108.1 km) from Robeston (courtesy Network Rail)

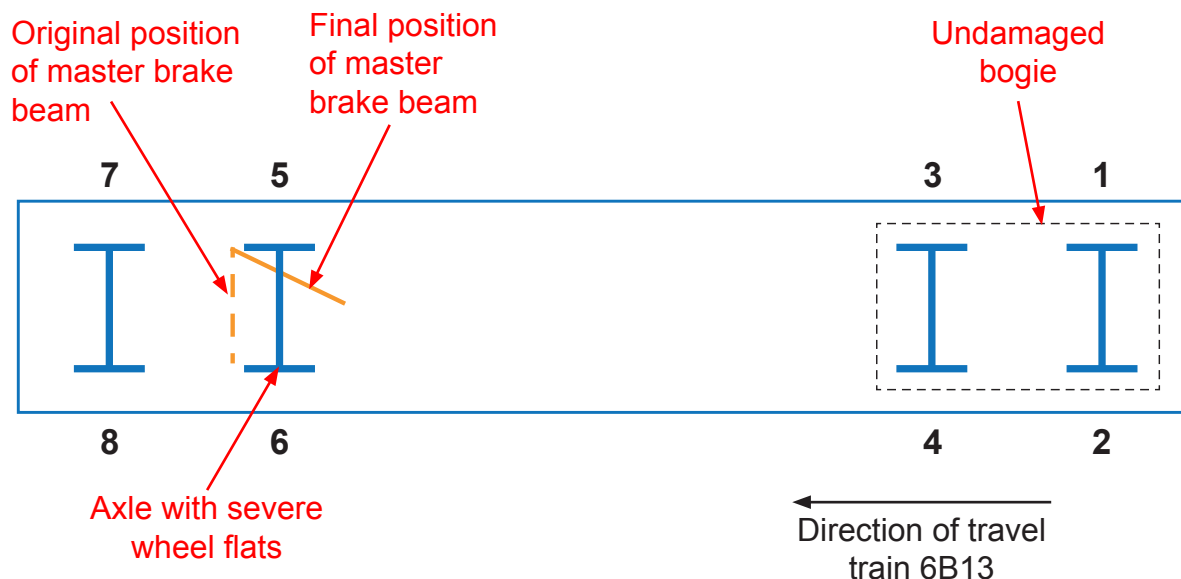
- 45 The driver of the train contacted the signaller at 08:21 hrs to advise him that the brake frame (actually the master brake beam, see paragraph 52) under the leading wagon had collapsed and was dragging under the train (figure 8).

Figure 8: Schematic of wagon GERS89009 showing wheel numbering in black, and the final position of the master brake beam

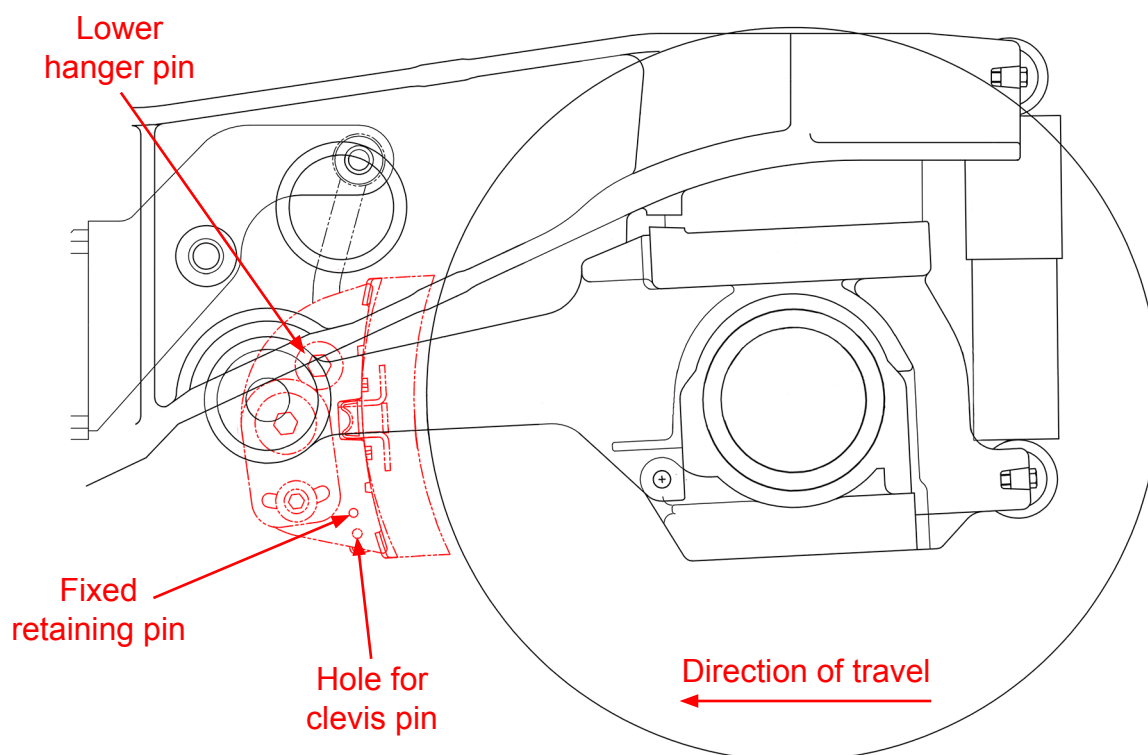
Figure 15: View of bogie at wheel position 6 (block holder and brake block shown in red) (based on a drawing supplied by Wabtec Faiveley)

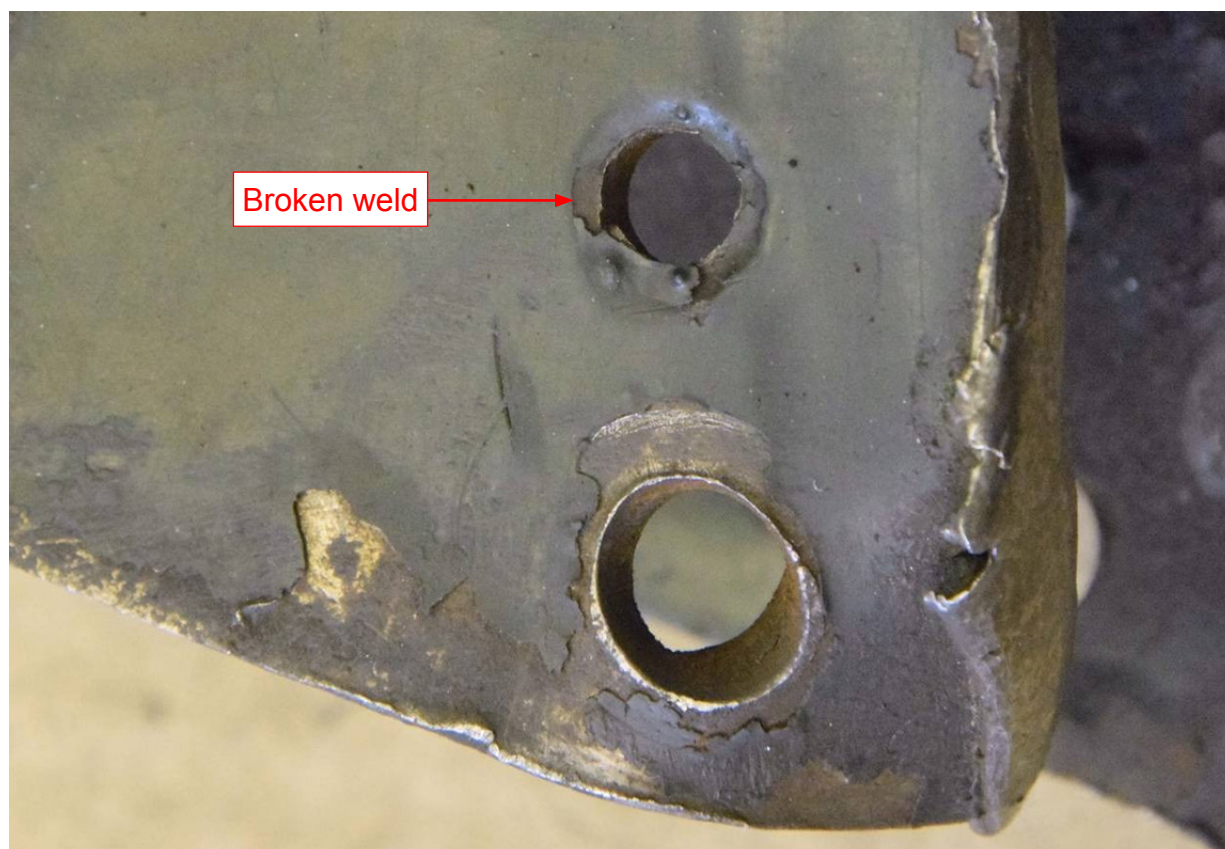
- 80 The fixed retaining pins that form part of the mechanism for attaching the brake blocks were missing from the block holders on the second wheelset of bogie 2741 (paragraph D9, appendix D). If one or both of these pins had fallen out, the associated key could also fall out and the brake block would no longer be restrained.
- 81 While the block holder from wheel position 6 (figure 8) was destroyed, accounting for the loss of that retaining pin, the block holder from wheel position 5 remained intact. The welds that secured the pin in position had failed (compare figure 16 with figure 14).

Figure 16: Inside corner of block holder from wheel position 5 (courtesy Serco Rail Technical Services)

- 82 The block holder from wheel position 5 connected the brake hanger to the master brake beam, so it was subjected to the forces necessary to drag the brake beam along under the train after the left-hand end had broken free (paragraph D2, appendix D), as well as to the impact loading due to the wheel flats (paragraph 65). It was distorted during the accident and it is therefore possible that loss of the retaining pin was a consequence of the damage to the bogie.

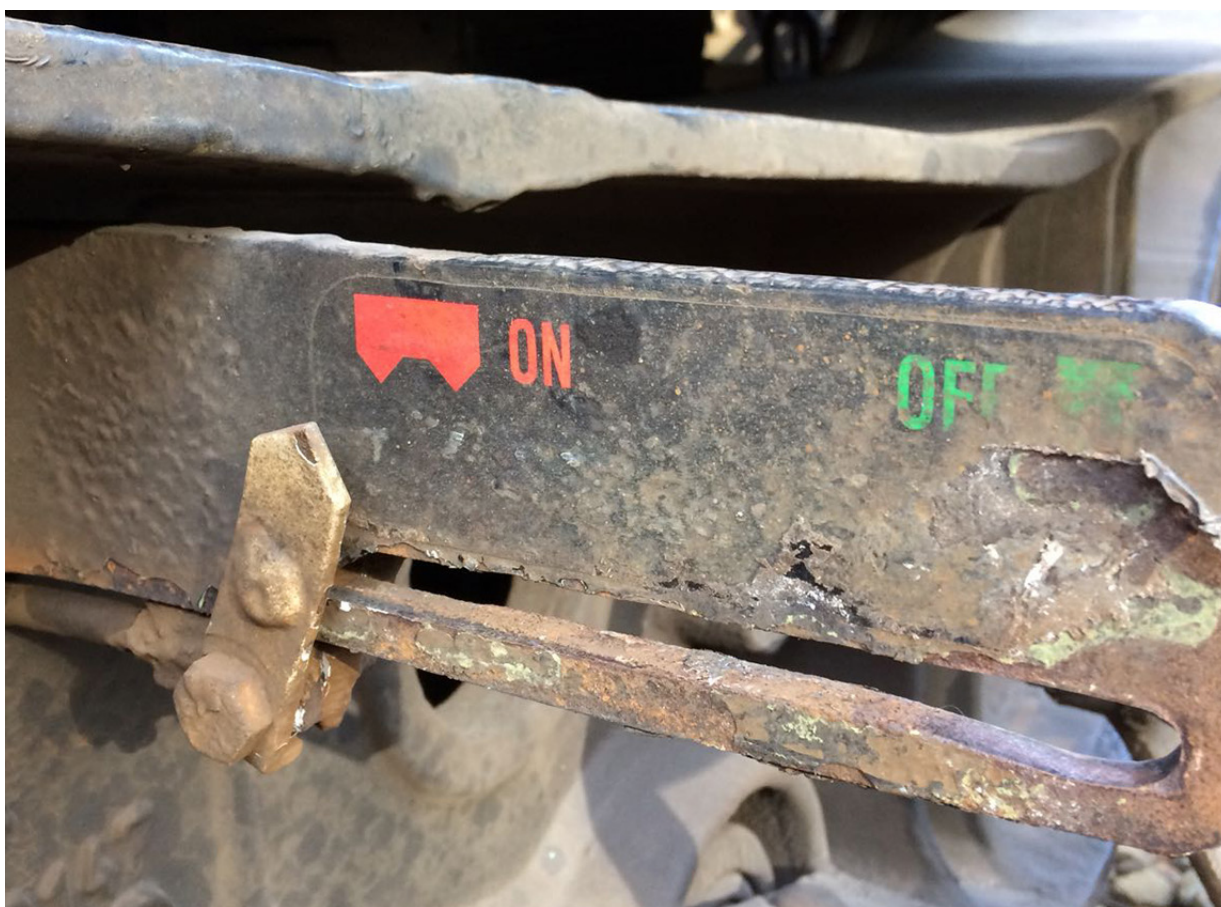
- 84 Wagon handbrakes that have been left on have been causal factors in previous accidents (eg the freight train derailment at Hatherley on 18 October 2005, [RAIB report 08/2006](#)), which is one reason for roll-by examinations such as that carried out as train 6B13 left Robeston (paragraph 32). Wagons are provided with tell-tale indicators showing the status of the handbrake.

Figure 17: Handbrake indicator on wagon GERS89009 after the accident (courtesy Network Rail)

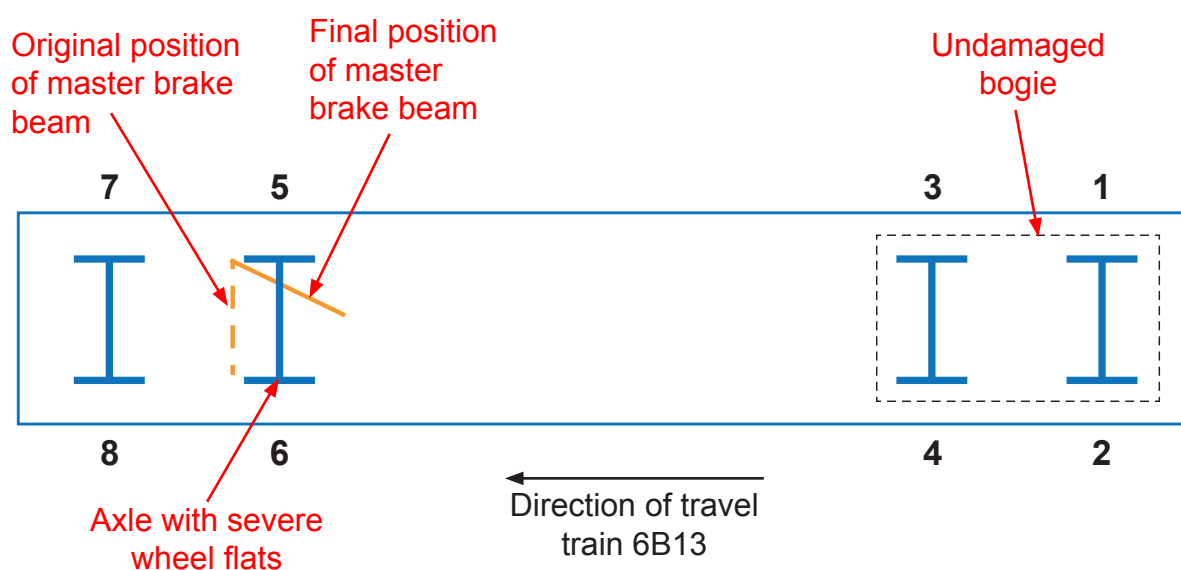
- D1 After train 6B13 was moved to Margam (paragraph 46), wagon GERS89009 was detached and held for examination. The diesel fuel was drained from the wagon on 8 January 2018, allowing the wagon to be lifted and the damaged leading bogie, no. 2741, to be swapped on 25 January. The bogie was then taken to Axiom Rail (Wabtec Faiveley) at Stoke on Trent, where it was examined by representatives of Touax Rail, DB Cargo, Wabtec Faiveley, Serco, ORR and RAIB on 13 February.
- D2 Examination of the bogie revealed that the lower left-hand hanger pin had sheared on the master brake beam, allowing the end of the brake beam to break free. The right-hand hanger was still intact, although twisted, and had pulled the partially detached beam along the four foot (figure D1).

Figure D1: Schematic of wagon GERS89009 showing wheel numbering and the final position of the master brake beam

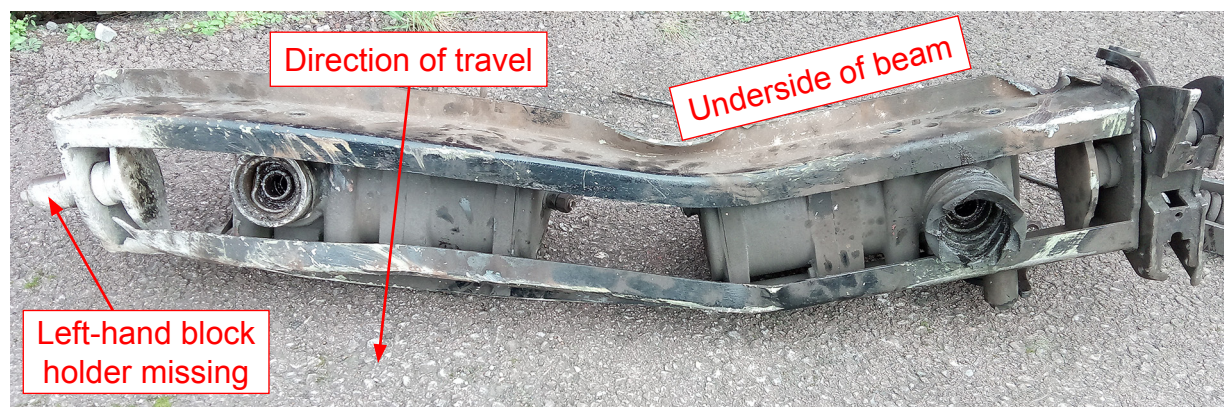
- D3 The master brake beam had bent around the middle (figure D2). The bending was consistent with the beam having come into contact with the trailing axle of the bogie while bouncing along at speed under the wagon. The left-hand block holder (wheel position 6) was missing from the end of the beam; part of it (the outer face) was later found 62.1 miles (100.0 km) from Robeston.

Figure D2: Master brake beam from bogie 2741 (courtesy DB Cargo)

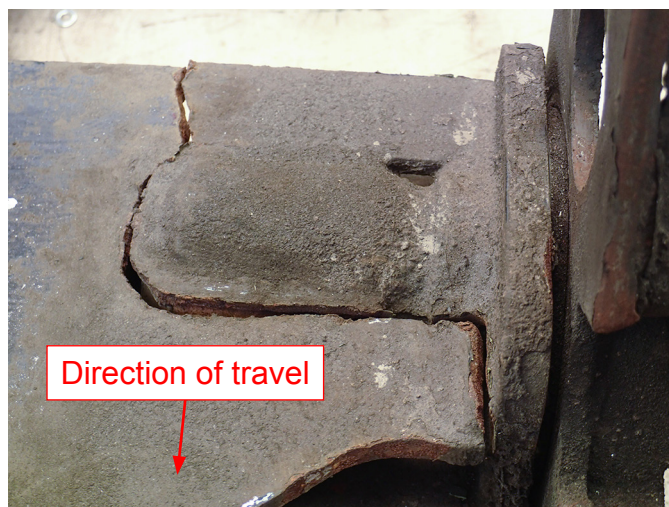
- D4 The welded joint at the left-hand end of the slave brake beam was found to be cracked adjacent to the block holder (figure D3).

Figure D3: Cracking of slave brake beam at wheel position 8

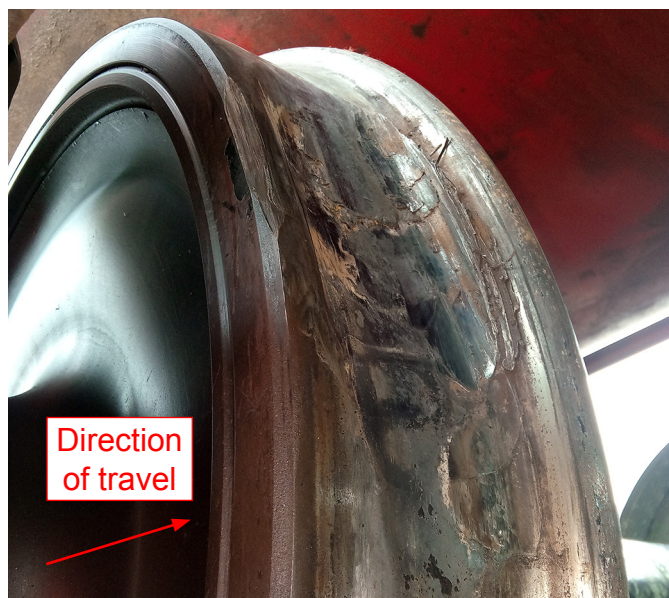
- D5 The second wheelset (wheel positions 5 and 6) of bogie 2741 had wheel flats approximately 250 mm long and 10 mm deep (figure D4). The size of the flats is consistent with the wheels having slid an estimated 5 to 10 miles (8 to 16 km) while the wagon was fully laden with a 25 tonne axle load. The marks on the rail head (paragraph 33) and the broken rails over the following 22 miles (36 km) indicate that the second wheelset had started turning again approximately 42 miles (67 km) from Robeston.

Figure D4: Flat on wheel at position 5 (courtesy DB Cargo)

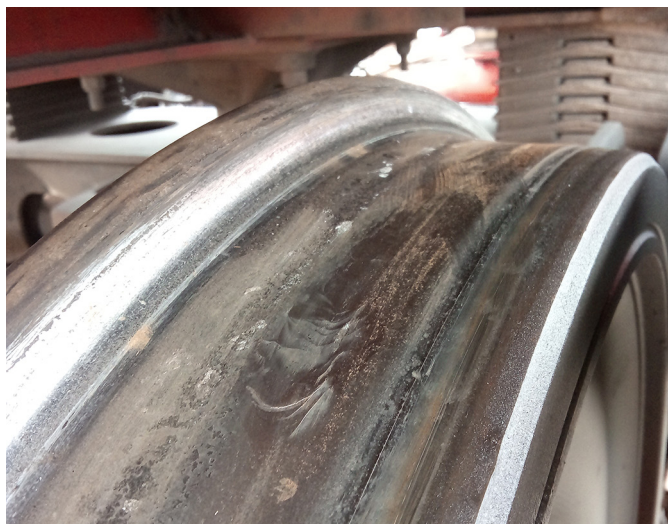
- D6 DB Cargo examined the wheelsets from bogie 2741 after the accident. In addition to the severe flats on the wheels at positions 5 and 6, there was also a small flat spot on the wheel at position 8 (figure D5). This was probably pre-existing and unrelated to the accident (paragraph 89).

*Figure D5: Flat on wheel at position 8 (courtesy DB Cargo)*

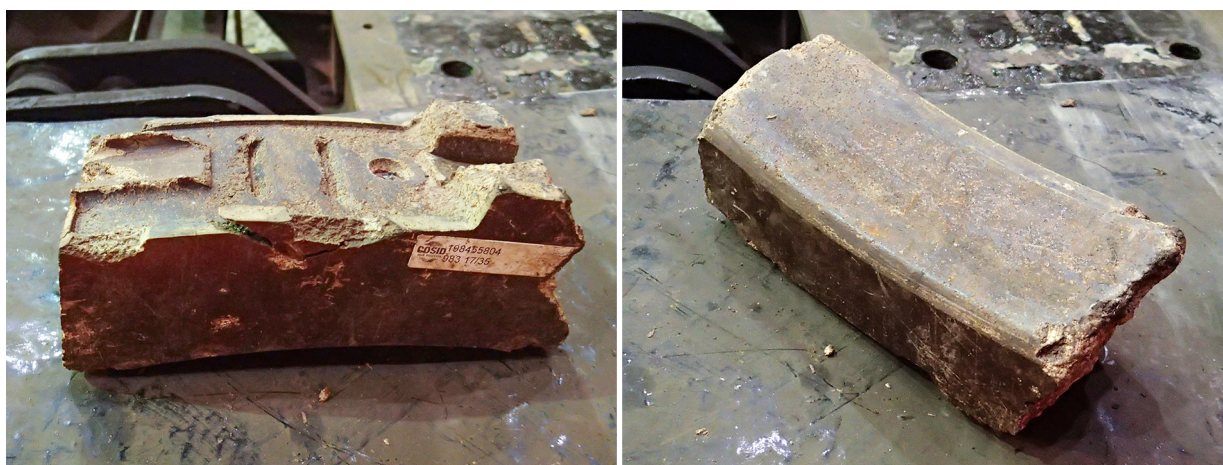
D7 The brake blocks were missing from all four wheels on bogie 2741, together with the keys and clevis pins (paragraphs 54 and 55). Part of a brake block was found 43.6 miles (70.2 km) from Robeston; this was 2.0 miles (3.2 km) after the start of damage to the rail head (paragraph 33). This was only lightly worn, indicating that it had recently been fitted to a vehicle (figure D6); the label records that it had been manufactured in the week commencing 28 August 2017. It is the same type of block as that fitted to wagon GERS89009 on 27 October 2017, which is not used on any passenger vehicles that operate in the Carmarthen area. No other brake blocks have been found that might have come from bogie 2741.

*Figure D6: Brake block fragment found 4 miles (7 km) east of Carmarthen*

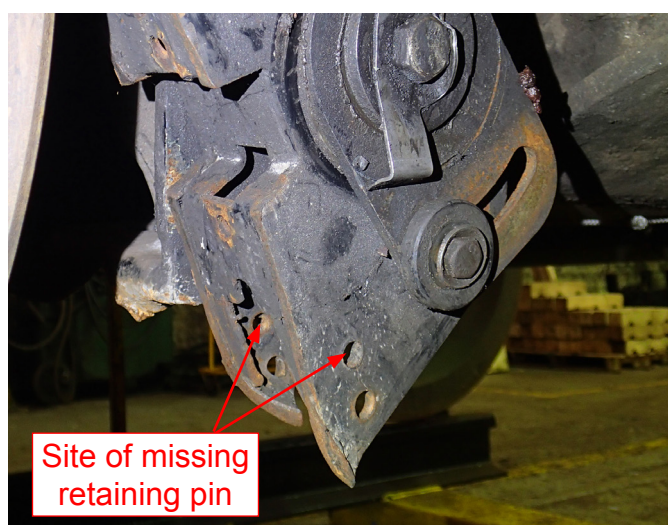
D9 The fixed retaining pins, that together with the clevis pin (figure 13) hold the brake block key in place, were missing from the damaged block holders on the second wheelset. The block holder from wheel position 6 had been torn in two, probably causing failure of the welded joints at the ends of the retaining pin. However, the retaining pin was also missing from the block holder at wheel position 5 (figure D8), which remained intact although distorted.

Figure D8: Brake block holder from wheel position 5

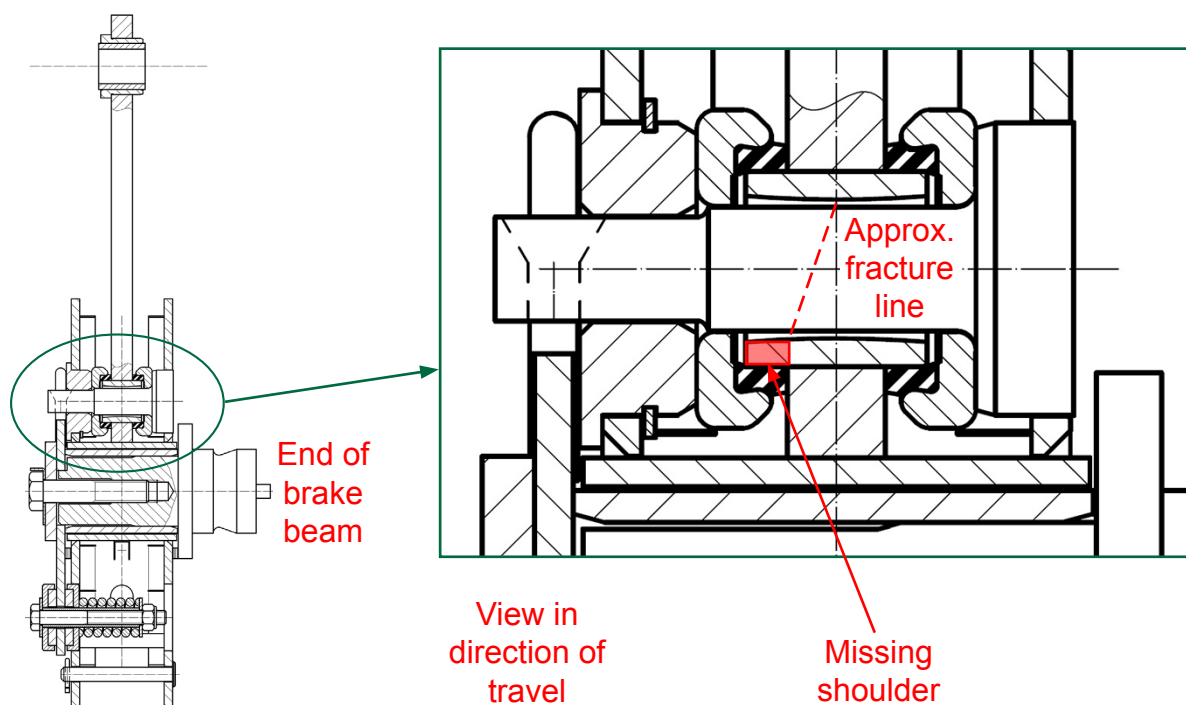
D10 The lower left-hand hanger pin (at wheel position 6) had sheared, and the corresponding shoulder of the hanger bush was damaged (figure D9). Only the outer half of the block holder has been found on the track, together with the tail of the hanger pin; the rest of the block holder and the head of the pin are missing.

Figure D9: Section through brake hanger from wheel position 6; inset showing lower hanger pin (courtesy Wabtec Faiveley)

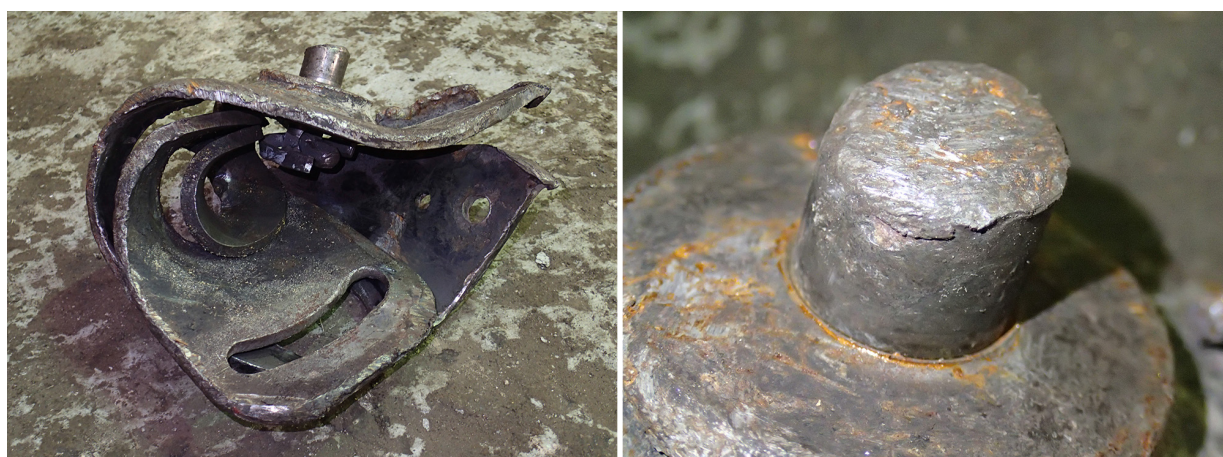
D11 Serco Rail Technical Services carried out a metallographic examination of the remains of the hanger pin. Serco concluded that, although the fracture surface of the pin was too badly damaged to determine the cause of the failure, the angled fracture (figure D10) indicated it had been overloaded in bending and shear. Conversely, failure due to fatigue would probably have resulted in a perpendicular fracture.

Figure D10: Remains of block holder from wheel position 6 and close up of fractured hanger pin

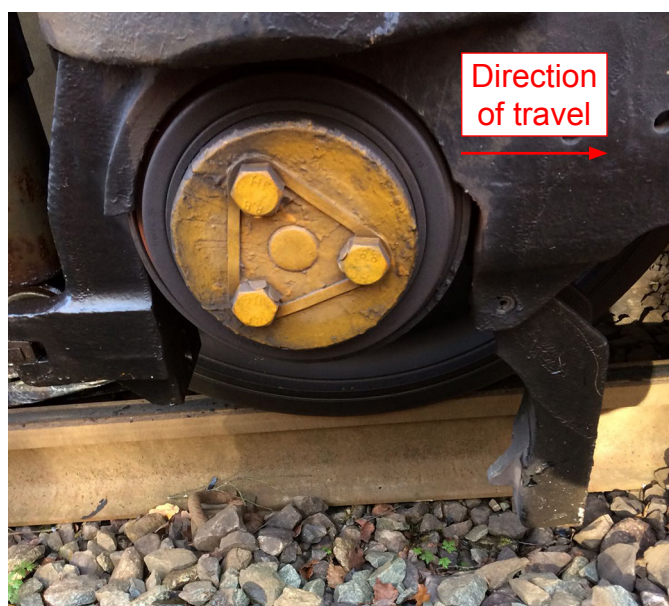
D14 The retaining bolt for the wheelset lift bracket at wheel position 5 was missing (figure D12). The bolt probably failed due to the dynamic loading caused by the wheel flats on this wheelset. The missing bolt has not been associated with any possible causal mechanism for the brake system failure on the wagon.

*Figure D12: Wheelset lift bracket at wheel position 5 hanging down after the accident (courtesy Network Rail)*
