# Rail Accident Report

## Passenger trapped and dragged at Notting Hill Gate station, 31 January 2018

Report 14/2018  
September 2018

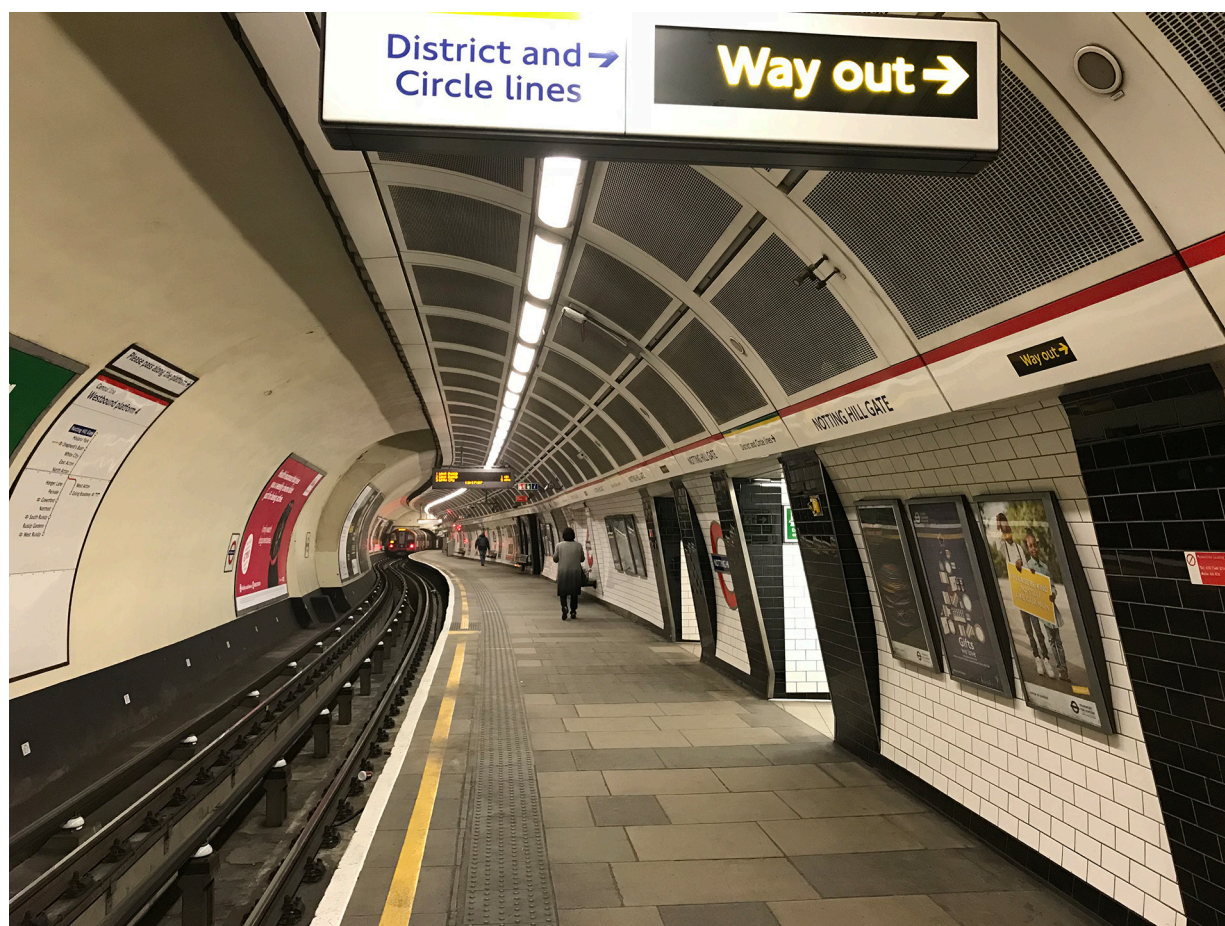
- 10 Platform 4 incorporates a reverse curve (ie an 'S' bend; figure 2) and, because of this, is classified by London Underground as a 'category A' platform. Category A platforms are defined as those where the train operator is unable to see the entire platform-train interface without mirrors or monitors. This means that platform staff are needed to assist with train despatch if the platform is busy or if the monitors are inoperative. At the time of the accident, the platform was not busy enough to warrant platform staff being needed.

Figure 2: View from the east (tailwall or rear) end of platform 4 at Notting Hill Gate facing west, showing the reverse curve

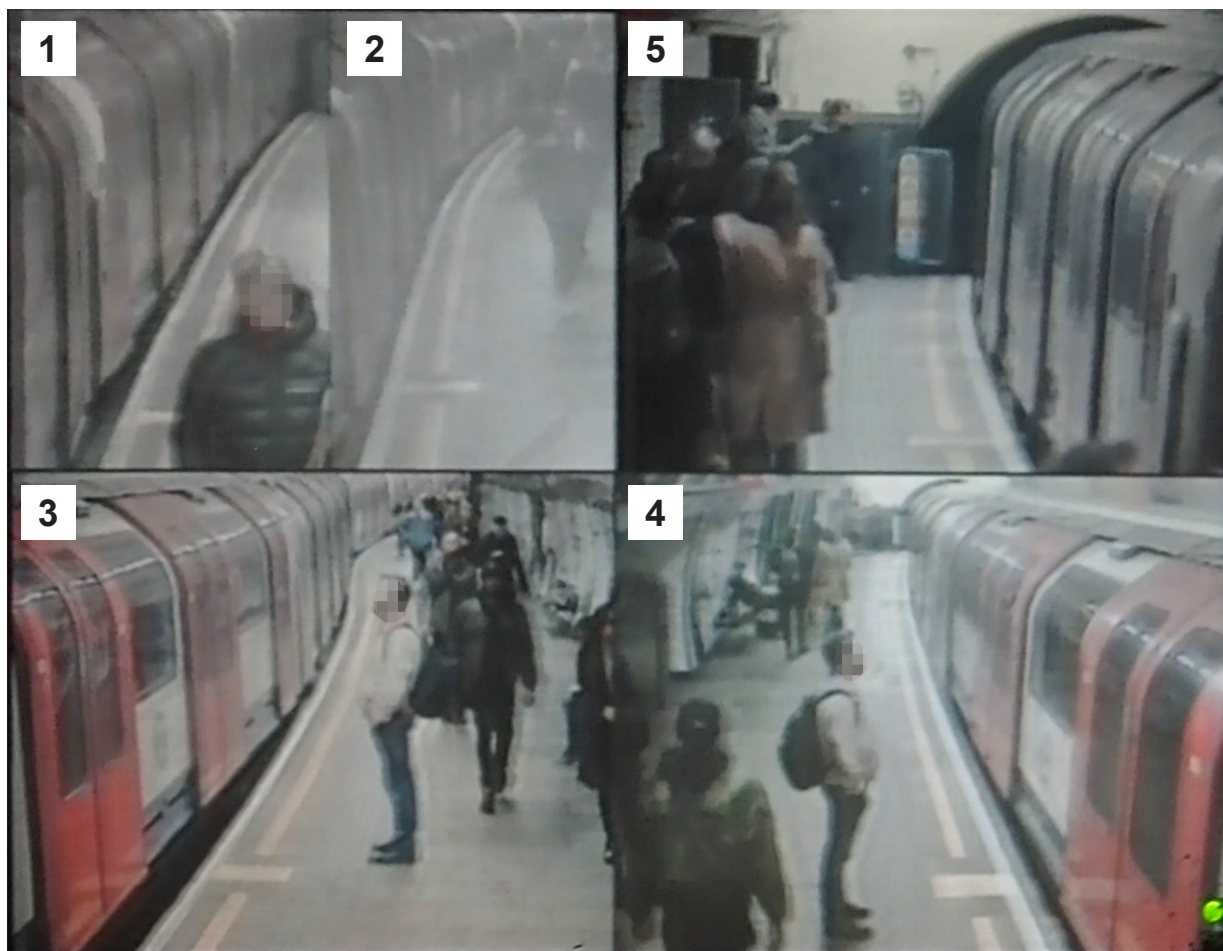
Figure 6: Arrangement of in-cab platform CCTV images at Notting Hill Gate platform 4 (numbers denote the ordering of images from front to rear of the train)

- 65 The investigation also examined the number and arrangement of images on the monitor, but the evidence is equivocal as to whether this could have affected the train operator's perception. LUL's current standard for platform-train interface CCTV sets out several requirements taking into account the visual information requirements of the train operator, which the Central line configuration does not meet (because it pre-dates that standard; paragraph 41). For instance, there should not be more than four images on a single screen, and the images from any cameras facing backwards should be inverted horizontally so as to display the platform side consistently across all images. Comparable standards for the mainline railway<sup>16</sup> further require that all cameras should face in the same direction, and that the arrangement of images on the monitor should be logical and sequential (eg arranged so that they can be read in a Z-shape from top-left to bottom-right).

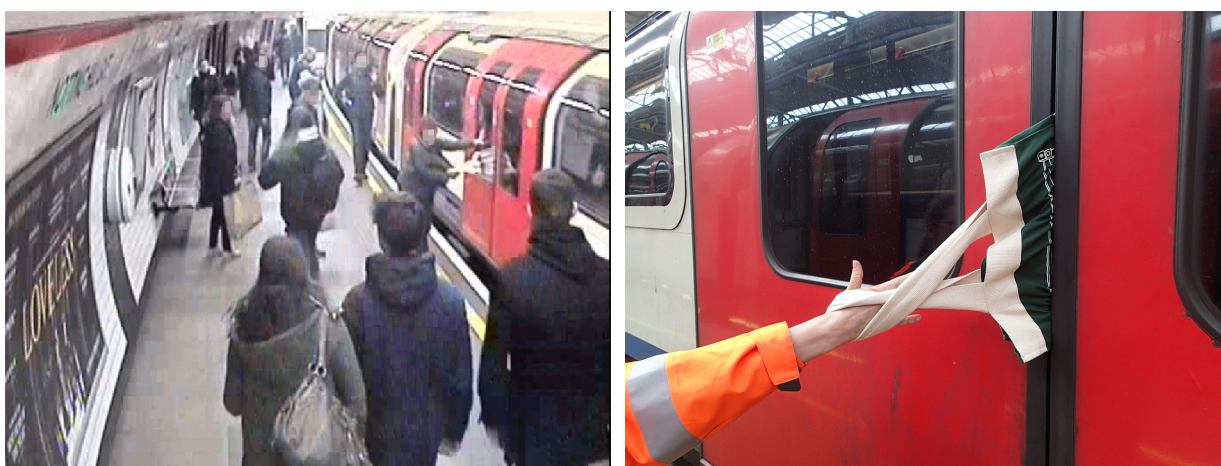
- 46 As the passenger led with her arm to try and board the train, her bag swung into the carriage, where the top of the bag became trapped in the closing doors (figure 7, left image). Witness evidence and station CCTV images suggest that the handles were twisted around her wrist. Tests conducted by the RAIB, using an identical bag and a 1992 stock train, showed that this would have made it very difficult to free herself (figure 7, right image). Because there were books and other belongings in the portion of the bag that was inside the train, it would also have been virtually impossible to pull the bag out of the doors.

*Figure 7: Image from station security camera (left) and RAIB reconstruction (right) showing the bag trapped in the doors*

- 1 *The intent of this recommendation is to reduce the risk of a train departing with something trapped in the doors, by improving the detection of small objects by the train's door systems.*

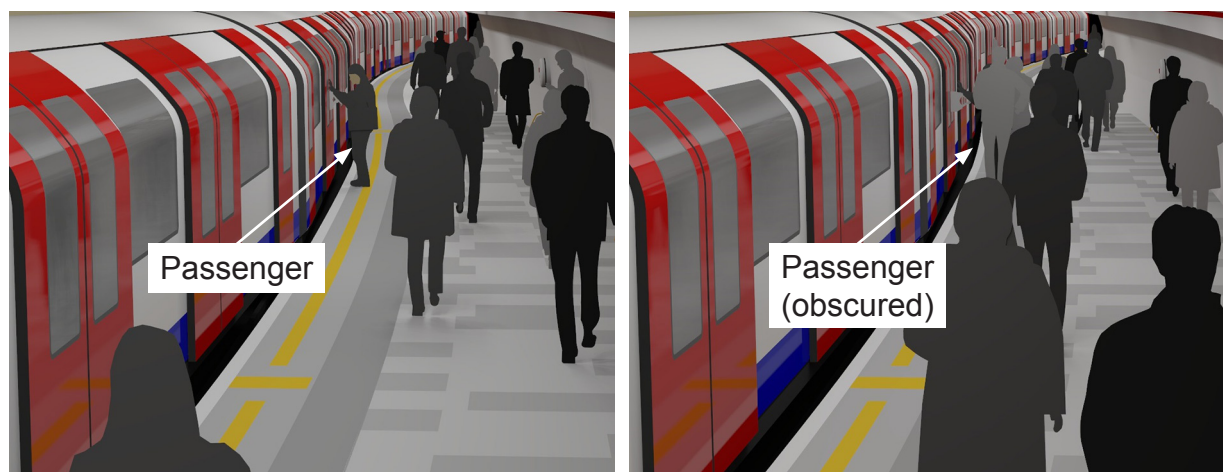
- 64 It is also possible that the view of the passenger was obscured by other people on the platform at the moment when the train departed. Because the in-cab monitor images are not recorded, the RAIB created a virtual model of the perspective from the relevant camera based on a site survey and reconstruction, as well as images that were recorded from station security cameras. The model shows that, at the time the train departed, there was a person on each side of the passenger, potentially blocking the train operator's view of her. However, about seven seconds before departure, when the train operator initially tried to start the train (paragraph 26), there was a clear view of the passenger (figure 8).

Figure 8: Virtual model of the perspective from the relevant platform-train interface camera showing the view seven seconds before departure (left image) and one second before departure (right image). NB: these represent the image that would have been displayed in the lower-left quadrant of the train operator's in-cab monitor.

- 3 *The intent of this recommendation is to optimise the views presented on in-cab CCTV monitors in order to minimise the possibility of a train operator being unaware of problems at the platform-train interface.*

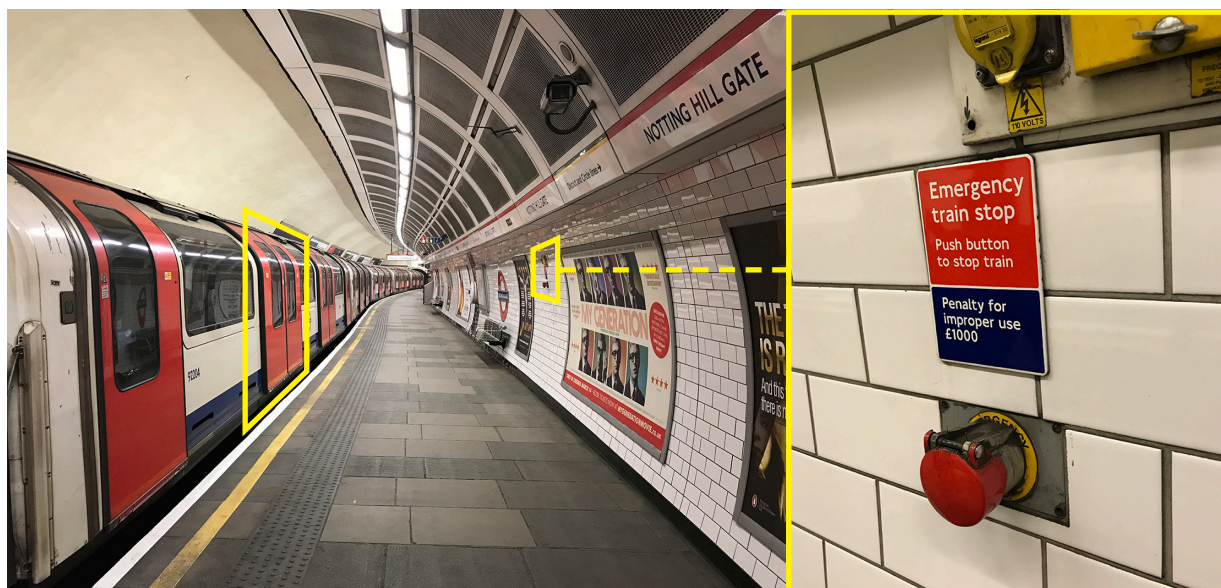
- 79 LUL's records for the past five years show no instances of PESPs being used on platform 4 at Notting Hill Gate. Its risk assessments for a trap-and-drag incident assume a high probability that neither customers nor platform staff will activate a PESP. LUL told the RAIB that misuse of PESPs following their original installation resulted in covers being added to the plungers to deter inappropriate activation, which has a significant operational impact. The covers have had a significant effect in reducing the number of activations.

Figure 9: Image of the platform emergency stop plunger (PESP) in relation to the incident door (both highlighted), with a close-up view of the PESP

- 5 *The intent of this recommendation is to mitigate the consequences of incidents at the platform-train interface by improving staff awareness of the available means to stop trains in an emergency.*

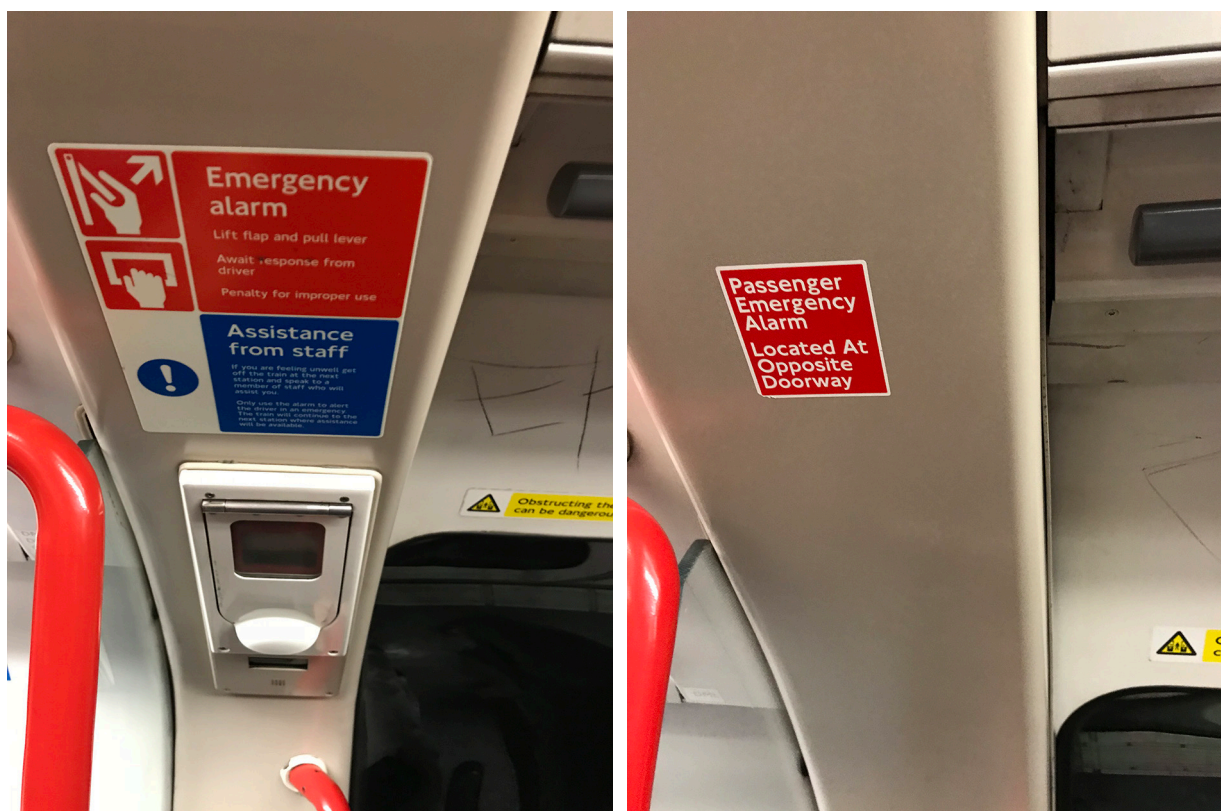
**81** On 1992 stock, one passenger emergency alarm (PEA) is provided at each door vestibule, on the pillar to the left of one set of doors. There is a label on the opposite corner stating the location of the PEA (figure 10). The door involved in the accident was one with a label (ie the PEA itself was on the opposite side of the train).

Figure 10: The passenger emergency alarm on 1992 stock (left), and the associated label on the opposite doorway (right). The incident door was fitted with a label, as shown in the right-hand image.
