Rail Accident Report

Structural failure caused by scour at Lamington viaduct, South Lanarkshire 31 December 2015

Report 22/2016
November 2016

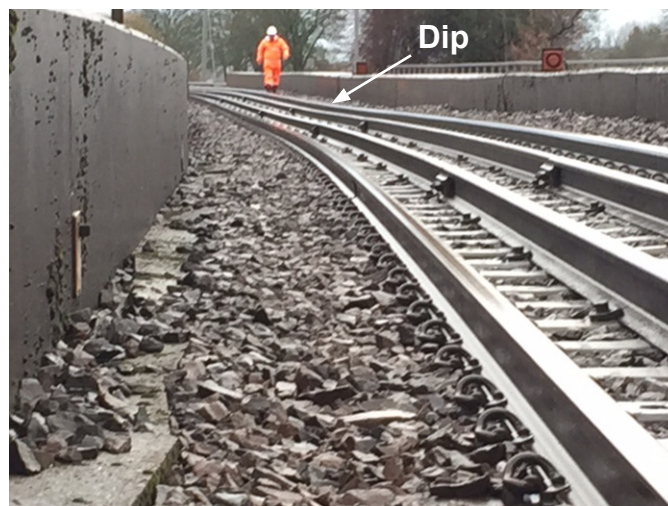
- 47 At the same time, another member of the track maintenance team informed control room staff that he had observed “great big sweeping dips in the track” (figure 8). He also reported that the *cant* of the track had deteriorated on both lines in the middle of the viaduct and that there may have been subsidence. He requested the attendance of a bridge examiner.

Figure 8: ‘Sweeping dip’ affecting down line on 31 December 2015 after closure. At this stage, the track had dropped by 70 mm (photograph courtesy of Network Rail)

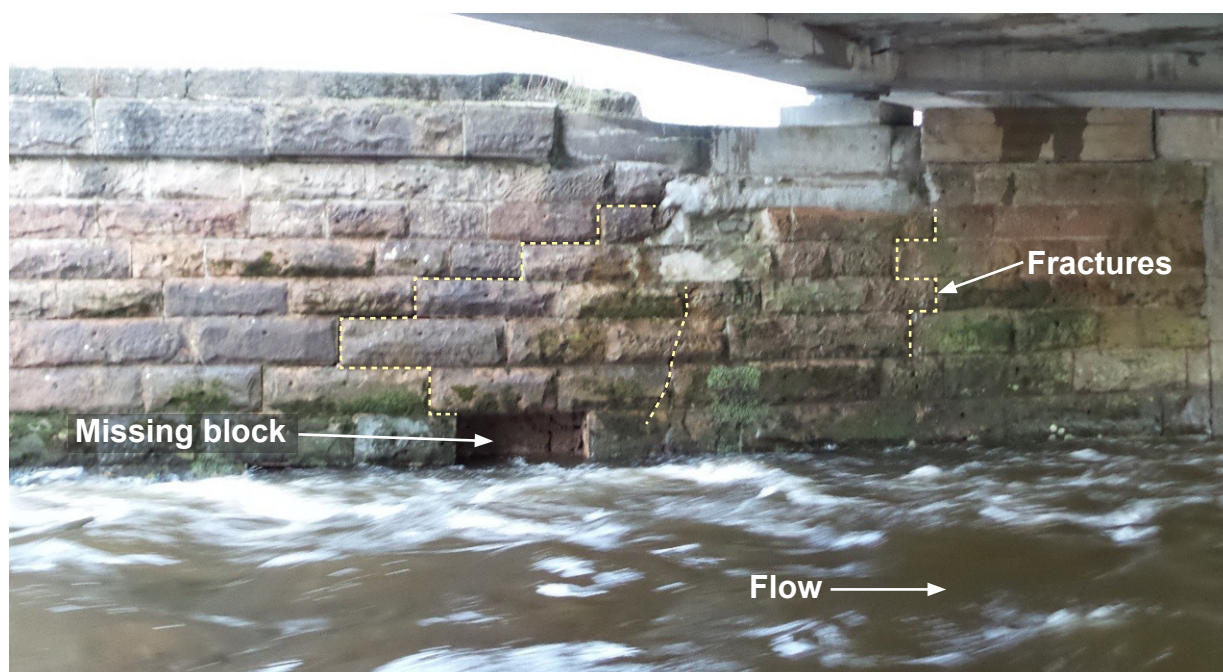
Figure 9: South face of pier 2 on 31 December 2015 showing missing block and fractures (photograph courtesy of Network Rail)

- 62 The missing block reported by the track maintenance staff at 08:52 hrs on 31 December (paragraph 49) was at the top of a pyramid-shaped void in the south face of pier 2, suggesting that significant damage had already occurred below water level. The void extended down by seven courses (2.8 metres) to the base of the structure. At its widest, the erosion extended 1.8 metres into the 2.1 metre wide solid masonry pier (figure 18), and beneath the concrete pier extension. The survey data shows that the total volume of masonry lost exceeded 20 m³, comprising 50 or more sandstone blocks, each weighing between 0.3 tonnes and 0.9 tonnes. It is likely that this damage occurred over a number of hours, gradually weakening the pier, although its north face remained intact providing residual support to the deck.

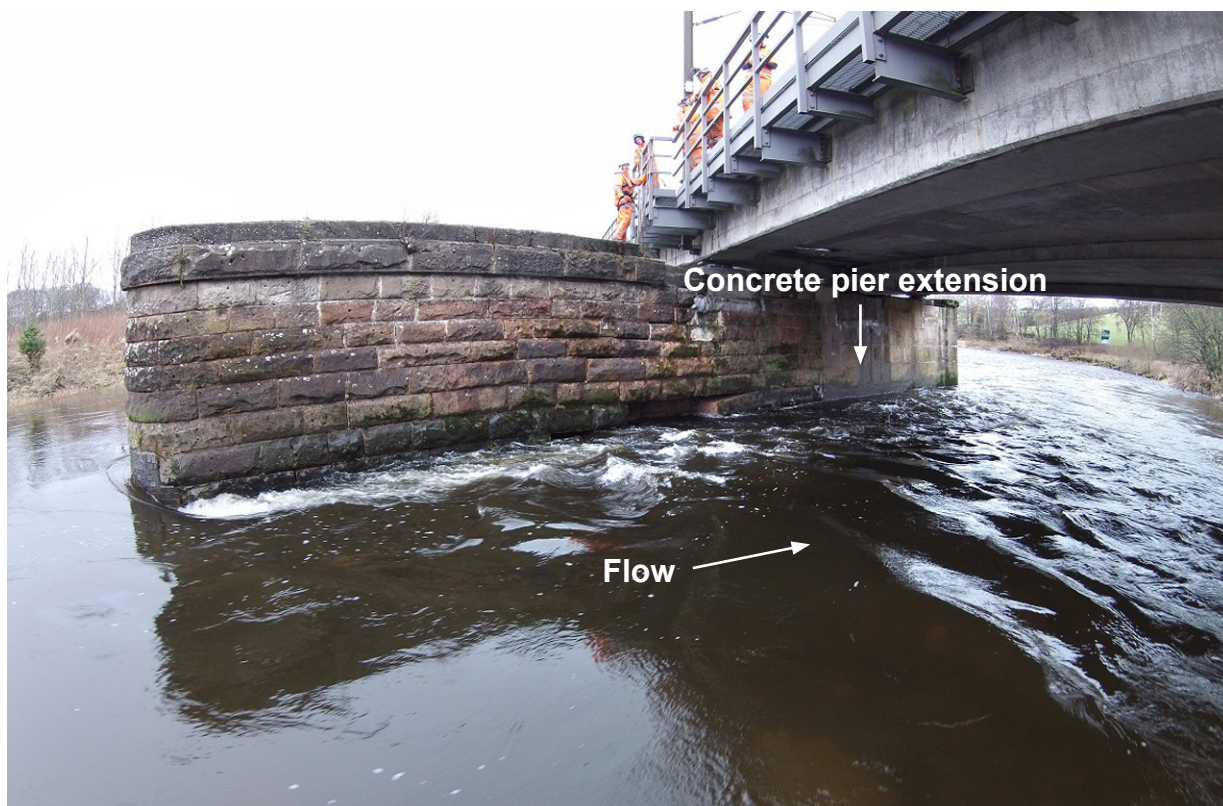
Figure 11: South face of pier 2 on 1 January 2016 prior to start of emergency stabilisation works. Note that the operative's safety harness is anchored to the adjacent overhead electrification mast (photograph courtesy of Network Rail Air Operations).

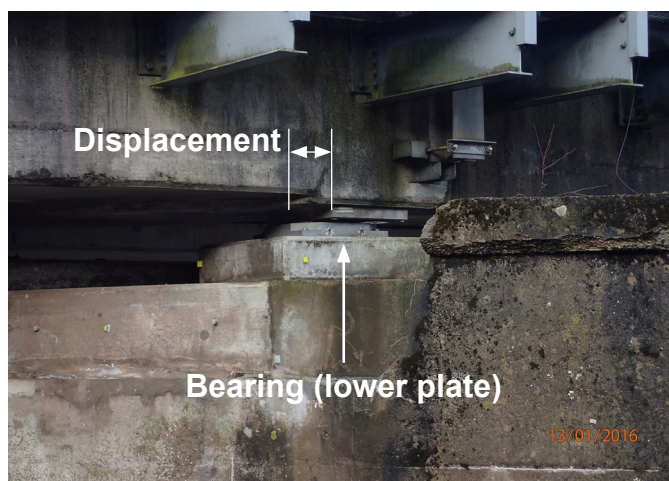
Figure 12: Bearing supporting outer main beam adjacent to the up line at the east end of pier 2. The bearing's lower plate is displaced to the left of its upper plate due to tilting of the pier

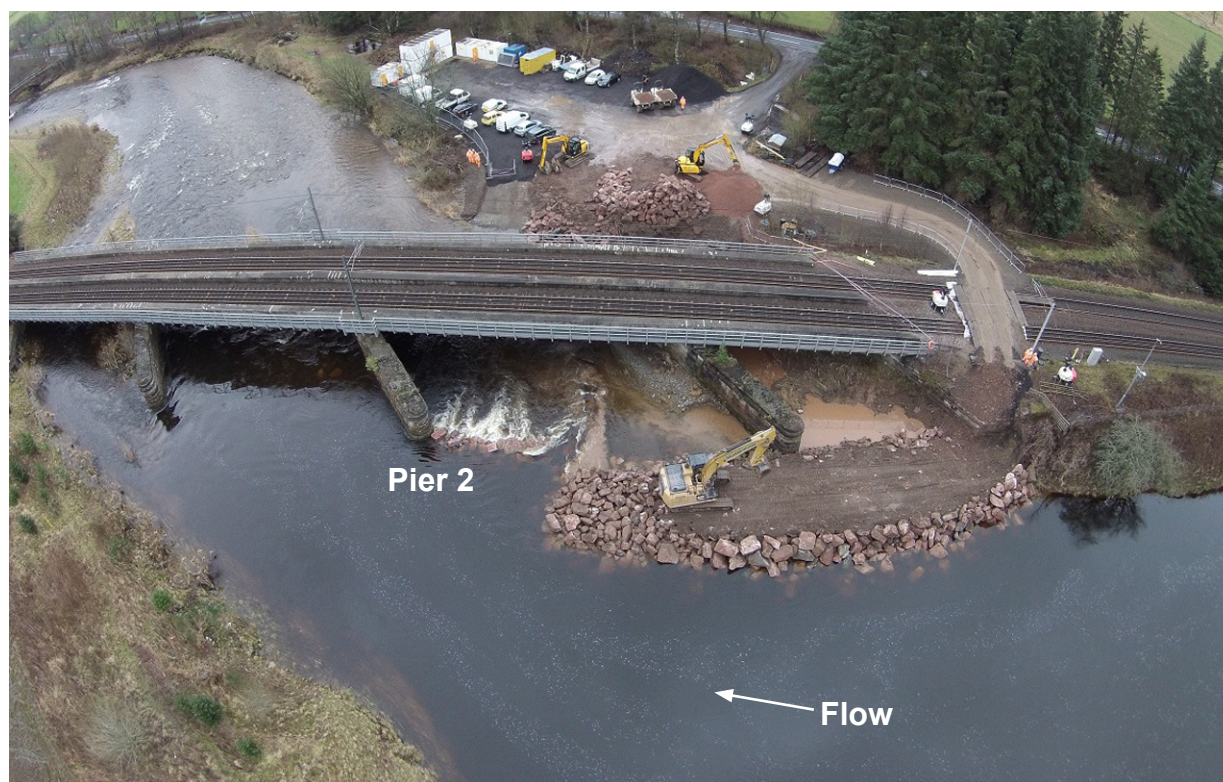
Figure 13: Stone causeway under construction from the south abutment to provide access to pier 2 on 6 January 2016 (photograph courtesy of Network Rail Air Operations)

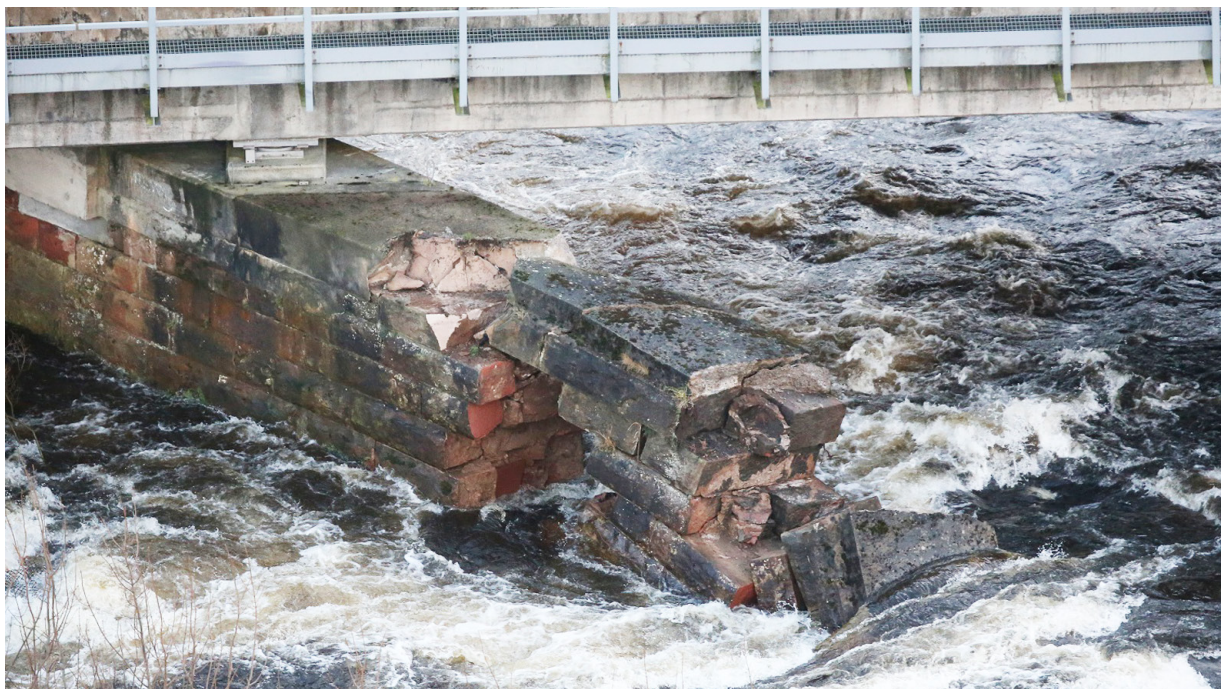
- 54 Subsequent periods of high river flow caused further scour damage. On 10 January, a 7 m redundant section of pier 3 collapsed (figure 14). On 27 January, a similar length of the north abutment and part of the approach embankment, including a disconnected overhead electrification mast, collapsed into the river (figure 15). On both occasions, the flow was significantly less than on 30 December 2015, but it was constricted by the stone causeway which would have increased the water velocity.

Figure 14: Scour damage to redundant section of pier 3 on 10 January 2016 (photograph courtesy of Network Rail Air Operations)

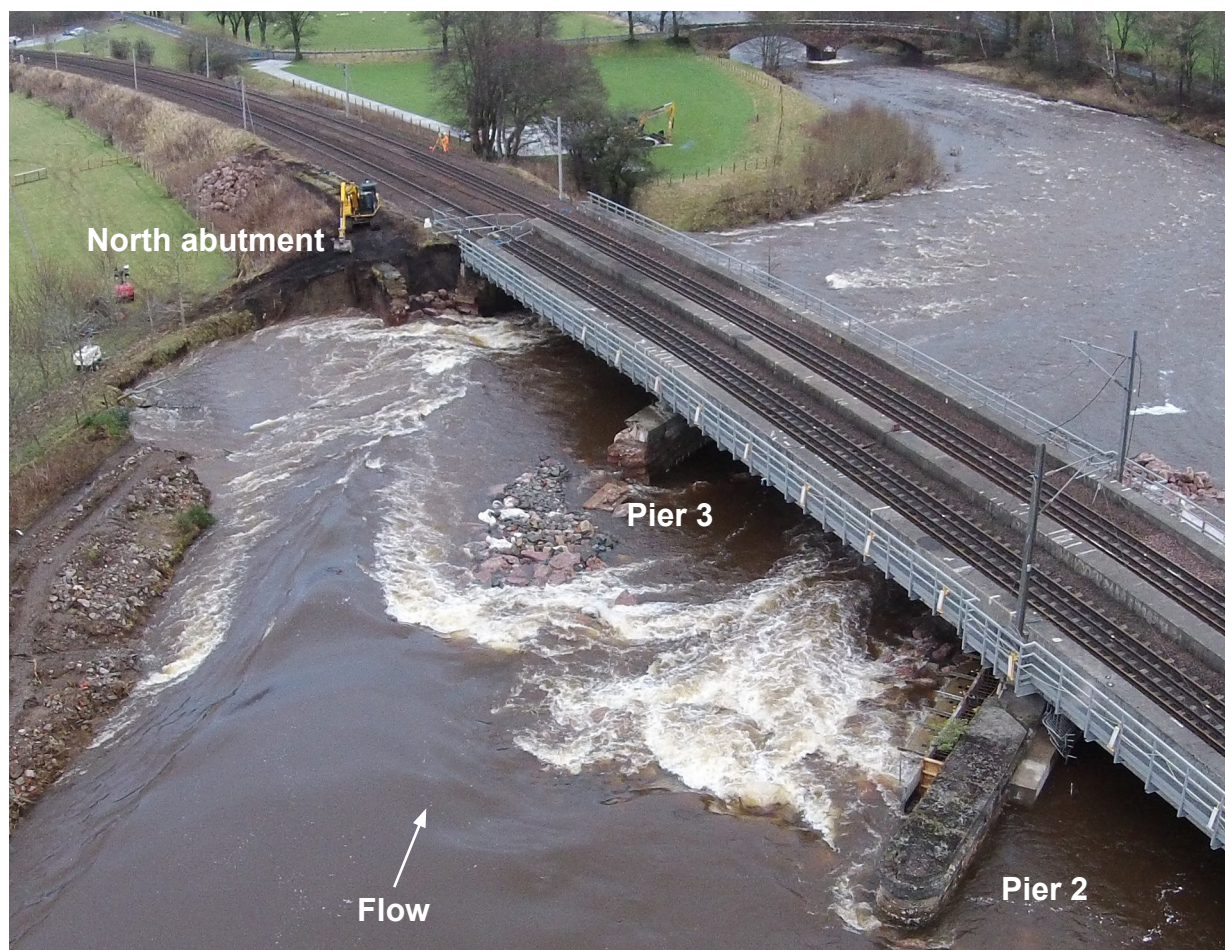
Figure 15: Scour damage to north abutment and embankment on 27 January (photograph courtesy of Network Rail Air Operations)

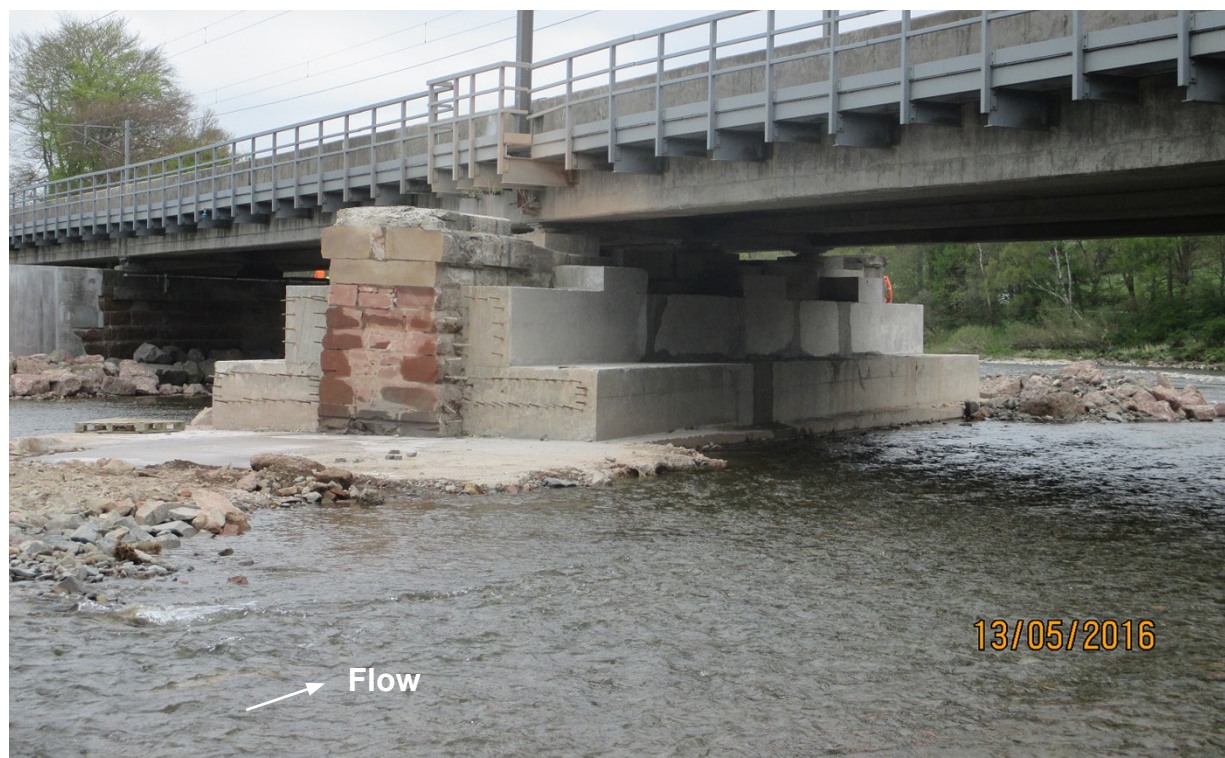
Figure 16: Pier 2 stabilisation works after removal of upstream end (photograph courtesy of Network Rail)

- 55 Pier 2 was stabilised in its final position by the construction of an additional reinforced concrete jacket on each side, attached with steel dowels to the original masonry and mass concrete pier, and anchored into the underlying ground. The steel bearings were replaced on modified concrete plinths, and the deck jacked back into its correct position to allow the line to reopen on 22 February 2016 (figure 16). Services were seriously disrupted while repairs were completed as trains were either diverted or replaced by road transport.

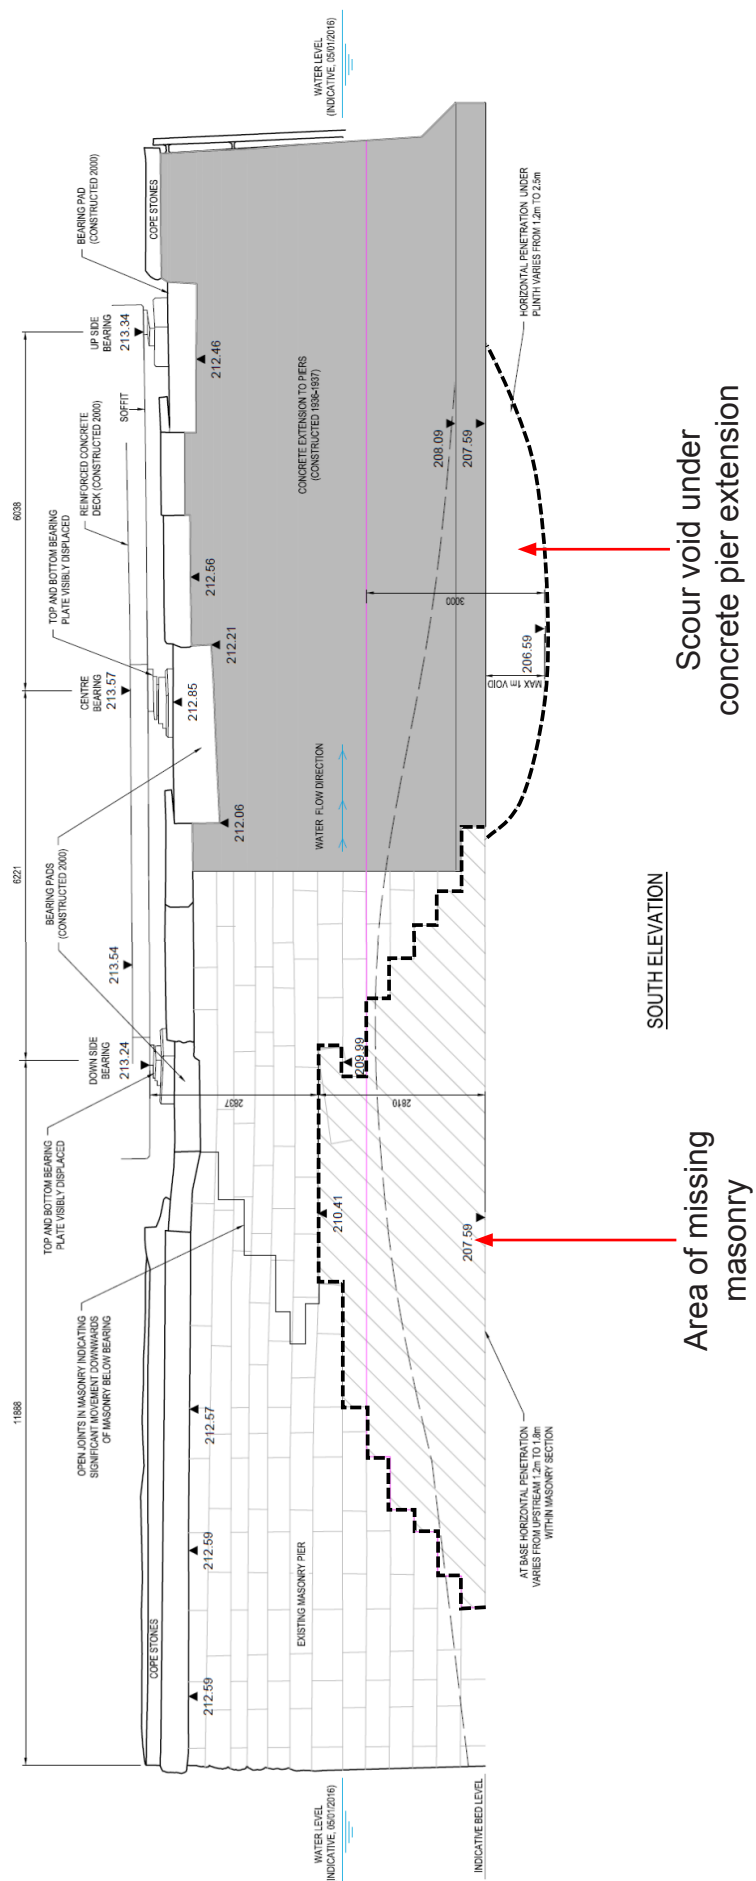
- 61 A diving survey on 2 January 2016 reported scour damage over a 21 metre length of the 28 metre long pier. The masonry section had partially collapsed and divers found a 1 metre deep scour hole underneath the concrete pier extension, with only its downstream end remaining supported (figure 17). It is probable that the masonry section also had its foundation undercut by scour with masonry falling into the resulting scour hole. Weak or missing mortar (refer to paragraphs 89 and 90), made it more likely that the water action would allow scour to displace the lowest level of blocks, with further blocks dropping downwards as each successive course was undermined.

Figure 17: South face of pier 2 showing scour damage recorded by divers on 2 January 2016 (courtesy of Network Rail)

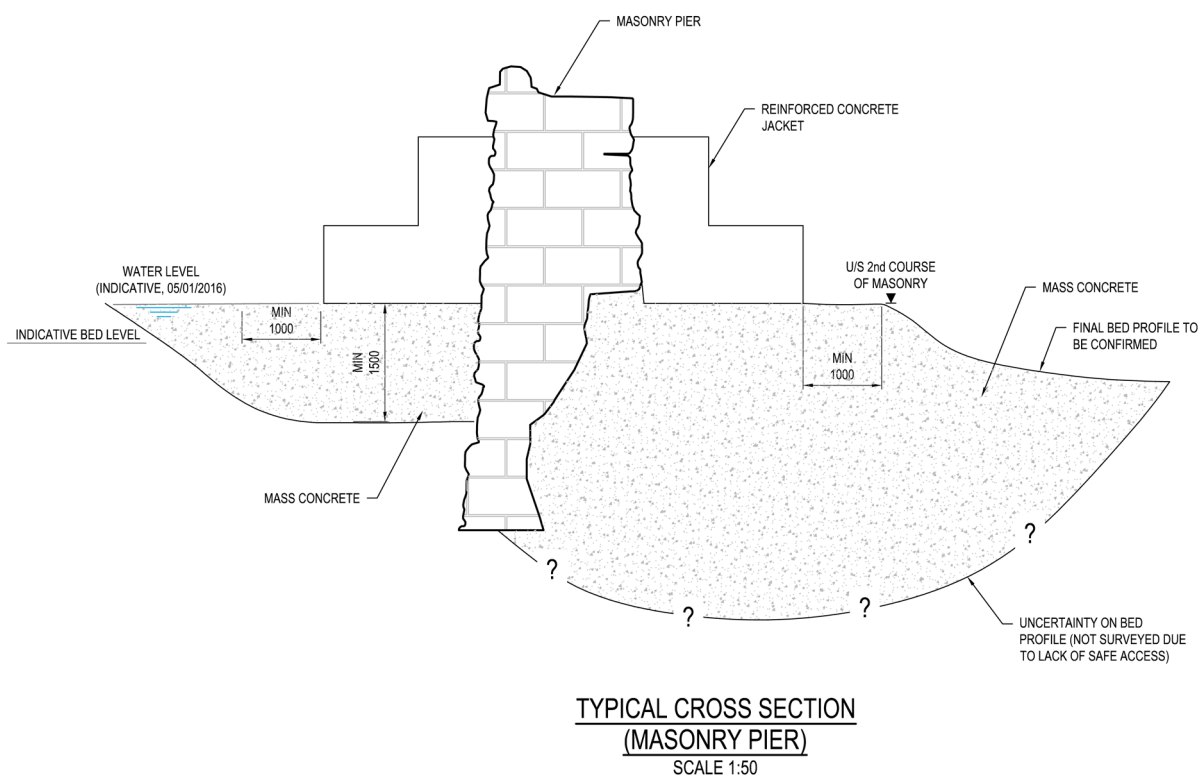
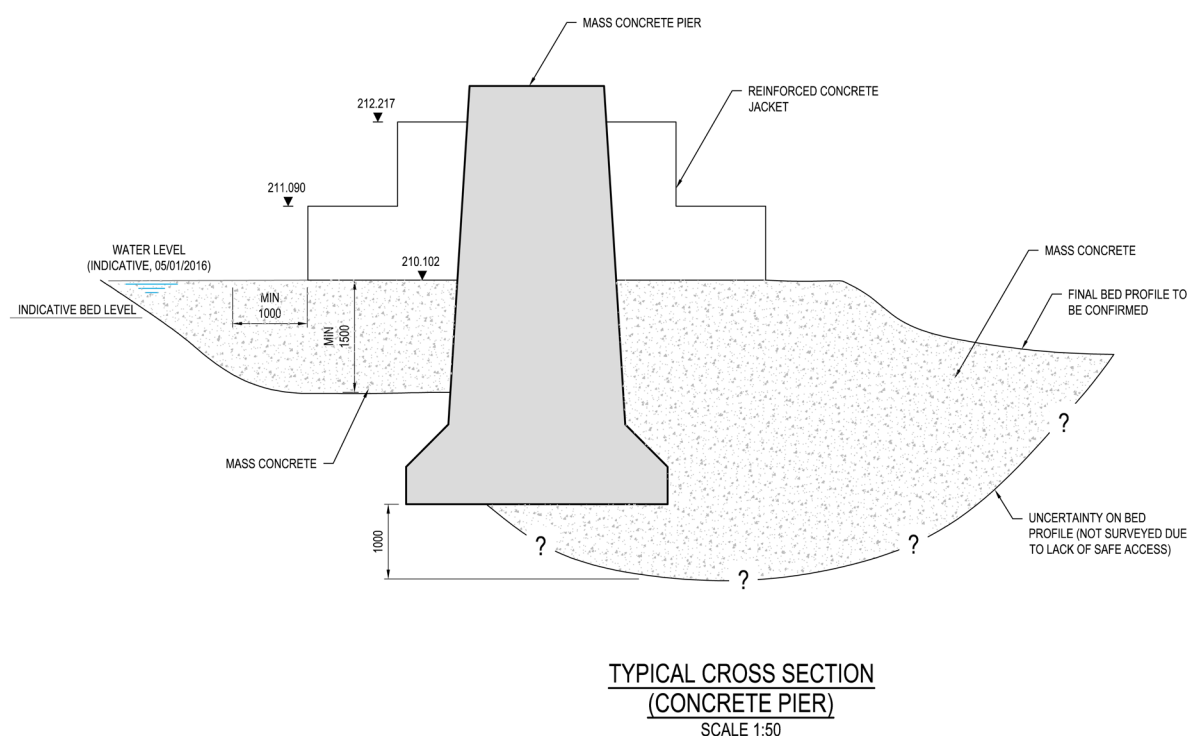
Figure 18: Cross-sections through pier 2's masonry section (upper) and concrete pier extension (lower) showing extent of scour damage recorded by divers on 2 January 2016. The reinforced concrete jackets installed to stabilise the pier are also shown (courtesy of Network Rail).

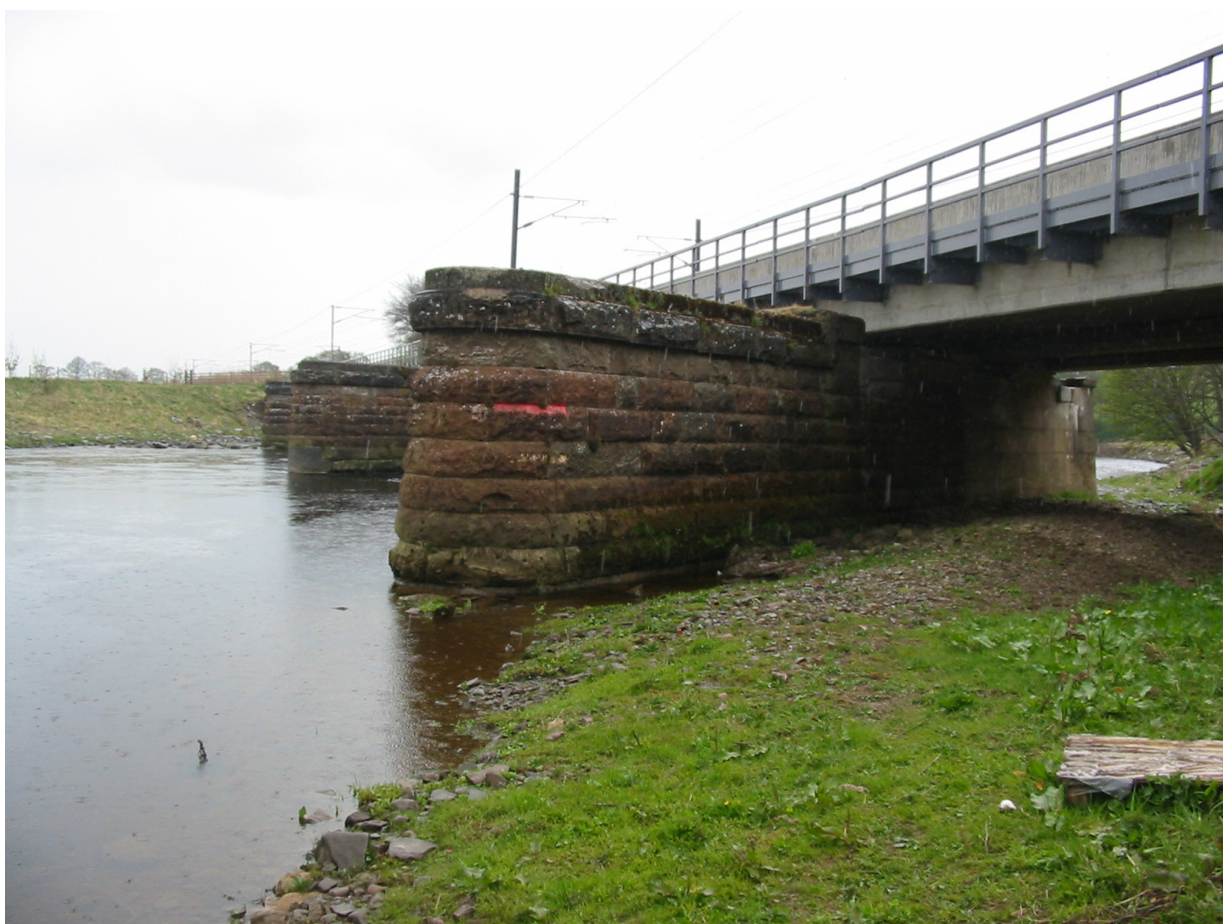
Figure 20: Red marker visible on upstream end of pier 1 in 2003 (photograph courtesy of Network Rail)

- 116 The level of the marker may originally have been set to avoid the risk of debris, carried by a flood, from striking the deck. As the structure was at risk of scour, the red marker should also have been set to correspond with a river flow at which line closure was justified by scour risk. No evidence was found that the red marker level had been set to take account of this.

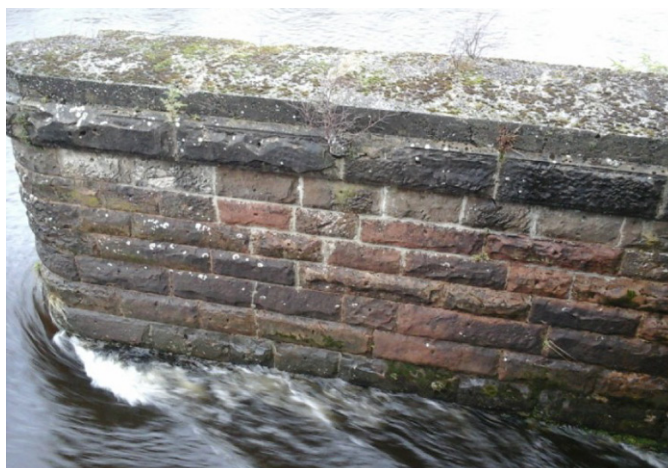
153 The upstream end of pier 2 had a long history of structural defects where voids had developed and masonry blocks had been displaced. Repairs were undertaken in 2008 and 2009, but these were limited in scope and did not address underlying structural issues. Despite these problems, the section of pier 2 that failed was downstream of the known voids and in an area with few recorded defects.

Figure 21: Upstream end of pier 2 on 9 December 2015, seen during a visual examination three weeks prior to the incident (photograph courtesy of Network Rail)

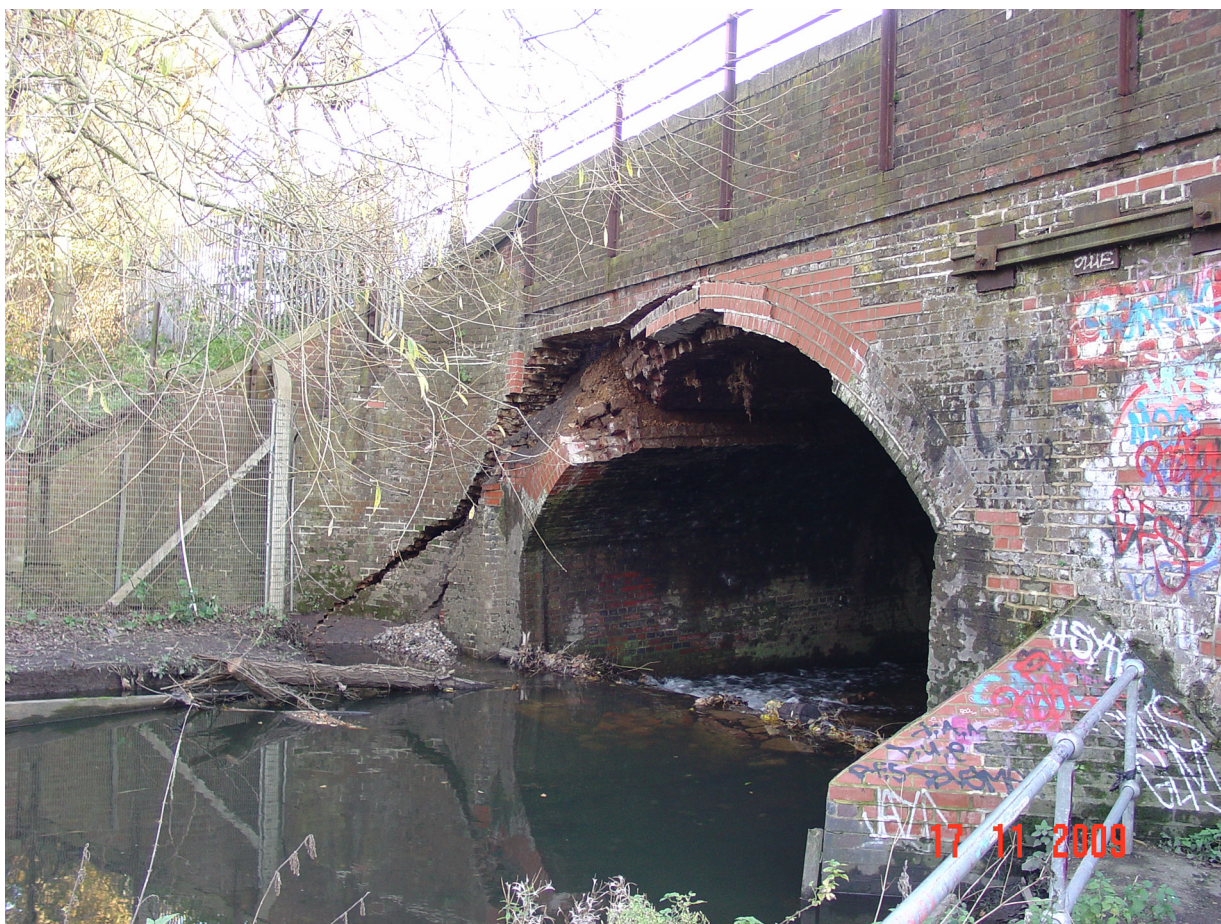
170 The most recent similar scour incident to affect Network Rail's infrastructure involved the failure of an arch bridge carrying the railway over the River Crane in Feltham, west London in November 2009 (figure 22). The bridge's foundations failed without warning after the river was partly blocked by debris, causing part of the bridge to subside ([RAIB report 17/2010](#)). The first indication of a problem was a track defect reported by a train driver. Track maintenance staff were called to the site and immediately blocked the line to all traffic when they became aware of a serious defect with the bridge. A total of 21 trains crossed the failing bridge between the first report and closure of the line. There was no derailment and no injuries occurred, but the bridge had to be demolished and rebuilt (refer to Recommendation 2).

Figure 22: Bridge RDG1 48, spanning the River Crane between Whitton and Feltham in west London. The arch failed after its abutment was undermined by scour erosion on 15 November 2009.

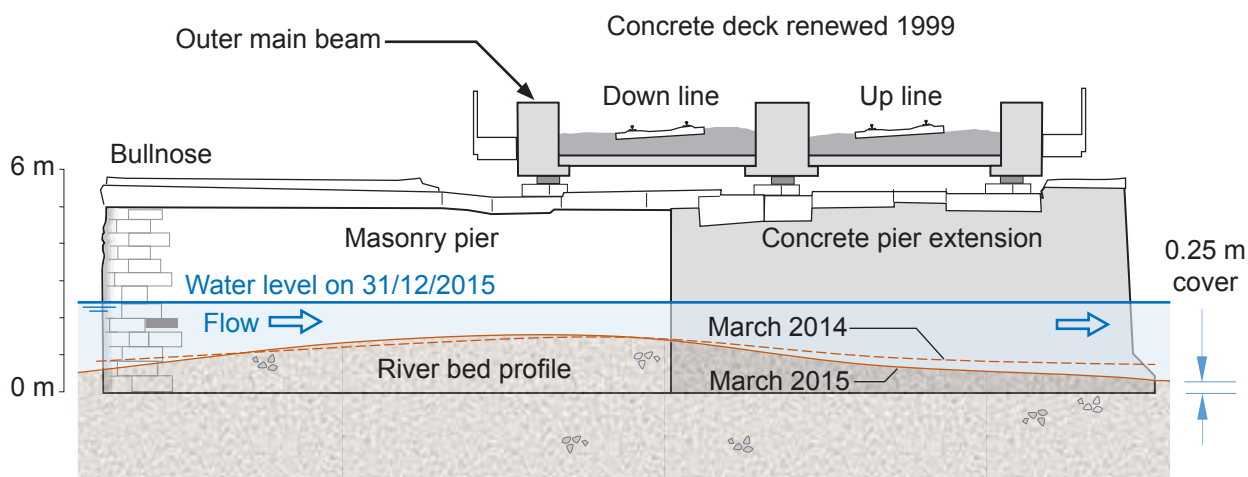
D1: South face of pier 2 prior to the incident, showing river bed profile as recorded in March 2015

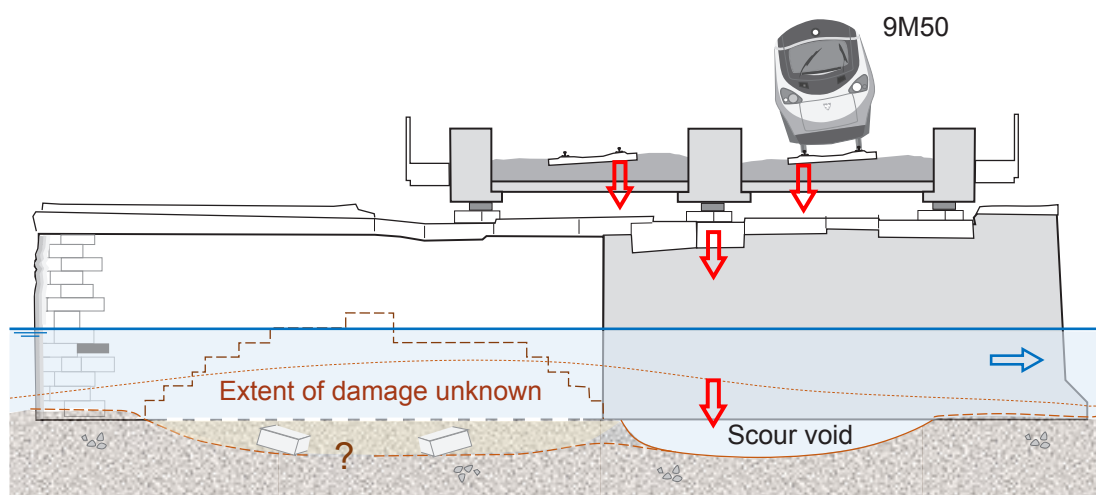
- 63 The relationship between scour damage and the dip felt at 07:28 hrs (paragraph 38) is illustrated in appendix D. The dipped rail on the up line was directly above a scour void beneath the concrete pier extension. It is likely that the loads imposed by train 1S34 passing over the viaduct at high speed at 08:40 hrs were the trigger for the large track movements seen after this train passed. It is likely that these loads fractured the already weakened masonry pier causing it to suddenly subside. Earlier trains would have imposed similar loads, but at a time when scour damage had not developed sufficiently for these loads to trigger a significant track movement.

D2: At 07:28 hrs on 31 December, the driver of 9M50 felt a dip in the track. This occurred because the supporting pier had been partially undermined by scour.

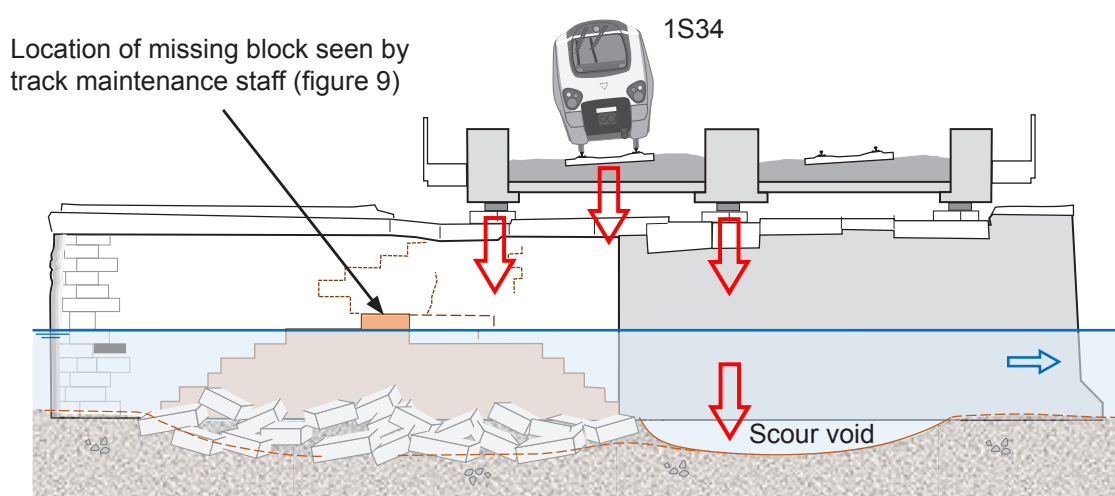
D3: At 08:40 hrs on 31 December, track distortion on down line revealed damage to the masonry section of the pier which had partially collapsed (refer to figure 16).
