Rail Accident Report

**Person struck by a train at Eden Park station,
south-east London
26 February 2020**

Report 01/2021
February 2021

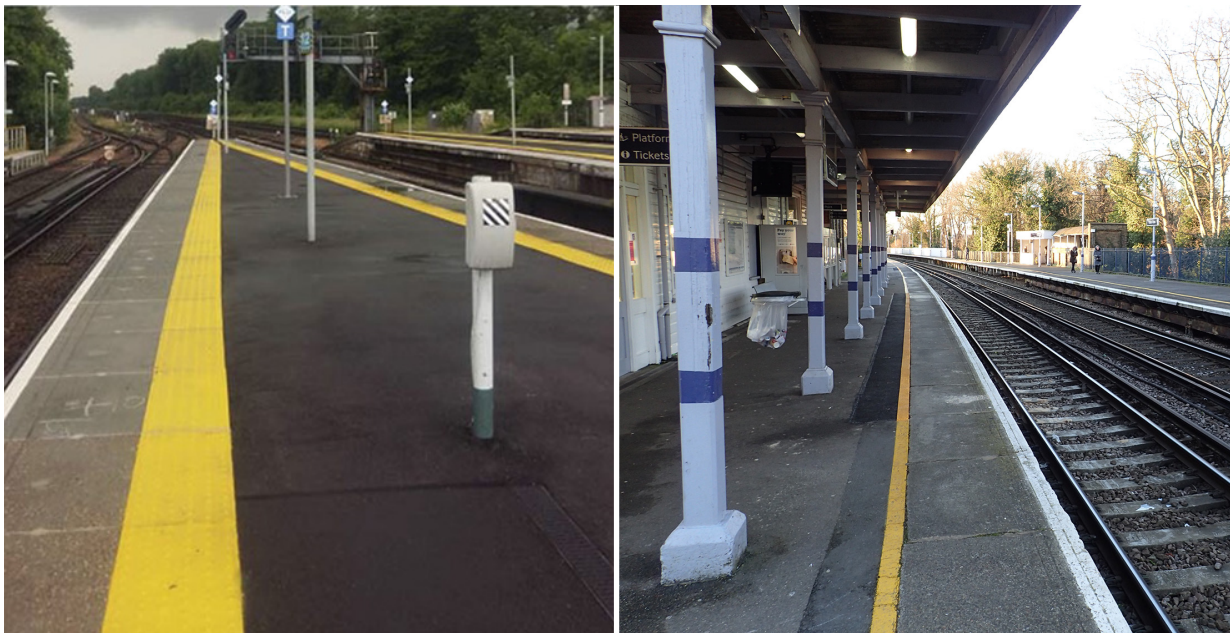
- 41 Prior to May 2018, some mainline railway platforms had tactile surfaces painted yellow and installed 760 mm from the platform edge (see figure 5). RSSB research⁷ recommended that this should become standard practice, where possible, to provide a high contrast between the platform surface and the track. The research noted that this contrast is important for both visually impaired people and the general population. Rail Industry Standard RIS-3703-TOM 'Passenger Train Dispatch and Platform Safety Measures' was updated (issue 4) to reflect this recommendation in March 2020.

Figure 5: Platforms at Three Bridges station (left) and platform 1 at Eden Park station (right). Left image courtesy of RSSB.
