Rail Accident Report

**Track worker struck by train near Roade,
Northamptonshire
8 April 2020**

Report 03/2021
June 2021

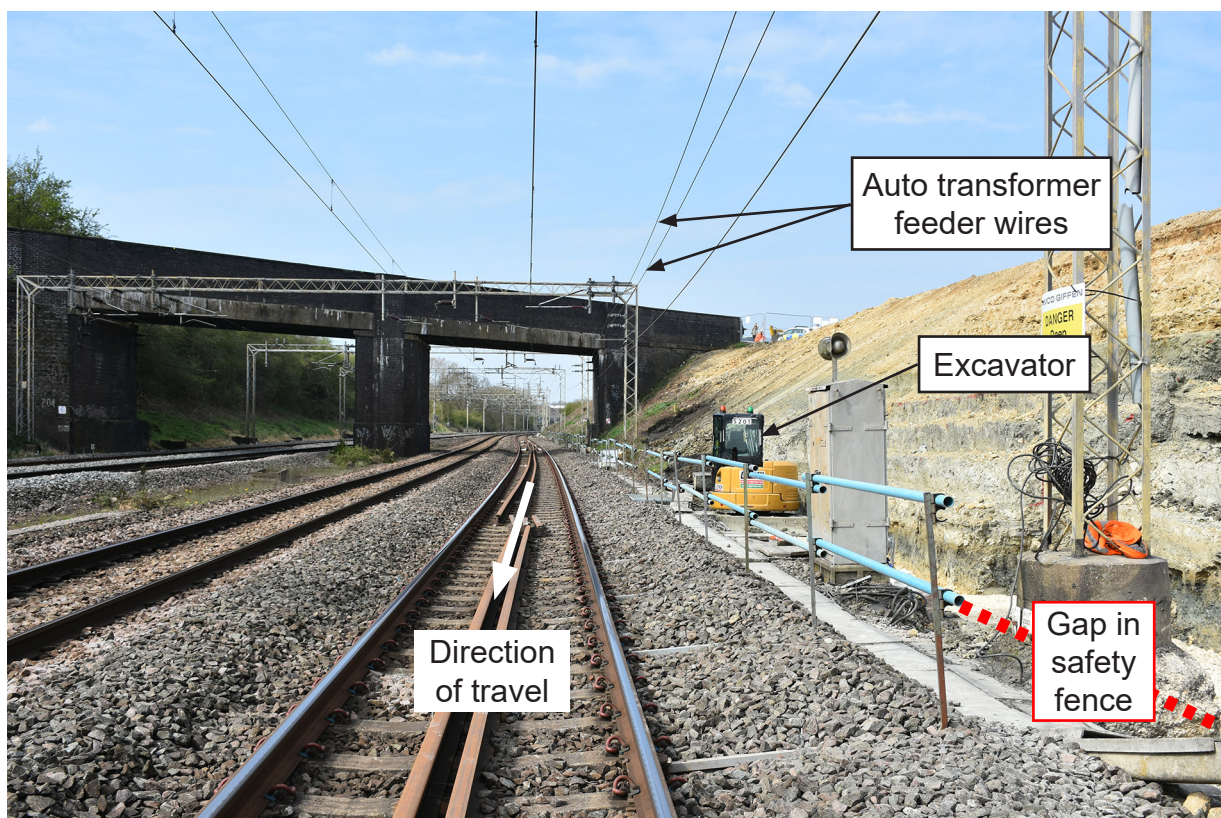
Figure 5: Image showing site looking north including safety fence and overhead line equipment

- 27 AmcoGiffen's documentation indicated that its plan was to protect staff from trains by implementing a fenced² safe system of work. It had begun to install temporary safety fencing 1.25 metres from the nearest rail, but due to the proximity of cable troughing and other obstructions, the fence was not complete. Four gaps were left in the length of fence between the overbridge and a set of temporary steps which had been installed south of the work site to create a safe access to the cutting. An alternative 'separated'³ safe system of work was planned to be implemented for the work at the site, until such time that the fencing was completed.

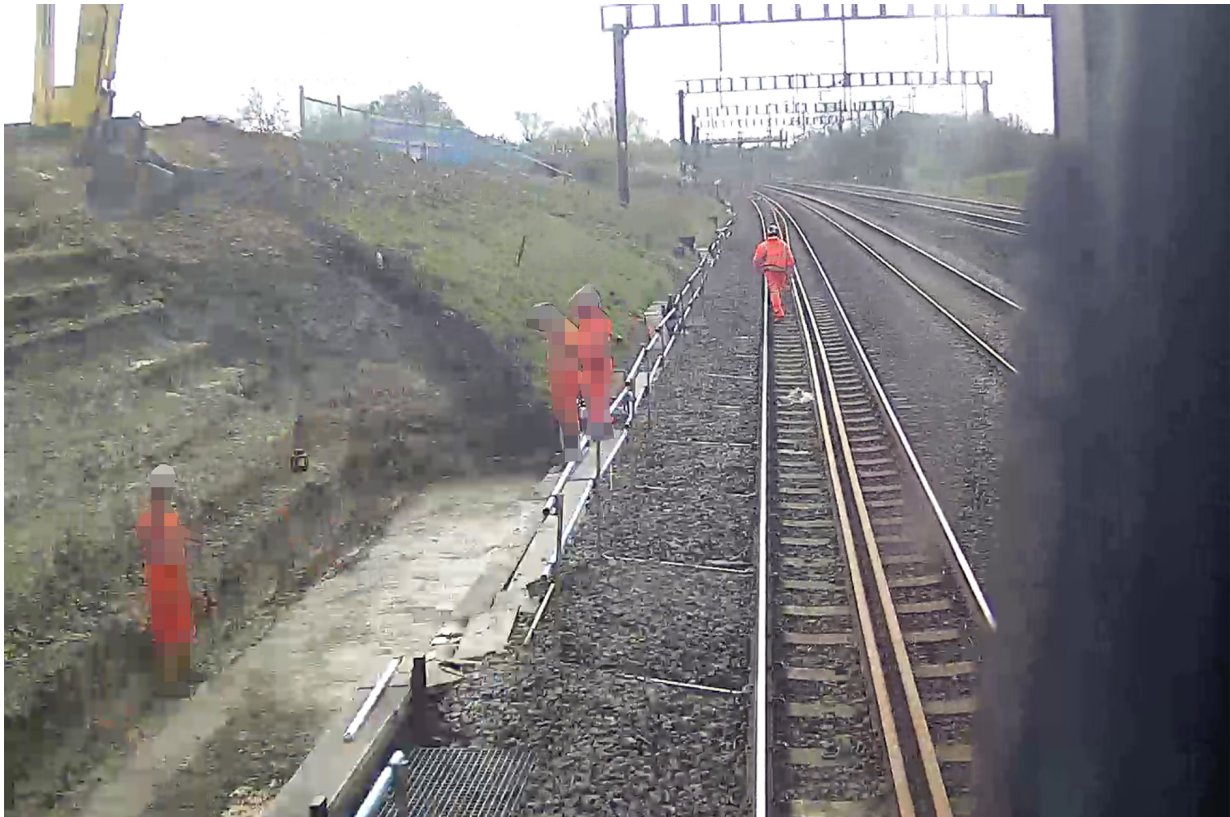
Figure 6: Image from the forward-facing CCTV of train 2N30, immediately before the accident

45 The immediate cause of this accident is clearly evidenced by footage from the train's forward-facing CCTV (figure 6).

- b) However, it is more likely that the track worker went back onto the track because he had ready access to the track, having just been onto the line to undertake a task that subsequently was found to be unnecessary (paragraph 60, **Recommendation 3**).
