Rail Accident Report

**Fatal accident at Waterloo Underground station,
London
26 May 2020**

Report 05/2021
September 2021

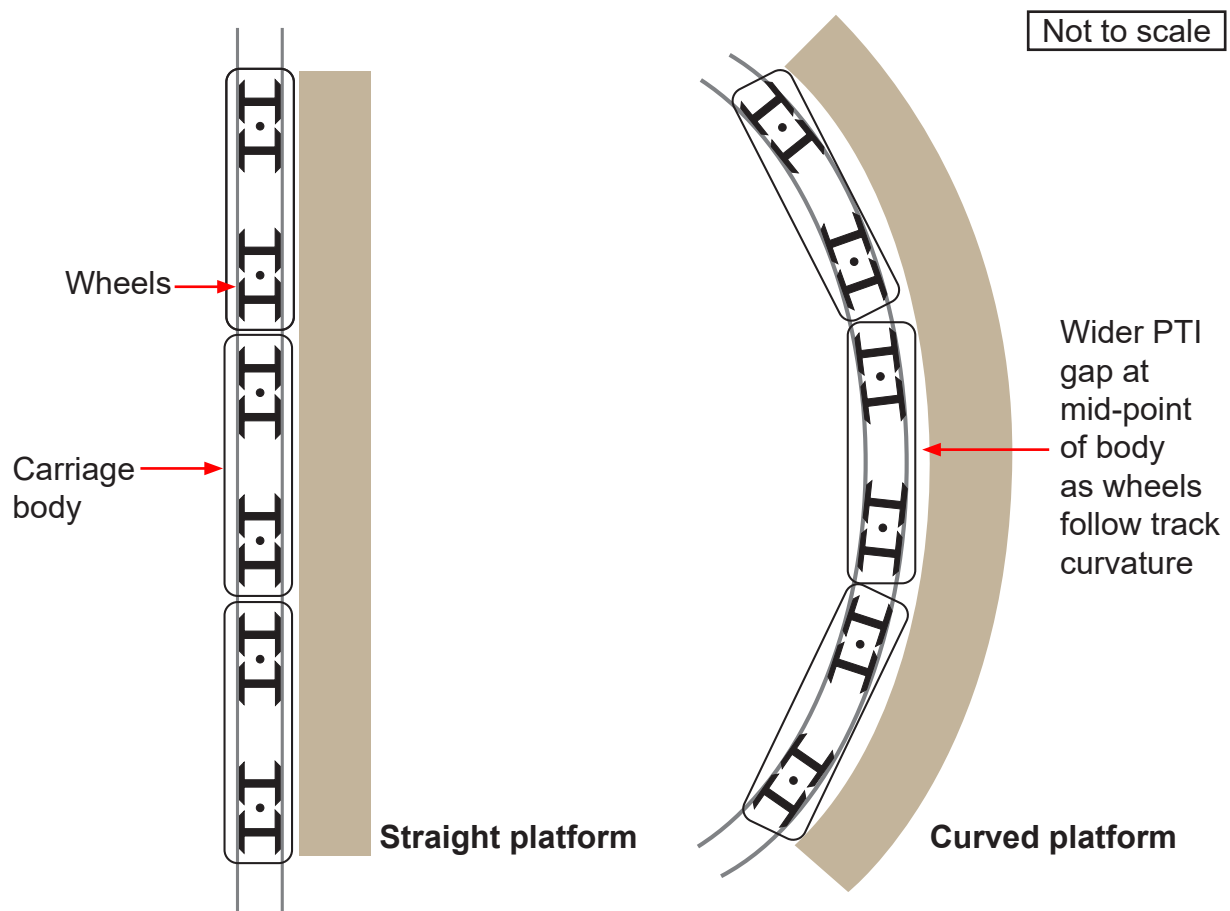
Figure 2: Diagram showing increased gap between the train and platform as a consequence of track curvature

- 6 The railway is tightly curved to the left (in the direction of travel of trains) through the platform, and this results in larger gaps between the platform and the train in some parts of the platform than would be found at a straight platform (figures 2 and 3). A lineside signal on the approach to the station controlled the movement of trains into the platform area and another signal, about 10 metres beyond the departure end of the platform, controlled movements out of the platform towards the next station.

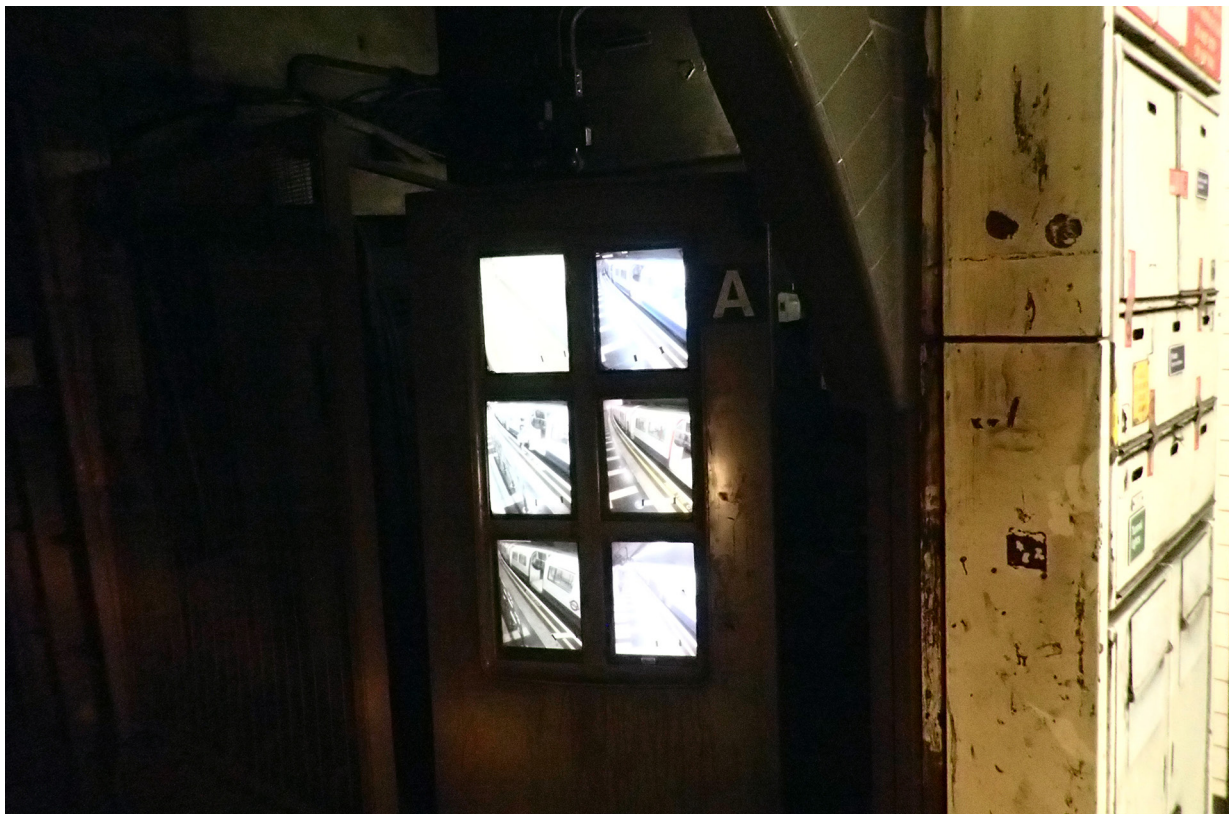
Figure 5: OPO monitors provided inside the tunnel at Waterloo Bakerloo line platform 3

- 12 Platform 3 at Waterloo was equipped with a CCTV system because the track curvature limited the view along the train. This CCTV system was independent of the station CCTV system and comprised six cameras, each feeding a single monitor. The overlapping images on the monitors allowed train operators to view the PTI along the full length of their train. These monitors, known as One Person Operation (OPO) monitors, were located just inside the tunnel mouth at the departure end of the platform (figure 5). In the event of a failure of the OPO system, platform staff must be provided to assist the train operator with the safe despatch of trains.

- 47 At Waterloo Bakerloo line platform 3, the six OPO monitors that allow train operators to view the full length of the PTI (paragraph 12) were positioned behind a glass screen approximately 3.2 metres from the train operator's driving position (station CCTV images show that train 210 had stopped in the correct position at the time of the accident). The monitors are inspected each morning to confirm that the cameras are correctly aligned and the images are displayed distinctly. The monitors were checked at 04:55 hrs on the day of the accident and no defects were recorded.

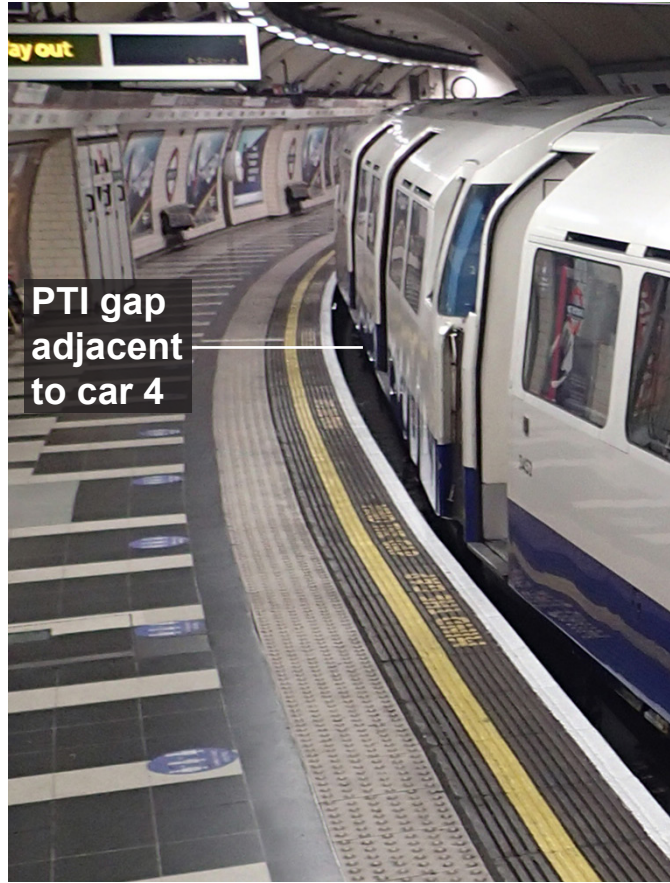
Figure 6: Platform-train interface gap adjacent to carriage 4 at Waterloo Bakerloo line platform 3

- 36 When the Bakerloo line was constructed at the start of the 20th century, the northbound track alignment through Waterloo station incorporated a tight curve with a radius of between 133 metres and 156 metres. This curve creates a large PTI gap close to the middle of the carriages (figure 6). With a train of this type stationary in the platform, RAIB found the gap to be approximately 264 mm when measured diagonally between the lower corner of the train body and the edge of the platform at the mid-point of the fourth carriage, the area in which the passenger fell (figure 7).

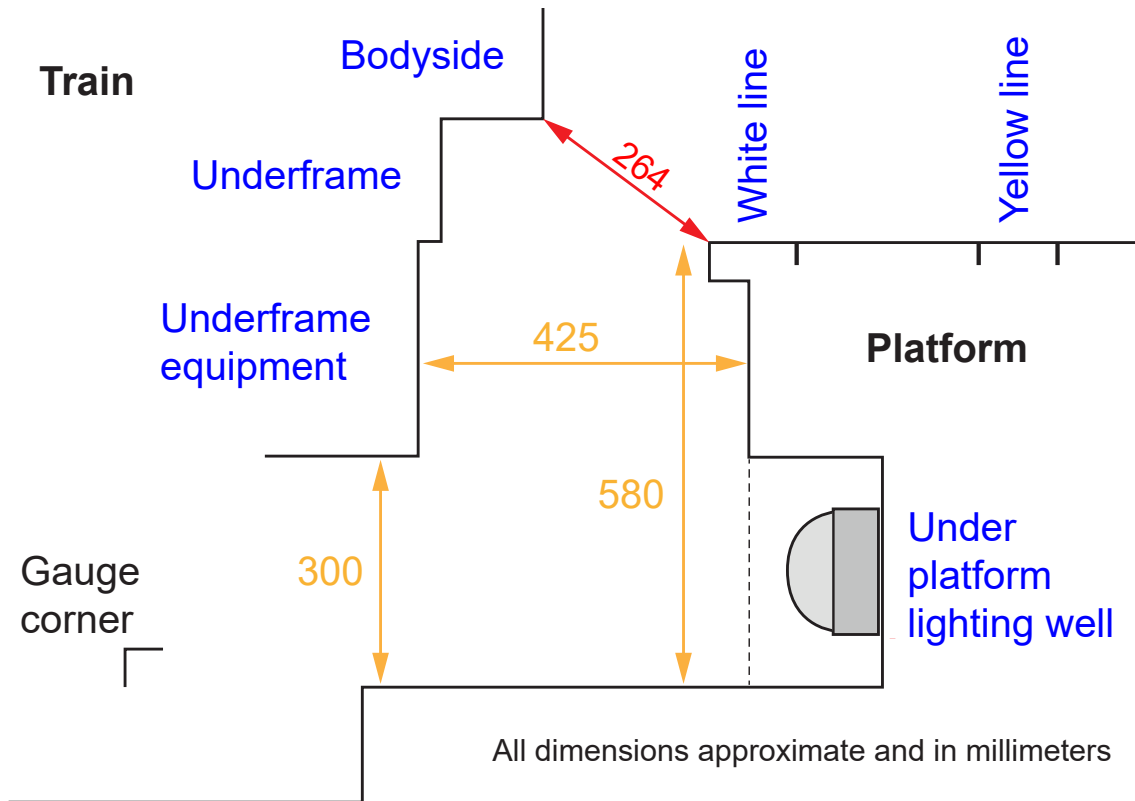
Figure 7: Cross-section between the platform and mid-point of carriage 4 at Waterloo Bakerloo line platform 3

- 38 Once in the PTI gap, the passenger was unable to get out. This was probably at least in part because there was limited space between the platform, the train and the track (figure 8). The task could have been made more challenging by pre-existing mobility limitations which were described (by the passenger's family) as being due to previous leg injuries, any injuries sustained in the fall, or a combination of both.

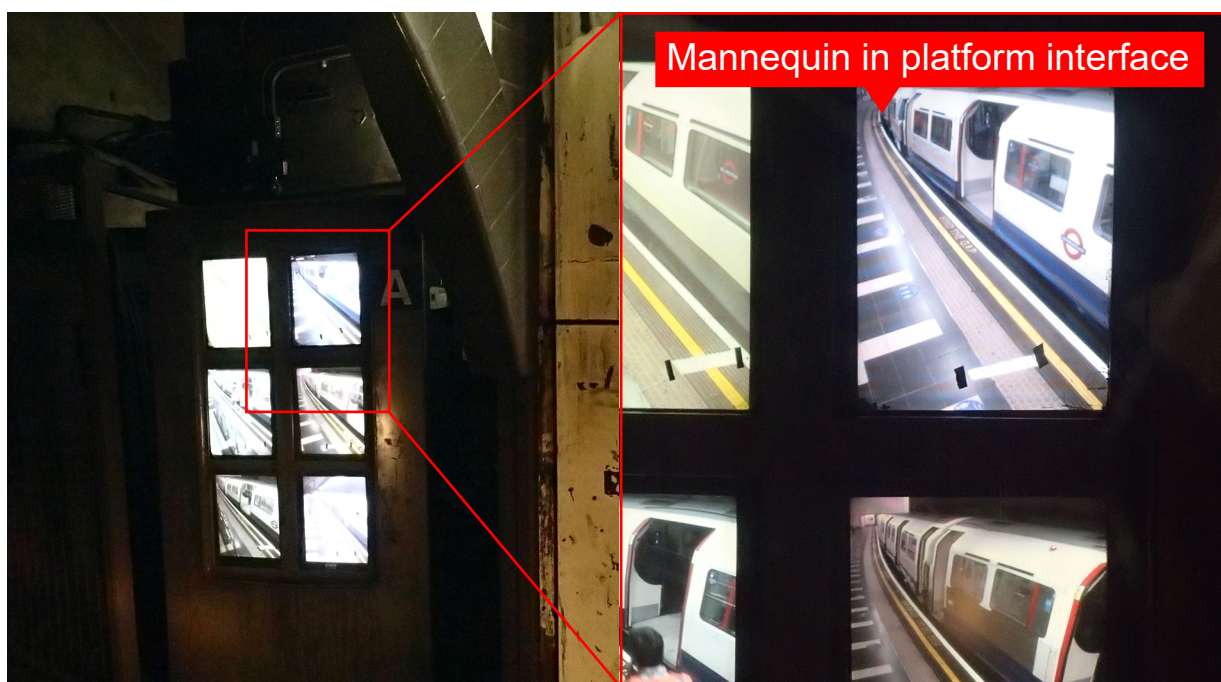
Figure 9: Layout of OPO monitors and position of passenger during despatch adopted by mannequin as would have been presented to operator of train 210 (inset)

- 49 At the time of despatch, the image of the passenger would have been in the top left-hand corner of the top right OPO monitor. The passenger was wearing dark clothes and only his head and arms were above platform level. One of his arms was out across the platform and this arm would have been the only part of his body visible on the OPO monitor. Given these factors, the simulation showed that it would have been very difficult for the train operator to detect the passenger. RAIB photo-edited an OPO monitor image to show there would be little difference in image with and without the passenger's arm and head above the platform (figure 10).

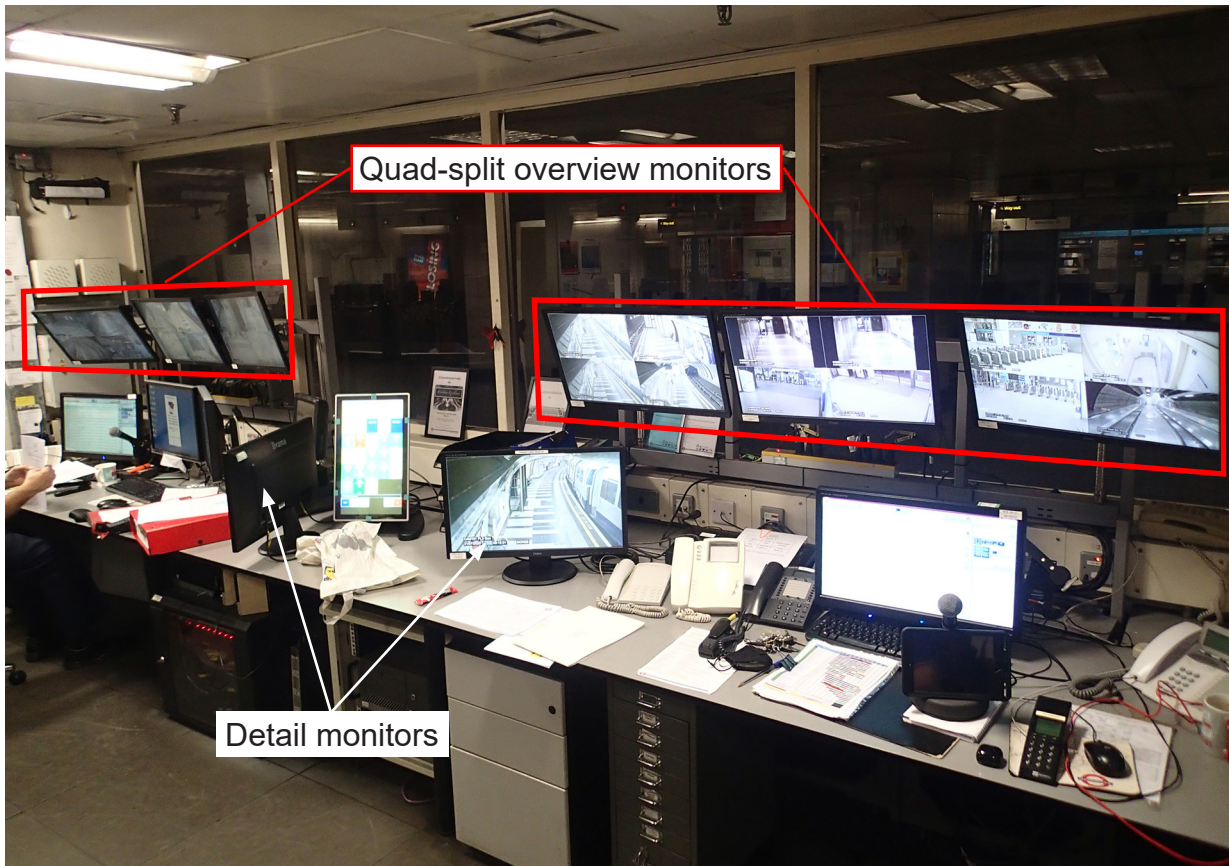
Figure 11: CCTV workstations at Waterloo station control room

- 62 There are two CCTV workstations in the station supervisor's office, each comprising three 'quad-split' overview screens, so each workstation can show twelve images (figure 11). The system is configured such that the image captured by each camera will appear for approximately five seconds in sequence. This automatic refresh sequence can be interrupted by many triggers such as an alarm or fire door being opened, which LUL states is a frequent occurrence. There is also an additional detail monitor at each workstation which can show any one of the camera images at the request of the system operator.

- 63 Camera 181 of the station CCTV system is on Bakerloo line platform 3 and captured the whole accident sequence, including the period between the departure of train 210 and the arrival of train 214. It is probable, but not certain, that part of this sequence was shown on the system monitors, but if so, it is not known if this would have been in time to stop train 210 from departing or to stop train 214 from entering the station area.

- 64 LUL has stated that staff in the station supervisor's office are not required to be continuously monitoring the CCTV system, nor are they responsible for supervising the PTI gap or taking part in the despatch process. The station CCTV system allows staff responsible for managing the station to observe events as they occur, for example passenger flows during busy periods. Recordings from the system allow investigation of reported events such as criminal acts and accidents. When using the Waterloo CCTV system, the user's attention would not normally be focused on the PTI of the eight LUL platforms. There is no evidence that station supervision staff witnessed the accident. If an unsafe event requiring a train to be stopped is seen on the CCTV monitors, station supervision staff are expected to get the train stopped by contacting the Bakerloo line service controller or, when in attendance, members of staff on the platform.
