Rail Accident Investigation Branch

Rail Accident Report

Signal passed at danger and subsequent near miss, Chalfont & Latimer station 21 June 2020

Report 04/2021
July 2021

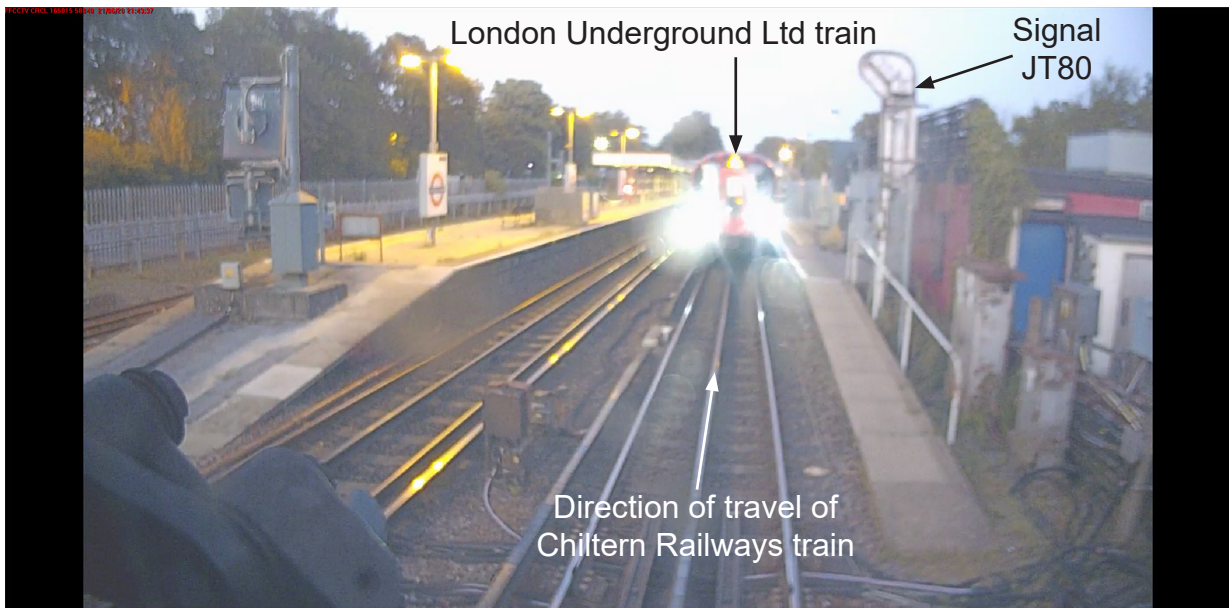
Figure 2: Image from forward facing CCTV camera fitted to the Chiltern Railways train (image courtesy of Chiltern Railways)

- 33 The Chiltern Railways train came to a stop 15 seconds after its emergency brake was applied and around 23 metres from the stationary Metropolitan line train in platform 1 (figure 2).

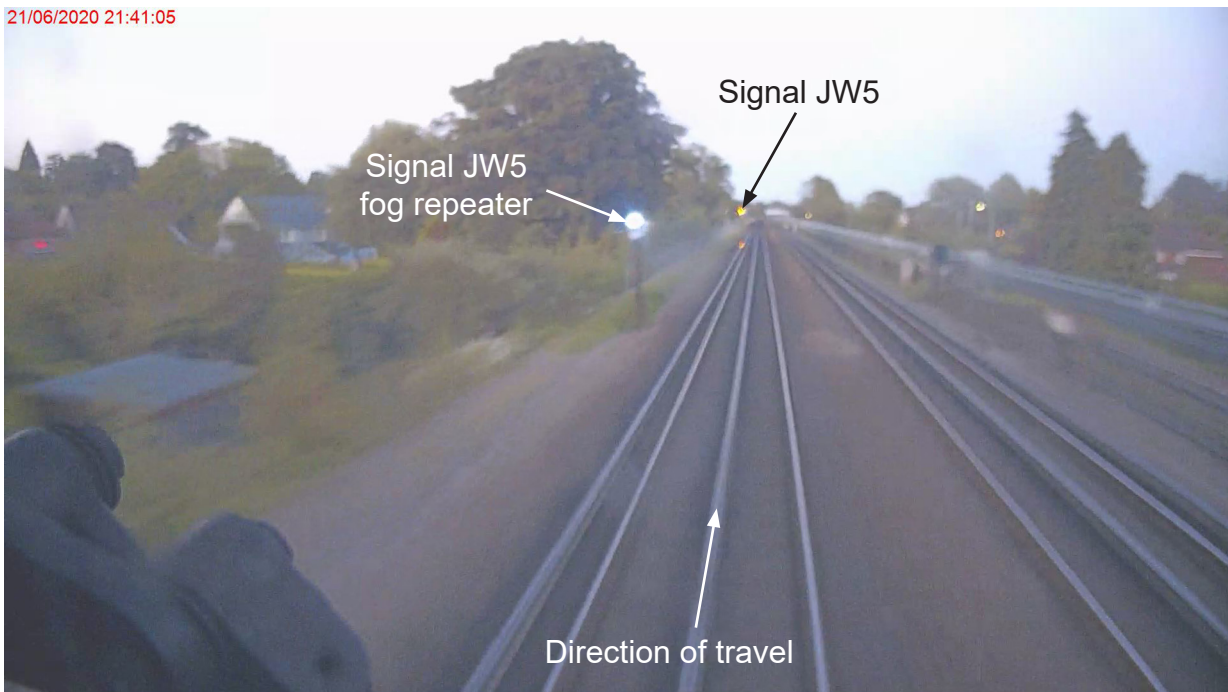
Figure 8: Signal JW5 displaying a single yellow aspect and associated fog repeater showing a white aspect (FFCCTV image courtesy of Chiltern Railways)

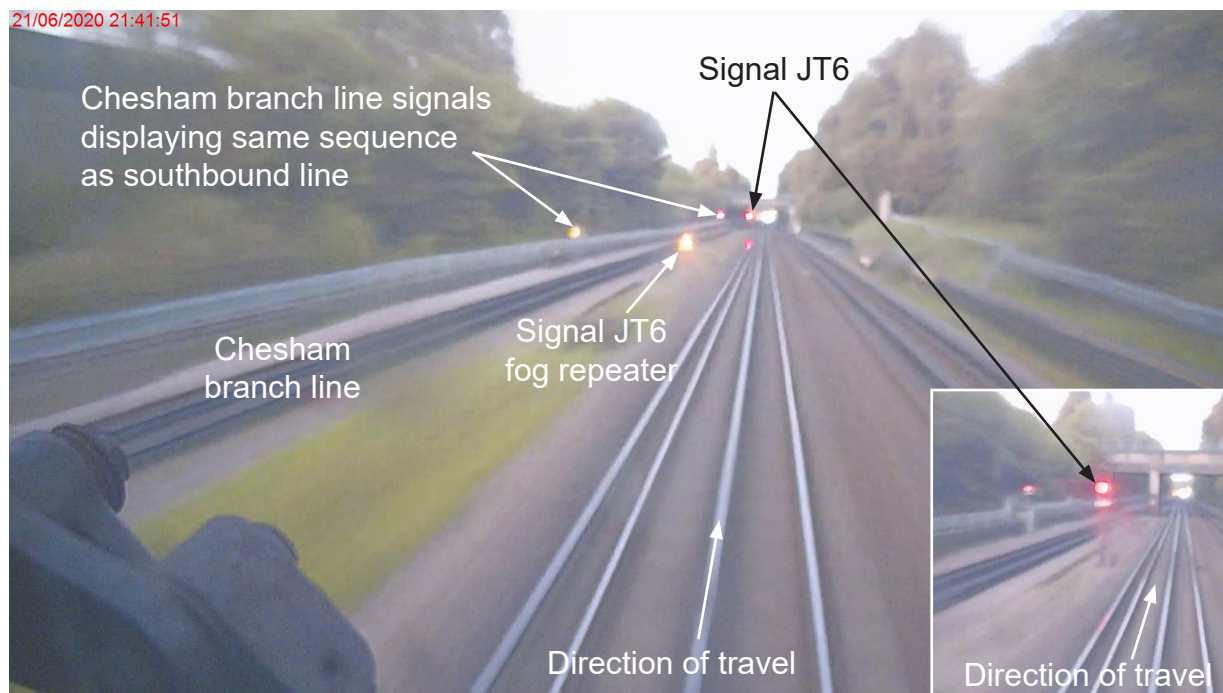
- 28 FFCCTV images (figure 9) show that around this time the fog repeater associated with JT6 and signal JT6 itself became visible to the driver and remained visible until the train passed them. The yellow aspect of the fog repeater and the red aspect of signal JT6 were visible to the driver for around 20 seconds. During this time, the driver allowed the train to coast as it descended towards Chalfont & Latimer, except for a brake application of around one second duration to stop the train's speed rising above 60 mph (97 km/h) again.

Figure 9: Signal JT6 displaying a red aspect and associated fog repeater showing a yellow aspect; inset image shows signal JT6 approximately one second before the train passed it (FFCCTV image courtesy of Chiltern Railways)

- 29 As the train was coasting, at just under 60 mph (97 km/h), it passed the red (stop) aspect of signal JT6 and the train's emergency brake was automatically applied when the raised trainstop operated the tripcock system on the train. The train stopped around 312 metres beyond signal JT6 and around 530 metres before the Chesham branch junction (figure 10).
- 30 As the Chiltern train was approaching signal JT6, the Metropolitan line service was just departing from platform 1 at Chalfont & Latimer station, with signal JT80 at the north end of the station displaying a green (proceed) aspect. This signal changed to a red aspect when the signalling system detected that the Chiltern train had passed signal JT6. The Metropolitan line train had not passed signal JT80 when its aspect changed, and its operator stopped the train immediately, having moved a very short distance.

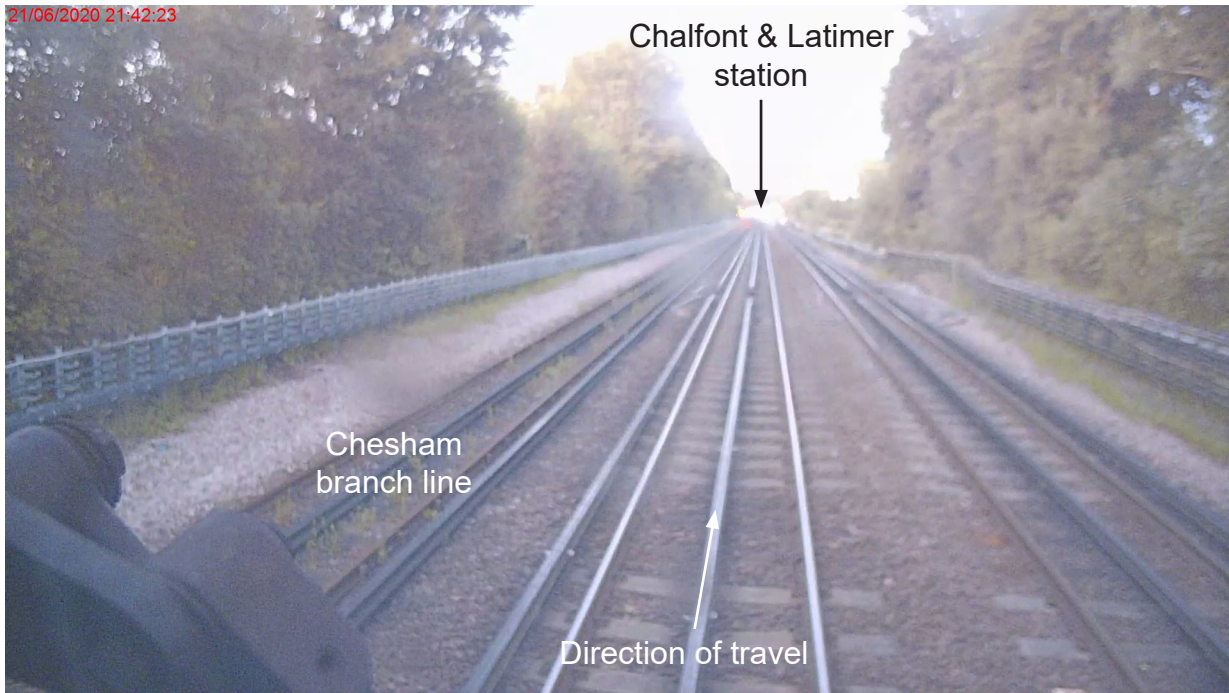
Figure 10: Stopping position of the train after tripcock activation (FFCCTV image courtesy of Chiltern Railways)

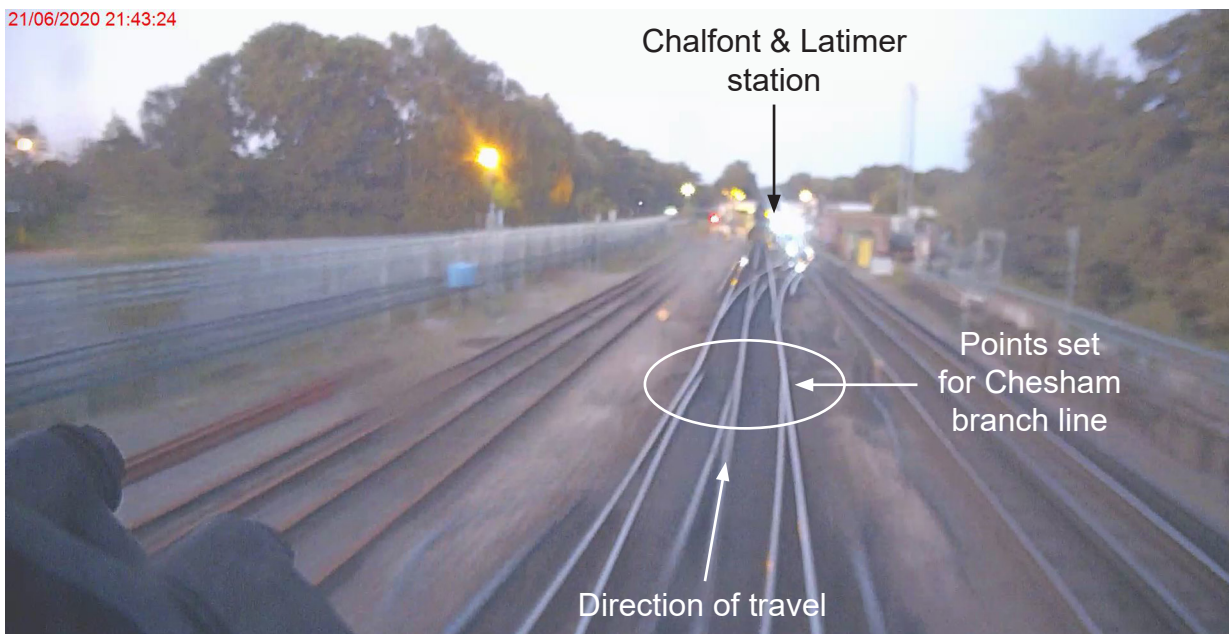
31 The Chiltern Railways train driver stated that he thought the automatic emergency brake application was spurious, and not associated with a signal, so he reset the tripcock equipment about five seconds after the train stopped. The driver restarted the train around four seconds later and accelerated for around 22 seconds, reaching a speed of around 27 mph (43 km/h). The driver then shut off power and allowed the train to coast for around 20 seconds before making a light (step 1) brake application which continued as the train passed over the Chesham branch junction about nine seconds later (figure 11). The train ran through the points at this junction which were still set for the LUL train going to Chesham.

Figure 11: The train approaching the points set for the Chesham branch (FFCCTV image courtesy of Chiltern Railways)

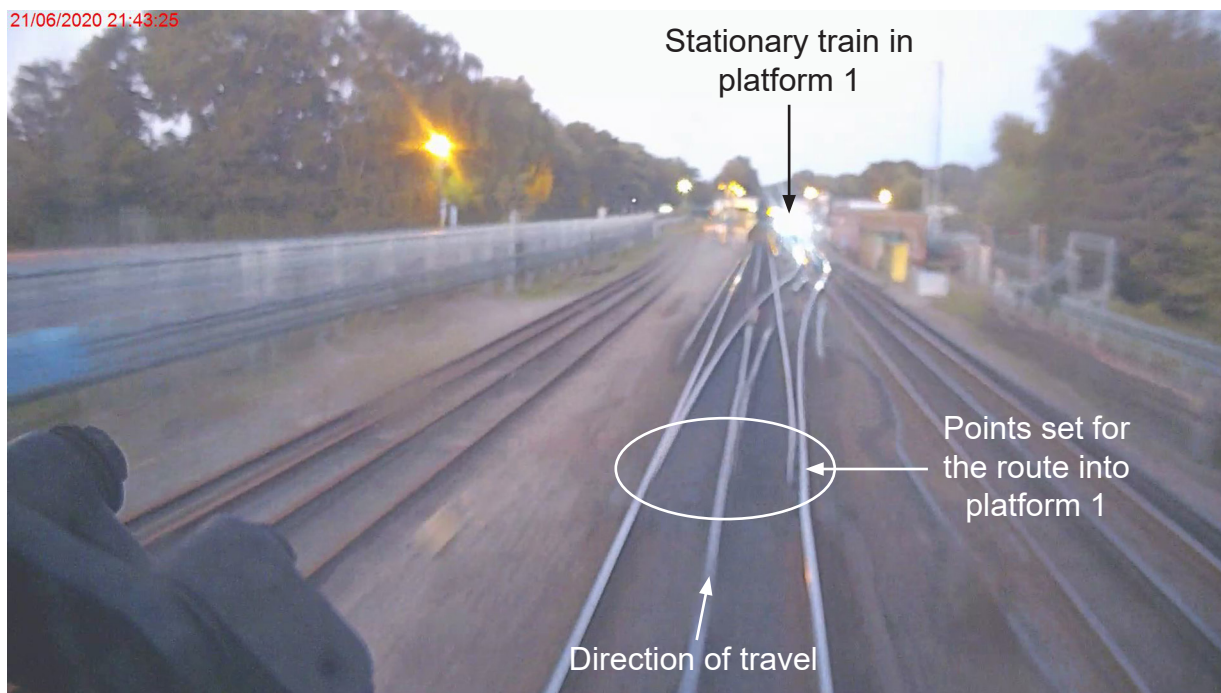
- 32 The Chiltern Railways driver did not notice that the train had run through and damaged these points. He released the train's brakes but then almost immediately applied the emergency brake when feeling a 'kick' as the train passed through the first set of points in the crossover that were set towards platform 1 at Chalfont & Latimer station (figure 12). The Chiltern Railways train was travelling at around 25 mph (40 km/h) as it passed over the crossover points, around 10 mph (16 km/h) more than the maximum permitted speed of 15 mph (24 km/h) that applied over them.

Figure 12: The train approaching the points set towards the stationary train in platform 1 (FFCCTV image courtesy of Chiltern Railways)
