Rail Accident Report

Locomotive failure near Winchfield 23 November 2013

Report 13/2014
June 2014

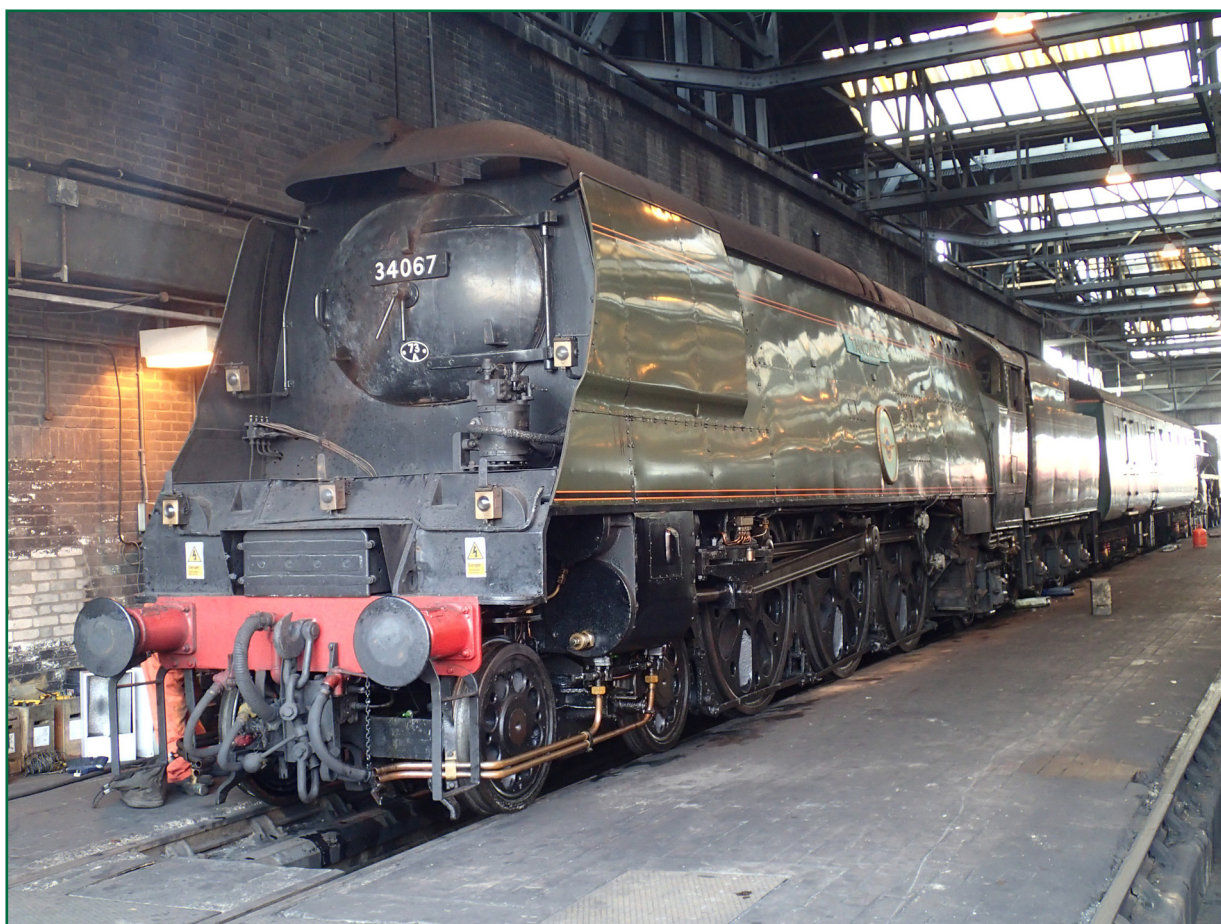
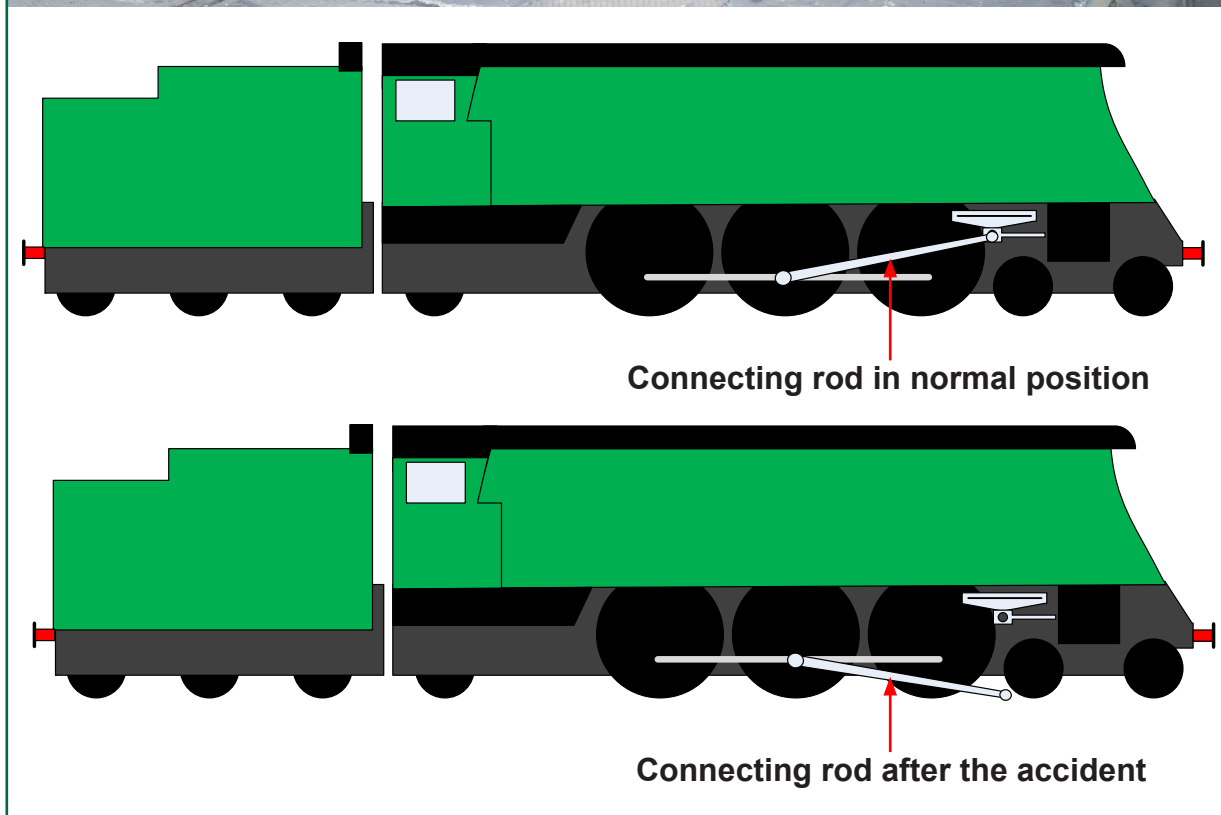
Figure 2: the locomotive 'Tangmere', showing how the connecting rod dropped

- 41 **The immediate cause of the accident was that the small end assembly came apart.**
- 42 After the accident, the connecting rod was found with its small (leading) end resting on the ground. The gudgeon pin was lodged on the bogie *splasher* of the locomotive. The nut and cotter which secured the gudgeon pin have not been found.

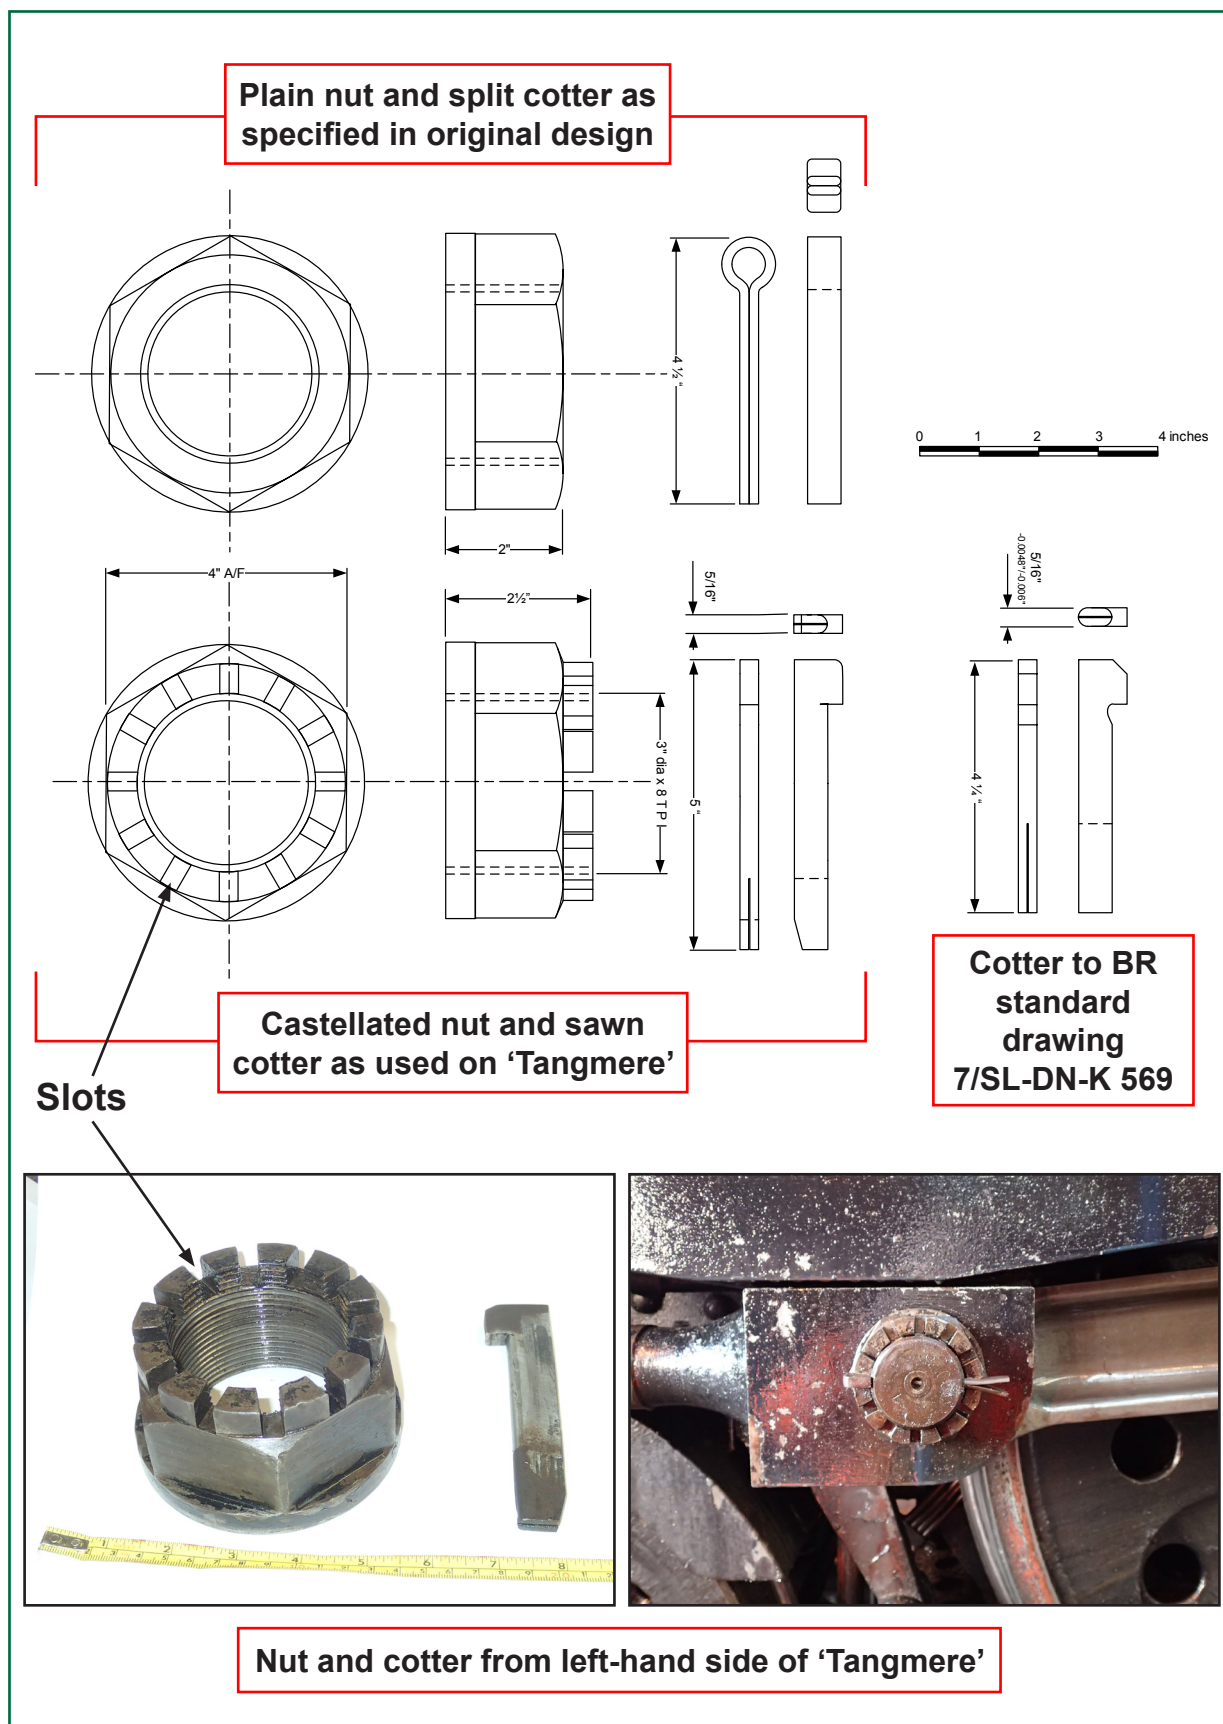
- 40 The original design of this assembly used a plain nut. However, when the locomotive was restored from scrapyard condition between 1981 and 2004, new gudgeon pins and nuts were manufactured. The nuts, which in the original design were 2" (51 mm) thick, were given an extra thickness of ½" (13 mm), and twelve slots 5/16" (8 mm) wide were machined in this ring to make a *castellated nut*. These slots have no radius at the base (a drawing and photograph of the modified designs of nut and cotter are in figure 6). The original design used a split cotter, but for the restoration a cotter was made from 5/16" (8 mm) thick plate with a saw cut to form the 'legs' (paragraph 62 and figure 6).

Figure 6: Nut and cotter

- 65 Making the slot in the cotter of this length is undesirable, firstly because having the base of the legs beyond the outer diameter of the gudgeon pin will permit the cotter to move in the slot if it becomes loose for any reason (paragraph 49), and secondly (in this application with a castellated nut) because the castellations of the nut can bear on the hinge point, where the stress concentration is greatest and the material has been weakened by the bend, and act as an initiating point for a fatigue crack as described in paragraph 49.

- 66 The sharp corner under the head of the cotter will also create a stress concentration, and may initiate development of a crack which could eventually lead to detachment of the head.

- 76 The gudgeon pin nut used on 'Tangmere' had twelve slots, in which the cotter could be located (figure 6). Each of these slots had sharp corners at the base. If the nut experienced high levels of stress and/or vibration, it is possible that fatigue cracks could be initiated at these corners: these might over time develop to the point where the nut fractured.

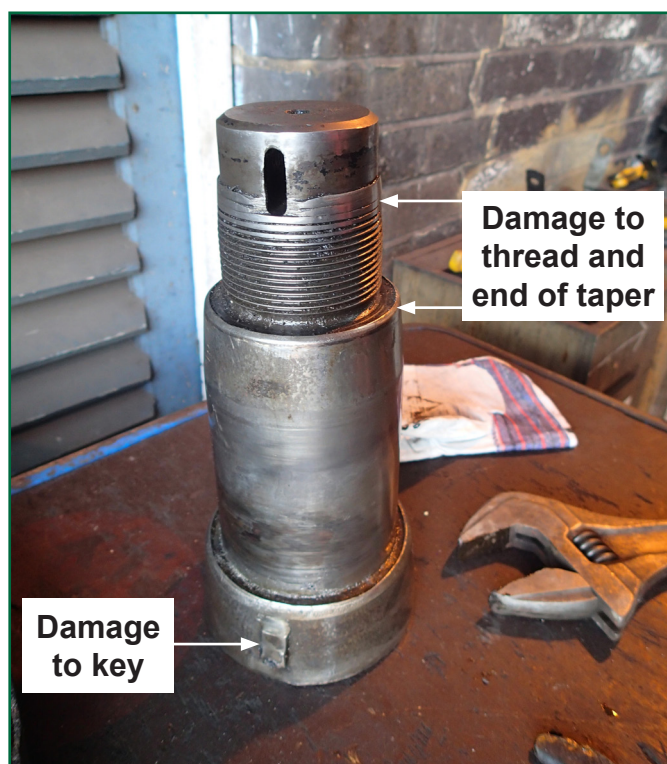
- 56 The final loss of the gudgeon pin nut was probably accompanied by the violent movement of the pin in the crosshead. The energy imparted to the nut was evidently sufficient to fracture the studs which secure the oil cup which is fitted to the upper part of the crosshead, directly above the gudgeon pin. The oil cup has not been found, but RAIB believes that its loss was a consequence of the small end failure, and was not among the causes of the event. There was no evidence of any heating of the gudgeon pin surface, as would have been the case if it had been starved of oil for any length of time. Following the detachment of the nut, the gudgeon pin was free to move in the taper bore of the crosshead. This movement damaged the end of the thread and the small end of the taper on the pin (figure 8). The gudgeon pin finally came out of the back of the crosshead, catching on the brake rigging and breaking the hanger of the brake block of the right-hand leading coupled wheel. It then lodged on the top of the bogie wheel splasher¹⁶ of 'Tangmere', where it was found after the accident.

Figure 8: Gudgeon pin of 'Tangmere' after the accident

- 122 WCRC reports that it has repaired 'Tangmere' and returned it to service. On the locomotive itself, the right-hand side gudgeon pin, nut and cotter have been renewed in accordance with the original BR (Southern) drawing number W11335. This means that the castellated nut previously fitted has been replaced with a plain nut and a Southern Region style split cotter which is now aligned vertically. The left-hand side and middle cotters have been renewed and the nuts have been examined and subjected to non-destructive testing. All motion cotter pins have been renewed. The piston rod/crosshead, connecting rod and brake hanger have all been stress relieved by a specialist contractor and checked for straightness and alignment. The right-hand connecting rod has been through a thorough non-destructive testing process using an Eddy Current system.

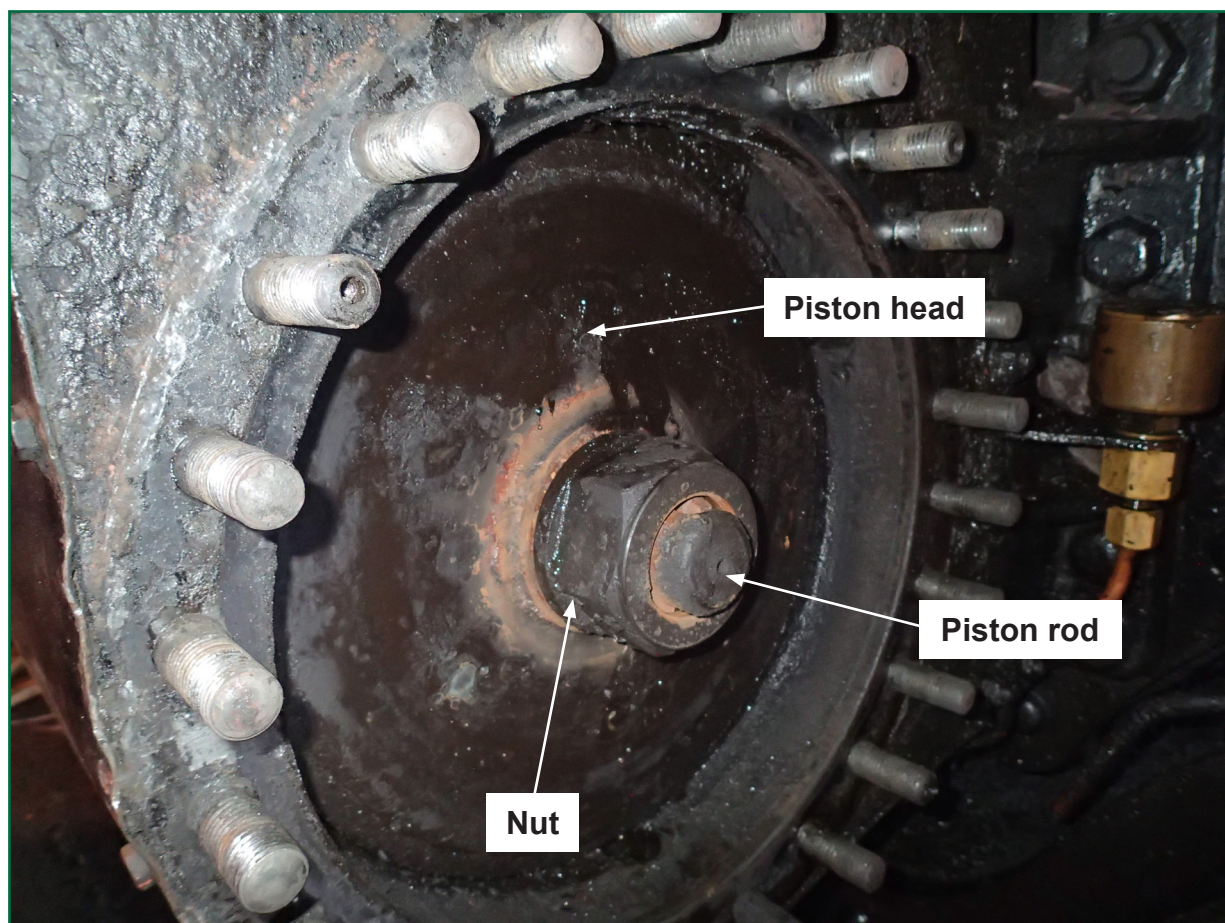
Figure 9: Loose piston head

- 94 The nut had unwound by about one turn when found, so that the piston head had about 1/8" (3 mm) free movement on the rod. There was evidence that the piston head had contacted the cylinder cover. The method of securing the piston on the rod had not been modified from the original design.

- 97 If the piston head had come loose before the small end failure, the slack between the piston head and piston rod would have created some additional shock loading on the small end joint, which would have been transmitted through the gudgeon pin. However, the small amount of movement that was present after the accident is unlikely to have had a significant effect on the loading of the joint. More importantly, the piston head nut, once loose and without its cotter, would have unwound quite quickly, because of the vibrational and inertial forces on it, leading to complete failure of the right-hand cylinder in a short time. RAIB therefore discounts this as a cause of the small end failure, and concludes that the looseness of the piston head was a consequence of the failure of the small end assembly.

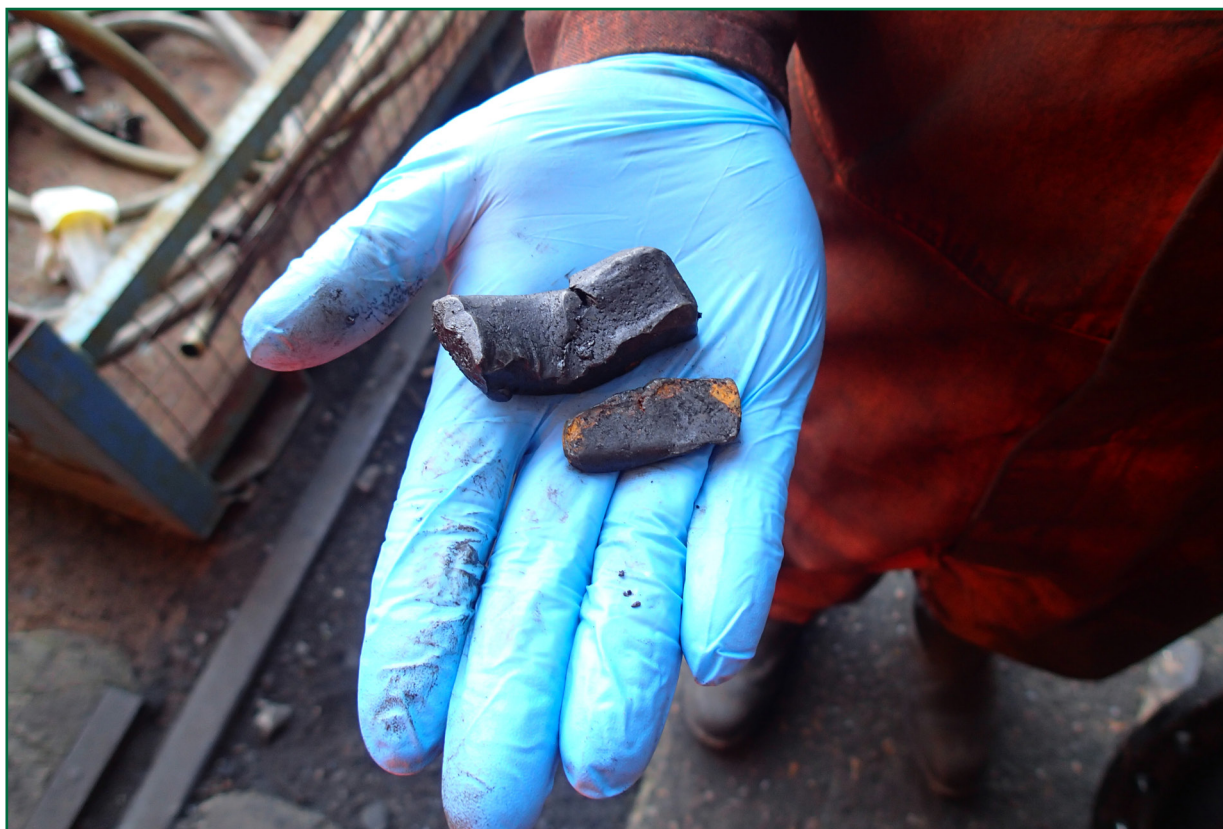
- 92 When the front cover of the right-hand cylinder of 'Tangmere' was removed at Southall depot after the accident, under the supervision of RAIB, the piston head was found to be loose on the piston rod. The piston head is held on a steep cone (tapered 1 in 2 on diameter) by a nut with a 2 $\frac{3}{4}$ " (70 mm) diameter thread, which is secured by a split cotter in a $\frac{1}{4}$ " (6 mm) slot in the end of the rod.
- 93 The remains of part of the cotter were found in the cylinder (figures 9 and 10). The body of the cotter and one of the legs were present, though detached, and the other leg could not be found.

Figure 10: Remains of cotter from piston rod

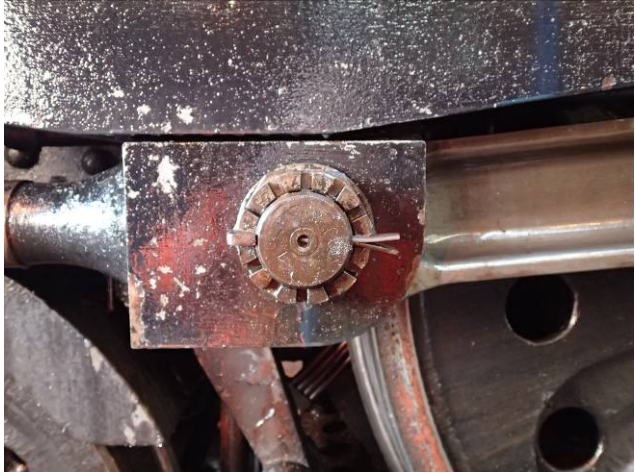
2. URGENT SAFETY ADVICE	
USA DATE:	17 March 2014
TITLE:	Detail design of cotters
SYSTEM / EQUIPMENT:	Connecting rod small end assembly
SAFETY ISSUE DESCRIPTION:	Possible design/manufacture deficiency
CIRCUMSTANCES:	<p>The small end assembly came apart while the locomotive was travelling at about 40 mph. The reasons for the failure have not been fully established because the nut and cotter which secure the gudgeon pin in the crosshead have not been located following the incident.</p> <p>Analysis of the possible failure mechanisms suggests that the most likely sequence of events involved the detachment of the cotter, leading to the detachment of the nut. Examination of the components from the other side of the locomotive found that the cotter was made from a single piece of steel bar 5/16" (8 mm) thick, with a saw cut up the centre to form the 'legs' of the cotter. The cotter was 5" (127 mm) long, and the saw cut was approximately 1" (25 mm) deep.</p>

<p>As installed, this meant that the legs of the cotter were bent outwards at the root of the saw cut (see photo), potentially giving rise to stress concentration in that area. It is not possible to be certain that this contributed to any failure of the cotter, but it represents poor practice in the design and manufacture of the component.</p>

REASONS FOR ISSUE:	<p>To alert owners and operators of steam locomotives to risks arising from the methods of manufacture and inspection of cotters used to secure small end nuts and other assemblies, and the need to assess the risks associated with design changes that may be introduced during restoration or overhaul.</p>
