# Rail Accident Report

## **Collision between a train and a car at Jetty Avenue level crossing, Woodbridge, Suffolk 14 July 2013**

This report is published by the Rail Accident Investigation Branch, Department for Transport.

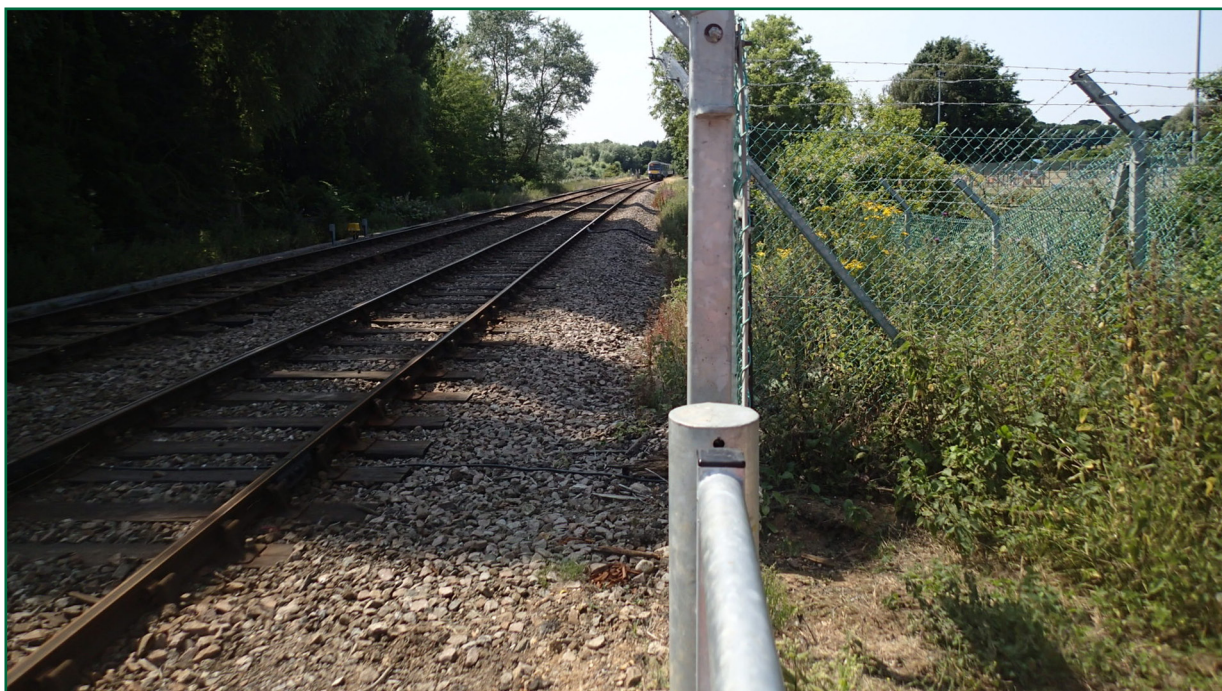
- 16 Jetty Avenue level crossing is classified as a user worked crossing (UWC) and is intended for use by road vehicles belonging to, or having business with, an authorised user. The UWC is fitted with a 5 metre wide metal vehicle gate on each side of the railway which the road user is required to open and close on foot (refer to paragraph 33). There is a parallel footpath crossing, provided with a metal pedestrian wicket gate adjacent to each vehicle gate (figure 4). On the down side of the railway (ie the west side from which the car approached in this instance), the vehicular gate is positioned 1.9 metres from the nearest rail where the railway corridor locally narrows (figure 3).

Figure 2: View from the west (down) side of Jetty Avenue level crossing looking south towards down direction trains

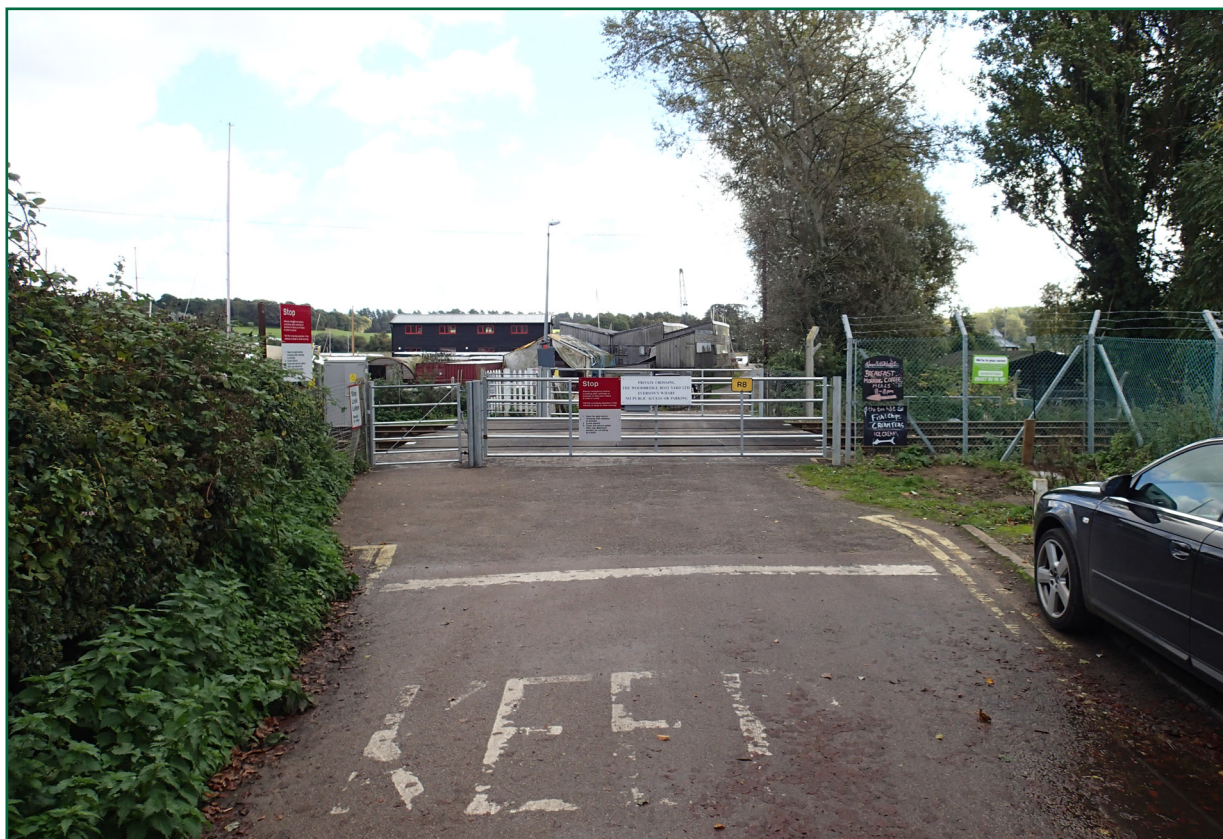
Figure 4: View approaching crossing from the west in direction that car was travelling

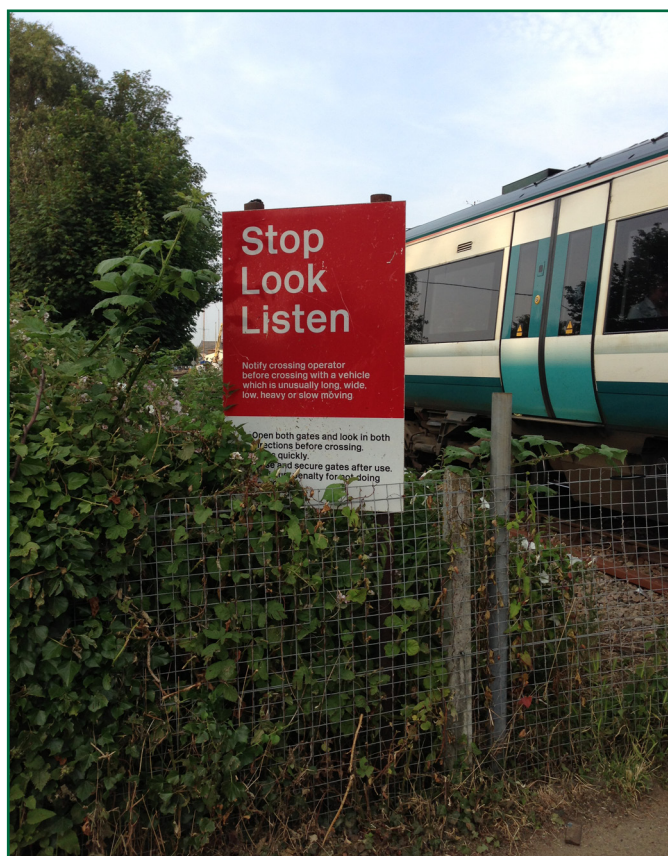
- 17 A sign at the crossing, partly obstructed by vegetation (figure 5), instructed vehicle users to:

Figure 5: 'Stop Look Listen' sign to car driver's left  
(photograph courtesy of Network Rail)

- 66 A vehicle driver stopping behind the sign in the manner of a normal road 'stop' sign would have found it difficult to see approaching trains from either direction due to vegetation and other obstructions (figures 5 and 10).

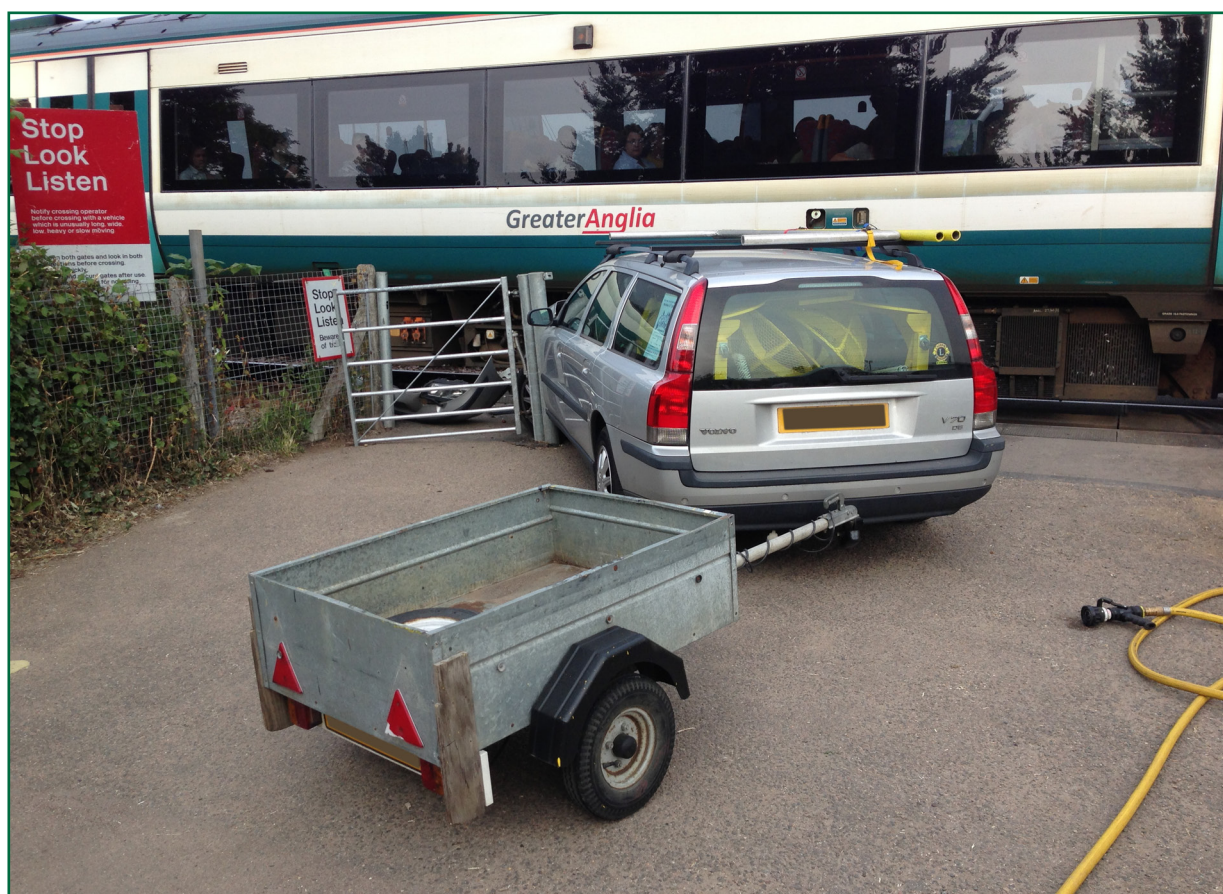
Figure 6: Collision between car and train (photograph courtesy of Network Rail)

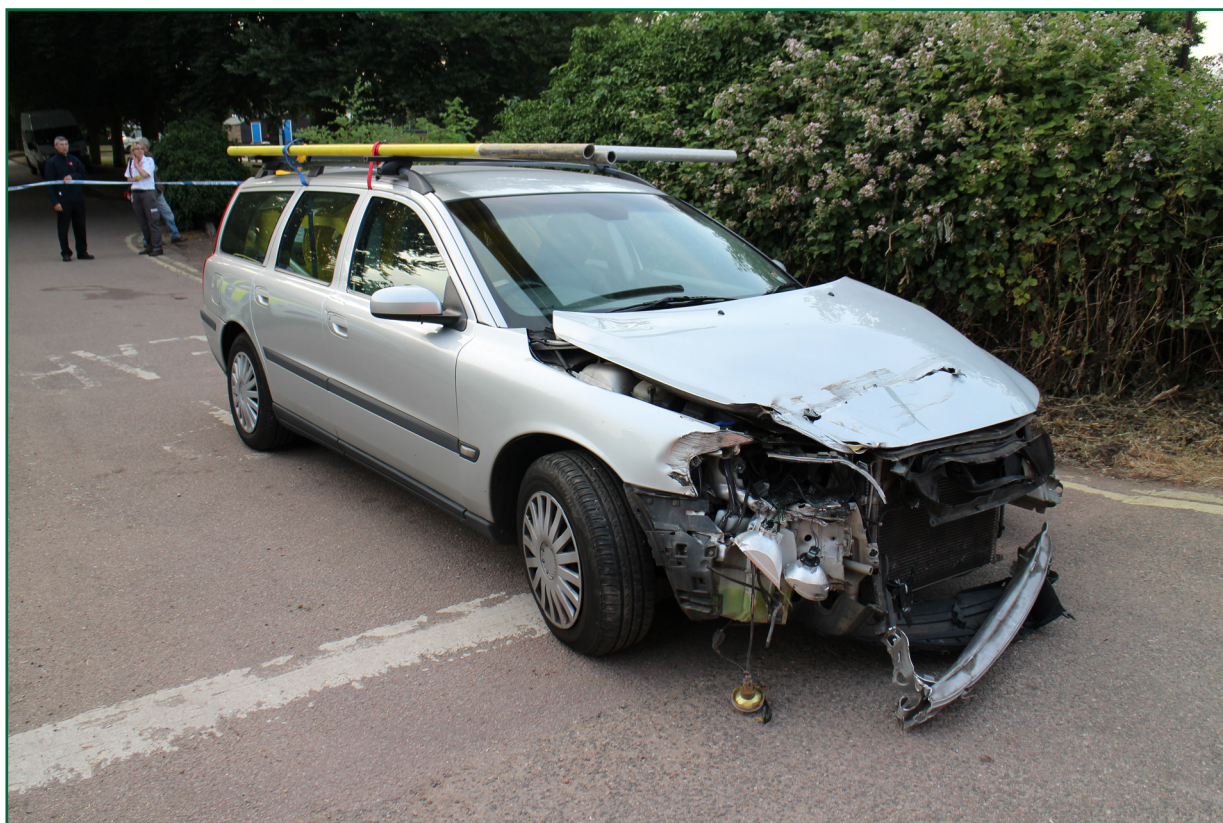
- 31 Minor damage was caused to the train, but the car was seriously damaged and the car driver suffered minor injuries.

Figure 7: Damage to front of car (photograph courtesy of Network Rail)

- 61 Damage to the front of the car (figure 7) indicates that the first 0.5 metres of the car was foul of the train at the moment of collision. As the car did not reverse and the train overhung the rail by about 0.5 metres (paragraph 47), this indicates that the front bumper of the car had stopped approximately above the first rail encountered by the car (figure 12). The car driver's viewing (eye) position was between 2.1 and 2.4 metres behind the front bumper (depending on whether he was leaning forwards in his seat).

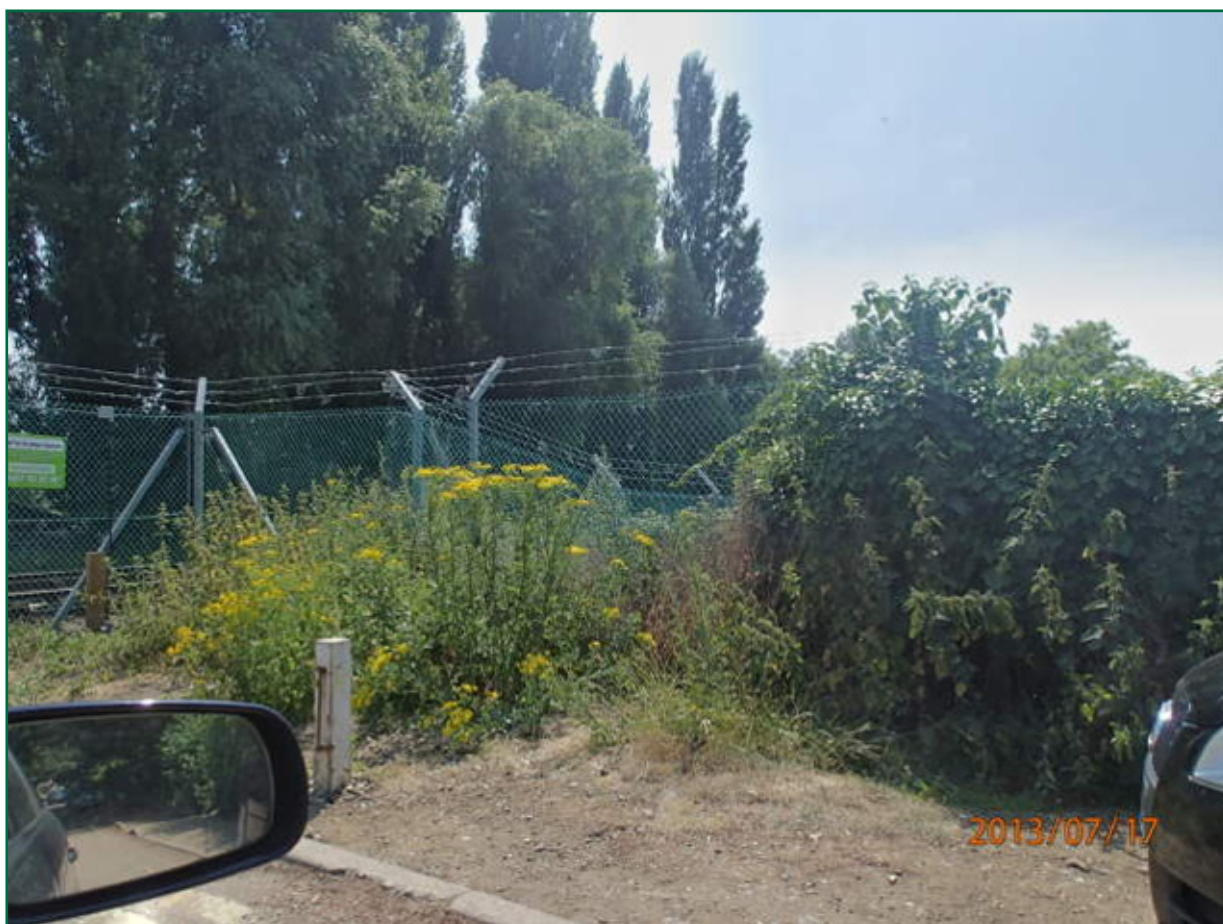
Figure 9: Car driver's view from behind stop line, 8 metres from the nearest rail

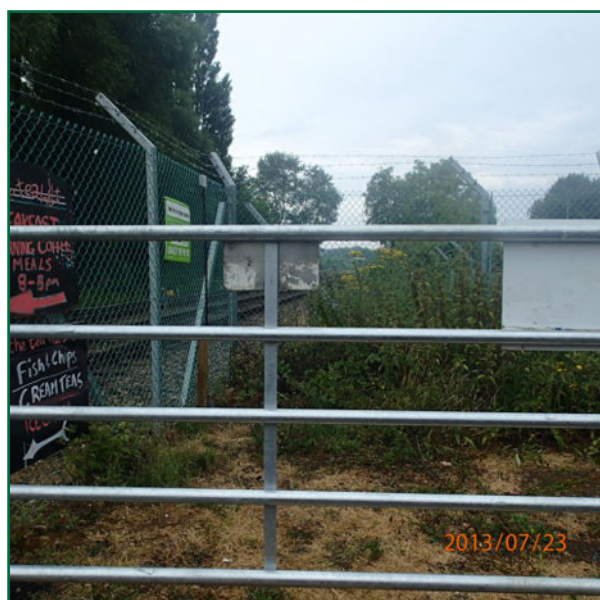
Figure 10: Car driver's view of railway approximately 4 metres from the nearest rail

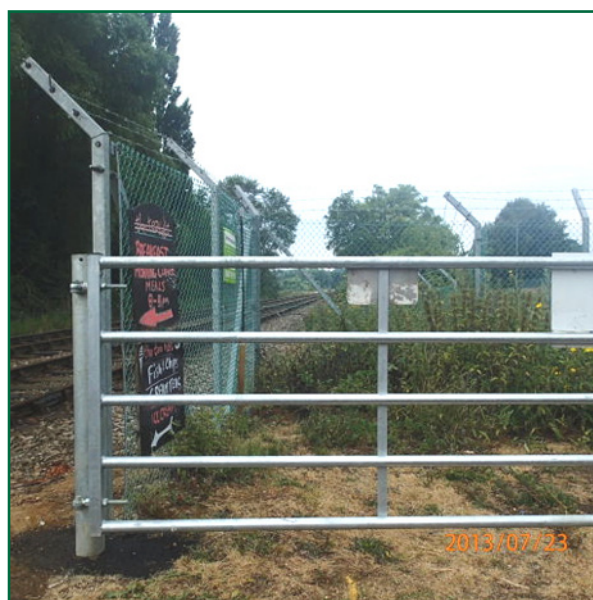
Figure 11: Car driver's view of railway approximately 3 metres from the nearest rail
