THE DUTCH
SAFETY BOARD

Train collision at Barendrecht,
24 September 2009

The Hague, January 2011

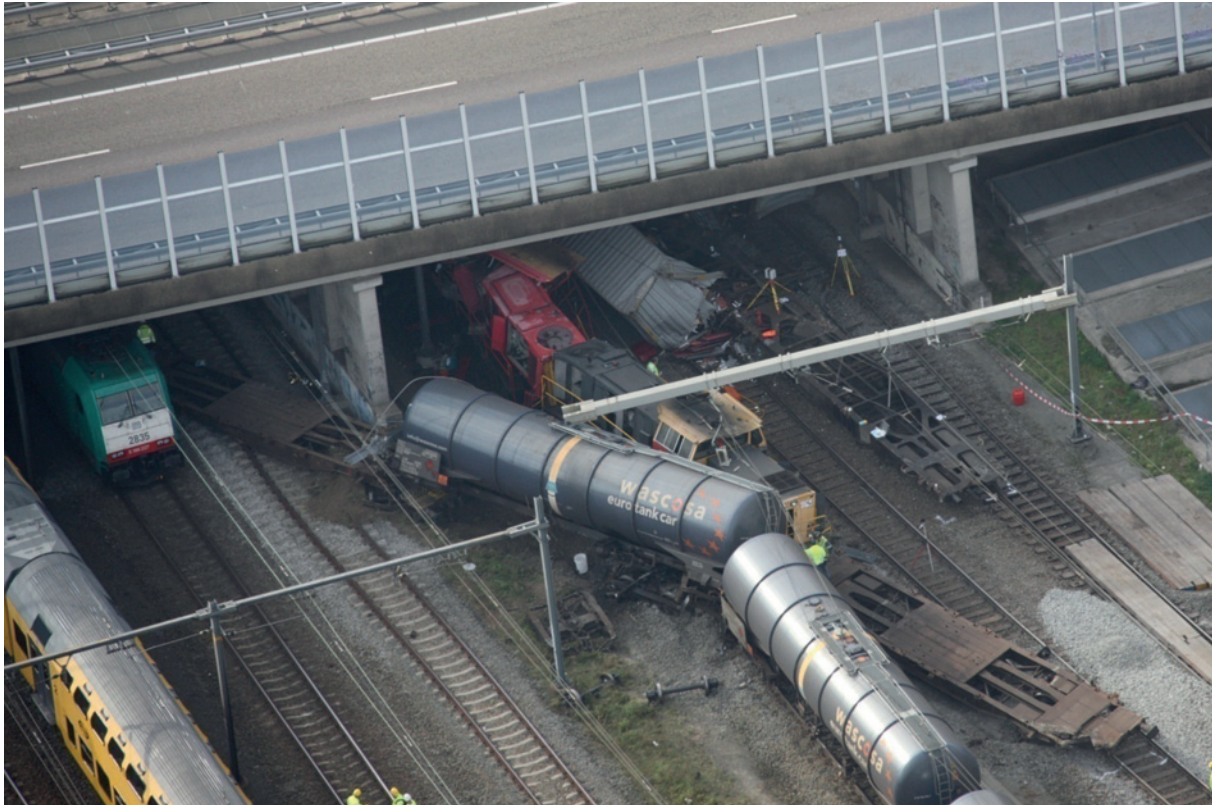
Figure 1: Aerial photo of the train collision at Barendrecht (source: KLPD, the Dutch National Police Services Agency).

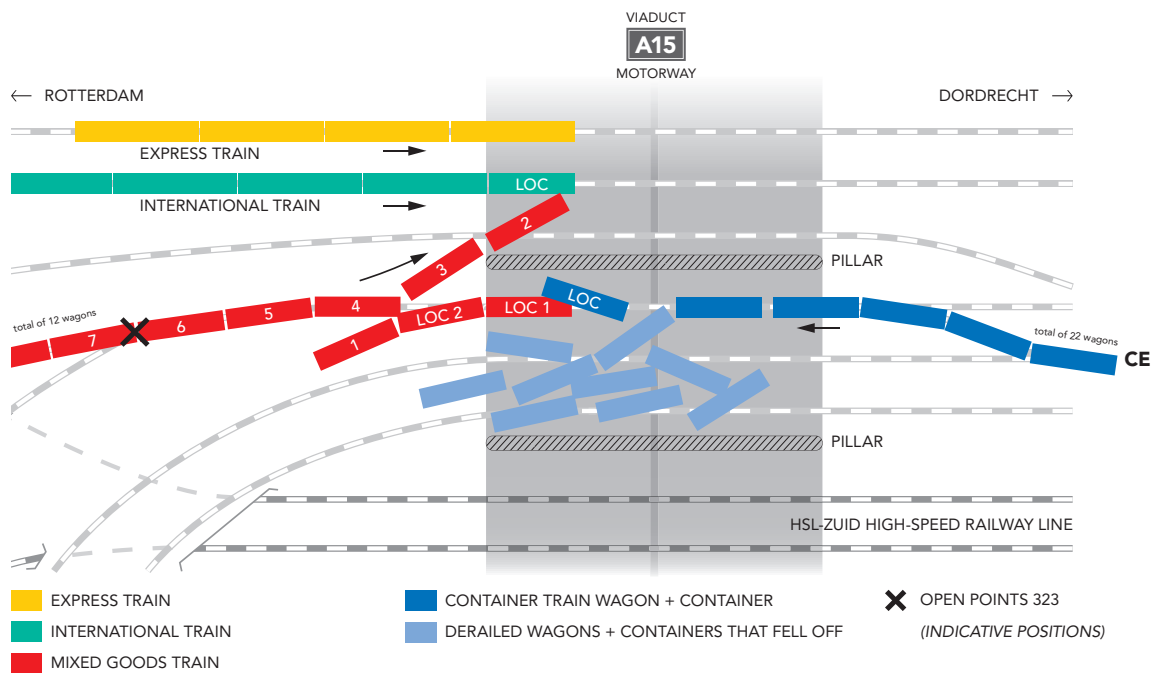
After the collision the two goods train continued about fifty metres in the direction in which the container train had been travelling. The collision forced the locomotive of the container partly over the front locomotive of the mixed goods train, as a result of which the two locomotives of the mixed goods train (see Figure 5) and the locomotive of the container train suffered extremely severe damage. The driver of the mixed goods train was killed in the collision and the driver of the container train was severely injured.

Three wagons of the container train derailed to the left and ended up on the adjacent tracks. The two locomotives of the mixed goods train were derailed together with the first three wagons (two empty container wagons and a tanker wagon filled with a flammable compound). The derailed tanker wagon came to rest a few metres from a pillar of the viaduct carrying the A15 motorway. One of the empty container wagons of the mixed goods train came to rest on the adjacent passenger train track and was hit at low speed by the international passenger train. One of the 150 passengers in this train was slightly injured. Two small fires burnt briefly, probably due to natural gas condensate residues in the filling pipe of the front tanker wagon. Although this filling pipe was torn off in the collision the valve was not damaged (in accordance with the design). The integrity of the tank was not impaired by the collision.

Figure 4: Diagram of the situation after the collision

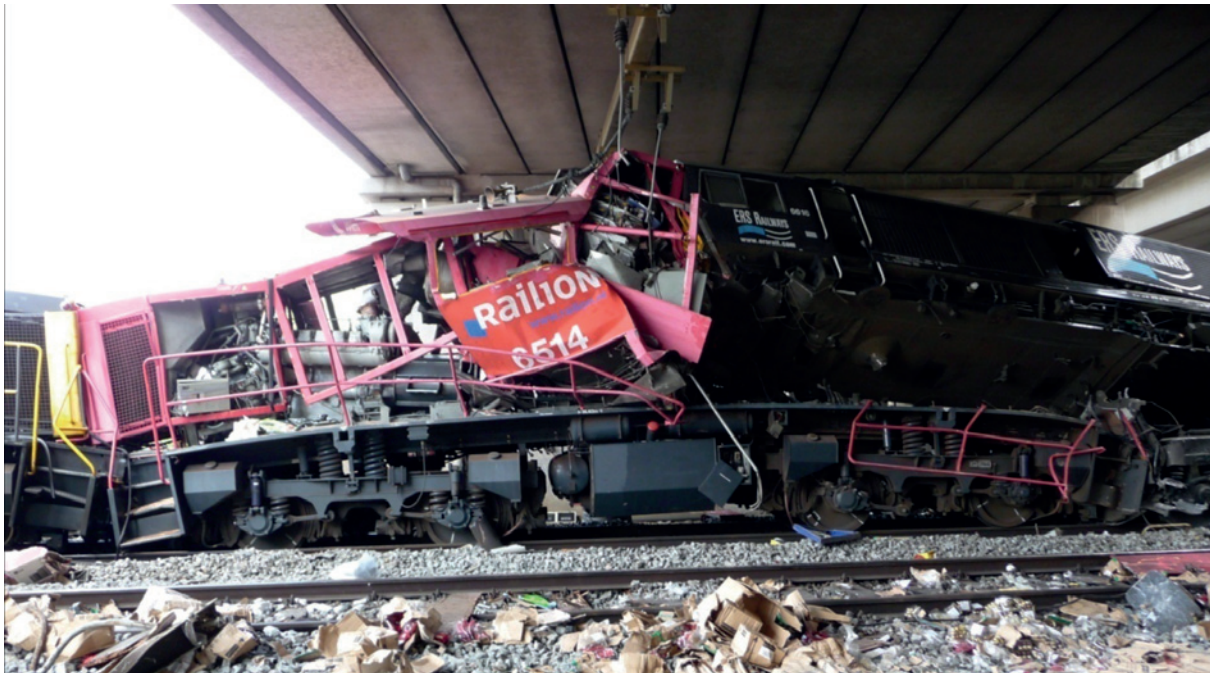
In addition to the considerable damage to the track, the overhead wire and the freight carried by one of the goods train the viaduct carrying the A15 motorway was also damaged. Since the consequences of this damage were initially unclear, road traffic over the viaduct was halted for a number of hours. After an assessment of the damage to the viaduct it was reopened to road traffic. Virtually no railway traffic was possible between Kijfhoek and the Port of Rotterdam during the four days after the accident. This had serious consequences for international goods transport, but passenger traffic suffered virtually no hindrance.

Figure 5: The damage to the locomotives of the two goods trains (in daylight)

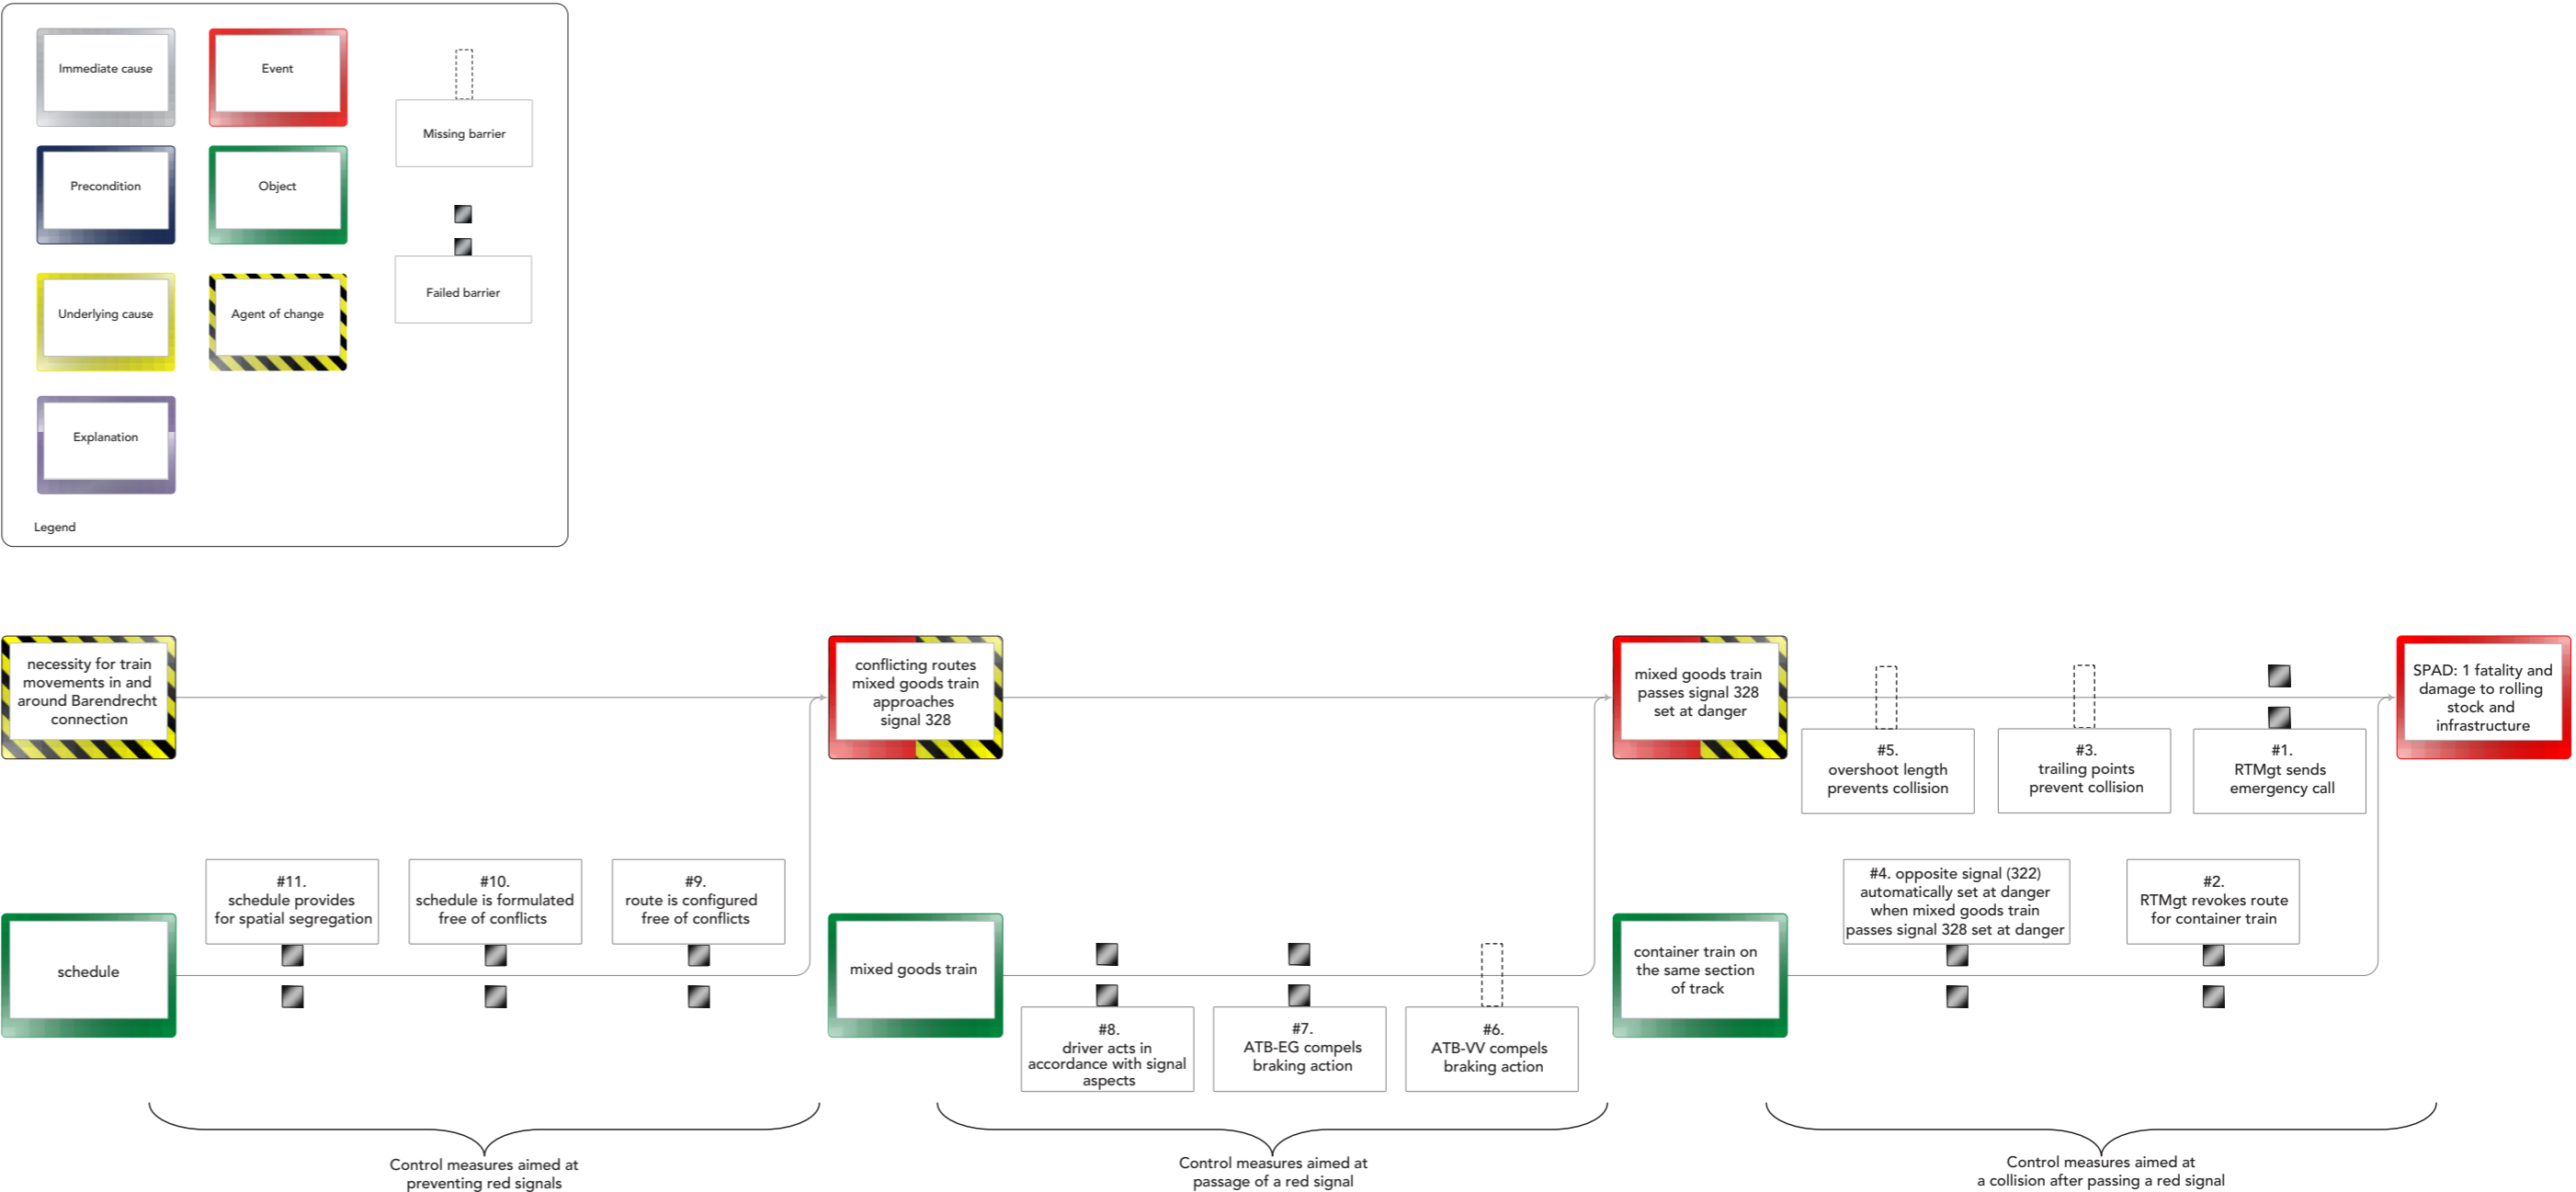
Figure 11: Causal model of collisions related to SPADs

Figure 11 shows the causal model and the barriers of relevance to this investigation.¹²⁴

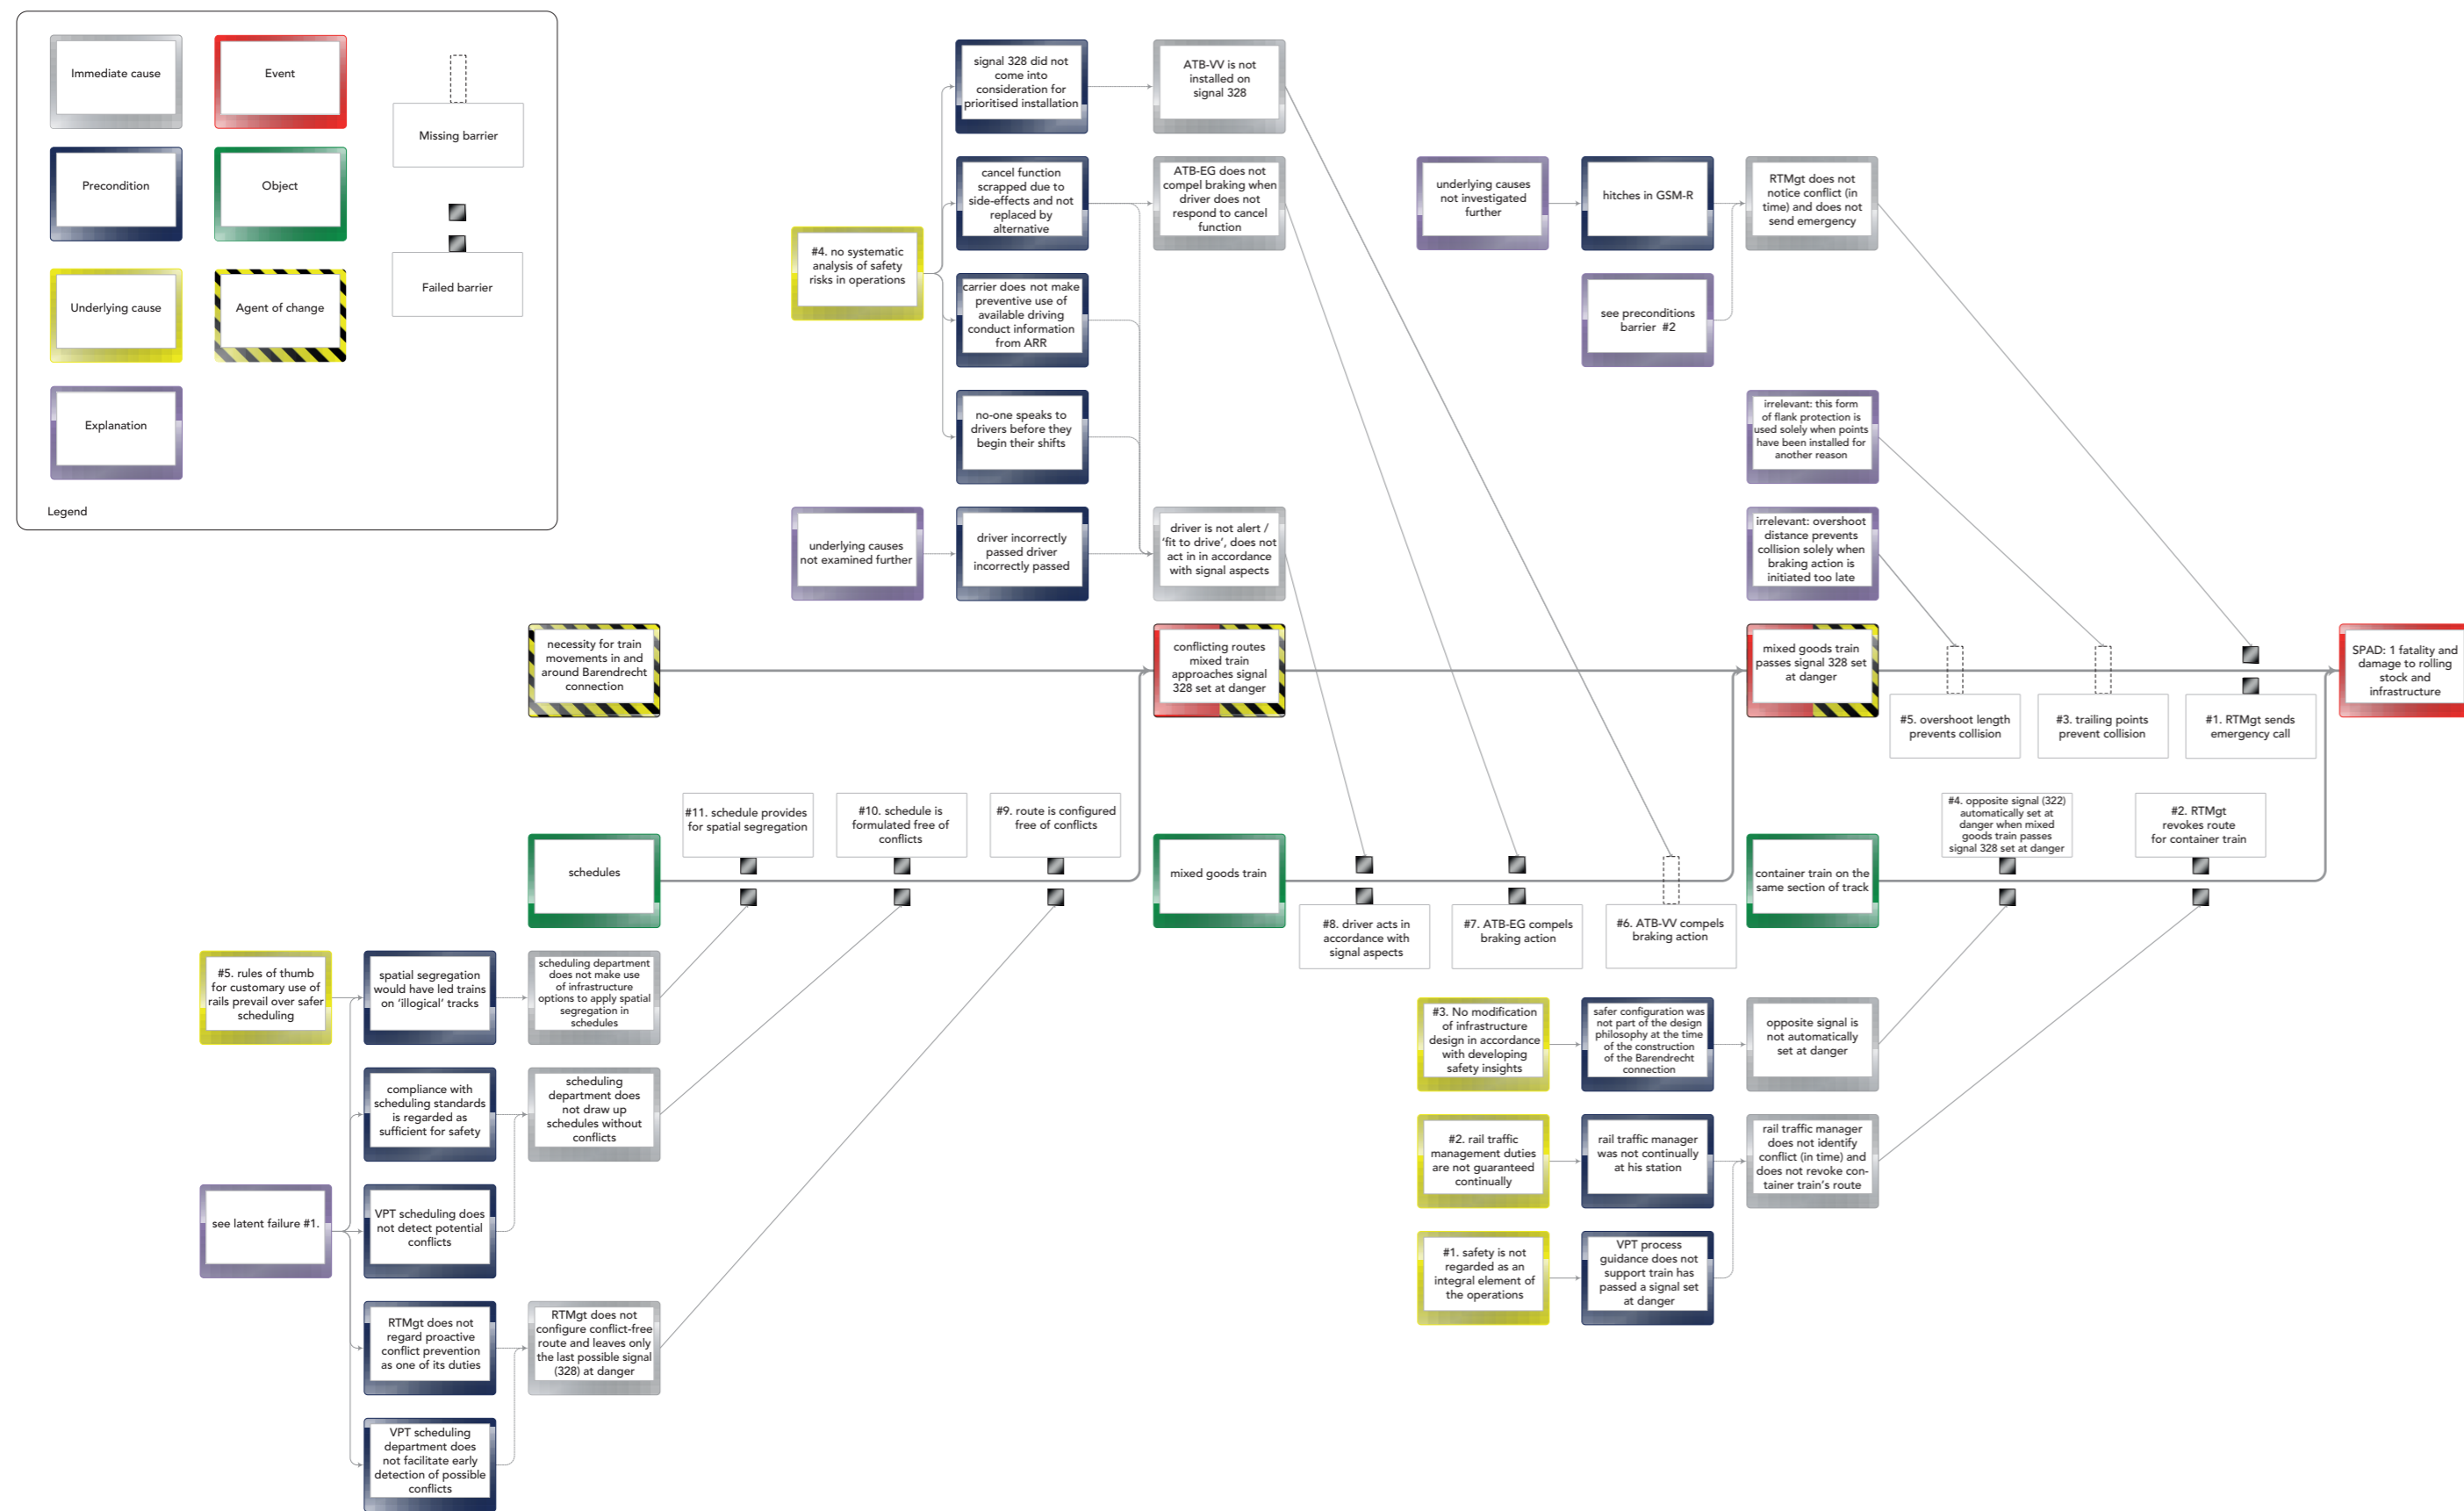
These were then investigated further using the Tripod method. This investigation revealed a number of preconditions¹²⁵ and underlying causes¹²⁶ that gave cause to the active failures that occurred. These are shown in Figure 12.

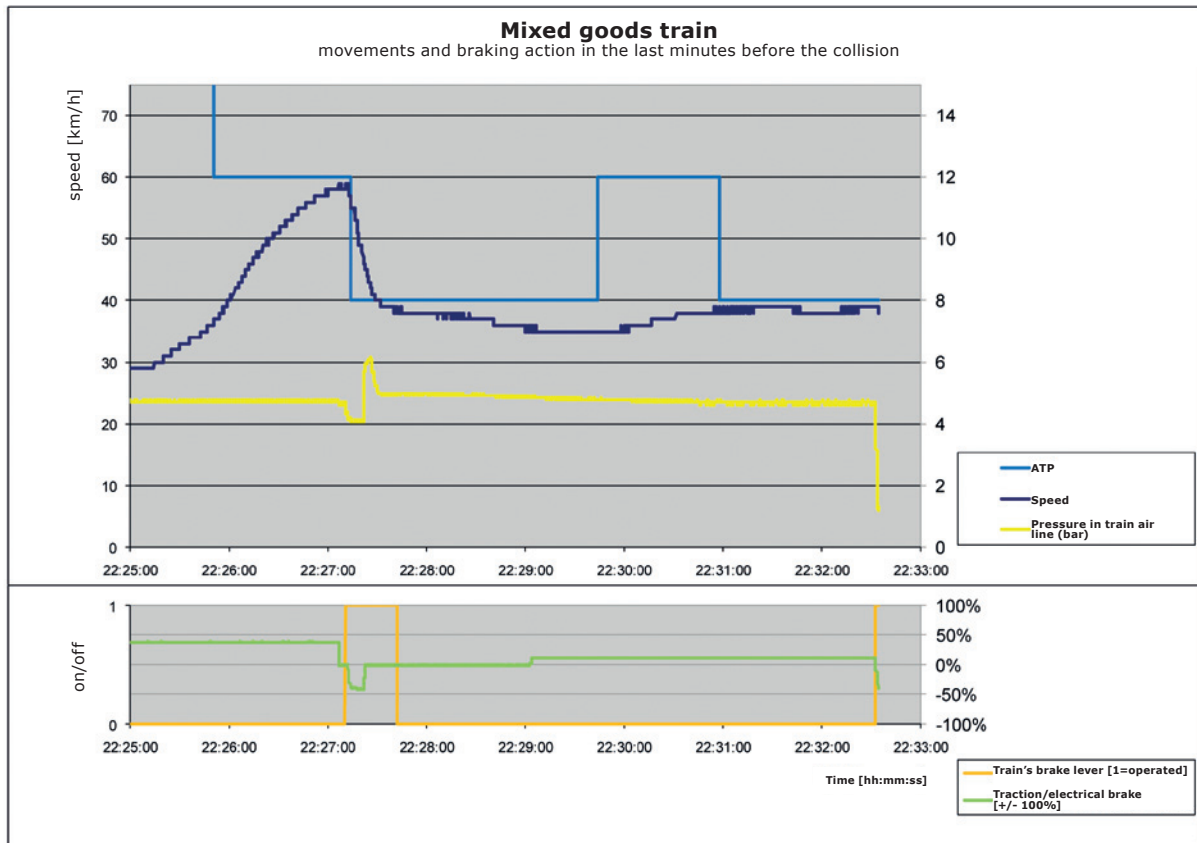
Figure 13 shows the speed of the mixed goods train in the last minutes before the accident. The driver reduced the speed to just under 40 km/hour at about 22:27 since the train needed to pass over the set of points in the IJsselmonde yard in the switch position. The train's speed subsequently remained approximately constant. The ATP code changed from yellow to yellow 6 at about 22:29:40 and the driver slightly increased the train's speed. The ATP code changed back from yellow 6 to yellow at about 22:31:00, when the train passed signal P-852 set at caution. The driver kept the speed constant at about 39 km/hour. The driver operated the train's brake handle shortly before the collision, and the locomotive's brakes were also applied.

Figure 13: The mixed goods train's movements and braking actions in the minutes before the collision

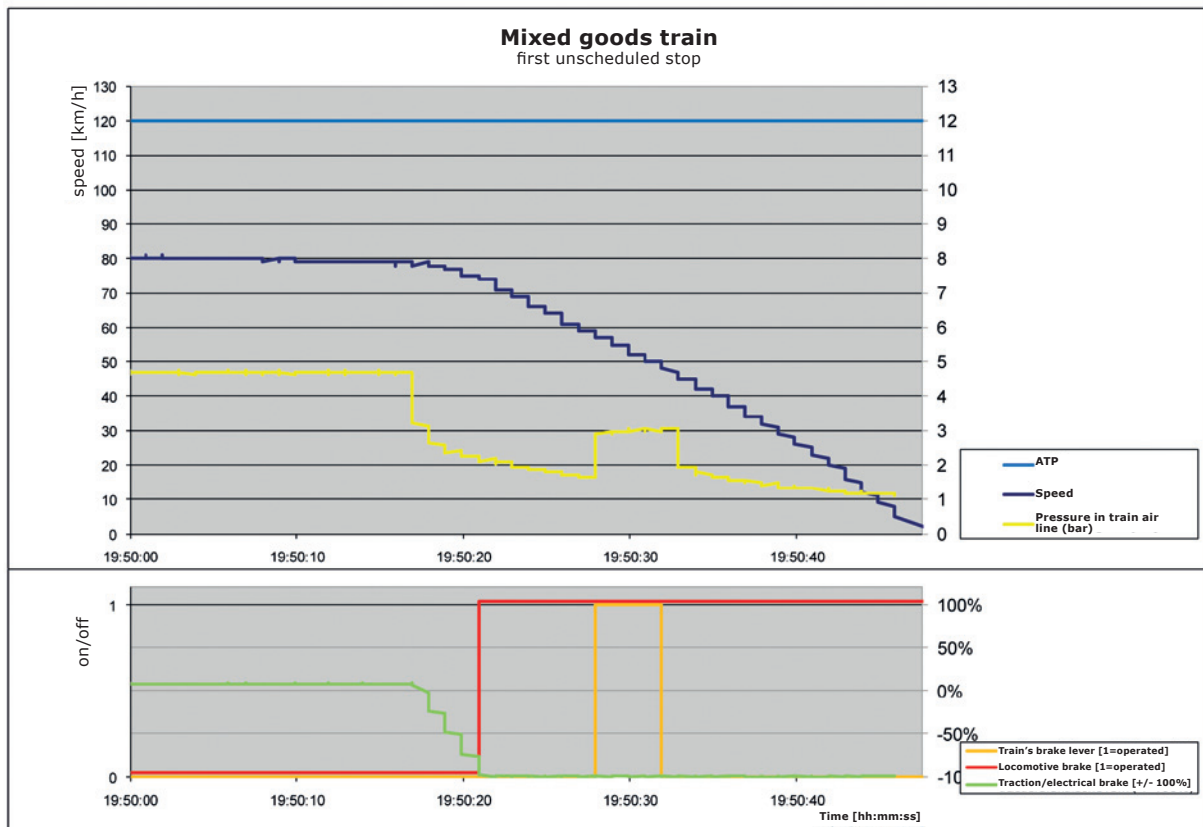
The mixed goods train was travelling between Nunspeet and Harderwijk at about 19:50 at a speed of approximately 80 km/hour when the braking system's air pressure fell away: the train's brakes were applied and the locomotive's electrodynamic brakes were fully applied (see Figure 14). This braking action was not initiated by the driver: he operated the brake lever more than 10 seconds later. The train continued to brake until it came to a standstill.

Figure 14: The mixed goods train's movements and braking actions at about 19:50

The maximum speed was not transgressed and there was no ATP code malfunction in either of these instances. Since no message was sent about a malfunction the most probable cause of these braking actions was an intervention by the dead man's system. The automatic trip registration does not include records of an intervention by the dead man's system as such. Any such intervention can be derived solely from the other data.

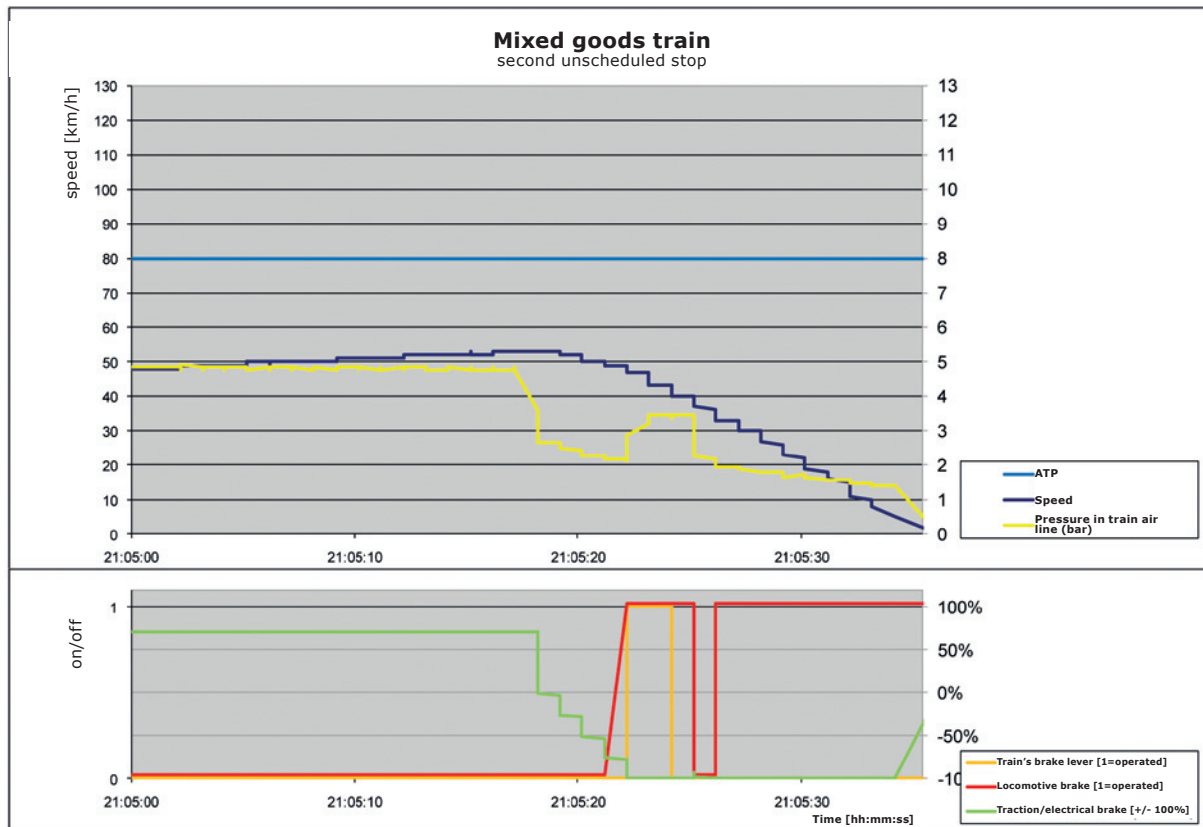
A similar braking action occurred at about 21:05 (Figure 15).

Figure 15: The mixed goods train's movements and braking actions at about 21:05

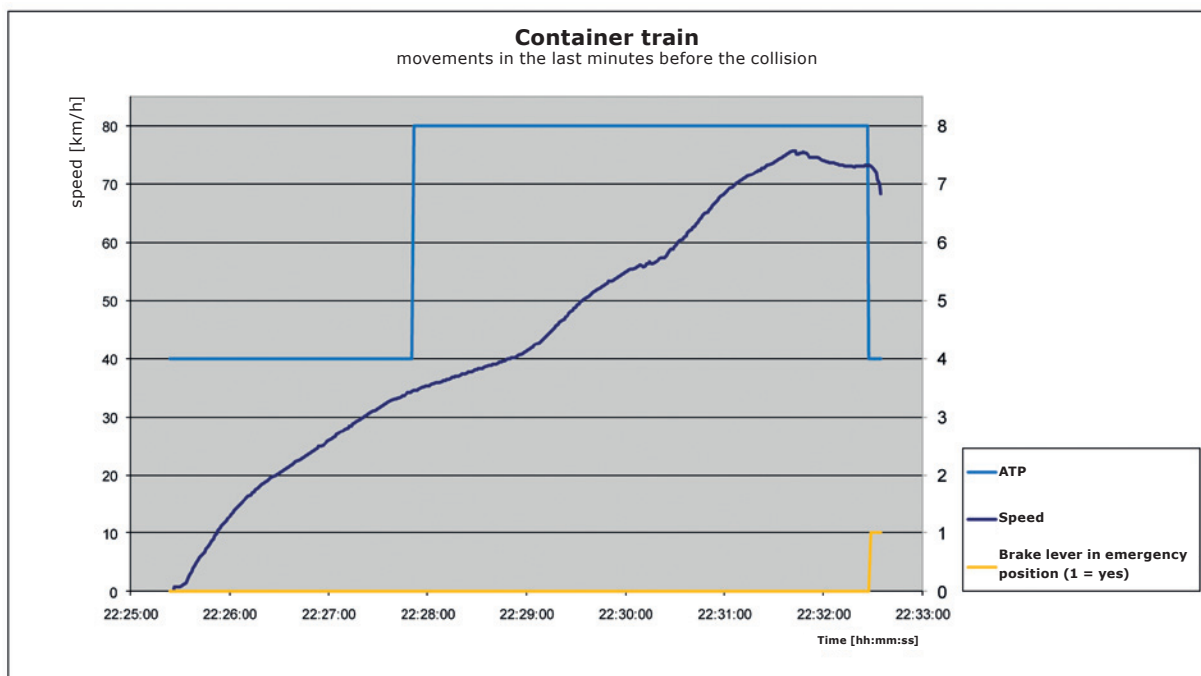
Figure 16 shows the speed of the container train in the last minutes before the accident. After its departure from Kijfhoek the train accelerated until it reached a speed of between 70 and 80 km/hour about one minute before the collision. At 22:32:28 the ATP indicated that the container train's route was no longer free. The driver initiated an emergency braking action one second later. It is not possible to determine from the data whether this emergency braking action was in response to the ATP message or was due to the driver seeing the train approaching him on the same track. The emergency braking action resulted in the rapid decrease of the train's speed from 73 km/hour to 68 km/hour.

Figure 16: The container train's movements and braking actions in the minutes before the collision
