THE DUTCH
SAFETY BOARD

Train collision at Barendrecht,
24 September 2009

The Hague, January 2011

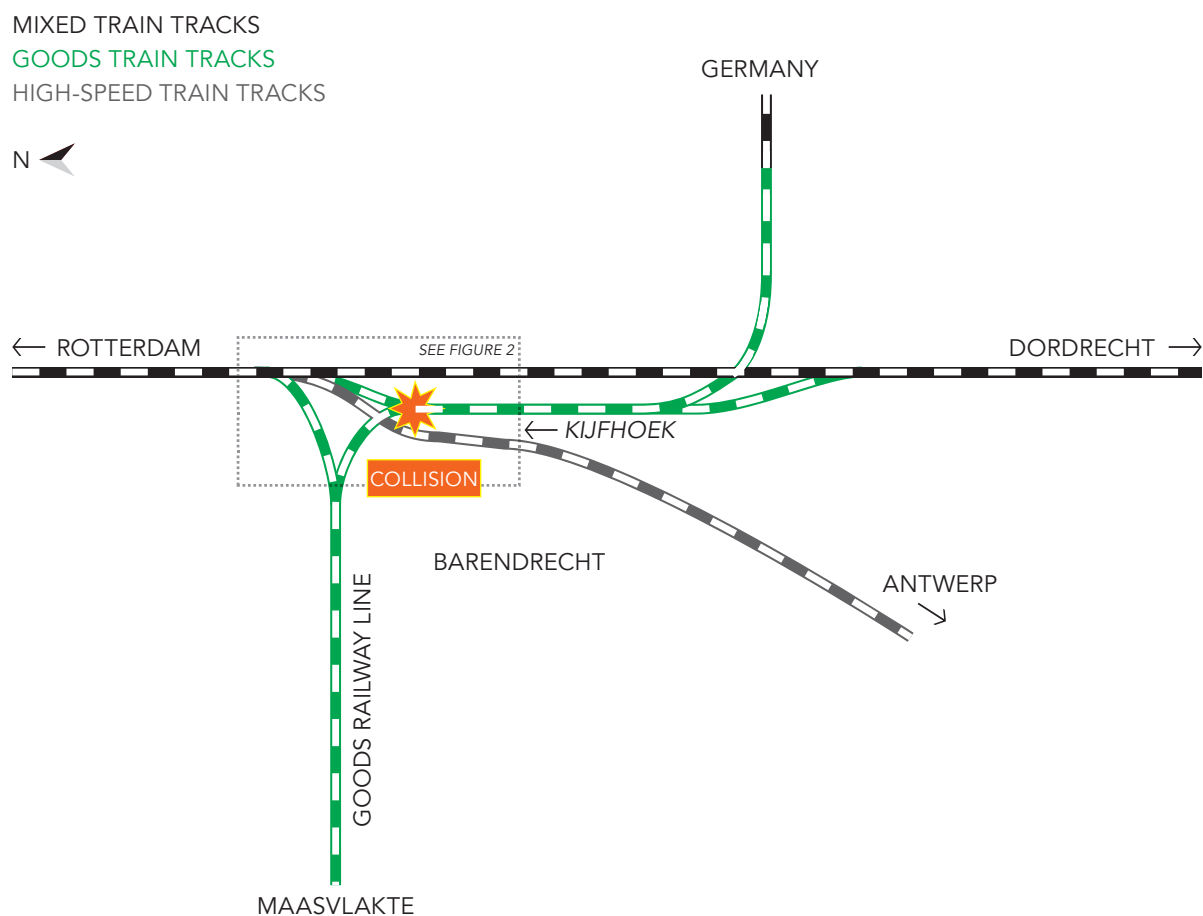
Figure 3: The railway tracks at the location of the collision

The location of the train collision is a busy and complex junction that was designed in its current form in the nineteen-nineties. The construction of the Betuweroute goods railway line and the HSL-Zuid high-speed passenger railway lines gave cause to the modernisation of the node, which included the construction of a number of connecting tracks and fly-overs³⁷. This location accommodates three tracks for goods trains from and to the Port of Rotterdam and four tracks for passenger trains. At the point where the collision occurred the HSL-Zuid high-speed passenger railway crosses the goods railway lines and the A15 motorway passes overhead on a viaduct.

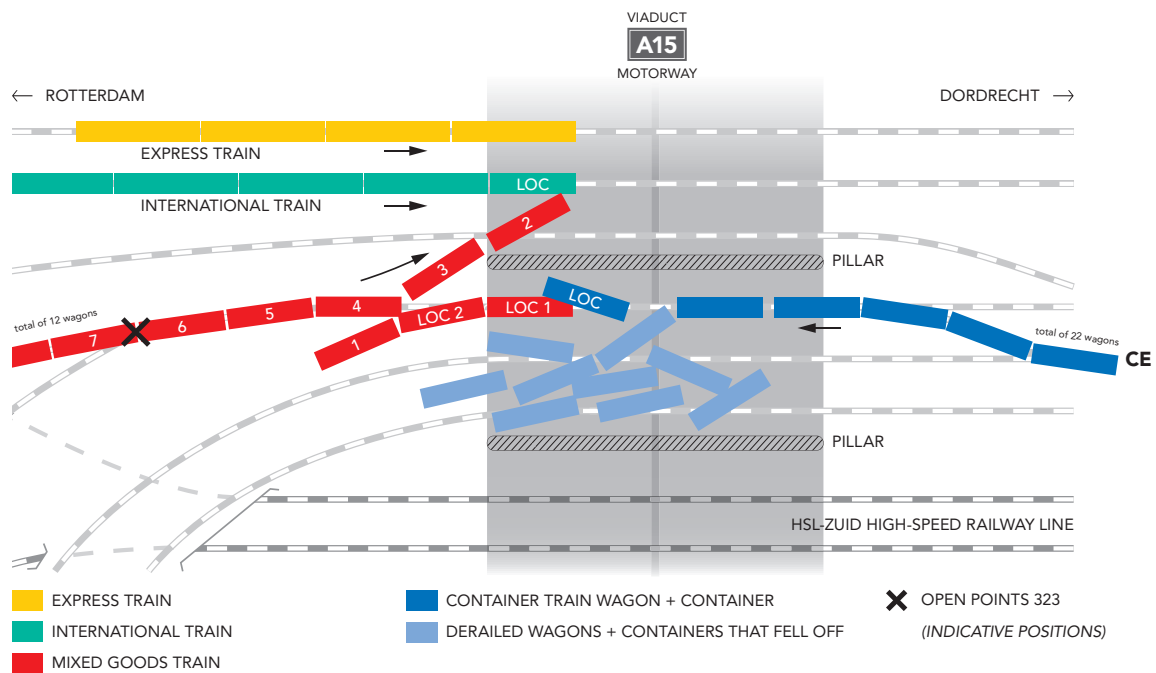
Figure 4: Diagram of the situation after the collision

After the collision the two goods train continued about fifty metres in the direction in which the container train had been travelling. The collision forced the locomotive of the container partly over the front locomotive of the mixed goods train, as a result of which the two locomotives of the mixed goods train (see Figure 5) and the locomotive of the container train suffered extremely severe damage. The driver of the mixed goods train was killed in the collision and the driver of the container train was severely injured.

Three wagons of the container train derailed to the left and ended up on the adjacent tracks. The two locomotives of the mixed goods train were derailed together with the first three wagons (two empty container wagons and a tanker wagon filled with a flammable compound). The derailed tanker wagon came to rest a few metres from a pillar of the viaduct carrying the A15 motorway. One of the empty container wagons of the mixed goods train came to rest on the adjacent passenger train track and was hit at low speed by the international passenger train. One of the 150 passengers in this train was slightly injured. Two small fires burnt briefly, probably due to natural gas condensate residues in the filling pipe of the front tanker wagon. Although this filling pipe was torn off in the collision the valve was not damaged (in accordance with the design). The integrity of the tank was not impaired by the collision.

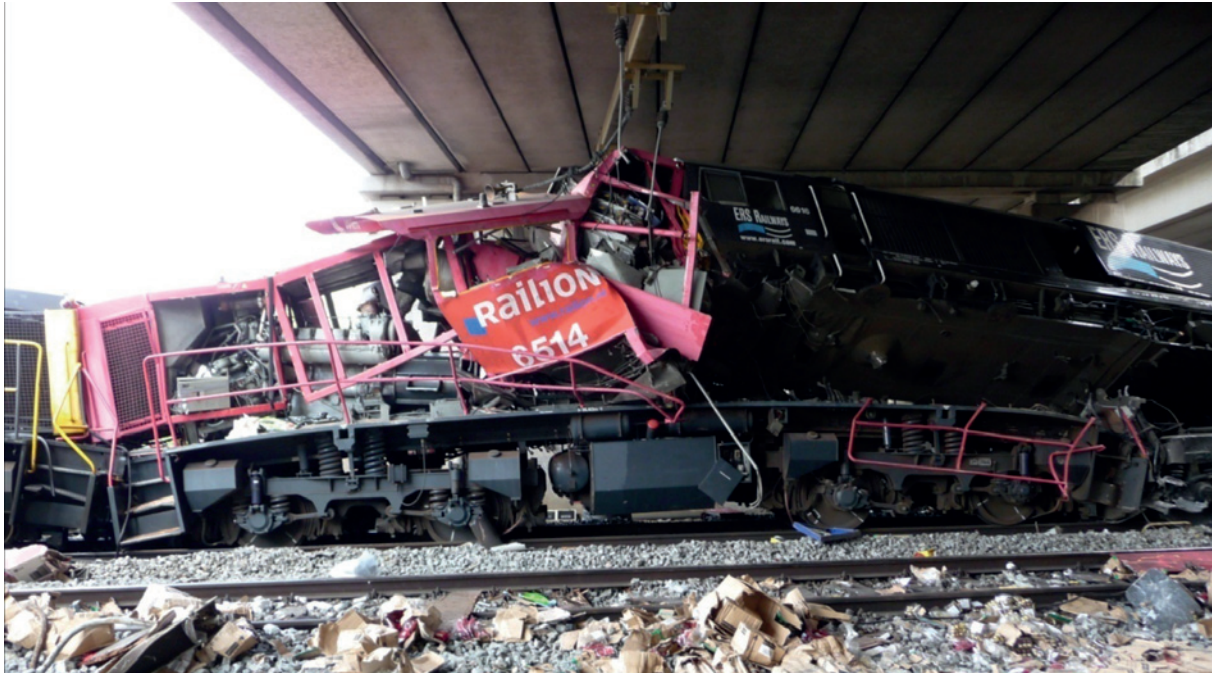
Figure 5: The damage to the locomotives of the two goods trains (in daylight)

In addition to the considerable damage to the track, the overhead wire and the freight carried by one of the goods train the viaduct carrying the A15 motorway was also damaged. Since the consequences of this damage were initially unclear, road traffic over the viaduct was halted for a number of hours. After an assessment of the damage to the viaduct it was reopened to road traffic. Virtually no railway traffic was possible between Kijfhoek and the Port of Rotterdam during the four days after the accident. This had serious consequences for international goods transport, but passenger traffic suffered virtually no hindrance.

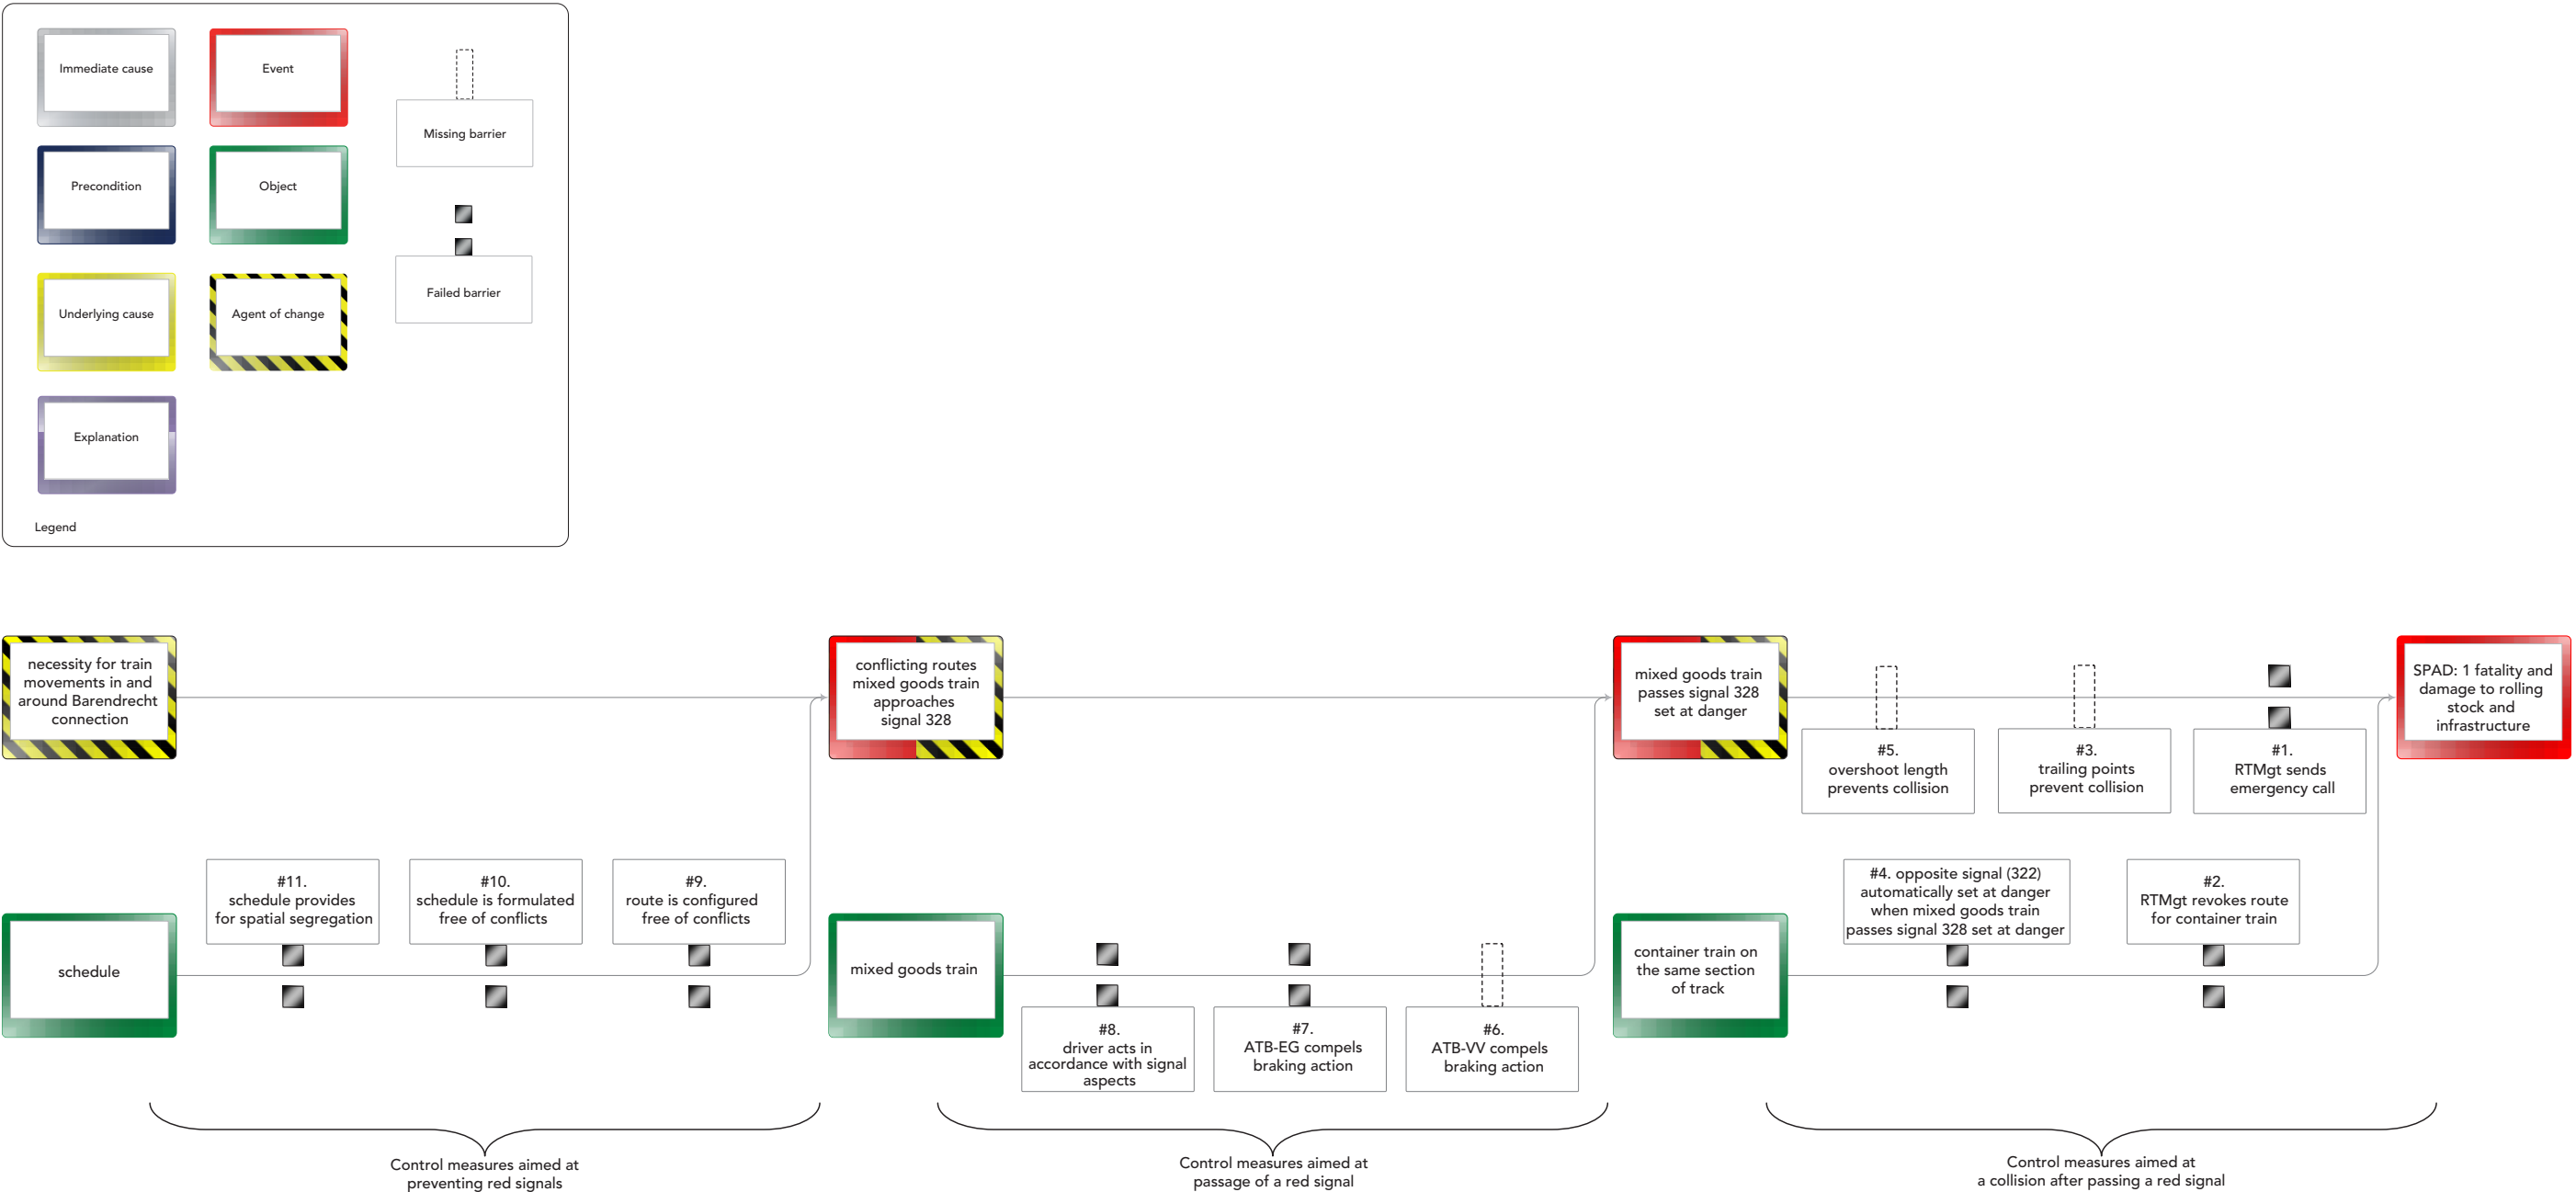
Figure 11: Causal model of collisions related to SPADs

The Tripod analysis was based on a causal model of collisions related to SPADs. This model was prepared using general knowledge about railway operations and data from earlier investigations carried out by the Dutch Safety Board. The model reveals that a collision related to a SPAD occurs in a three-phase process and that risk control measures can be implemented in each of those phases (see Section 5).

Figure 11 shows the causal model and the barriers of relevance to this investigation.¹²⁴

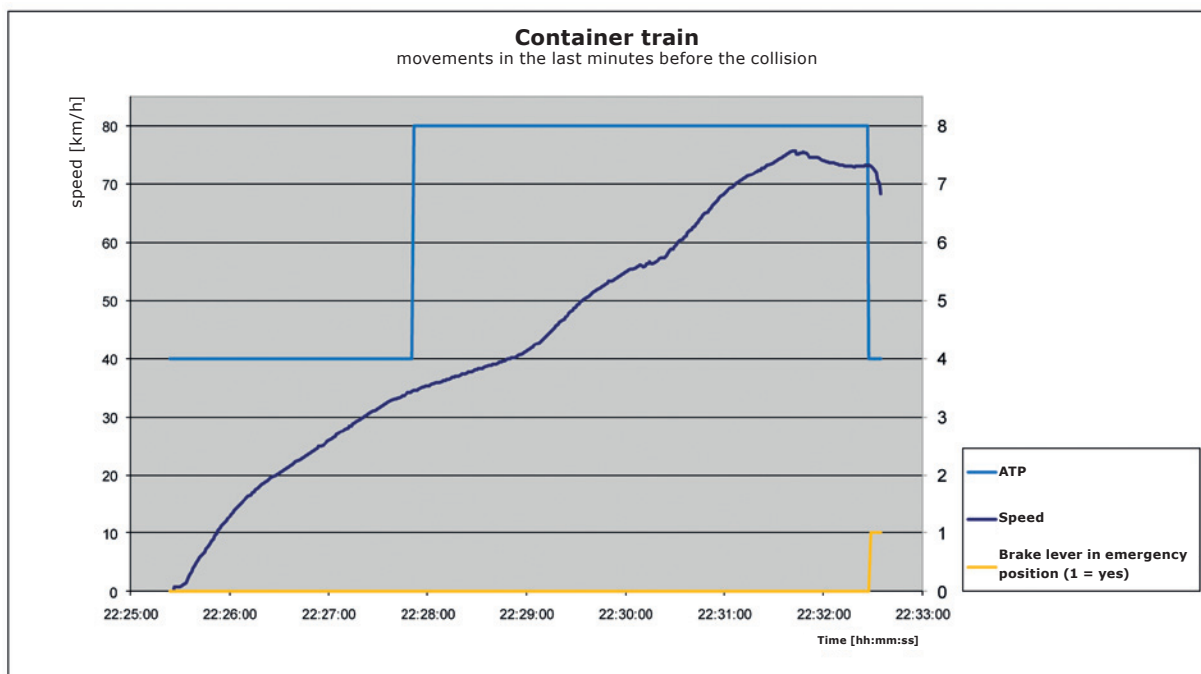
Figure 16: The container train's movements and braking actions in the minutes before the collision

Figure 16 shows the speed of the container train in the last minutes before the accident. After its departure from Kijfhoek the train accelerated until it reached a speed of between 70 and 80 km/hour about one minute before the collision. At 22:32:28 the ATP indicated that the container train's route was no longer free. The driver initiated an emergency braking action one second later. It is not possible to determine from the data whether this emergency braking action was in response to the ATP message or was due to the driver seeing the train approaching him on the same track. The emergency braking action resulted in the rapid decrease of the train's speed from 73 km/hour to 68 km/hour.
