**REPUBLIC OF BULGARIA**  
**NATIONAL AIR, MARITIME AND RAILWAY TRANSPORT, ACCIDENTS**  
**INVESTIGATION BOARD (NAMRTAIB)**

**FINAL REPORT**

**Investigation of railway accident – fire in locomotive № 91520044063-3, serviced passenger train  
№ 80132 in Yambol station on 20.07.2023**

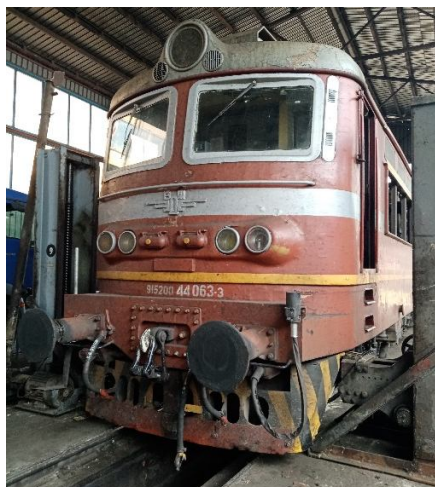
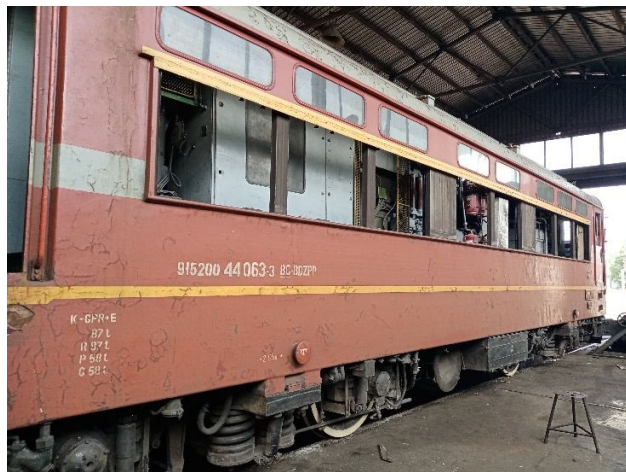
Damages were caused to the fired locomotive № 91520044063-3, which serviced PT № 80132 (fig. 1.2 and 1.3).

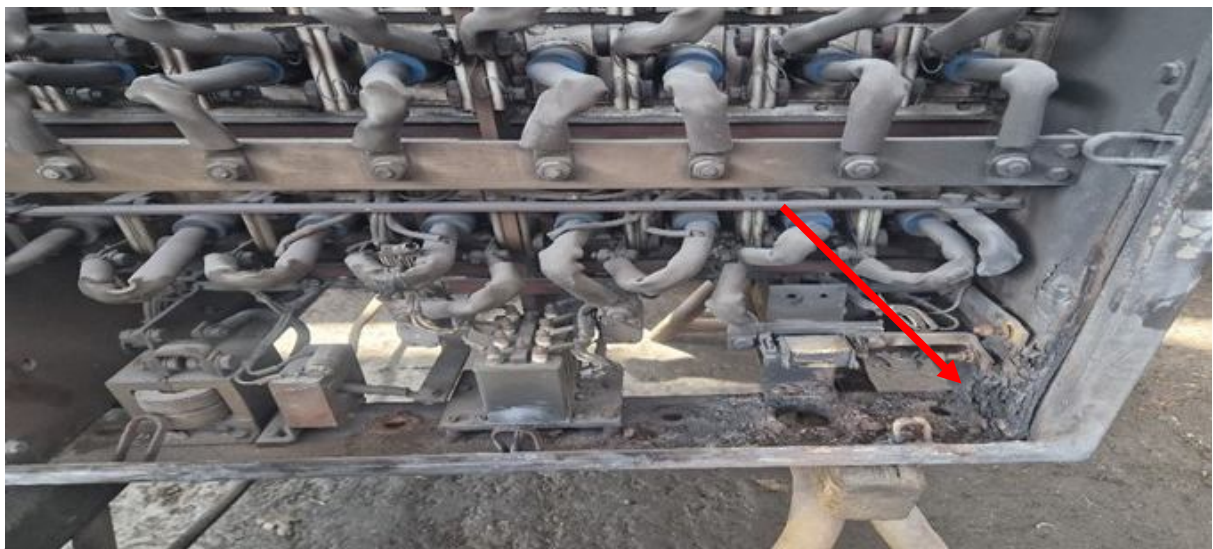
2. The burned traction rectifier 022 (fig. 4.8) in the area of the auxiliary rectifier 221 of engine compressor 235;

**Fig. 4.8. The burned traction rectifier 022.**

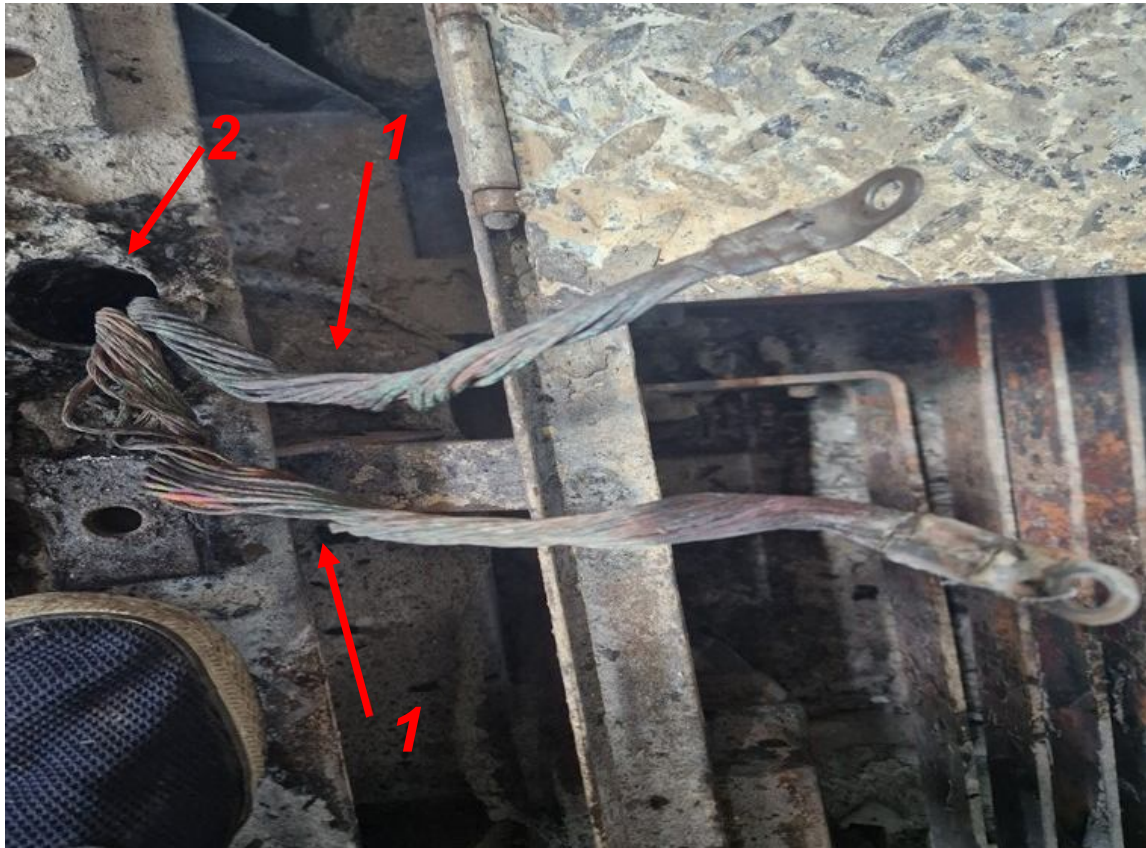
3. The burned insulation of power cables of second engine compressor 235 (fig. 4.9, pos. 1);

**Fig. 4.9. Power cables of second engine compressor 235.**

4. After dismantling of repair group 022 - a violation of the insulating pads of the bus bars of the second engine compressor was found. Mainly the power cable of the compressor engine and its protective fuse P7 were burnt (fig. 4.9, item 2).

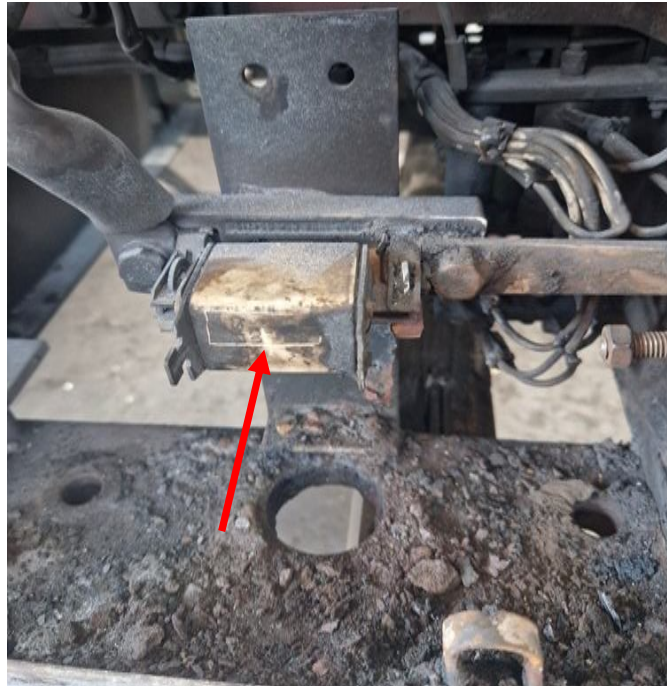
cables of the second compressor engine 235 were burnt and the presence of a loose connection from power fuse P7 to engine compressor 235 (fig. 4.12).

**Fig. 4.12. Protector P7 of the engine compressor.**

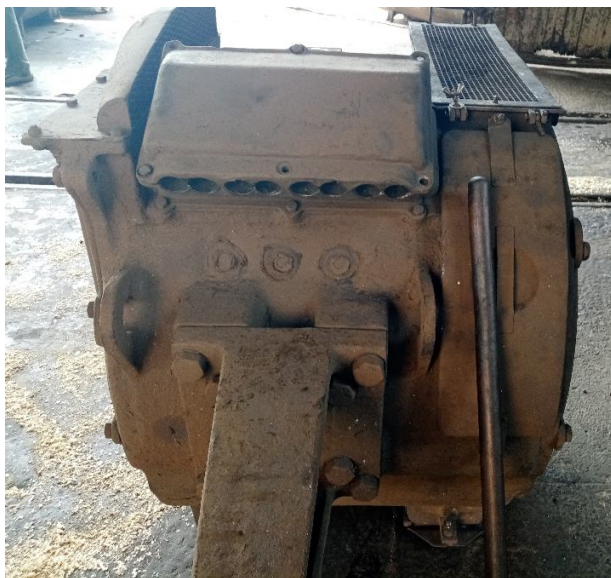
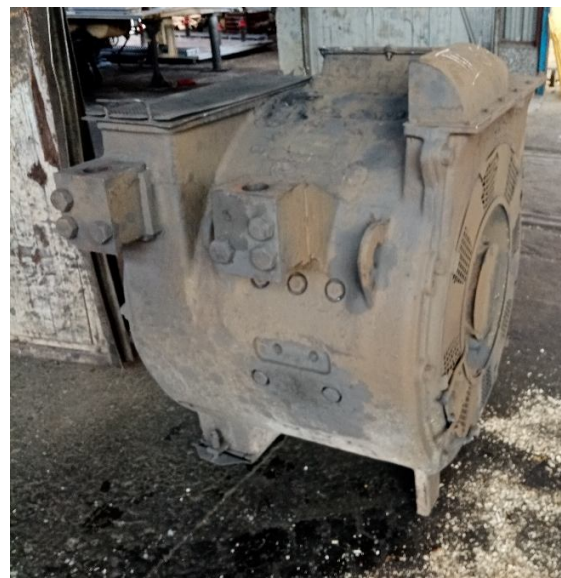
9. By Protocol 13 was checked compressor 235 and a low debit was found, broken valves, which led to continuous work of the engine compressor 235 and to burning of the power cables.
10. By Protocol 14 was established that the integrity of the power cables of third traction engine was not interrupted (fig. 4.13 and 4.14).

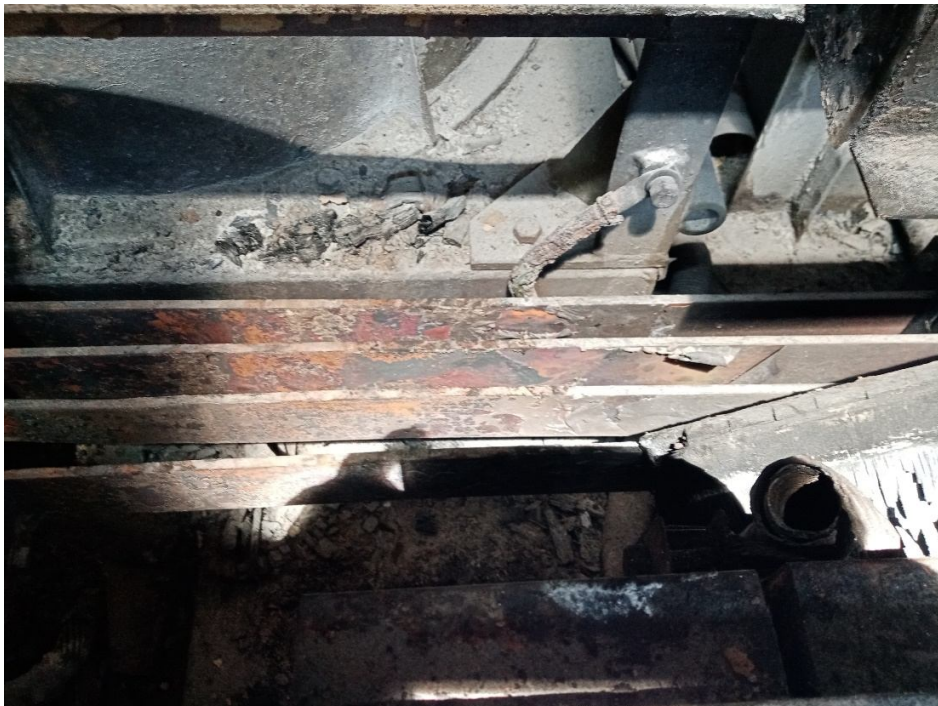
**Fig. 4.18.**

There was established a modification in the colour of the current leading bus bars to the interim terminal board of third traction engine, which could be one of the causes for the ignition (Fig. 4.18).

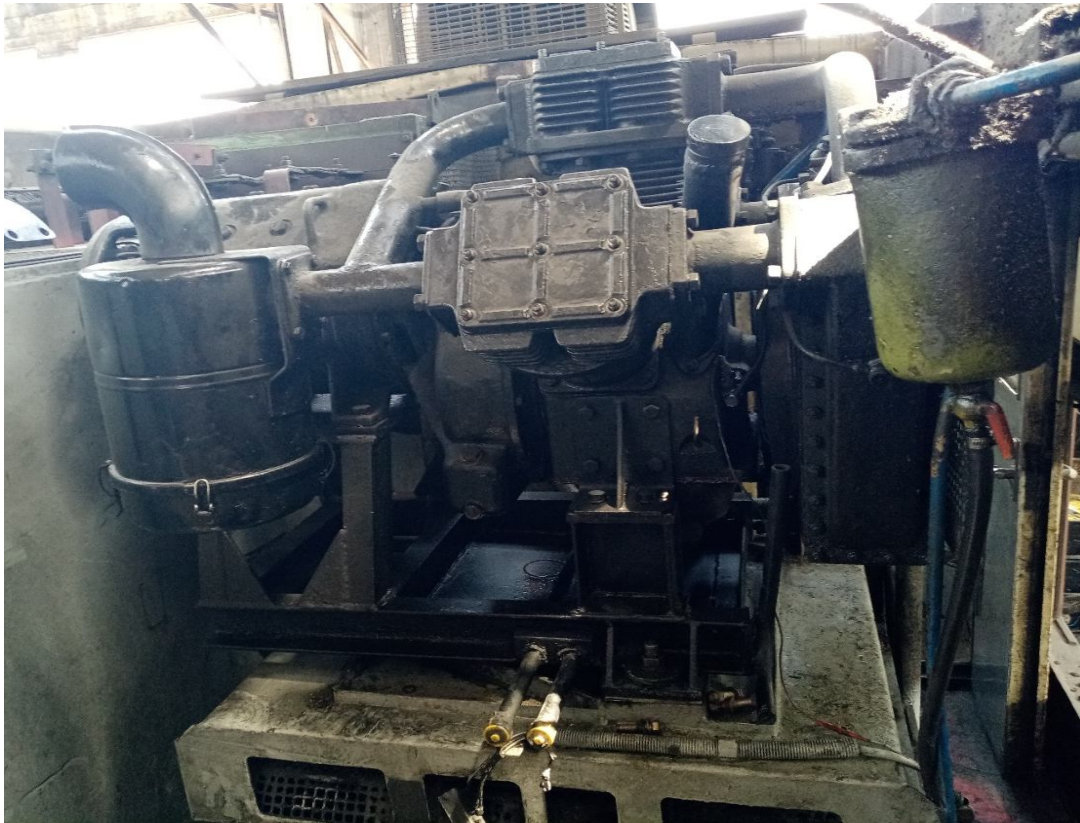
**Fig. 4.22.**

Upon inspection and disassembly of the compressor, it was found that there were two broken valves, which resulted in a reduction in the flow rate when the compressor was running, which in turn forced the compressor itself to run longer to obtain the necessary compressed air, resulting in an increase its operating temperature, as well as the current with which its electric motor is supplied. That caused the temperature of the power unit to rise to unacceptable values, which eventually led to the melting of the insulation and the ignition of the cables and other elements located in the area (Fig. 4.22)

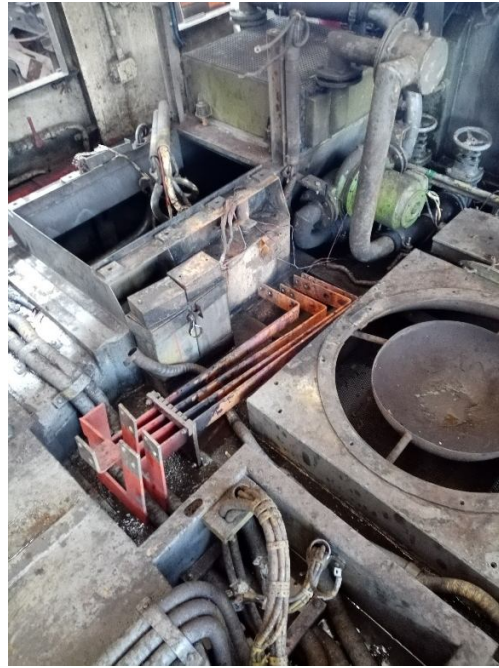
smoothing reactor as well as in the air channel for cooling a considerable amount of oil was collected, which leaked from the air compressor, and together with the accumulated dust and other impurities, heavily polluted the channel and thus contributed to the creation of a fire-hazardous environment in this area (Figs. 4.23 and 4.24).

The available amount of oil has collected from gaps in the air compressor seals or from leaking after filling with oil. During the movement of the locomotive, the leaking oil flows onto the smoothing reactor 080.
