Translation of an excerpt of the investigation report

“Train collision Altheim (Hesse) halt – Dieburg station on 19/05/2022”

Status as of 11/12/2023, version 1.0.

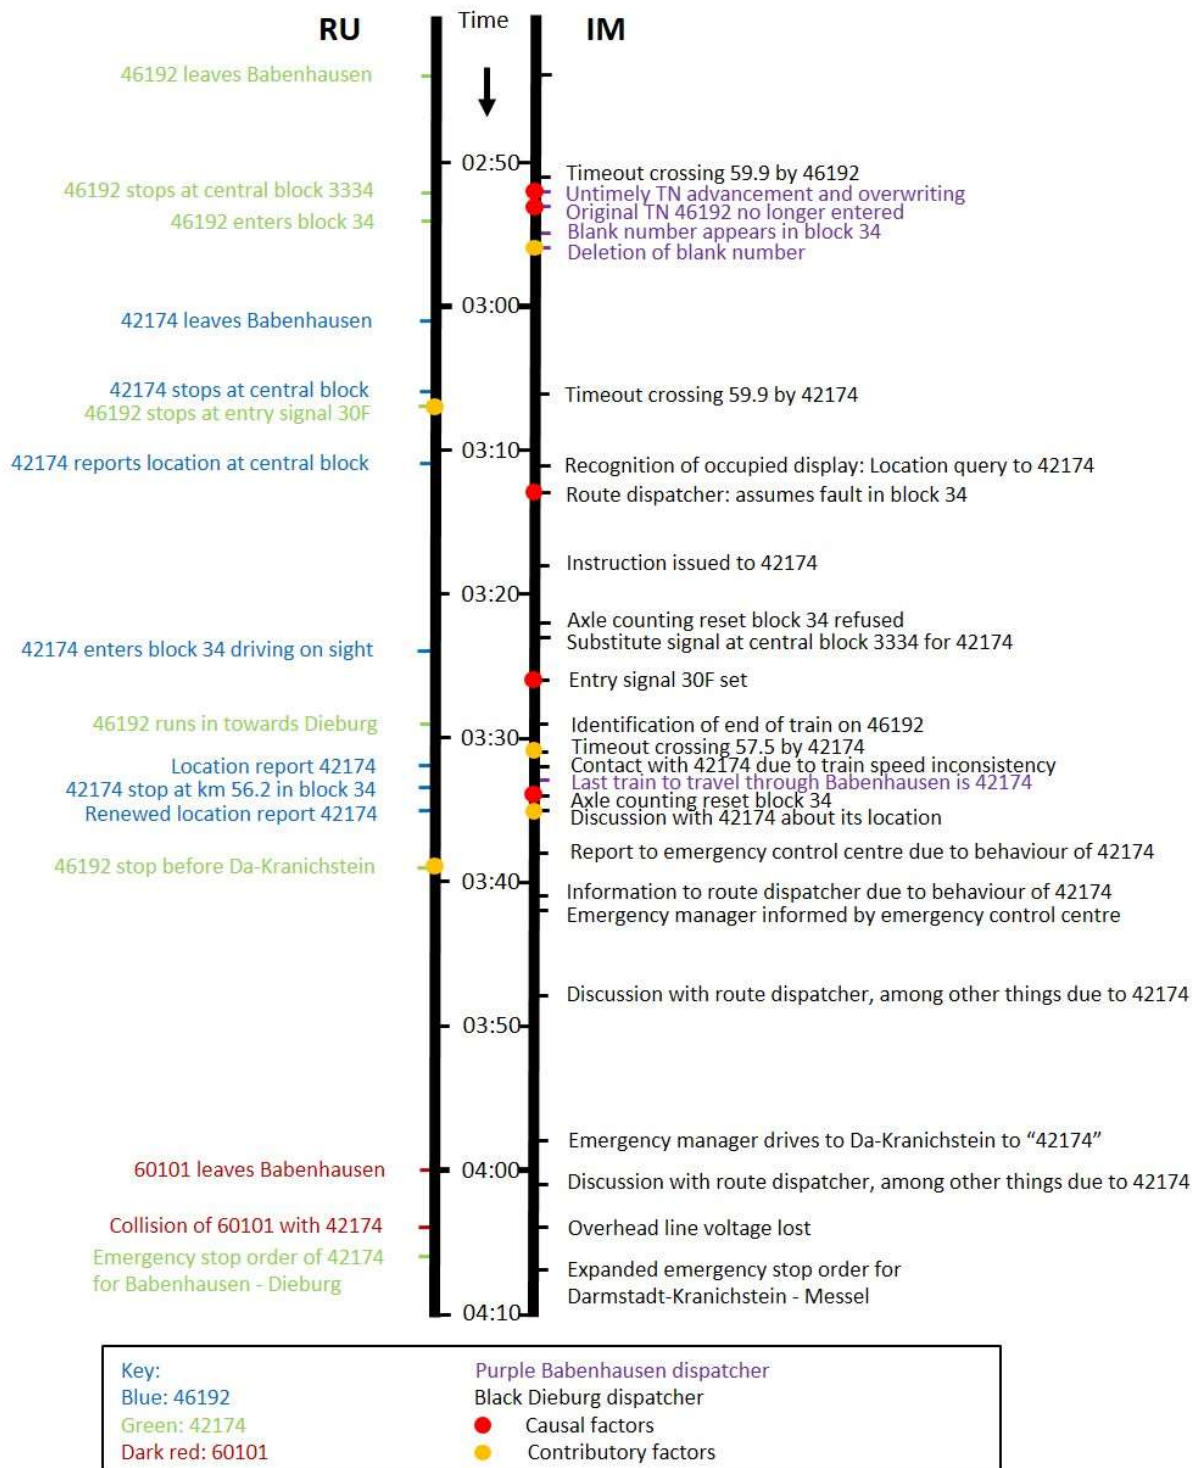
Figure 25: Timing of the chain of events

The diagram below provides another visual representation of the key steps in the chain of events in time order, separated according to the infrastructure manager (right) and railway undertaking (left). The causal factors mentioned above are indicated by red dots, while orange dots are used for the contributing factors.
