**STATE COMMISSION ON RAILWAY ACCIDENT INVESTIGATION**  
**Ministry of the Interior and Administration**

**REPORT No. PKBWK 5/2023**

**on the investigation of a railway accident  
that occurred on 20 February 2023 at 18:11 hrs on the Chałupki – Krzyżanowice route,  
track no. 2, Category B level crossing, at km 47.973  
of railway line no. 151 Kędzierzyn-Koźle – Chałupki,  
the area of the infrastructure manager PKP PLK S.A. Railway Line Plant  
in Tarnowskie Góry**

**WARSAW, 19 December 2023**

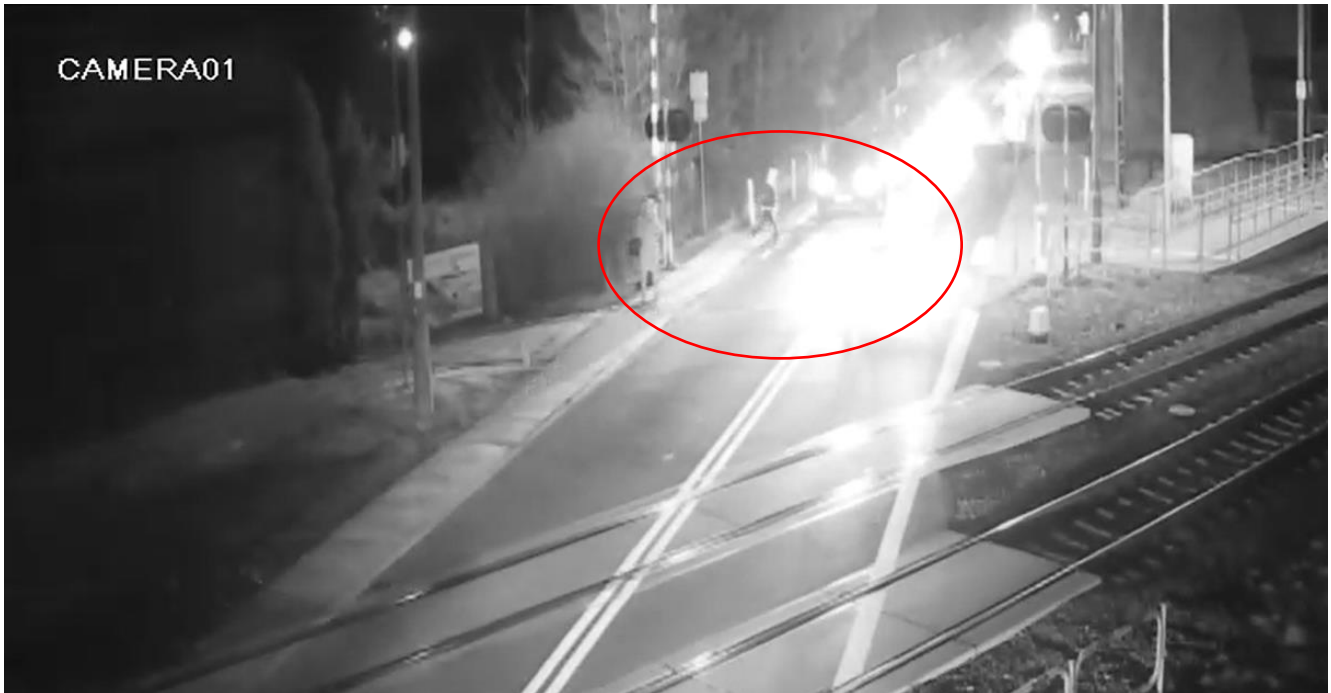
Photograph 1 – Pedestrians entering the pedestrian crossing

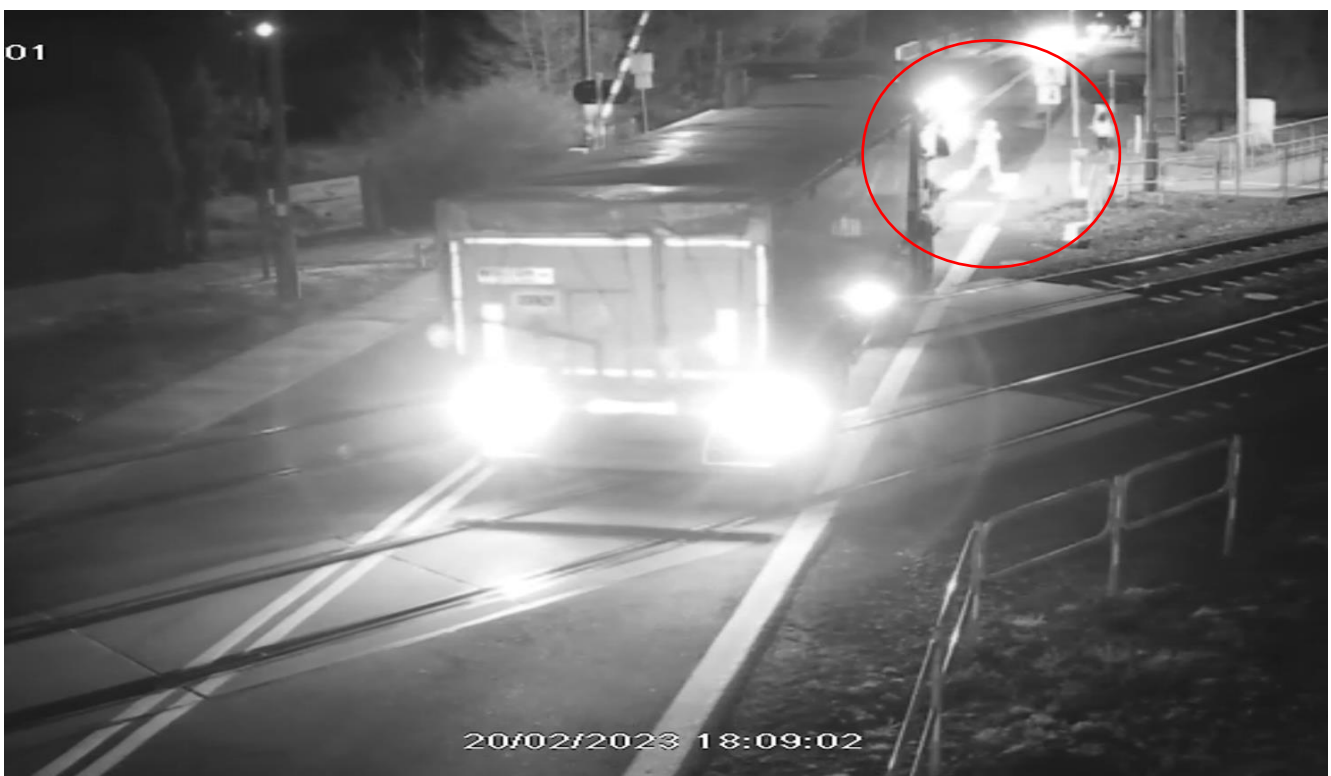
Photograph 2 – Vehicles stationary at the crossing to give way to pedestrians

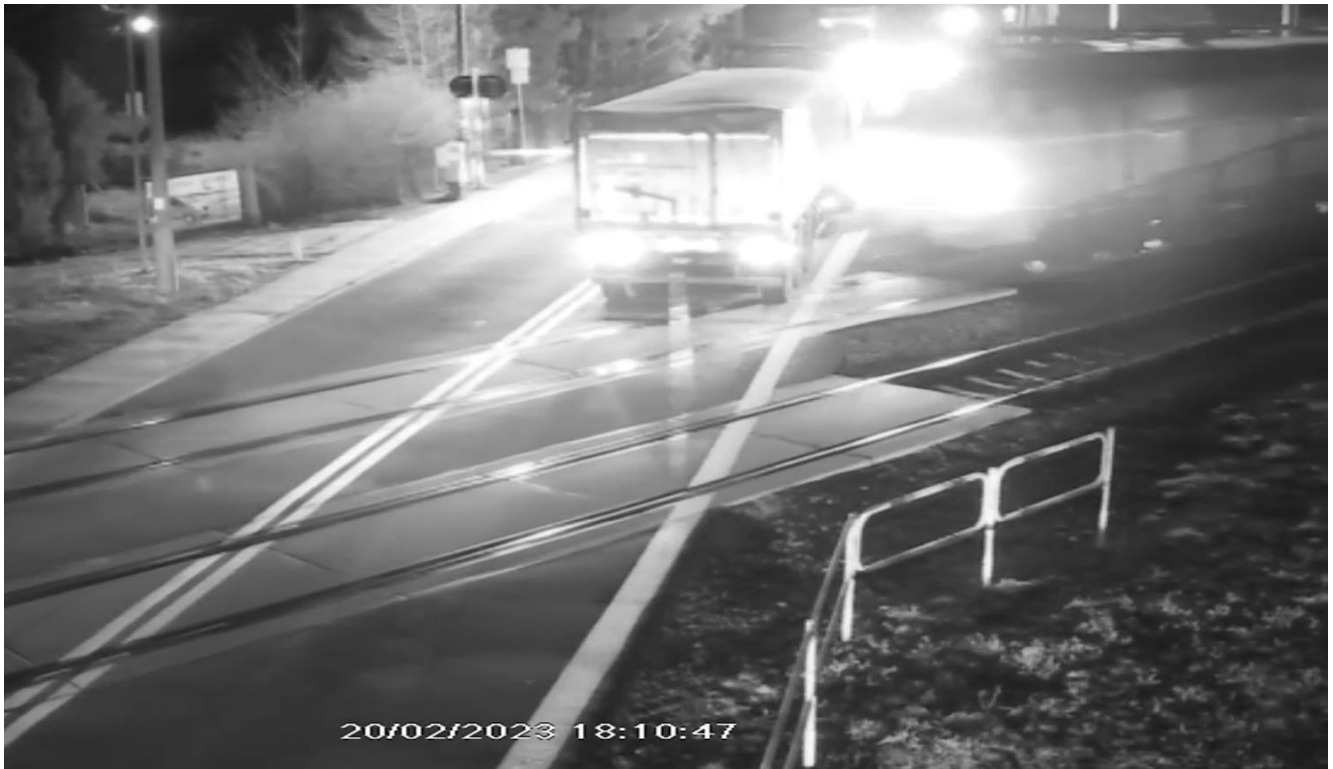
**Photograph 3 – The moment of the occurrence**

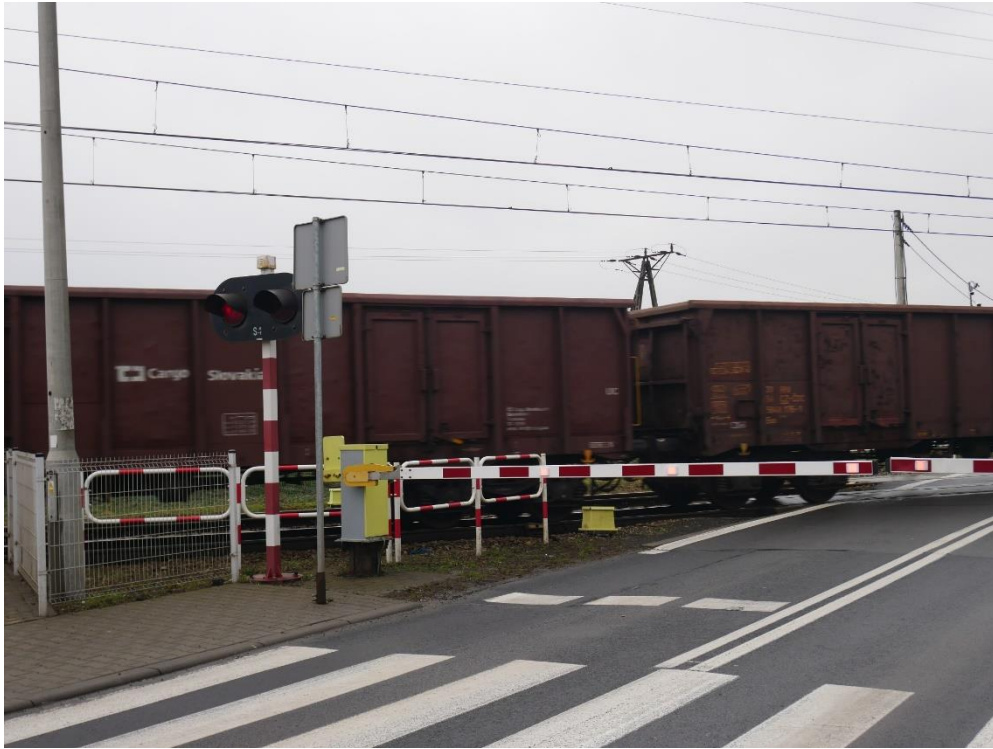
1. Inappropriate organisation of pedestrian traffic in the area of a level crossing.
2. The location of the pedestrian crossing at 2.5 m behind the exit barrier, hindering smooth passage and exit of road vehicles through and from the level crossing.
3. A passenger car stopping at the level crossing in front of the pedestrian crossing to give way to pedestrians, which prevented a road tractor with a semi-trailer following the passenger car from continuing to go.
4. Installation of lockable half-barriers on the exit lane from the level crossing, which prevented raising them manually.
5. Failure to implement recommendation no. 2) in Point 4.2 of the PKBWK's Annual Report 2018 concerning disassembly of exit barriers.

Photograph 6 – Position of the pedestrian crossing

- 3) take immediate actions to relocate the pedestrian crossing from the immediate vicinity of the level crossing to at least 22 metres away from the entrance barrier on the entry lane (the recommendation is under implementation).

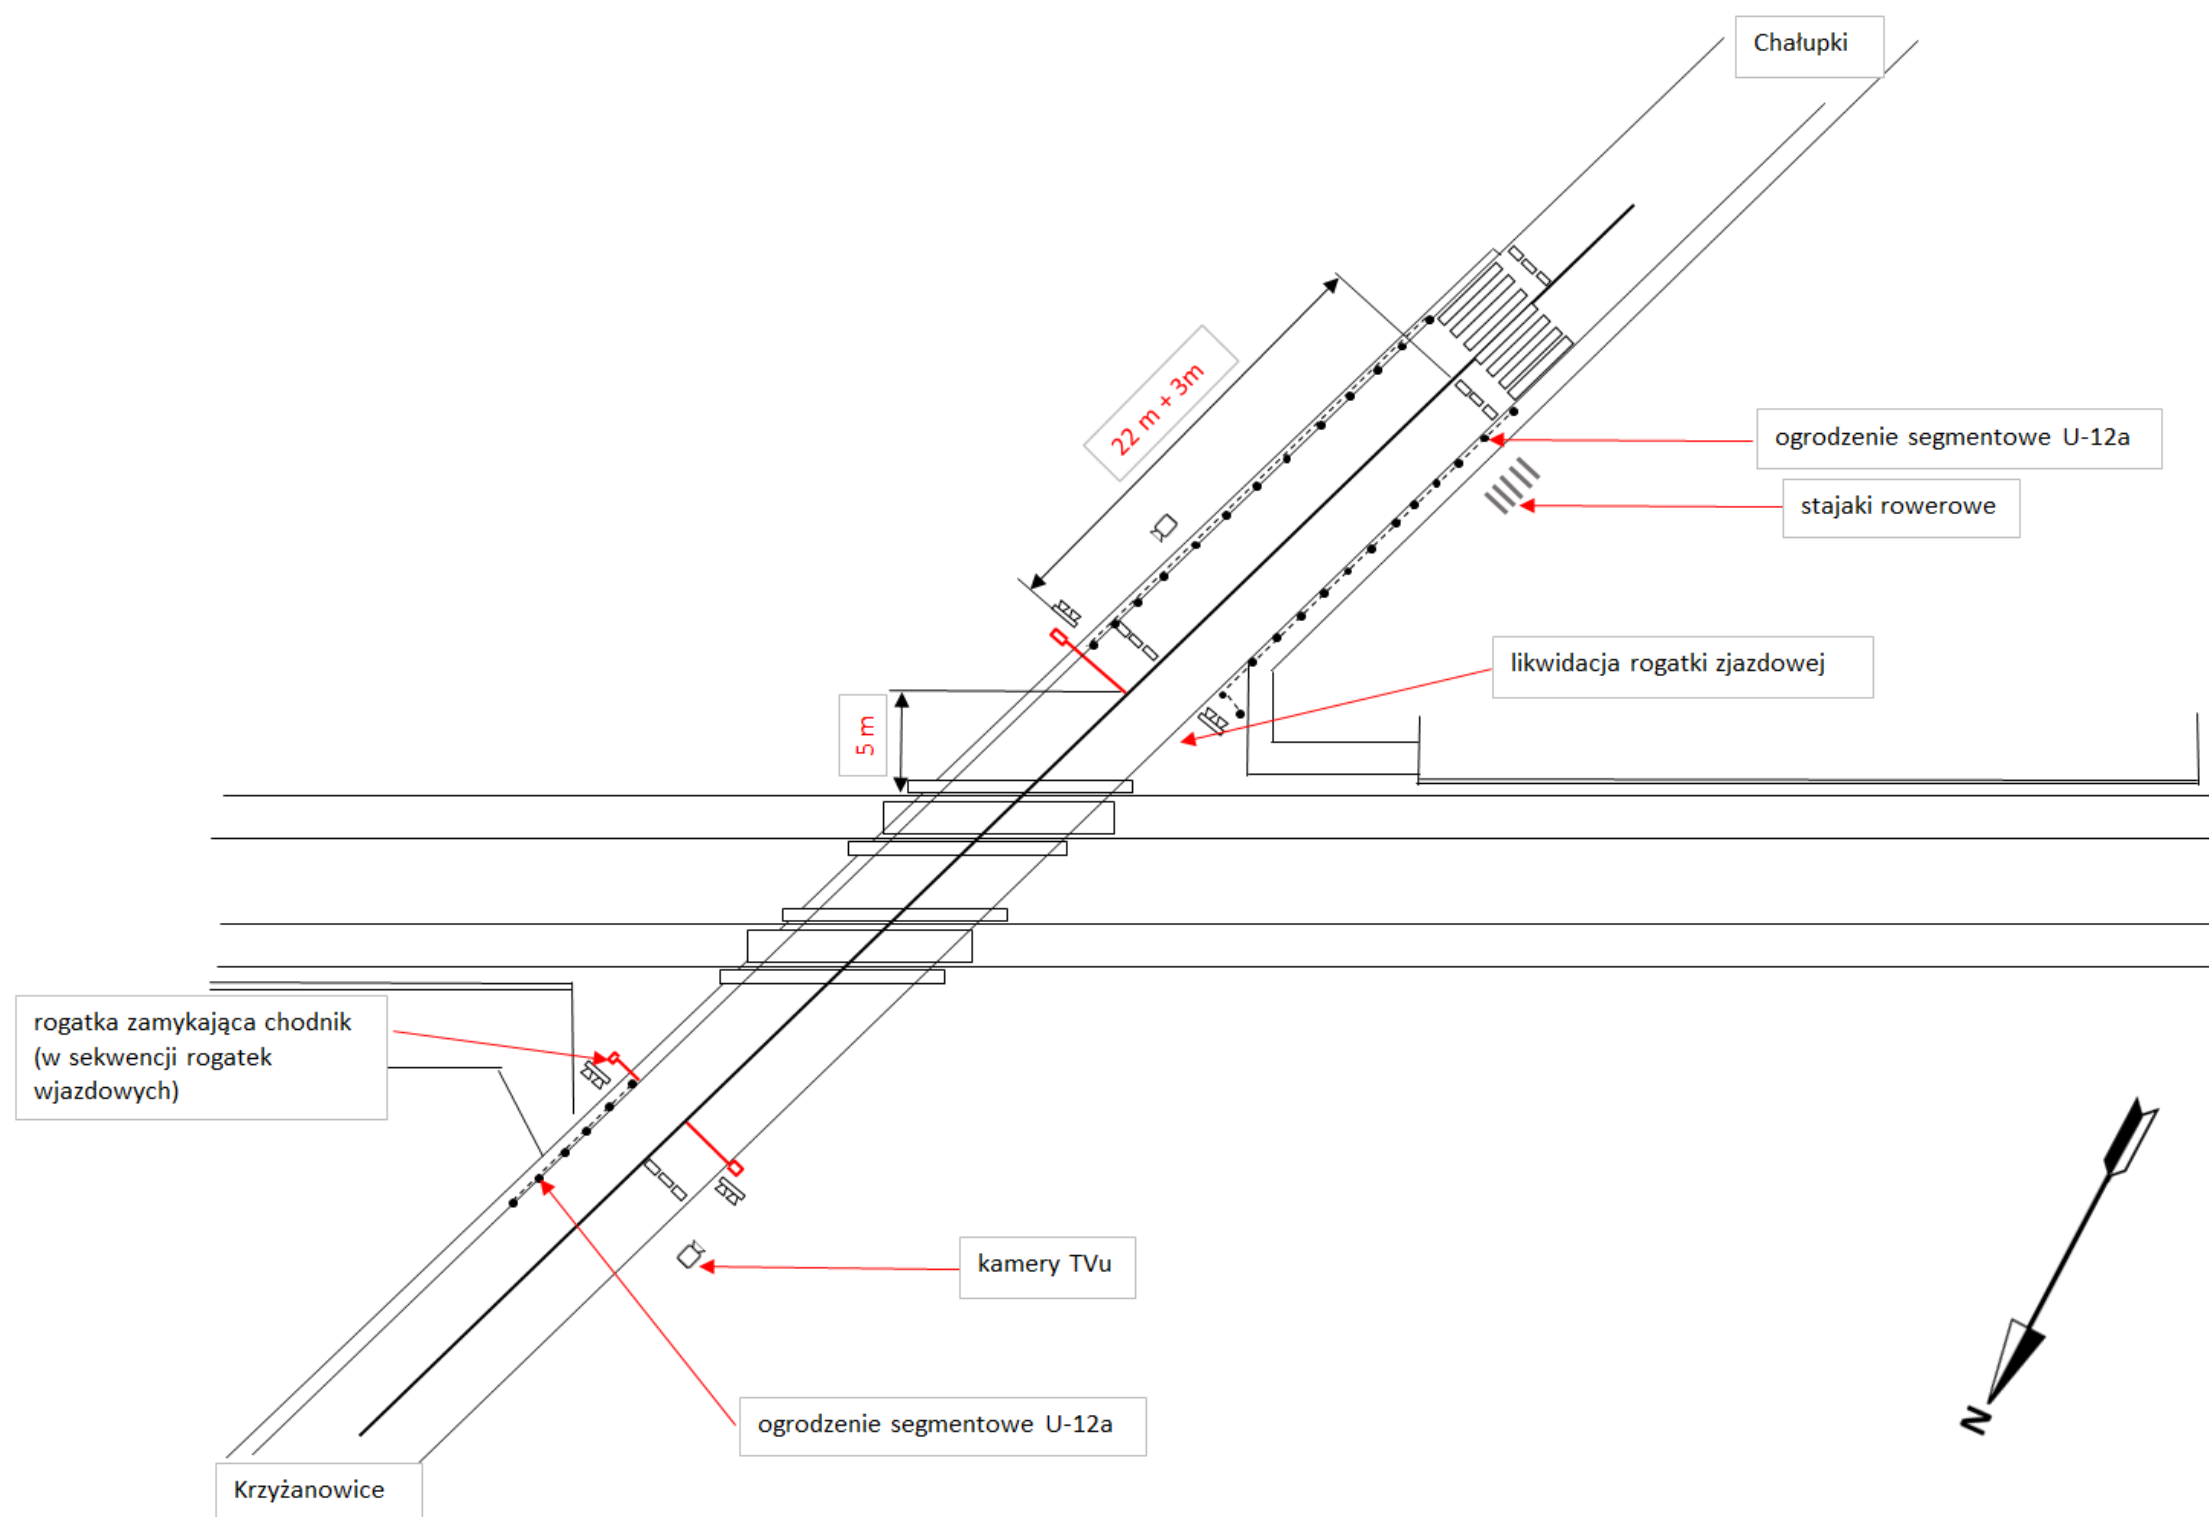
Figure 3 – A proposed solution of the organisation of traffic at the level crossing (one of possible solutions that ensure safety)

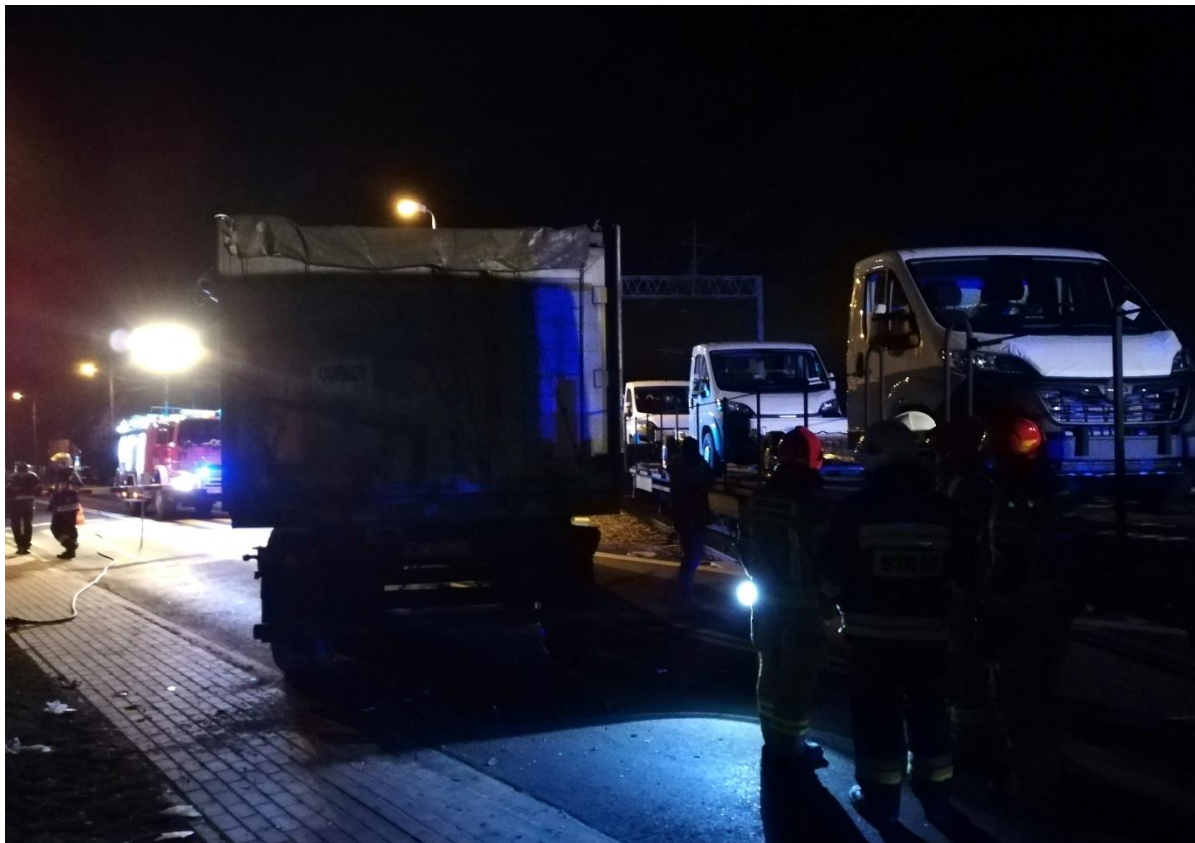
Photograph 8 – Stationary vehicles after the occurrence (material provided by the railway commission)

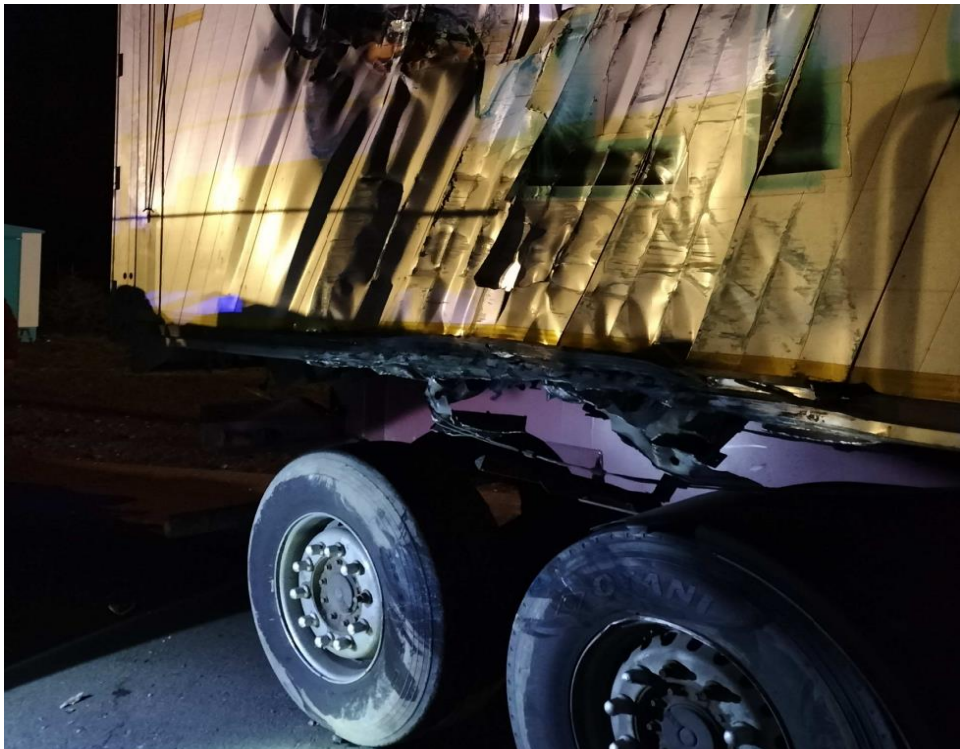
As a result of the accident, the following elements of the semi-trailer were damaged:

**Photograph 9 – Damage sustained by the road tractor's semi-trailer (material provided by the railway commission)**

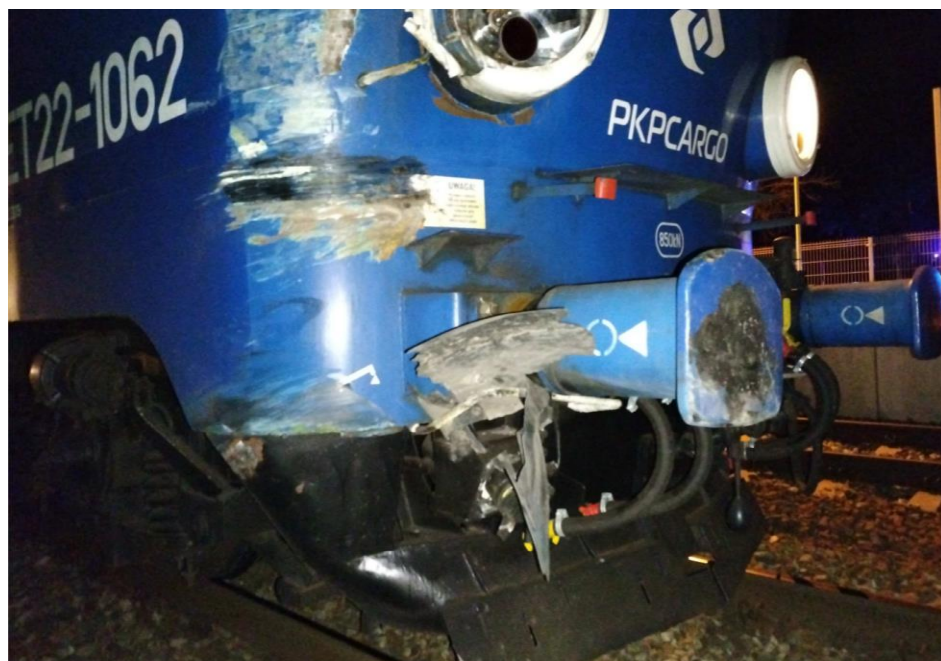
Train no. 441008 was not derailed. As a result of the collision, the ET22-1062 locomotive sustained the following damage: - deformed and grazed front on the right side of cabin A, from the rail fender to the corner window,

- broken corner window pane together with the window frame and seal,
- broken side window fairing on the train driver's side,
- broken and dented head lamp on the right side of the cabin,
- damaged train heating box and jumper, warped tubing with pipes,
- bent step and handle for climbing on the head of the locomotive and cowling,
- grazing and shear on the right bumper.

**Photograph 10 – Damage sustained by the ET22-1062 locomotive (material provided by the railway commission)**

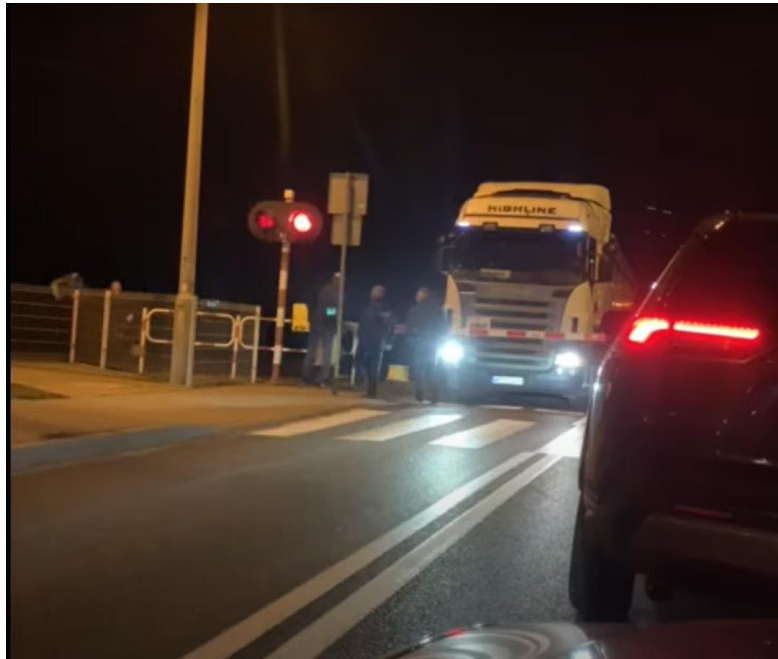
- The electrical drives are fitted with locking devices that prevent manual lifting of the exit half-barrier.

Photograph 11 – Attempts to lift the barrier bar undertaken by the witnesses (source: Youtube)

- 4) remove the barrier and its drive (no. N4) closing the exit from the level crossing (the recommendation is under implementation),
- 5) change the function of the barrier (no. N3) from a barrier closing the exit from the level crossing to a barrier closing the pedestrian pathway on the pavement in the direction of the tracks for the duration of train passage; replace the bar of barrier N3 with a type that will secure only the pavement, and the barrier should operate in the entrance barrier sequence (the recommendation is under implementation),
