**REPUBLIC OF BULGARIA**  
**NATIONAL AIR, MARITIME AND RAILWAY TRANSPORT, ACCIDENTS**  
**INVESTIGATION BOARD (NAMRTAIB)**

**FINAL REPORT**

**investigation of railway accident – fire in locomotive № 91520044202-7, serviced international  
fast train № 464 between the stations Zmeyovo – Tulovo on 01.12.2023**

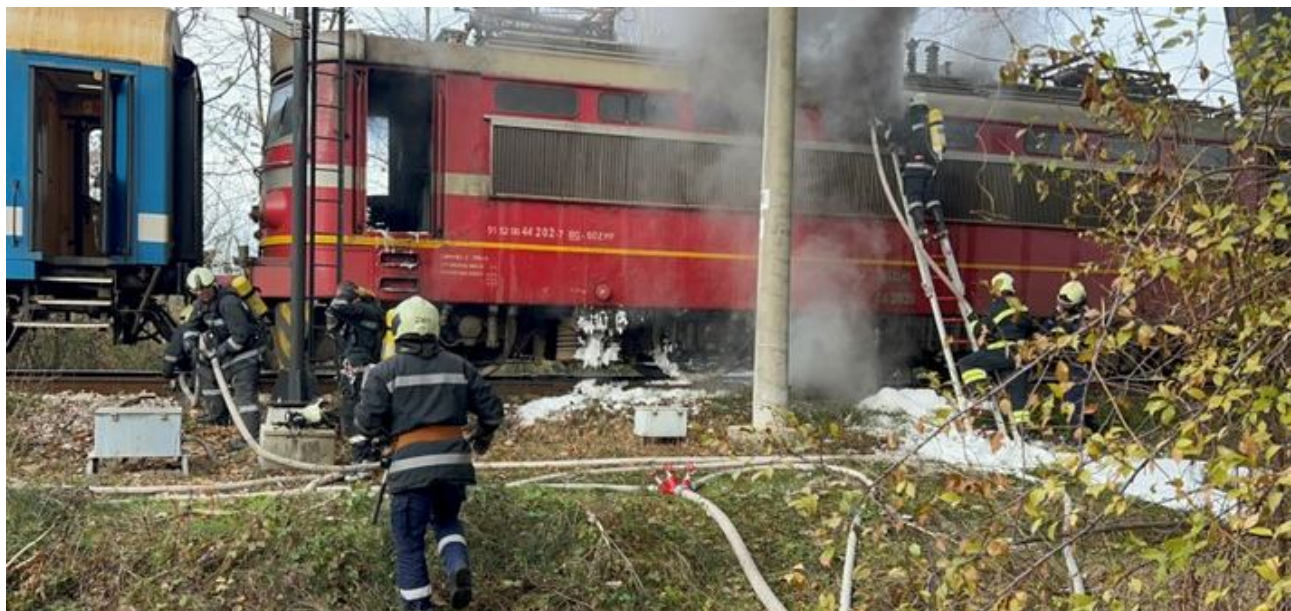
**Fig. 1.1. Locomotive № 91520044202-7 with IFT № 464 at km 226+642 between the stations Zmeyovo and Tulovo**

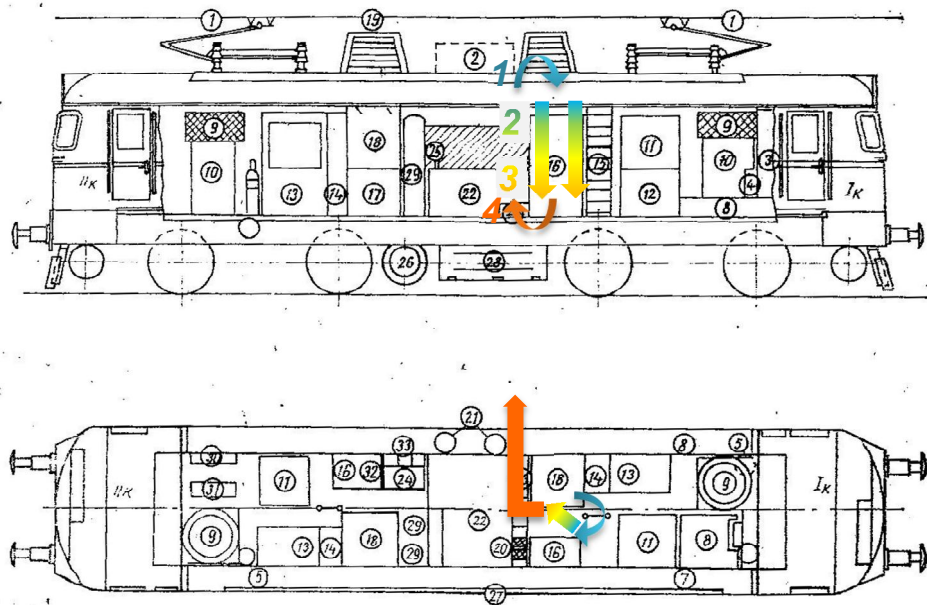
The cooling of the blocks is forced by air, which is sucked from the engine compartment (Fig. 4.6, item 1), enters through the upper opening of the cabinet, passes through it downwards, taking away part of the heat released by the drawbridge valves (Fig. 4.6, pos. 2), the already heated air passes down to cool the valves of the auxiliary bridges (fig. 17, pos. 3) and exits through the suction pan horizontal fan into the atmosphere (fig. 4.6, pos. 4). The side of the block is not cooled. With the scheme described in this way, the way in which the operation is carried out is particularly important, because when the fans of the cooling system are turned off, overheating of the rectifier unit occurs, and especially in its lower part, where the rectifier bridges of the auxiliary machines are located - fans and compressors. When the locomotive goes into traction mode, the valves heat up, give off a large amount of heat, and when the air passes through, they cool down. The same air, instead of cooling, additionally heats the rectifier bridges of the auxiliary machines, whose operation is not synchronized with that of the traction rectifier bridges. After switching the locomotive out of traction mode and into inertia moving mode, it is the practice of locomotive drivers to turn off the ventilation with the button on the locomotive control panel and stop the cooling of the rectifier units. Heat removal from the traction rectifier bridges continues, but without cooling. At the same time, the rectifier bridges of the auxiliary machines (compressors that consume a sufficiently large amount of energy) continue to work, because the auxiliary

machines work in a different mode than the traction motors. As a result, on insufficiently cooled auxiliary bridges, they continue to heat up, due to the heat emitted by the drawbridges, along with the heat they themselves emit during operation. All this affects the temperature in the side of the block and heats the capacitors located in this area. Their housing bursts, the electrolyte ignites and becomes a catalyst for igniting the entire block.

**Fig. 4.6. Scheme of the movement of the air for cooling one of the rectifier blocks. By arrows is shown the direction of air passing through the rectifier blocks. The colors illustrate the passing through them and the changing temperature: cool, heated, warm, and hot.**

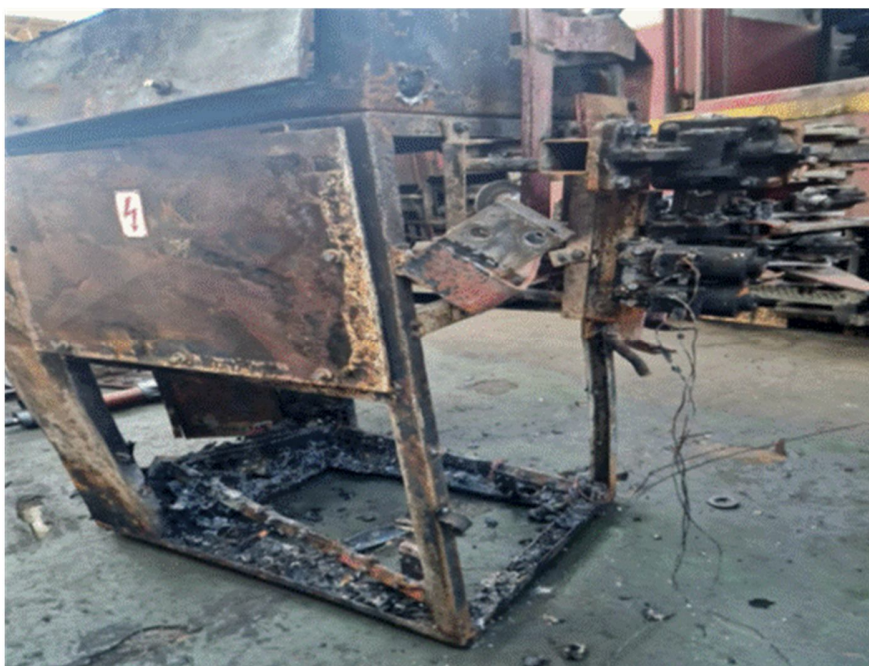
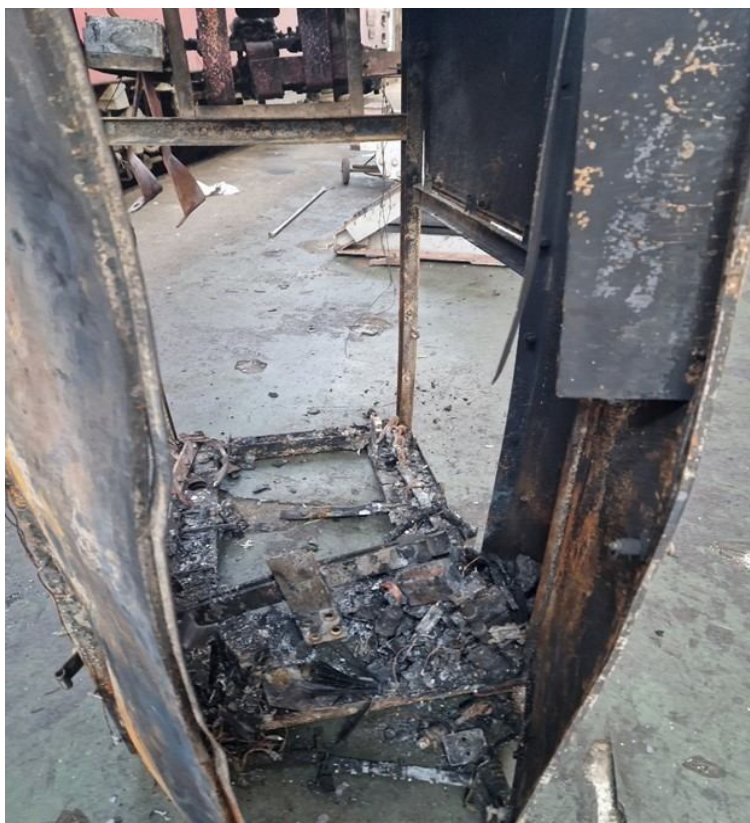
**Fig. 4.7. Rectifying group 022**

**Fig. 4.8. Image of the rectifying group 022**

- After the dismantling of the rectifying group 022 – (fig. 4.7 and fig. 4.8), it was found that totally melted the cooling bodies of the diodes of the rectifying group, and the auxiliary rectifiers 221 are totally destroyed as well 221;
- From the performed inspection of the auxiliary rectifier 221, feeding engine compressor 235 and engine-fans 222 and 223 it was found that it was destroyed, the temperature there were the highest. Probably the source for the fire occurrence is rectifier 221;

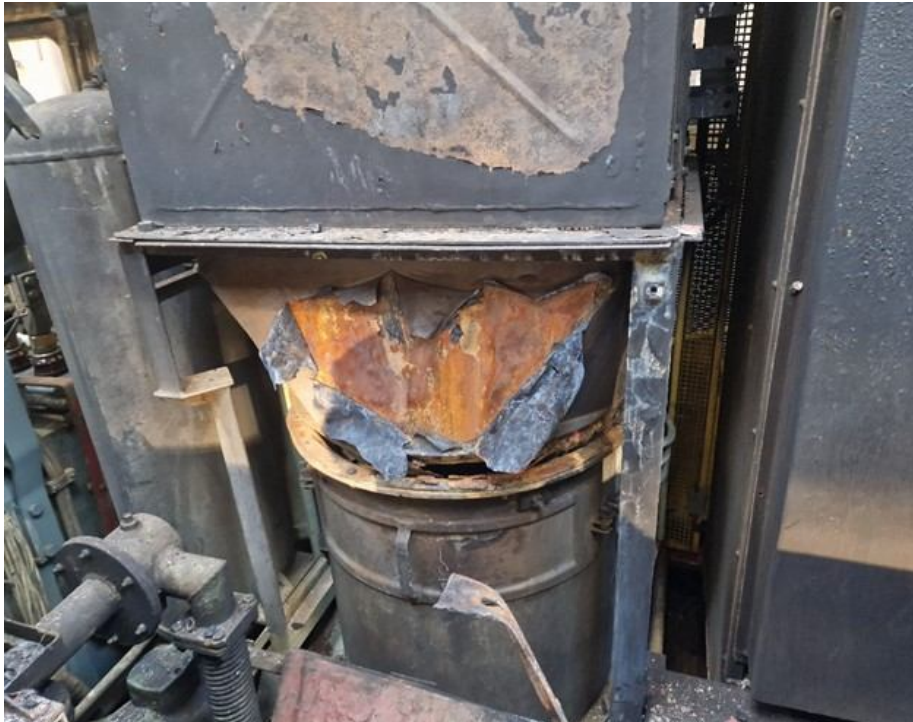
**Fig. 4.9. Image of the brake fan**

- After the inspection it was found that the engine fan of the brake resistor of fig. 4.9 was externally burnt. From the figure it is evident that the paint was burnt and the bellows of the fan was ignited;

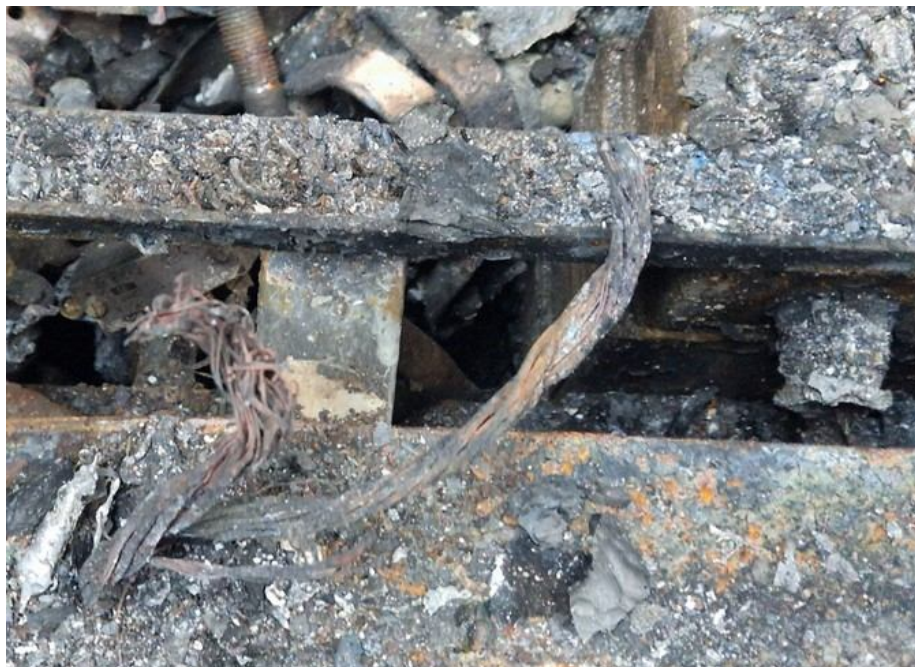
- The aggregates around the rectifier group 022 were also burnt. In fig. 4.10 the remains of the rectifier diodes are visible;
- On fig. 4.11 remains of the melted power cables of the engine compressor are visible. Melt is also visible at the end of the cable. The motor-compressor power cable melted due to the high temperature and it is very likely that the fire started from there;

**Fig. 4.11. Image of the feeding cables of the engine compressor**

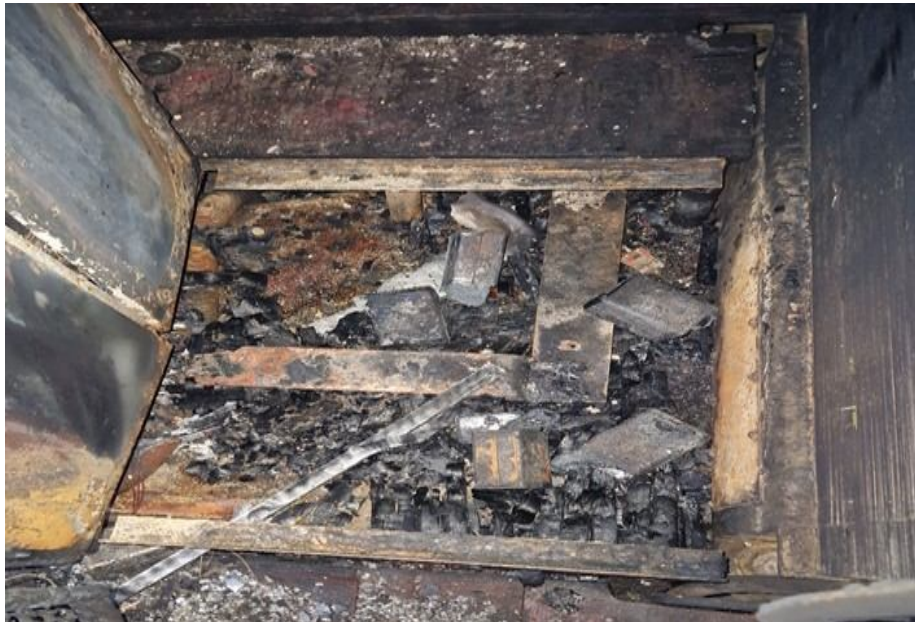
- **Occurrence of an explosion in the capacitors of the R-C groups of the auxiliary rectifier 221, which supplies the motor-compressor 235.** The occurrence of the explosion in the capacitors (Fig. 4.12) occurred because of an increase in temperature in the power unit of the engine-compressor. It has risen due to not cooling the rectifier group 022. The location of the power auxiliary unit 221 is at the bottom of the rectifier group 022. It was cooled after the rectifier diodes 022 were cooled. The R-C groups of the power and auxiliary units 022 and 221 are for protection against external and internal overvoltage. The construction of the capacitors that participate in the R-C groups are metal boxes filled with liquid electrolyte. As the temperature increases, it expands and causes the capacitor to explode. The hot electrolyte falls on the heated surfaces of the rectifier diodes and on the power unit of the auxiliary rectifier, which leads to the ignition of the auxiliary rectifier. Initially, thick black smoke was formed, impenetrable due to the lack of oxygen, and subsequently ignited.

**Fig. 4.12. Image of the burst capacitors.**
