## FINAL REPORT ON SERIOUS ACCIDENT INVESTIGATION

Serious accident type: Train collision

Train Nos: 25412 and 49028/73478

Location: Municipality Odžaci, between the settlements Ratkovo and Odžaci,  
open track between the station Ratkovo and Odžaci

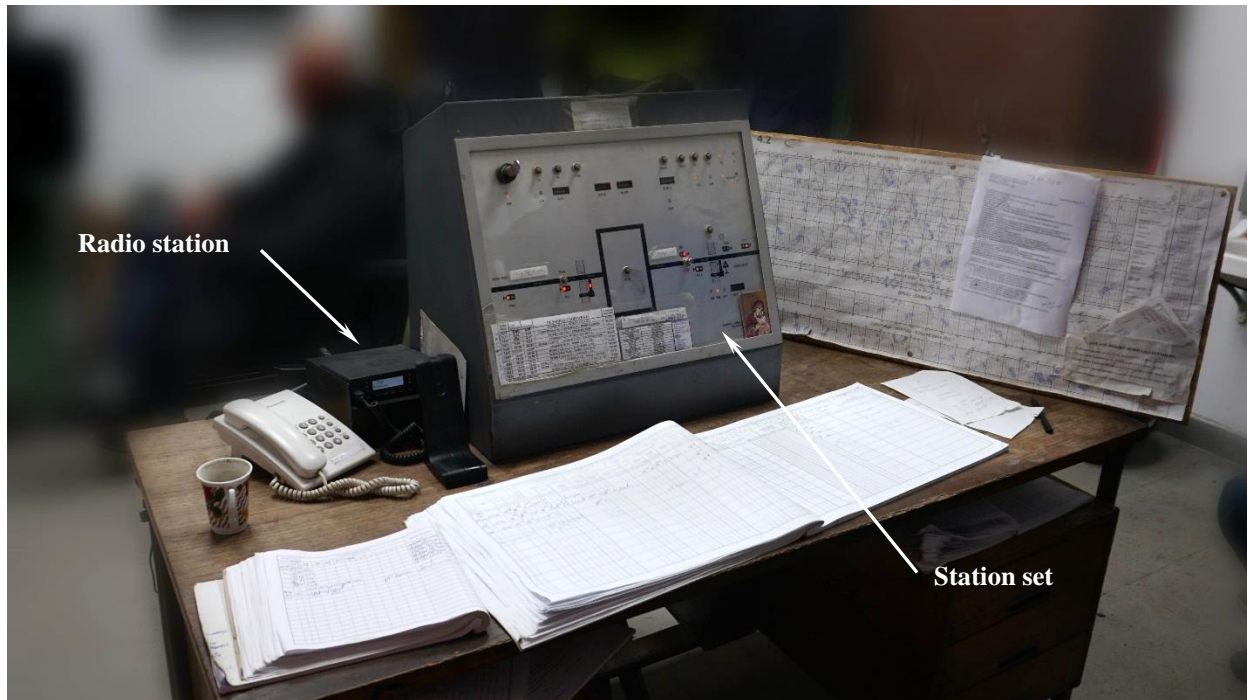
On the section of the railway between Ratkovo and Odžaci stations, there are no communication devices between the train dispatcher and the train driver. In practice, this communication is conducted via mobile phones (train driver and train dispatcher), or through calls made from a mobile phone (train driver) to the public fixed telecommunication network telephone of the station (train dispatcher).

**Figure 3.4.3.1:** The appearance of the radio station and station set  
at the office of the train dispatcher of station Ratkovo

- SR\_03/24** “IŽS” a.d., in terms of maintaining the public railway infrastructure in relation to the elements of the control, management and signaling subsystem, to replace and supplement the missing telecommunications devices and facilities on the regional railway line 207 Novi Sad - Odžaci - Bogojevo, which are missing and have been switched off due to technical malfunctions, as the designed technical functionality of the elements of the control, management and signaling subsystem would not be impaired, in the sense of the provisions of Art. 55 and 56 of the Law on Railways (“Official Gazette of RS”, Nos. 41/18 and 62/23) (see points: 2.2.4, 2.2.4.1, 2.2.4.2. and 3.3.1.)

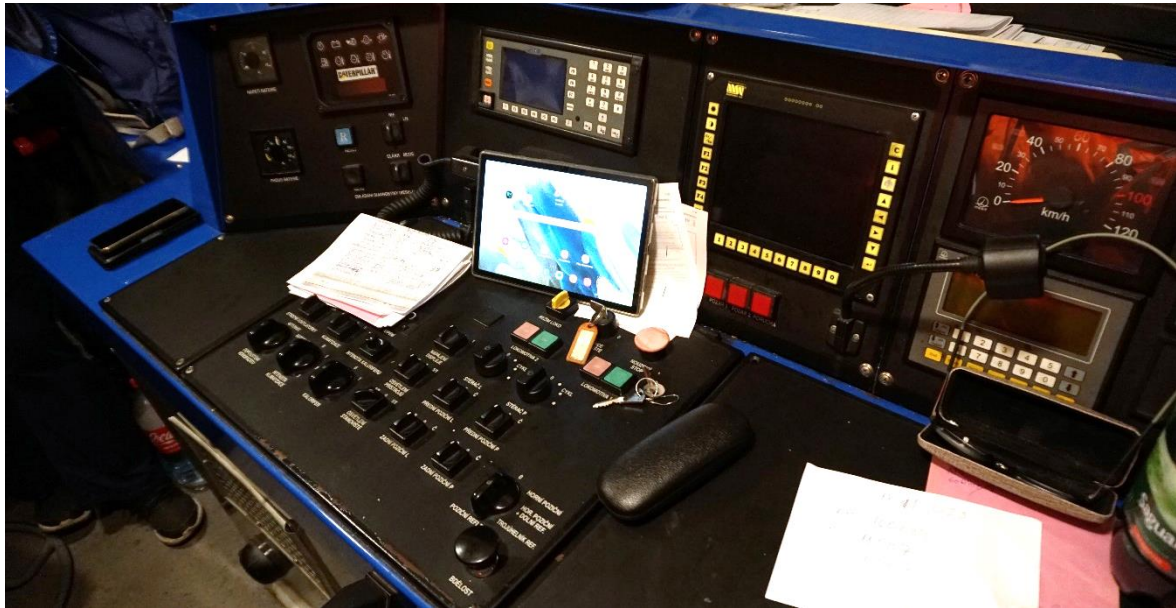
The locomotive was operated from driver's cab II. According to the train driver's statement, during the journey between Ratkovo and Odžaci stations, due to a hydraulic malfunction or oil temperature problem, the audible and visual alarm indicating a fault was activated, the diesel engine of the locomotive was shut down, and the train was forced to stop. Based on the "Report on the malfunction of locomotive 753-782" issued by the specialist for coordination and monitoring of maintenance of rolling stock at "Transagent operator"d.o.o. Belgrade (provided in the attachment to the email dated January 16, 2024), measurements and tests conducted after the serious accident revealed that there was a fault in the auxiliary contact of the blade-type fuse FU11, resulting in no supply and digital impulse at point PRH of the NES electronic regulator, as the electrical circuit was open. At the time of the serious accident, train No. 49028/73478 was stationary on an open track.

**Figure 3.4.4.1:** The appearance of the driver cab II of locomotive 753-782 from train No. 49028/73478

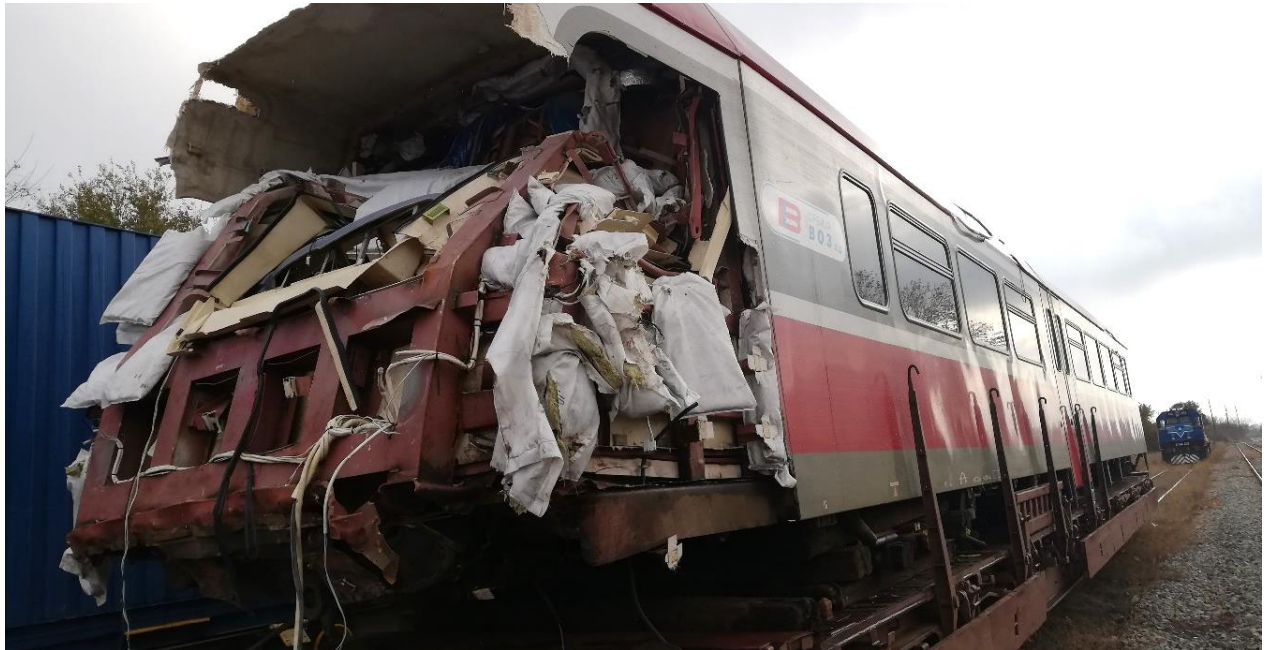
**Figure 3.4.4.2:** External appearance of the driver cab of the motor wagon 711-078 DMV 711-077/078 at the train No. 25412 after the serious accident

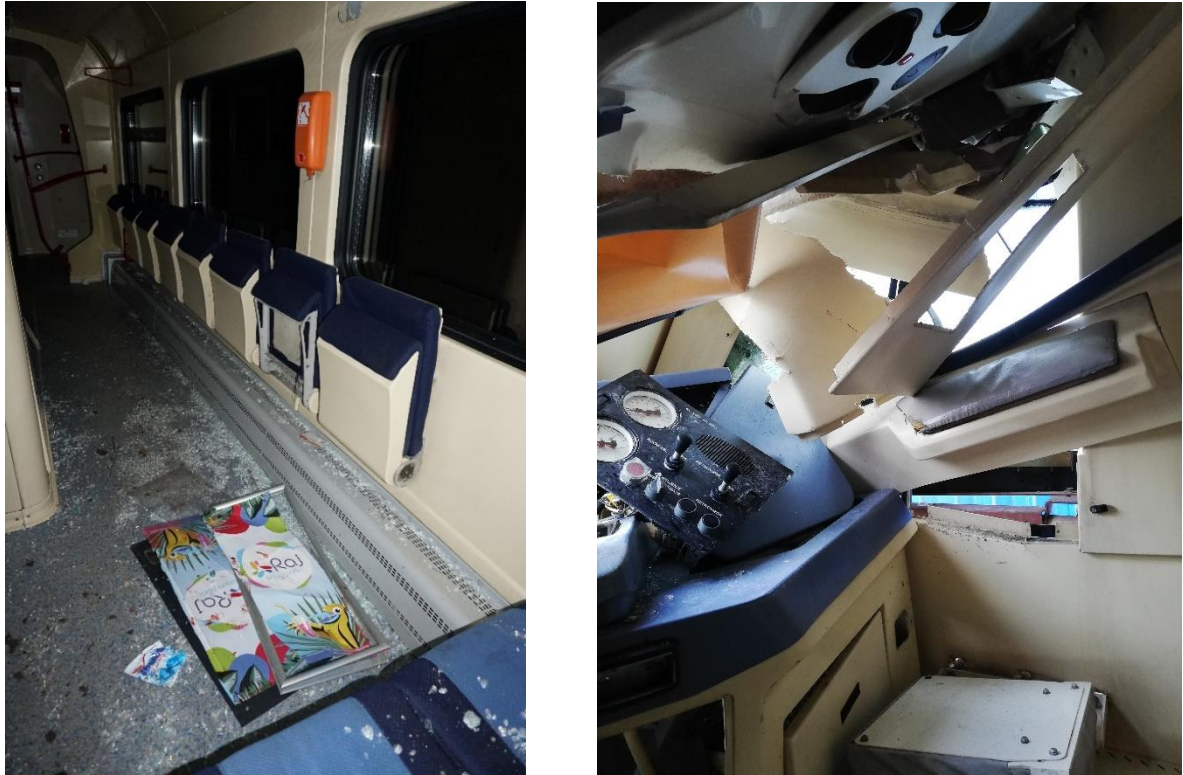
**Figure 3.4.4.3:** The appearance of the passenger compartment and the driver cab DMV 711-077/078 at the train No. 25412 after the serious accident

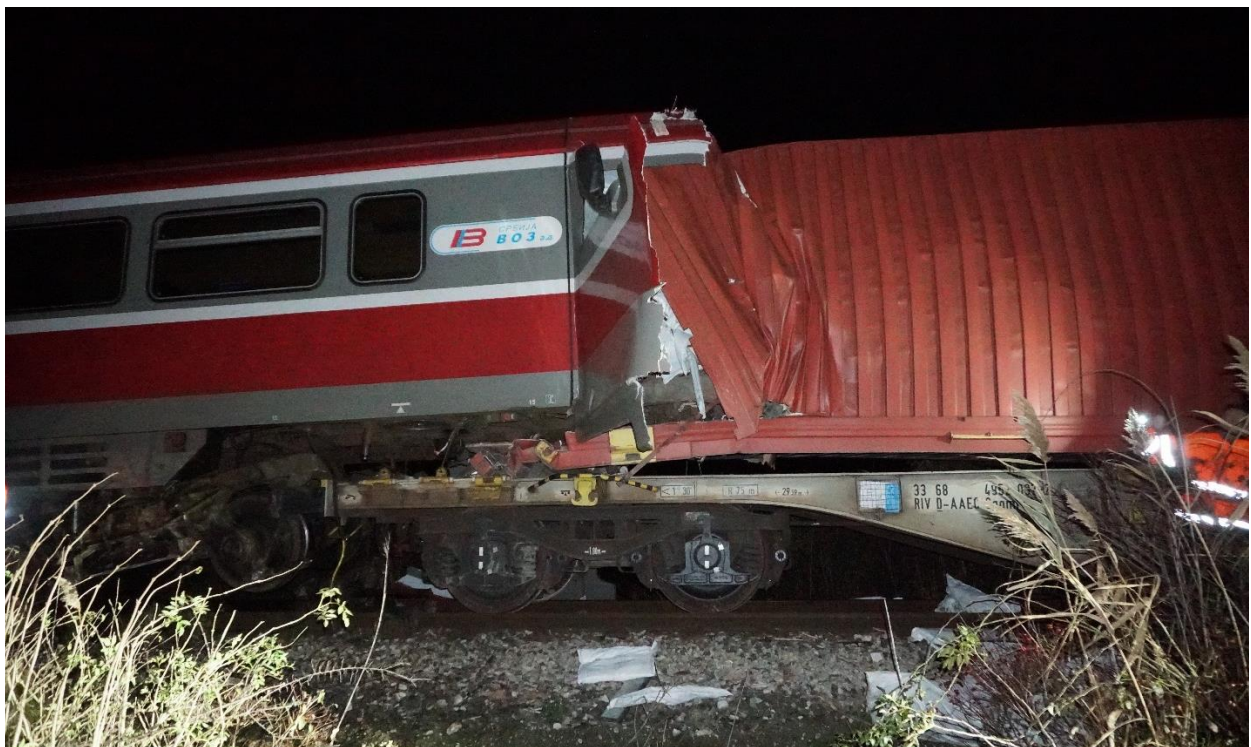
After the collision, train No. 49028/73478 (which was stationary) remained in place (did not move), while train No. 25412 continued its movement for approximately 6 m. During this movement, the front part of the DMV 711-078 box climbed onto the rear end of the flat wagon No. 33 68 4952 037-2, pushing forward and deforming container No. CNEU 453486-3, which was loaded on the wagon. This led to deformation of the front part of the box in the area of the drivers' cab and container. The first bogie of DMV 711-078 (viewed in the direction of travel) shifted approximately 3 m from its position towards the end of DMV, with the wheelsets on the first axle of the bogie raised above the track (approximately 30 cm from the top edge of the rail). All other vehicle wheels in both trains remained on the tracks (did not derail). Due to the shift of the bogie, damage occurred to the drive group of DMV 711-078.

**Figure 4.1.1:** Appearance of train collision No. 25412 and 49028/73478

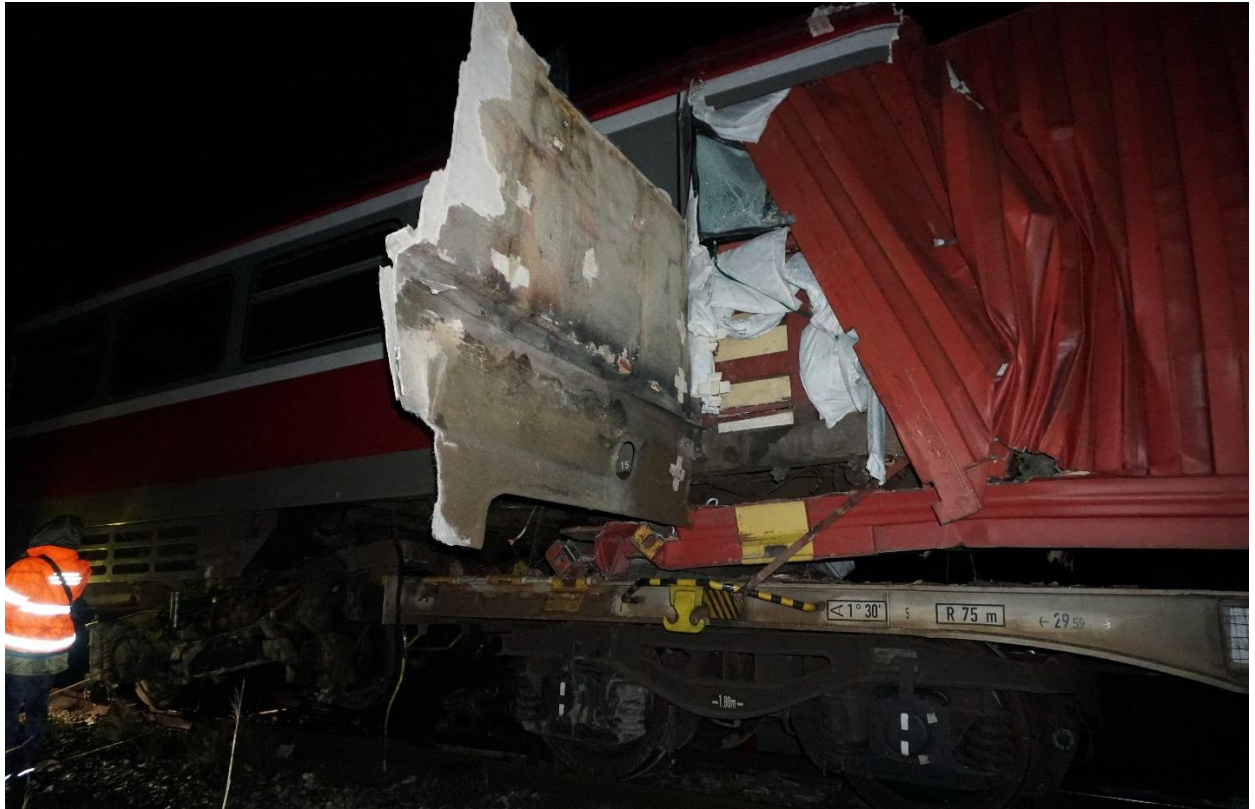
**Figure 4.1.2:** The appearance of damage to the front part of the DMV 711-078 box and container No. CNEU 453486-3

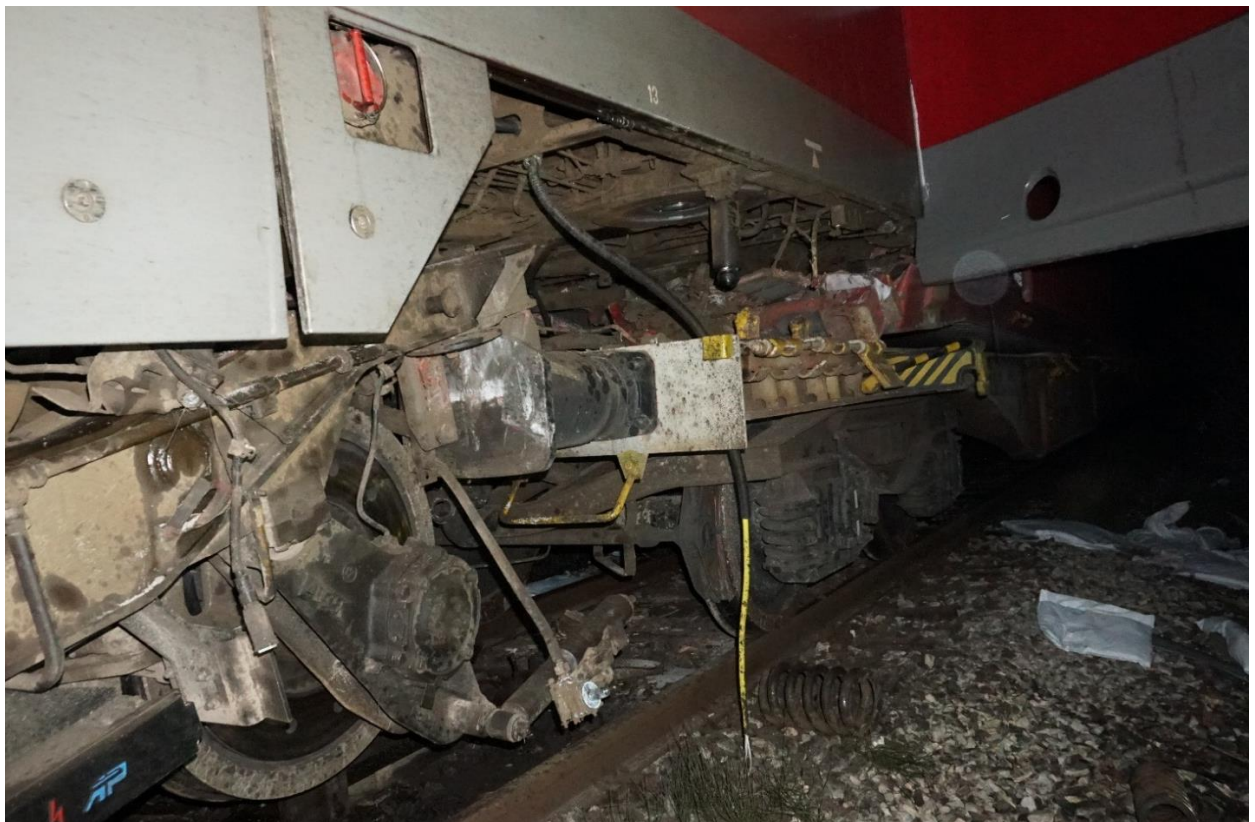
**Figure 4.1.3:** Appearance of the damages on the wagon No. 33 68 4952 037-2

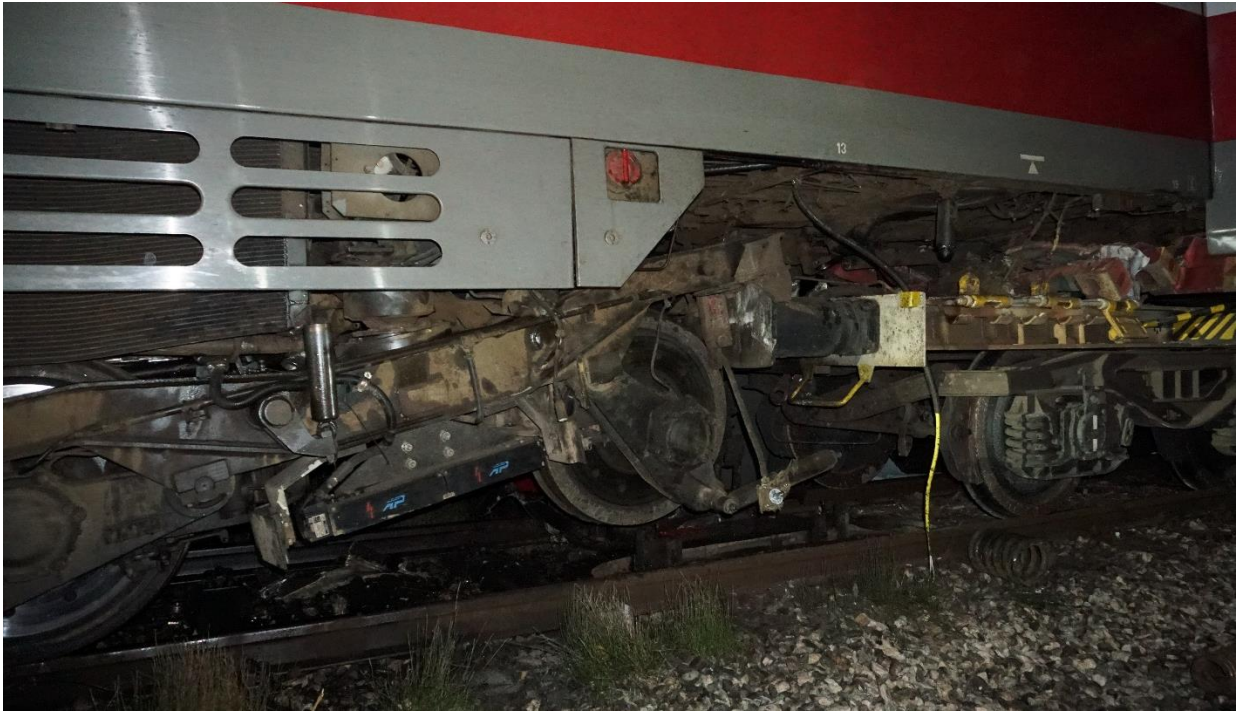
**Figure 4.1.4:** Appearance of the shifted bogie on the DMV 711-078

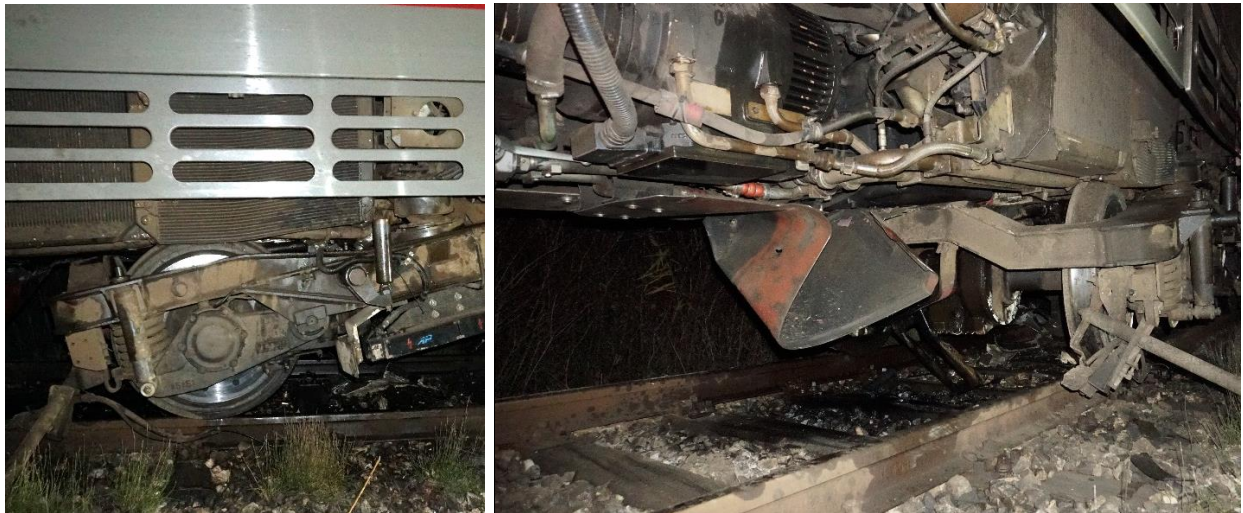
**Figure 4.1.5:** Appearance of the damages on the power unit DMV 711-078

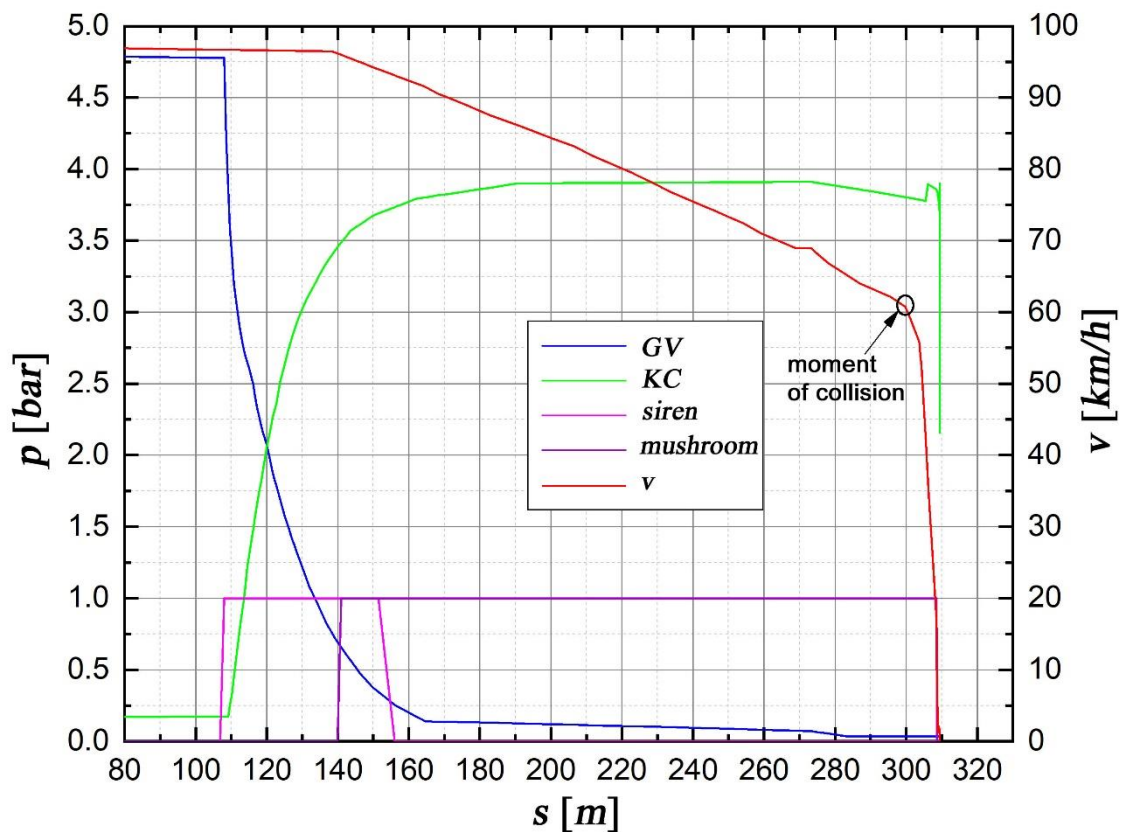
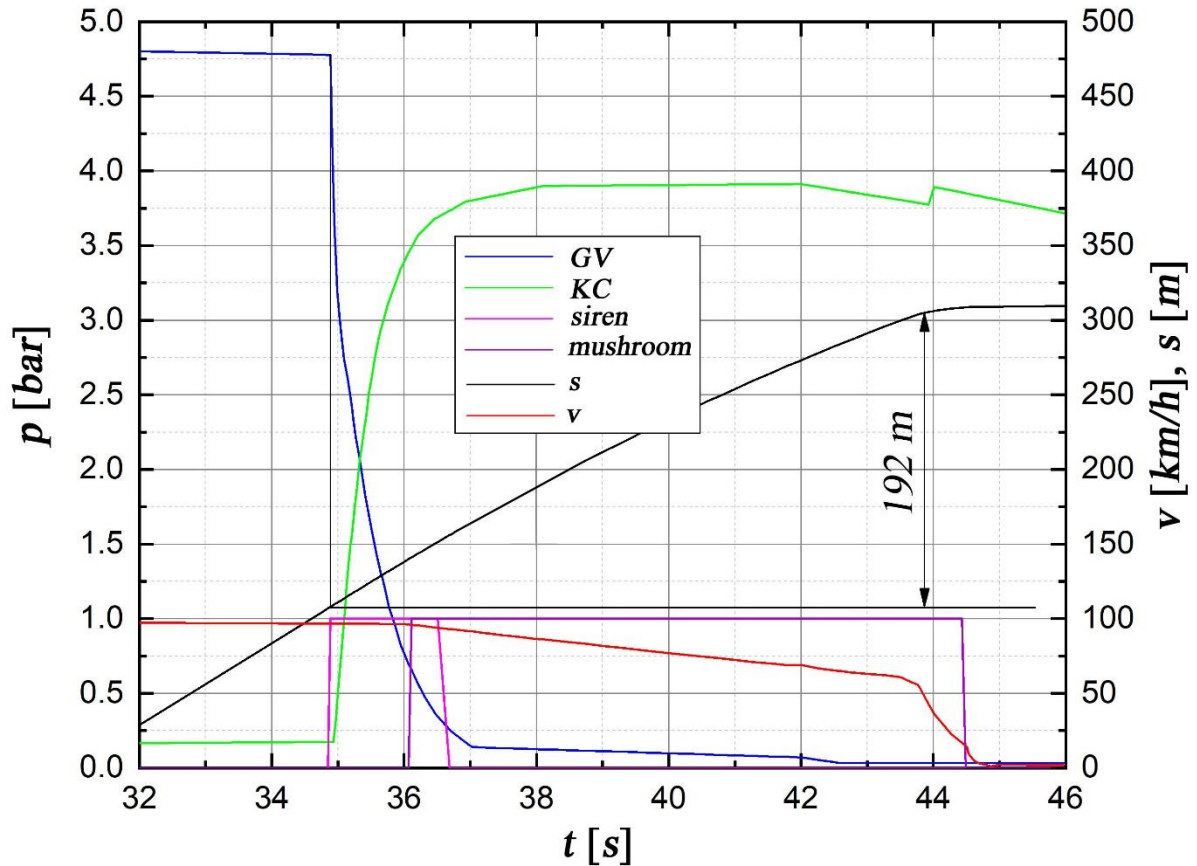
From the diagrams, along with the statement from the train driver of train No. 25412 (see point 3.1.1.), it can be concluded that when the train driver observed the end signal of train No. 49028/73478 which was stationary, he activated the siren and initiated emergency braking at a distance of 192 m from the stopped train, approximately 8.5 seconds before the collision. One second later, he activated the “emergency” button (mushroom). At that moment, train No. 25412 (DMV 711-077/078) was moving at a speed of 96.7 km/h. The brake cylinder pressure increased and reached a maximum value of 3.9 bar. After covering a distance of 192 m, train No. 25412 (DMV 711-077/078) collided at a speed of 60.7 km/h with the last wagon of train No. 49028/73478 which was stationary.

**Figure 4.2.2.1:** Diagram of values for main air pipe pressure (GV), brake cylinder pressure (KC), speed ( $v$ ), as well as the moment of siren activation (siren) and emergency button (mushroom) activation depending on the traveled distance ( $s$ )

**Figure 4.2.2.2:** Diagram of values for main air pipe pressure (GV), brake cylinder pressure (KC), speed (v), traveled distance (s), as well as the moment of siren activation (siren) and emergency button (mushroom) activation depending on time (t).

Based on the information provided, it can be stated that the train driver of train No. 25412 (DMV 711-077/078) reacted to the sighting of the end signal of stationary train No. 49028/73478 by initiating braking, and that the brakes on train No. 25412 (DMV 711-077/078) were functioning properly at that moment.

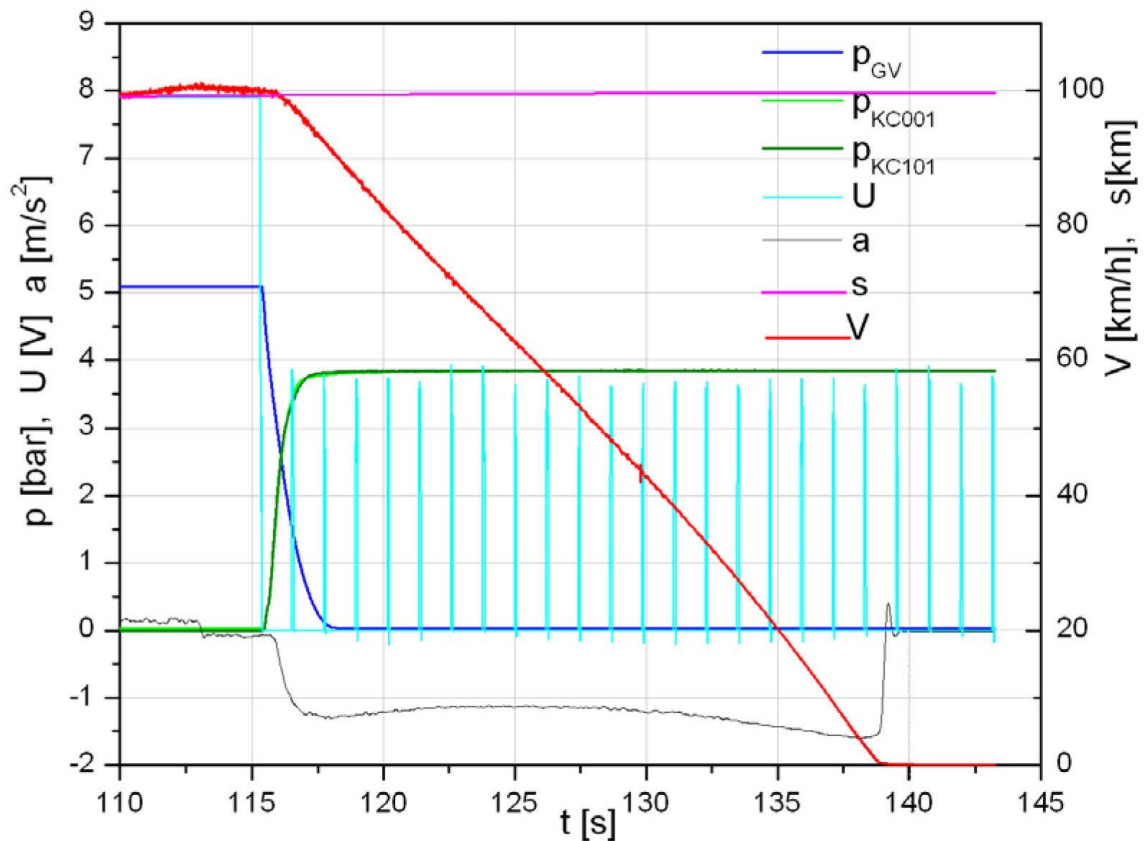
**Figure 4.2.2.3:** Diagram of braking from the speed 100 km/h

From the diagrams, it can be observed that during braking (from an initial speed of 100 km/h) to reduce the speed from 96.7 km/h to 60.7 km/h, a braking time of 8.5 s was achieved.
