STATE COMMISSION ON RAILWAY ACCIDENTS INVESTIGATION Ministry of the Interior and Administration

REPORT No. PKBWK 02/2025

on the investigation of a railway accident that occurred on 5 October 2023 at 7:00 a.m. at Gdynia Główna station, track No. 5, turnout No. 45, km 21.522 of railway line No. 202 Gdańsk Główny – Stargard

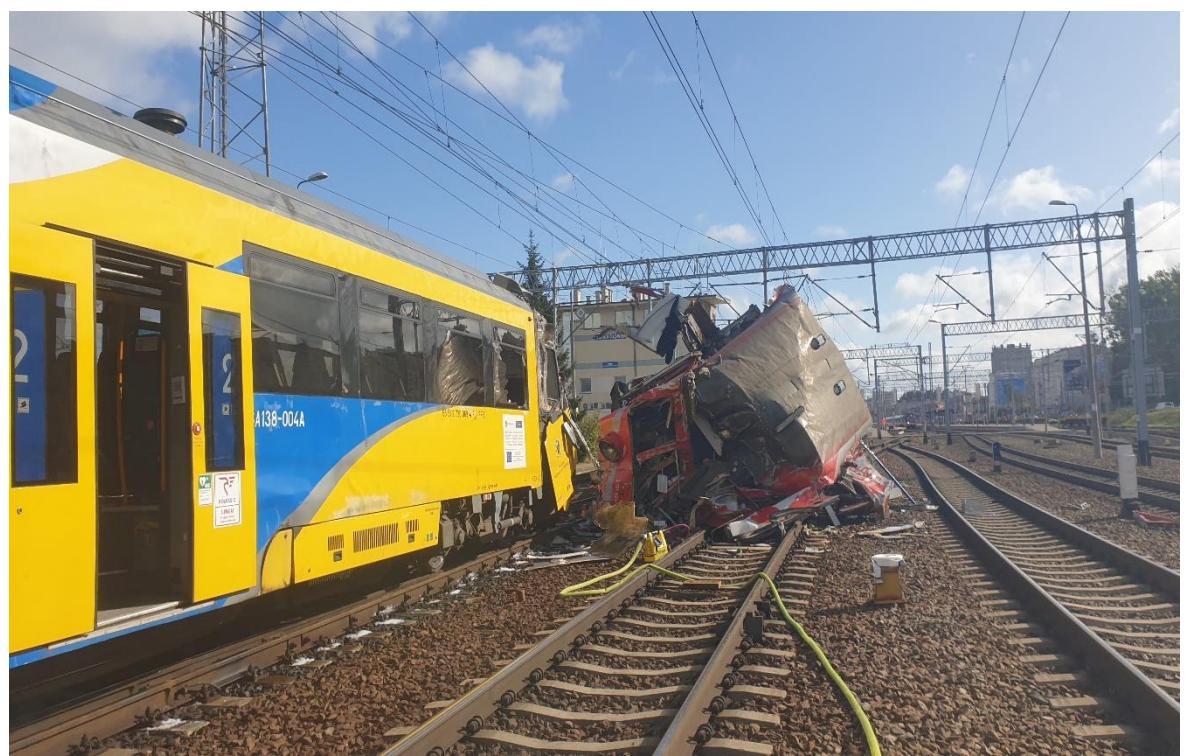
Photo 1 – The site of the occurrence (source: PKBWK documentation)

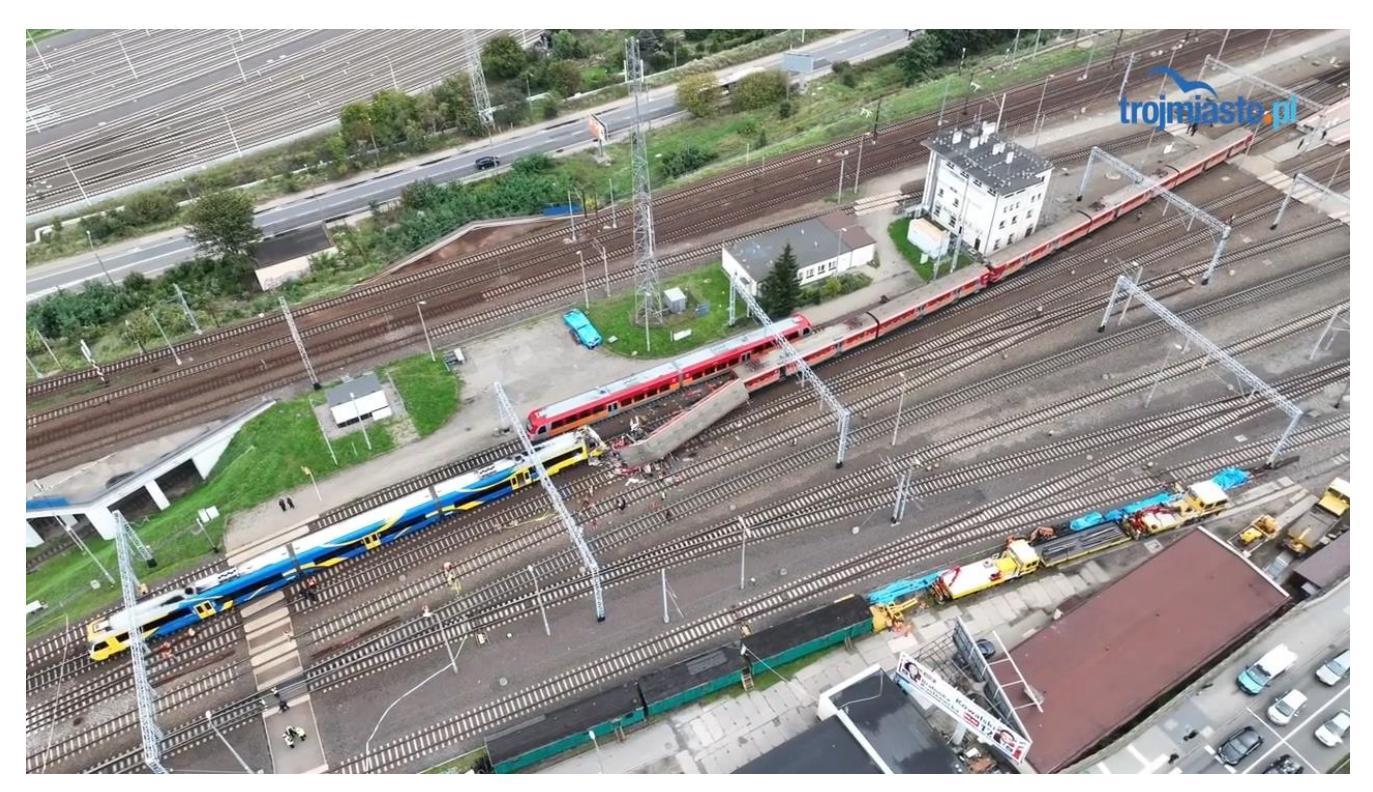
Photo 3 - View of the location of vehicles after the accident (source: trójmiasto.pl)

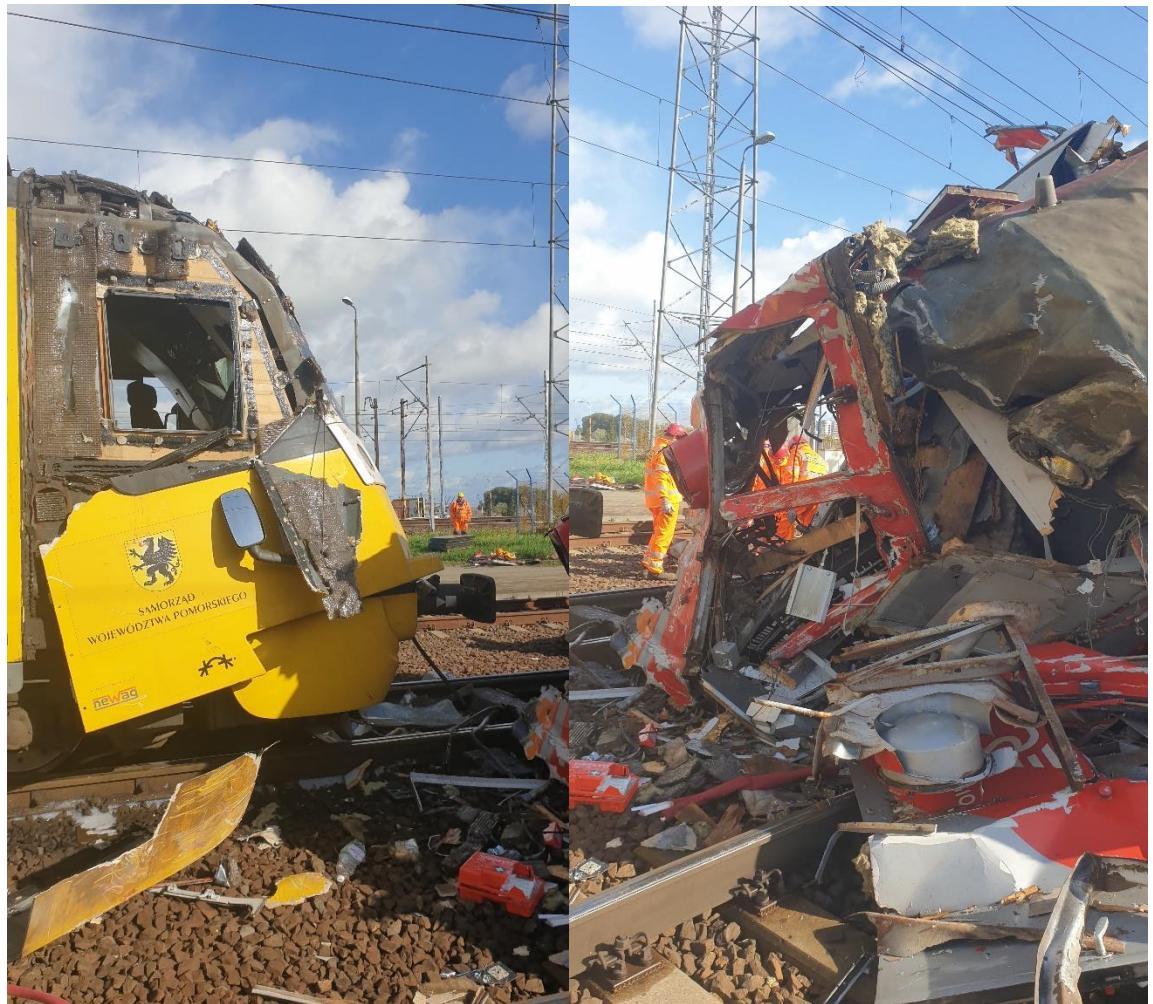
- EN57-1248ra: damaged frame, damaged wheelsets, damaged bogie frames, damaged lead coupler, damaged inter-car coupler, completely destroyed driver's cab and car structure, numerous dents in side wall plating,
- EN57-1248s: damaged frame, damaged wheelsets, damaged bogie frames, dented frame (from the direction of the ra car), bumper plate pressed into the frame, damaged bumper and bumper plate, damaged inter-car coupler (connecting cars s and rb), dented car body plating (right side from the direction of the ra car), dented wall from the direction of the inter-car door, dented wall from the direction of the windows inside the car,
- EN57-1248rb: damaged frame, damaged wheelsets, damaged bogie frames, damaged inter-car coupler (connecting cars s and rb).

SA138-004 railbus, segment A: damaged driver's cab structure, damaged draw and buffer gear, damaged pneumatic half couplings, damaged driver's console, damaged cab heaters, damaged windscreen, damaged side windows, damaged headlights, damaged electrical cabinet, damaged air-conditioning unit and air-conditioning ducts, damaged floor, damaged segment structure, damaged external plating, damaged two pairs of automatic doors, damaged window panes.

Photo 4 – Damage to rail vehicles after the occurrence (source: PKBWK)

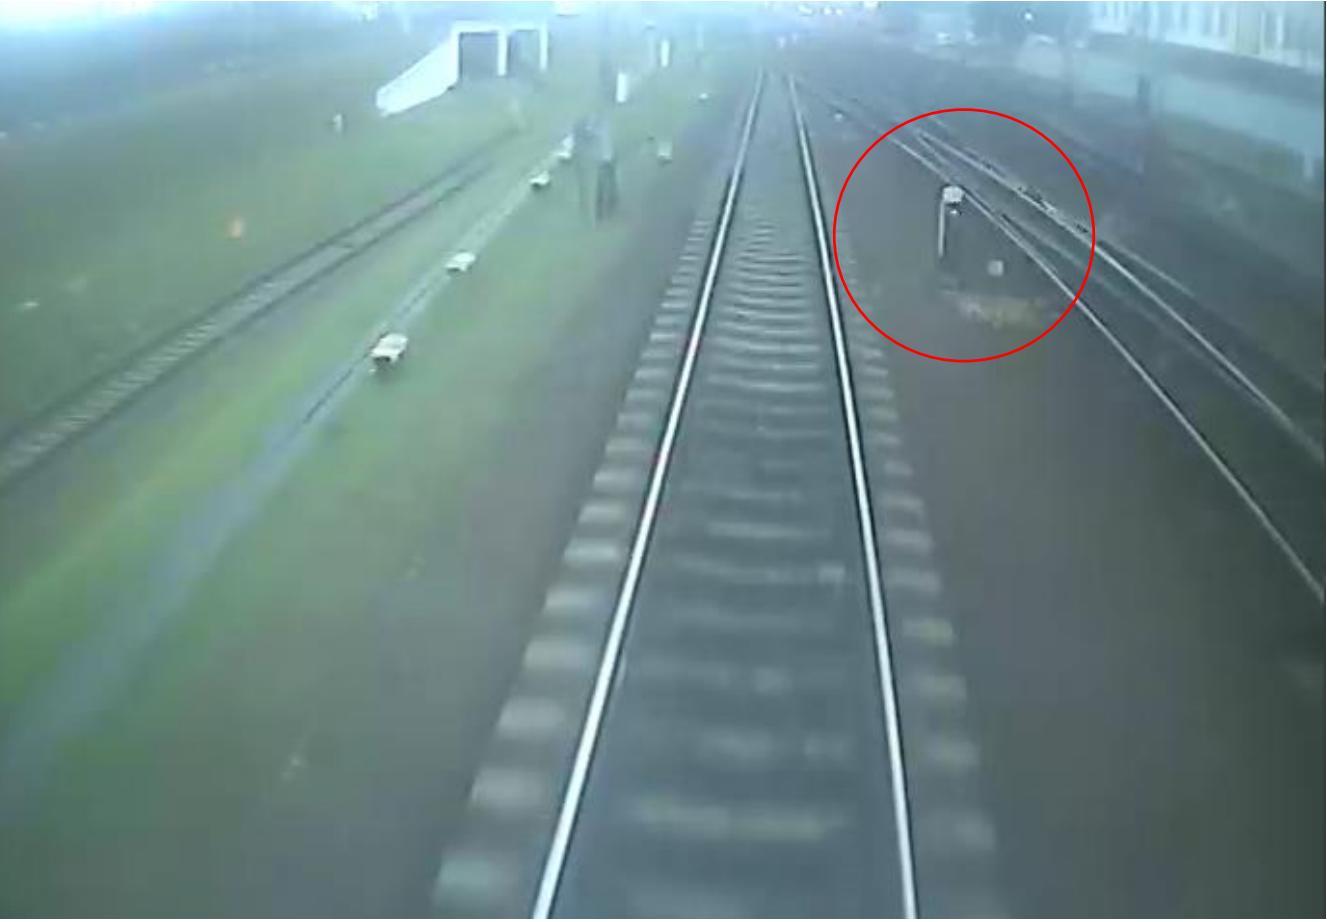
07:00:04 a.m. – the railbus runs past shunt signal Tm30 displaying aspect Ms1;

Photo 6 – View from the railbus of the shunt signal Tm30 displaying the Ms1 aspect (source: POLREGIO S.A.)

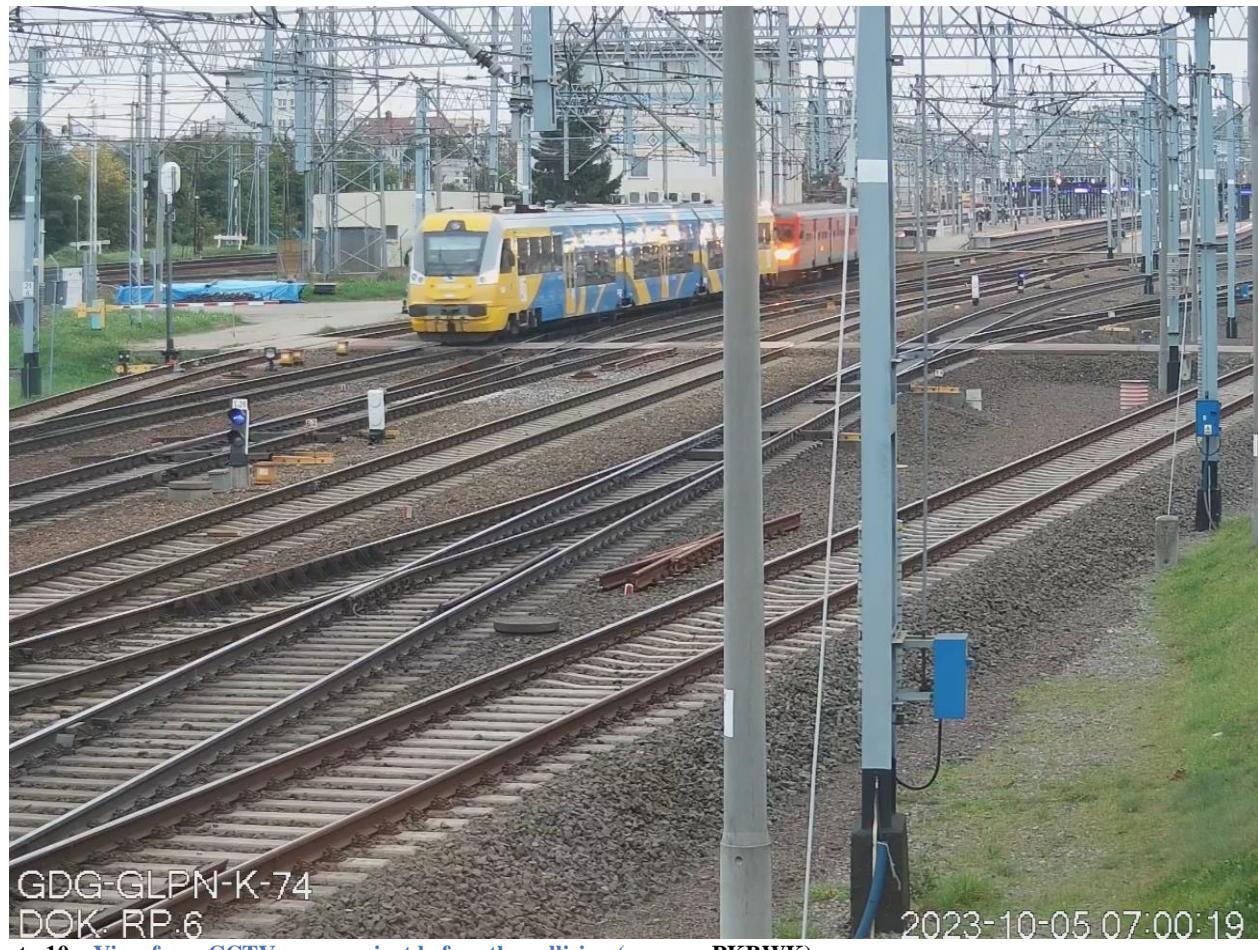
Photo 10 – View from CCTV cameras just before the collision (source: PKBWK)

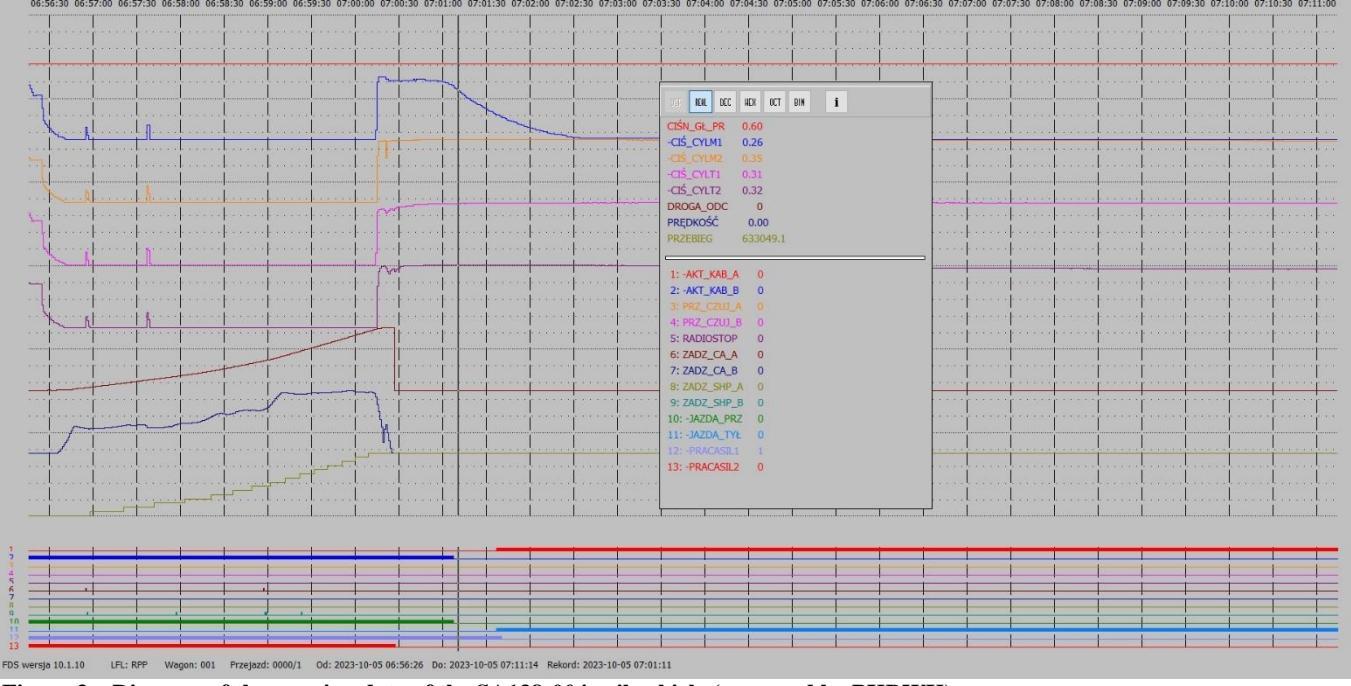
Figure 3 – Diagram of the running data of the SA138-004 rail vehicle (prepared by PKBWK)

The above irregularities, in the opinion of the Investigation Team, may be due to missing or incorrectly connected cables feeding signals from individual devices to the recorder.

- 3) The carrier POLREGIO S.A. will ensure that the running data of powered rail vehicles are correctly recorded in accordance with the real state.
- 4) Railway carriers shall include in their internal rules the need to carry out periodic inspections of the on-board recorders of rail vehicles to the extent and within the periods of time recommended by the manufacturers of the recorders and covering, in particular, the correct recording of the actual operating state of the vehicle. Inspections should be carried out by the recorder manufacturers or entities authorised by the manufacturers.

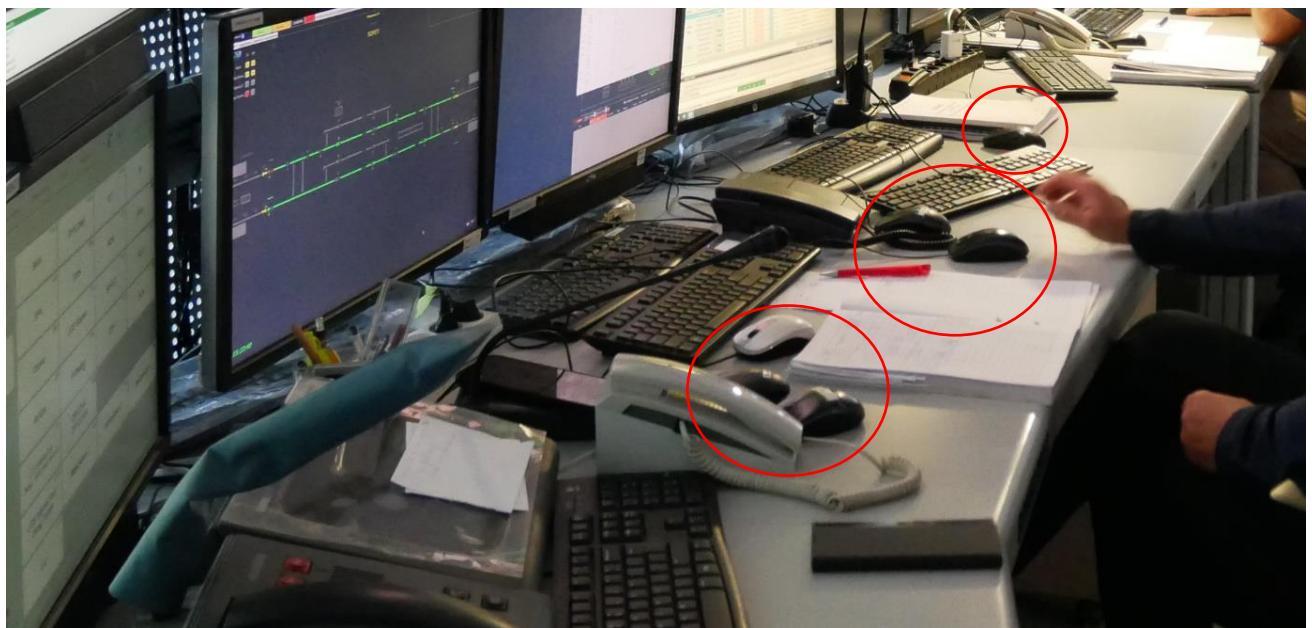
Additionally, the traffic operator at the operator station operates the equipment using several mice with the same appearance and profile, but only one mouse, not marked in any special way, is intended for the operation of the radio communication system and can be used to transmit, in particular, the "ALARM" signal.

Photo 12 - LCS GO operator's station (materials of PKBWK)

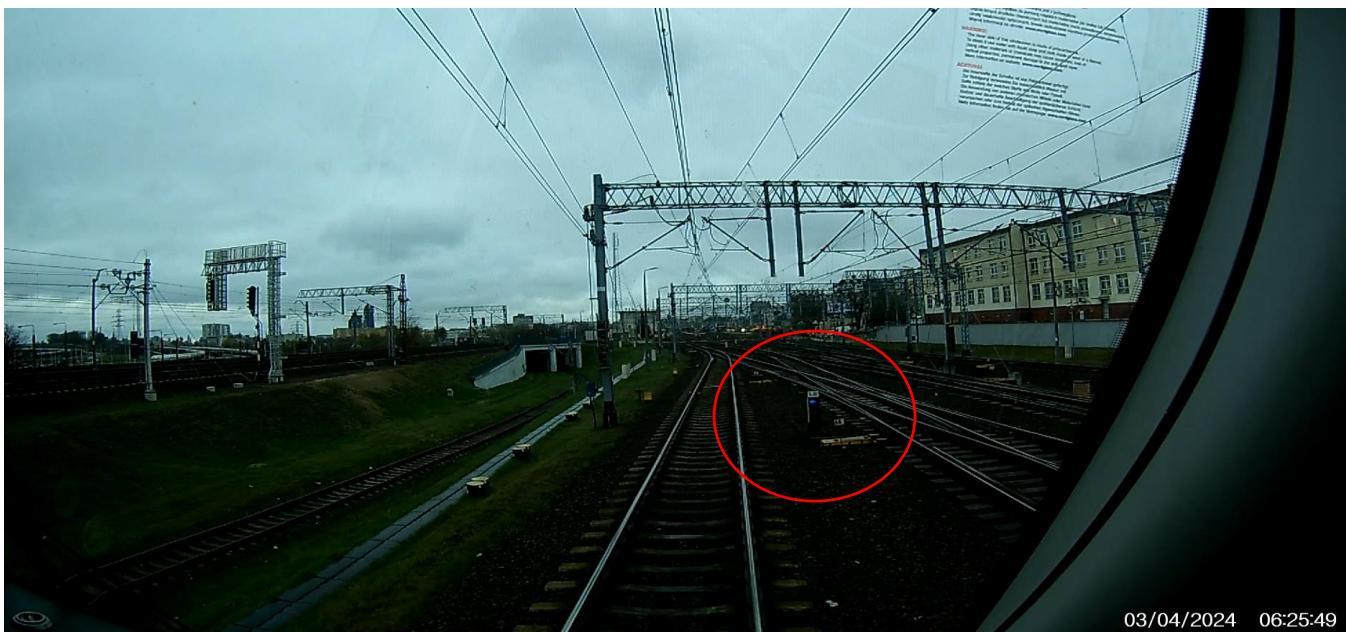
- 8) Limited ability to recognise the signals displayed in the daytime by the dwarf shunt signal Tm30 in sunny weather.

Photo 13 - Visibility of the shunt signal Tm30 displaying signal Ms1. (PKBWK materials)

- Infrastructure operator PKP Polskie Linie Kolejowe S.A. will undertake actions aimed at the elimination of irregularities found by the Investigation Team in the course of the investigation, and included in section V.3(6– 10).
