# **NIB ANNUAL REPORT 2017**

Safety Investigation Authority

FINLAND

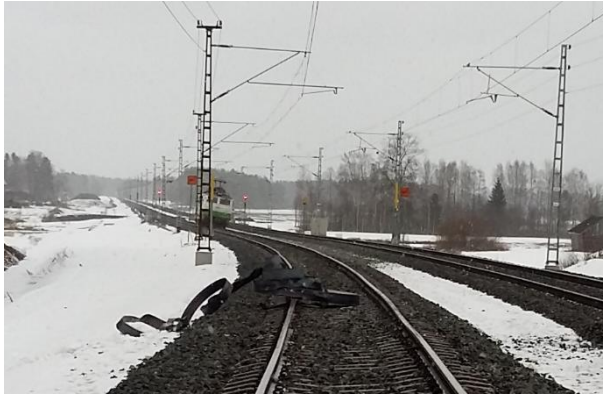
**R2016-02**

**Collision of a locomotive with a steel slit coil and derailment in Matkaneva 23 March 2016**

The driver of the locomotive that collided with the steel slit coil and was derailed sustained minor injuries. 257 metres of track and track equipment were damaged. The costs of repairs to the locomotive and the track caused by the accident amounted to approximately €500,000. The damaged track at the site of the accident was repaired and ready for operation by 25 March 2016, and the repairs were completely finished on 11 May 2016. Railway transport of slit coils was interrupted after the accident, and they were transported in lorries until 17 August 2016.

The immediate cause of the accident was the breaking of the radial straps holding the slit coil pack together. The break was preceded by the radial straps becoming loose and displaced during the handling and transport after they were bound at the factory. The loose radial straps allowed the slit coil pack to tilt during transport. The pack fell over and a slit coil fell off the wagon.

In order to avoid similar accidents, the Safety Investigation Authority recommends that the Finnish Transport Safety Agency (Trafli) ensure that the following recommendations on binding slit coil packs, loading them on a wagon as well as collecting and analysing safety information are implemented:

2. VR finds out the best placement for the coils in the wagons in order to improve the running characteristics of a loaded coil wagon and takes the results into account in the loading instructions.
3. In order to identify risks, SSAB collects information about deviations related to binding, storage handling and transport, and deals with them.

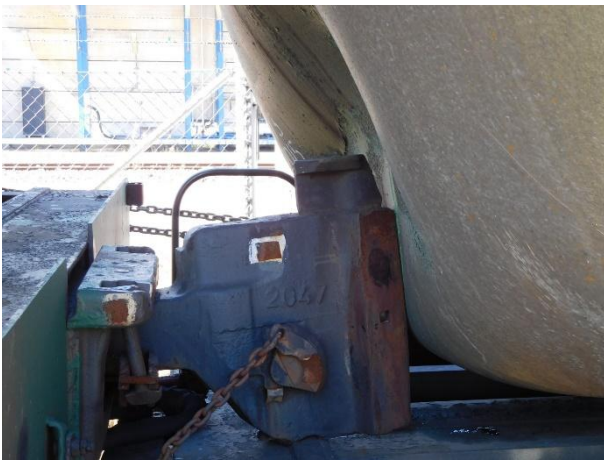
#### **R2016-03**

#### **Collision of tank wagons with buffer stop during shunting in Mussalo, Kotka, on 8 July 2016**

An emergency call was made to the emergency response centre nine minutes after the derailment. A lot of time was taken to notice the collision and raise the alarm, which was not important in this case, however. The delay was partly caused by the fact that there are differences between the instructions of different operators in the port area on raising the alarm about accidents.

The immediate cause of the accident was the placing of the shunting foreman during shunting, where he could not see the end of the track during the final stage of shunting. The choice of place

In order to avoid similar accidents in the future, the Safety Investigation Authority, Finland recommends that the Finnish Transport Safety Agency (Trafi) for its part ensure the implementation of the following new recommendations:

1. The Finnish Transport Safety Agency (Trafi) and railway operators should improve the supervision of shunting work.
2. Infrastructure managers are responsible for ensuring that the usable track length in railway yards are consistent regardless of the system.
3. Railway undertakings should comply with local emergency plans in ports and other areas where other companies are also operating.
4. Infrastructure managers should modernise buffer stops on tracks where shunting work is done related to the transport of dangerous goods.

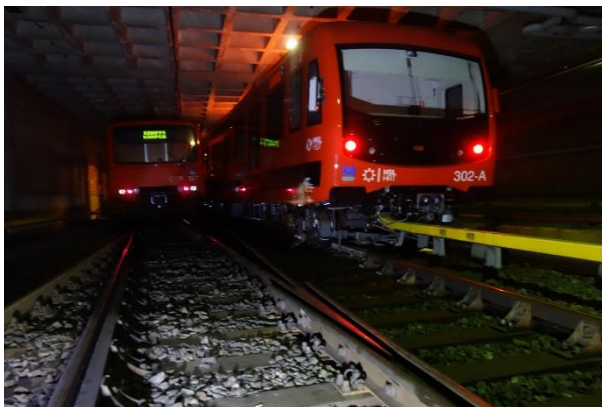
**R2016-04**

**Collision of metro trains in Itäkeskus, Helsinki, on 27 July 2016**

Several different levels of factors created conditions for the accident. The custom in Itäkeskus was to park teaching trains in the turnout area while drivers and traffic controllers took their breaks. Traffic control had not recognised the danger this posed to other traffic.

The actions of the driver of the test drive train also contributed to the accident. The driver failed to recognise the fouling point indicator and misjudged the space available for the over-take. The skills of the drivers contributing to the accident were inadequate, which in turn was due to shortcomings in the training system.

In order to improve safety and prevent accidents, the Safety Investigation Authority issues the following recommendations:

The Safety Investigation Authority also recommends that Helsinki City Transport ensure that recommendations S265 and S266 given by the Safety Investigation Authority in investigation report B2/2008R are extended to also apply to metro traffic.

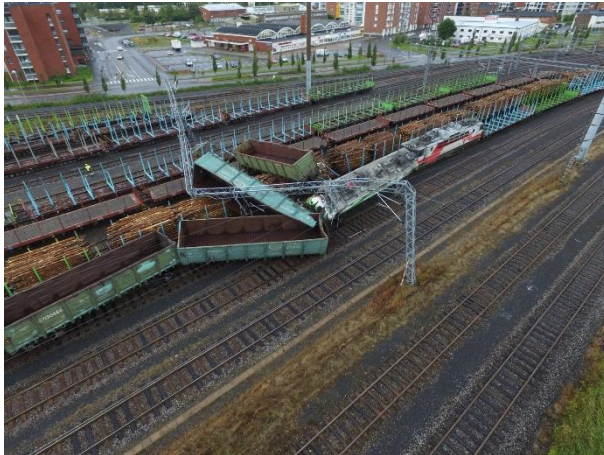
#### R2016-06

#### **Collision of a freight train with wagons standing on the tracks in the Oulu freight yard on 13 August 2016**

A freight train arrived on track 118 and collided with the empty wagons standing on the tracks at 16:49 at a speed of 33 km/h. The first two wagons standing on the track reared up due to the force of the impact. The first wagon that reared up broke the right front corner of the first locomotive on the side of its driving table. The second wagon damaged the electric railway portal. Finally, both wagons fell on top of the timber wagons on the neighbouring tracks. The third and fourth wagons standing on the track were derailed. The first locomotive of the train was derailed and tilted heavily to the left. In the accident, the engine driver was injured on the right side of the body.

Risk assessments conducted at the railway yard failed to identify the risks related to the working methods and practices used. For example, overlapping instructions that are not fully consistent were seen as a problem. Some instructions are drawn up for common use, but some of their content cannot be followed everywhere. The instructions are not consistent in all parts, and some of the actors do not know which instructions should be applied to which function.

Neither instructions nor training had been provided on the procedure used to protect a route. The procedure used by the switchman to ensure that the track was unoccupied led to the switchman failing to notice the wagons on track 118. The procedure used in route protection is vulnerable to errors. The switchman alone made the decision to protect the route, and this was not verified in any way.

In addition, the engine driver's attention prior to the collision had been on things other than driving the train. It is likely that greater attentiveness from the engine driver would have either prevented the accident, or at least considerably reduced the damage caused.

In order to avoid similar accidents in the future, the Safety Investigation Authority, Finland, recommends that the Finnish Transport Safety Agency (Trafi), for its part, ensure the implementation of the following new recommendations:

In its other comments, the Safety Investigation Authority states that if the intention in Oulu is still to protect the route of a train instead of using shunting operations, a route allowing trains to drive through the Oulu freight yard under the control and monitoring of centralised traffic control could be built at reasonable cost. For example, the route could be built via tracks 121 and 123 to the Nokela track, 208. All 17 switches of the route should be replaced by electrically operated ones, and the tracks should be equipped with indicators showing their unoccupied status.
