Bundesanstalt für Verkehr [Federal Office of Transport] Unfalluntersuchungsstelle des Bundes [Federal Accident Investigation Bureau] TrauzIgasse 1 1210 Wien Austria Tel.: 0043 (664)818 90 96 Email: <u>peter.urbanek@bmvit.gv.at</u> Web: http://versa.bmvit.gv.at **BUNDESANSTALT FÜR VERKEHR** [FEDERAL OFFICE OF TRANSPORT] Unfalluntersuchungsstelle des Bundes [Federal Accident Investigation Bureau] Bereich Schienenverkehr [Rail traffic area]

ANNUAL REPORT 2010

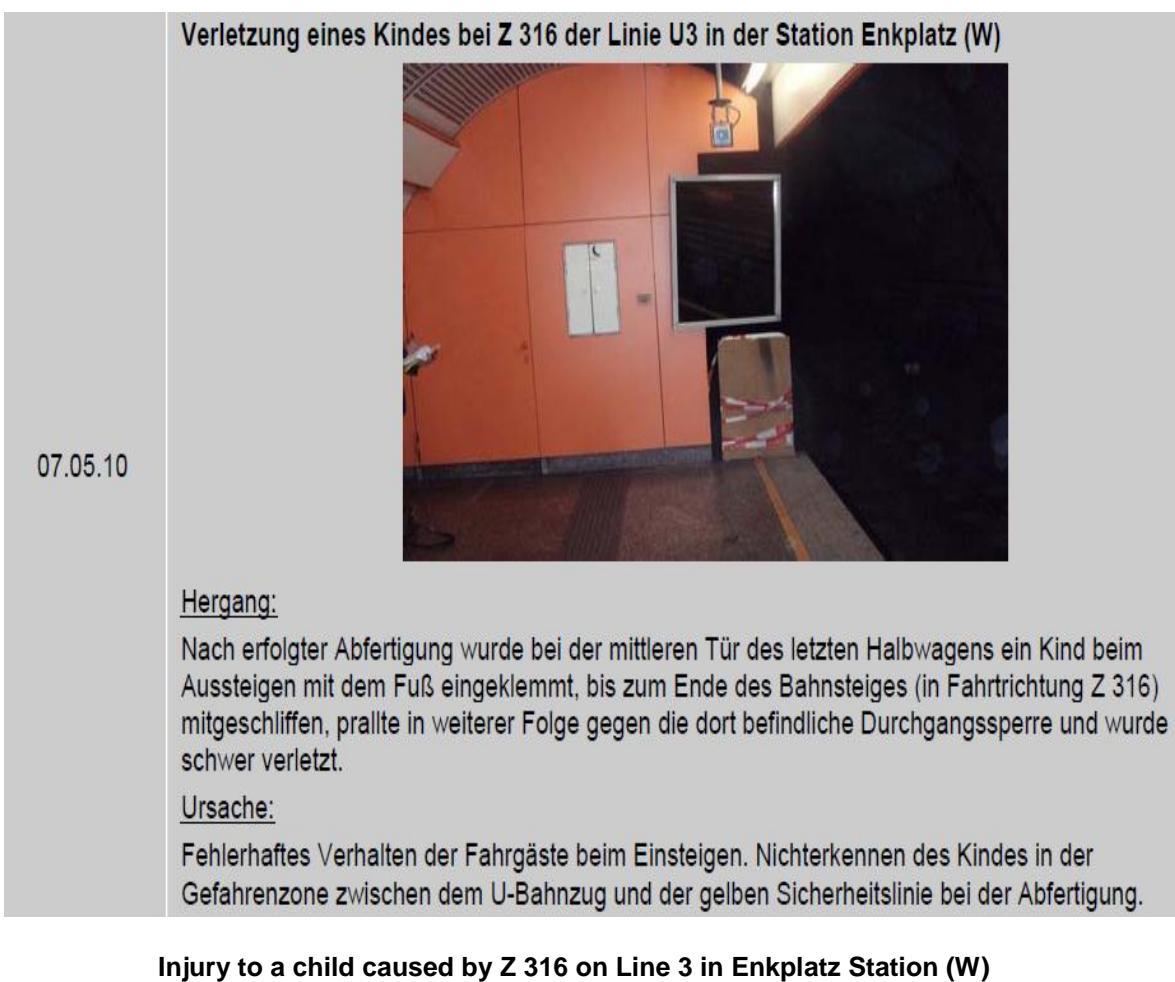
After the signal for departure had been given a child got its foot caught when trying to leave the train from the middle door of the last half coach and was dragged to the end of the platform (in direction of travel of Z 316), hit the passageway block that was there and was seriously injured.

Incorrect behaviour of passengers when boarding. Non-observance of the child in the danger zone between the underground train and the yellow safety line when getting ready to leave.

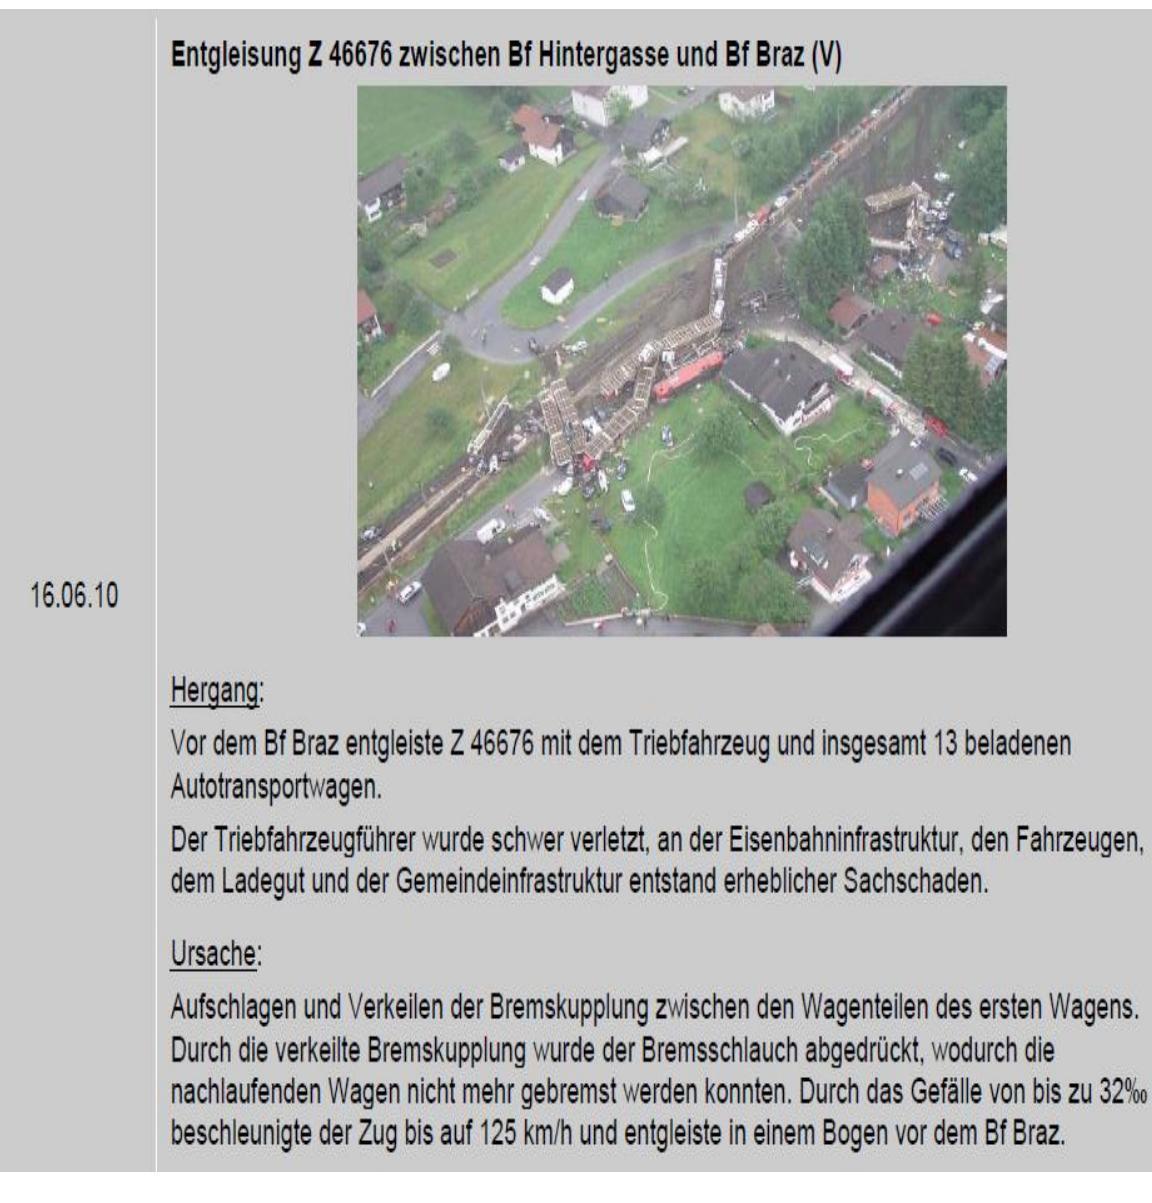
Derailment of Z 46676 between Hintergasse and Braz Stations (V)

The locomotive and 13 loaded car transporter wagons of Z 46676 were derailed just before Braz Station. The locomotive driver was seriously injured by the railway infrastructure. The vehicles, the payload and the local infrastructure suffered considerable damage.

Striking and blocking of the brake coupling between the parts of the first wagon. Due to the blocked brake coupling the brake hose was squeezed and the following wagons could no longer be braked. Because of the gradient of up to 32% the train accelerated to 125 km/h and derailed in a curve before reaching Braz Station.

Derailment of Z 46676 between Braz and Hintergasse Stations (V)
	 For car transporter wagons of type 23 87 437 2 xxx-x and the country code 'F' which have the same or similar design of the connection and suspension of the brake coupling between the two parts of the wagon (Figure 3 and 4) it is necessary to ensure that:
	 a safe support and fixing of the brake coupling is available (two wire clamps are available, wire clamps are tightly screwed up, undamaged wire cables as well as fixing clamps),
	 the height position of the brake coupling is guaranteed,
16/06/2010	 there is a minimum distance of 140 mm above rail for the parts of the screw coupling, the parts of the brake couplings and the suspension system.
	 Checking these parameters on the vehicles of Type 23 87 437 2 xxx-x and country code 'F' involved should be done as part of the wagon examinations in service and by a special examination in the ser- vice workshops of the vehicle owners.

For car transporter wagons of Type 23 87 437 2 xxx-x and country code 'F' which have the same or a similar design of the connection and suspension of the brake coupling between the two parts of the wagon (Figure 3 and 4), it is recommended that as a middle term measure the brake coupling between the two parts of the wagon should be replaced with a continuous air pipe without brake coupling.
	Collision of Z 72366 with a car on level crossing at Munderfing (OÖ)
29/06/2010	 Holding special information events locally on the subject of level crossings in general and the correct behaviour of road users in particular (e.g. in the community, in schools, directly at the level crossings, etc.).
	The focus of action of the executive direct on site at the level crossing.
	Collision of Z 4530 with a cyclist on a level crossing in Wolfsberg (K)
	 Rail and road side check on the level crossing. This includes, in particular, the assessment of the decision taken in 1999 in regard to the currently valid regulations as for example:
