# **ANNUAL REPORT 2013**

On the investigation of General Interest Rail Network Accidents and Incidents

Rail Accident Investigation Commission - CIAF, June 2014

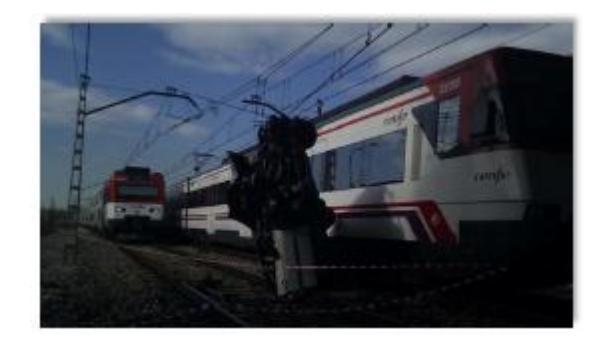
File	Date	Line	Manager	Operator	Place
0015/13	26/02/2013	930 Madrid Atocha-San Fernando de Henares	Adif	Renfe Operadora	Open track

Summary:	At KP 16+100 on line 930 Madrid-Atocha Cercanías at San Fernando de Henares, between San Fernando de Henares and Coslada stations, in the province of Madrid, commuter train 21626 owned by Renfe Operadora was travelling on track II between Coslada and San Fernando de Henares stations and, as it was approaching the overpass at KP 16+100 of the line, the driver noticed that there was a road vehicle that had fallen towards the track from this overpass, and had become suspended from the catenary of track II in the space between the tracks. The train came to a halt, without colliding with the vehicle and the driver informed the control centre.
	For its part, train 21809 was travelling between San Fernando de Henares and Coslada on track I, but the control centre was not able to advise the driver in time, so that the latter, upon becoming aware of the vehicle suspended on the catenary, applied the emergency brake and before coming to a halt the train hit the road vehicle side-on. The latter was not dislodged or dragged along. The driver of the road vehicle received minor injuries.

Conclusion:	The accident occurred due to encroachment of the track gauge by the road vehicle when it left a road overpass.
Final recipient	Recommendation
Adif	<b>15/13-1</b> To look into the possibility of requiring overpass construction projects to apply the current <i>'Circular Order 23/2008 on criteria for the application of metal railings on roads'</i> , from the Directorate General of Roads at the Ministry of Infrastructure and Transport.
Adif	<b>15/13-2</b> To look into the possibility of installing detectors of objects falling onto the line, linking these to the railway signalling, in cases where it is advisable due to the road and rail traffic and the existing installations make it viable.
