NIB ANNUAL REPORT 2012

Safety Investigation Authority

FINLAND

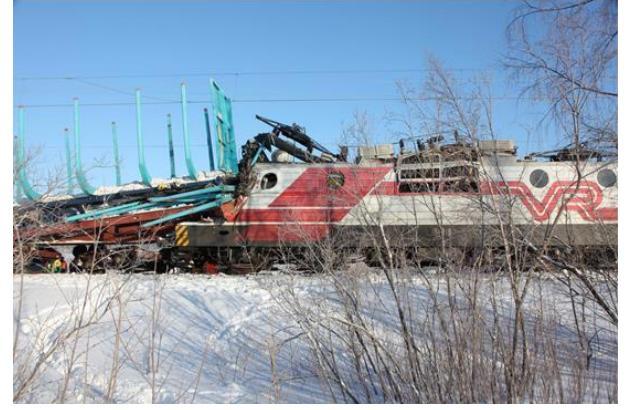
B1/2011R

Collision of a freight train with rear end of another freight train in Siuro, Nokia on 21 February 2011

A freight train, which had arrived to assist another freight train travelling to Mäntyluoto, Pori, collided with the end of the other train in Nokia, between Siuro and Suoniemi, at 4.05 am on 21 February 2011. The engine driver of the assisting train fatally injured in the accident. One wagon and the locomotive, which collided the end of the other train, were badly damaged and had to be scrapped. Additionally, one wagon was badly damaged, but was still repairable. The tracks were undamaged. Traffic at the accident site was interrupted for 14 hours.

The accident was caused by the erroneous location information of the train to be assisted. This led the driver of the assisting train to approach the location at too high a speed. He believed that the other train was further away. The investigation found that a failure of the charge voltage regulator of the Dv12 locomotive serving as the leading locomotive led to the need for assistance which precipitated the accident. This caused the locomotive battery voltage to drop, which in turn stopped the locomotive. The driver of the train to be assisted had little experience of Dv12 locomotives and their problem solving procedures. This was a factor in the driver failing to note the low battery voltage. Darkness and the track geometry led to the driver of the assisting train's failure to notice the other train in time. At the speed he had attained, he was unable to prevent the collision.

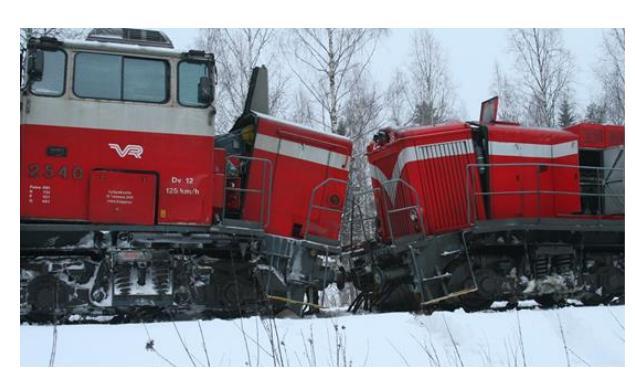
C1/2011R

Collision of freight trains in Nurmes on 2 February 2011

A collision between a freight trains occurred in the direction of Lieksa, two kilometres from the Nurmes yard, on Wednesday 2 February 2011 at 11.55. Both the engine driver and traffic controller in the locomotive were injured, while both locomotives sustained major damage.

The immediate cause of the accident was the cancellation of interlockings necessary to signal box safety, thus allowing the trains to use the same track. The insulation fault, frequency of critical commands, inadequate train location information and inadequate communication all contributed to the accident. Apparently, the traffic controller believed that train 4713 was already at the Nurmes yard. Despite having spoken to the engine driver, the controller did not realise that this train was standing at the entry signal.

- Traffic control personnel should undergo regular training and drills, with a special focus on identifying hazards related to error situations and adopting pre-defined, safe procedures.
- Safety management should have a particular focus on punctuality and consistency of communication, as well as accuracy of train location information.
- On all axle counting sections, a prerequisite for emergency resetting should be that axles exiting the section are the final ones counted at an axle counting point.

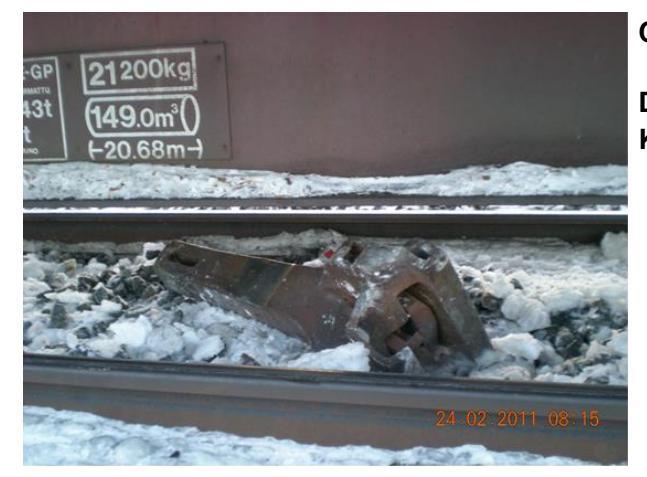
C2/2011R

Derailment of locomotive bogie wheelset in Kolppi on 24 February 2011

An accident occurred at 4.55 am in Kolppi, Pedersöre on Thursday 24 February 2011, due to the derailment of the front bogie wheelset on the second locomotive of a freight train travelling from Kokkola to Pietarsaari. The locomotive, one turnout, and 163 sleepers were damaged, with total repair and clearance costs amounting to 132,000 euros. The accident prevented all traffic on the section of line for nine hours.

Taking all factors into account, accidents of this type are statistically rare. Nevertheless, to prevent similar accidents the Safety Investigation Authority recommends that all SA3 automatic coupler draft clips without screw holders be replaced with clips with screw holders. The Authority further recommends that traffic controllers be issued with clear instructions on how to obtain immediate advice in exceptional situations, in order to solve problems safely.

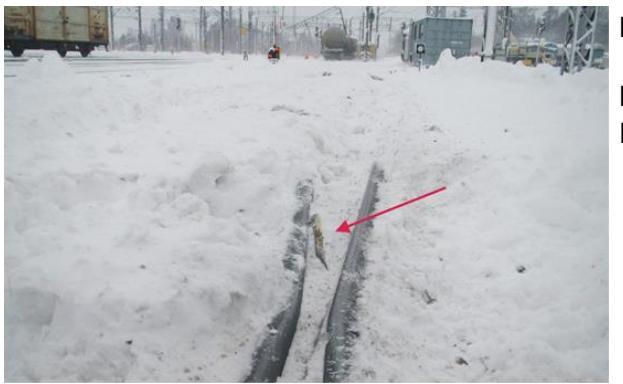
R2012-01

Derailment of two freight train wagons in Kouvola railway yard on14 January 2012

The accident was caused by a stop block left under the train. Difficult weather conditions and darkness made it difficult to see the stop block. Additionally, the brake tester responsible for removing the stop block decided to perform an extra shunt on the train in place of standard procedures, because the train had moved too far alongside the shunting signal.

The Safety Investigation Authority made two recommendations. The operator should improve the visibility of the stop block and develop its yard work instructions in order to take account of all situations that arise during normal work. Instructions important to safety should be presented as a checklist.

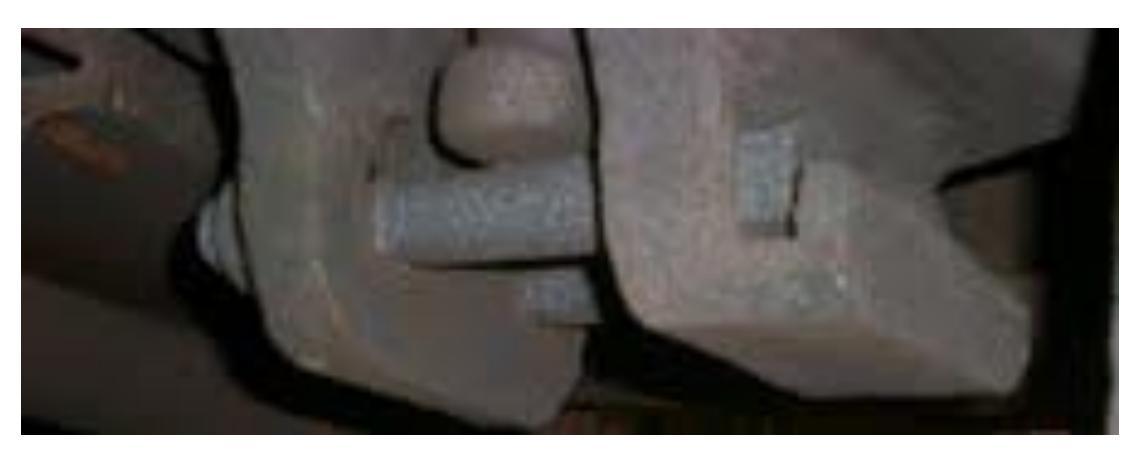
In the case of SA3 automatic coupler draft clips without screw holders, the hex screws supporting the bolted key can slide out of place when the nut is missing. In the version with the screw holder, the head of the hex screw enters the holder, preventing the screw from sliding and falling off when the nut is detached. Only a fraction of all SA3 automatic coupler draft clips have no screw holder. For this reason, the Safety Investigation Autority recommends that the Finnish Transport Safety Agency ensure that VR Group takes the required actions to implement the following recommendation:

Figure 6. SA3 automatic coupler draft clip with screw holder.

SA3 automatic coupler draft clips without screw holders should be replaced by ones with such holders. [C2/11R/S307]
