Railway Accident Investigation Unit Ireland

Annual Report 2019

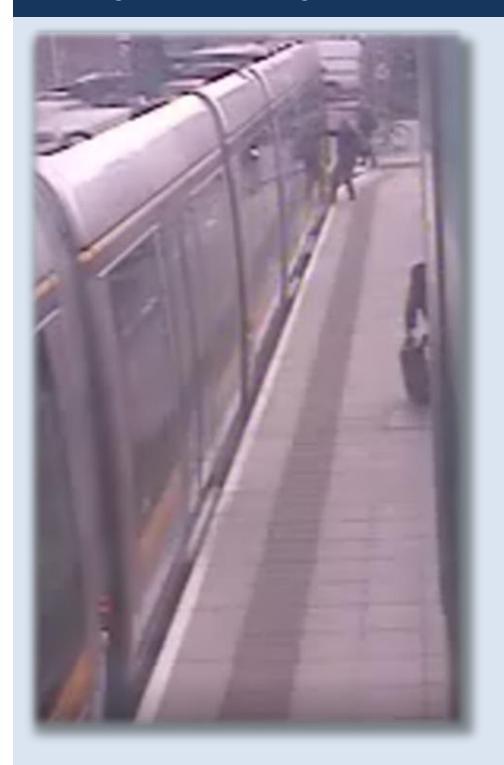
Passenger trap-and-drag occurrence on Luas tram at Heuston Stop, 26th March 2019

On the 26th March 2019, at approximately 14:22 hrs, a male passenger attempted to board inbound Luas tram, Tram 3011, at Heuston Stop. The passenger placed his hand between the door leaf and the door pillar of the rear most entrance door as the door was closing. The passenger's hand became trapped in the door seals. The door obstacle detection system did not detect the presence of the hand as it was less than 10 millimetres (mm); the door operation mechanism allows 10 mm obstacle detection to facilitate door closing.

The tram departed Heuston Stop nineteen seconds after the doors were closed with the passenger's hand trapped in the door. Two security staff came to the passenger's assistance, with one of the security staff communicating with the driver by radio.

and the passenger walked along the platform with his hand trapped in the door seal for five seconds before the security staff assisted in freeing the passenger's hand from the door. The tram came to a stop four seconds after the passenger had freed his hand.

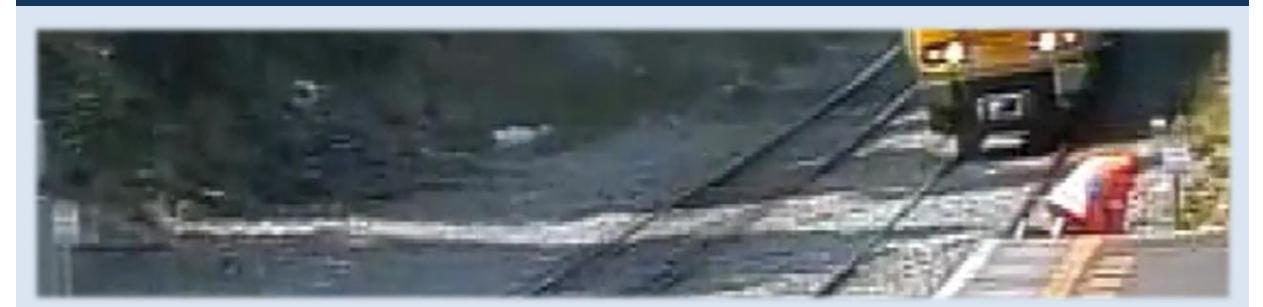
Near-miss collision between a train and an IÉ-IM staff member, at Rush and Lusk Station, 20th June 2019

At approximately 09:50:31 hrs, on the 20th June 2019, a member of IÉ-IM's SET Department's staff (to be referred to as SET Worker) accessed the railway line at Rusk and Lusk Station and began walking on the railway line (Up Line). The SET Worker was accessing the railway line to inspect electrical equipment associated with a nearby SET location case.

Seven seconds later the SET Worker sees the 08:00 hrs Belfast to Connolly passenger train approaching on the Up Line and starts to walk towards the other railway line (not occupied by the train, the Down Line). At 09:50:42 hrs, while standing in the middle of the Down Line, he raises his hand above his head to acknowledge the presence of the train, he is not in a position of safety. Two seconds later (09:50:44 hrs) the SET Worker walks across to the Down Platform and leans his elbow down on the platform and raises his other hand to acknowledge the train for a second time, he is not in a position of safety.

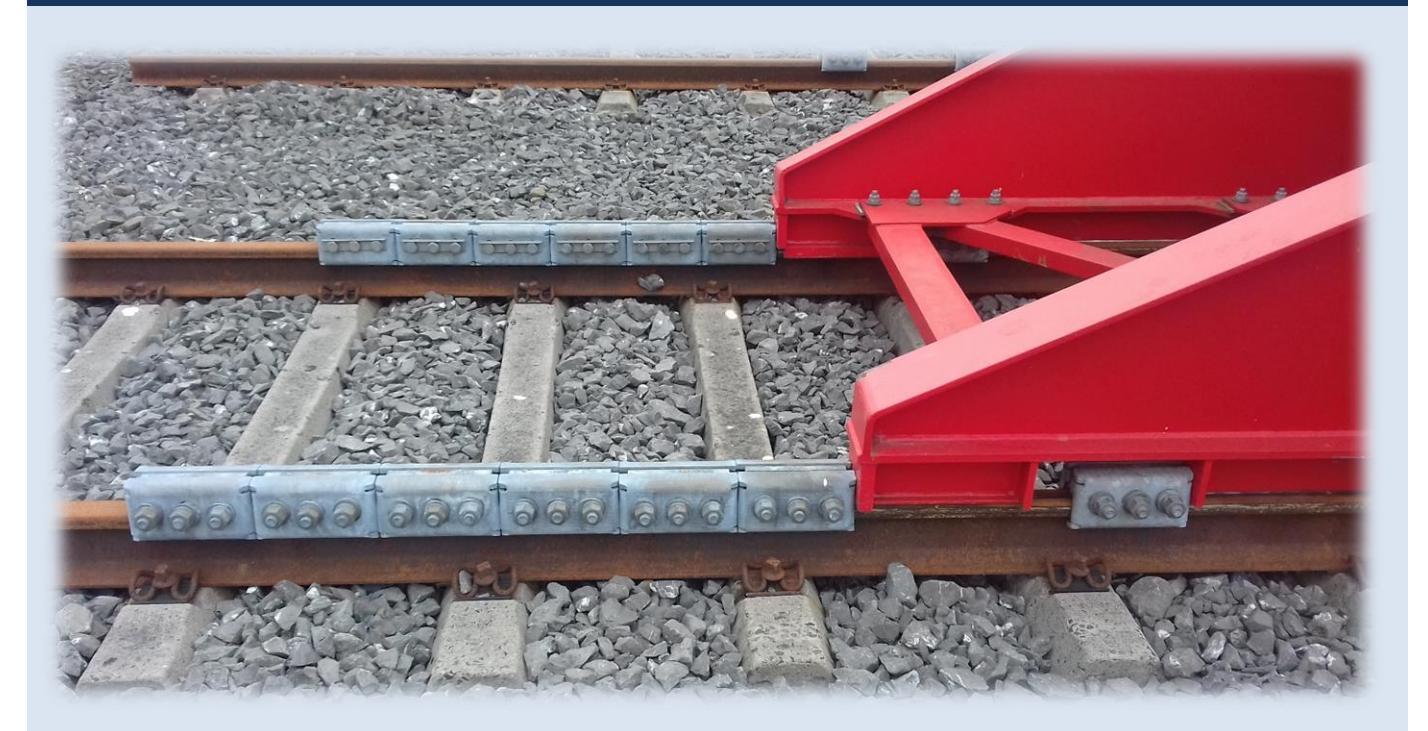
RAIU Report No: R2019 - 002

On the 17th July 2018 an IÉ ICR, set 16 (ICR 16), was required to be shunted from Road 6B to Road 8 in LTCD to allow maintenance repairs to be carried out on the set following a collision with cattle at Tullamore on 28th June 2018.

The immediate cause of ICR 16 colliding with the buffer stop at LTCD was as a result of ICR 16 bee driven with no operational brake on the train.

- The formal and informal processes in place for: the use of Not To Be Moved Boards; the labelling of defective vehicles; and the communication of train statuses, was not sufficient in notifying the staff at LTCD of the issues with ICR 16;
- The suite of LTCD documentation does not refer to the ICR Hauling Assisting Instructions which would have ensured that ICR 16 was sufficiently braked while stabled.

- IÉ-RU CME should review their Portlaoise Train Depot Safe System of Work & Operating Instructions (SSOW & OI) and
 associated documents related to the identification, communication and prevention of movement of defective vehicles to
 ensure relevant staff are made aware of identified defects and that the defective vehicles are adequately labelled and
 tagged; and these processes and staff responsibilities are fully understood by all CME staff working on trains;

- IÉ-RU CME should review its training and competency of CME Drivers and Limited Shunters ensuring the stabling and movement of vehicles (defective or otherwise) are adequately addressed;

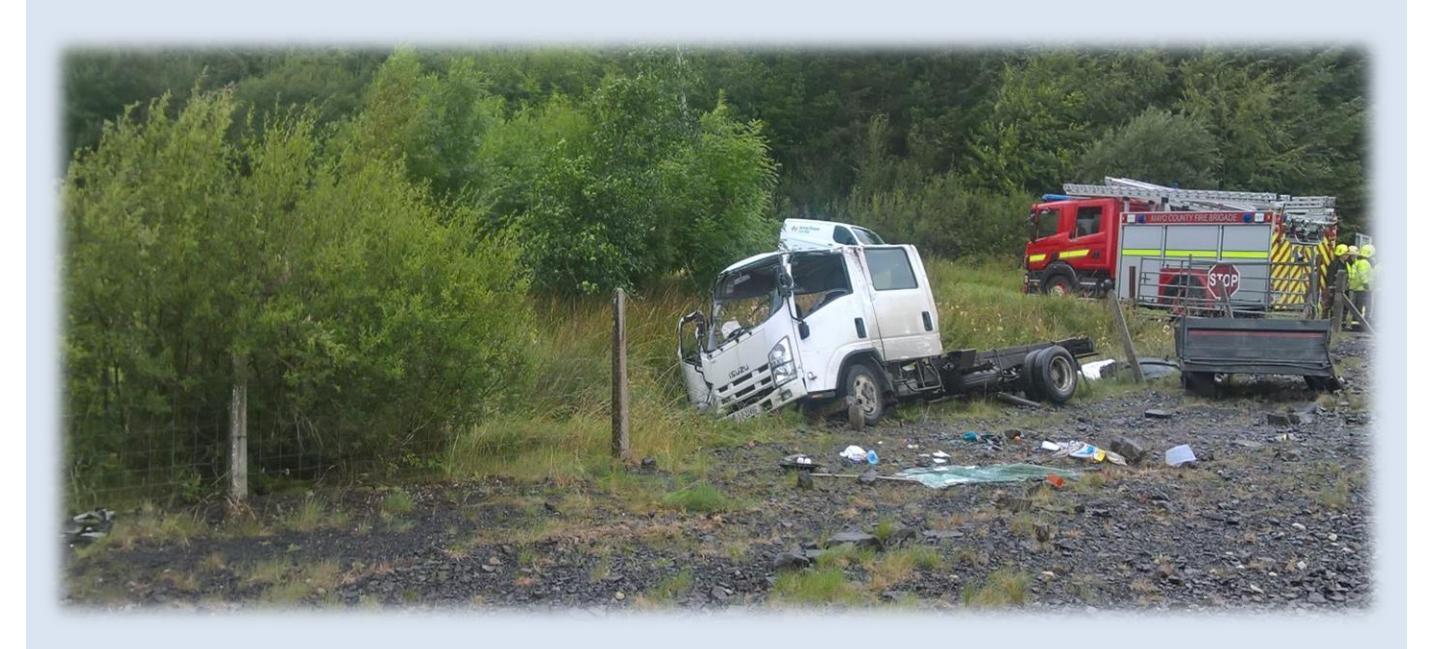
RAIU Report No: R2019 - 003

At 08:47:03 hrs a Mayo County Council truck (Truck) approached and drove onto Cartron Level Crossing, IÉ-IM asset number XM220 (LC XM220) and drove onto the Level Crossing. At the same time, the 08:15hrs Ballina to North Wall Dublin goods train, Train K801, was approaching and travelled through the level crossing, striking the truck.

On impact the truck was thrown clear of the train and into the adjacent ditch before coming to a stop, the truck driver was dazed and subsequently left the scene with two colleagues before emergency services arrived and was later treated at Mayo General Hospital. The driver of train was also conveyed to Mayo General Hospital from the scene by ambulance, he was treated for shock.

The immediate cause of the accident was that the Truck Driver did not stop at LC XM220 to look for approaching trains, as required; but instead drove onto LC XM220, into the path of the oncoming train. Contributory factors associated with the accident are:

- The gates at LC XM220 were left open by the previous user (which was normal at this level crossing), allowing the truck to drive onto the track without stopping to look for approaching trains;
- The Truck Driver may have been distracted due to the driving manoeuvre and works he was about to undertake and the weather conditions at the time;
- On the approach to LC XM220, the Truck Driver was not thinking about approaching trains; the traffic calming measures on site (such as the advance warning signs) may not be adequate at communicating to the users that they are approaching a railway line.

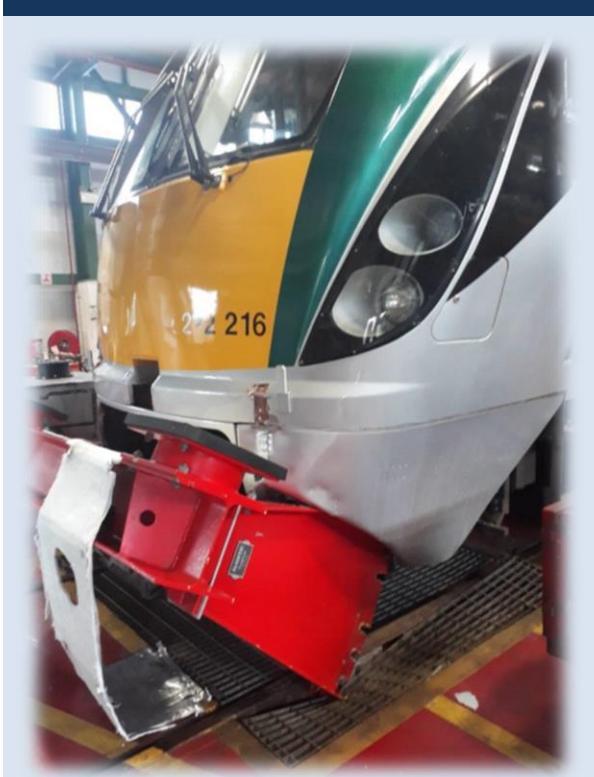
Collision of an ICR with a fixed buffer stop at Laois Train Care Depot, 6th July 2019

While undergoing maintenance intervention on Pit Road 8, LTCD, ICR 16 was moved approximately 8.25 meters under its own power before colliding with a fixed buffer stop.

The fixed buffer stop was significantly damaged.

- IÉ-IM should review the selection of fixed buffer stops at locations at LTCD for their suitability and efficacy in protecting staff and infrastructure;
- IÉ-IM should conduct review of their current specification for fixed buffer stops and their associated design forms to ensure they are fit-for-purpose; and fixed buffer stops are only selected where appropriate. Based on this review, IÉ-IM should commence a programme of inspections for fixed buffer stop at all locations on the IÉ network to ensure their suitability and effectiveness at protecting passenger, staff, track and infrastructure.
