Ministry of Economic Affairs and Communications of the Republic of Estonia Emergency Management Department Unit for Investigation of Railway Accidents

Annual report of railway accidents investigated in 2007

Tallinn 2008

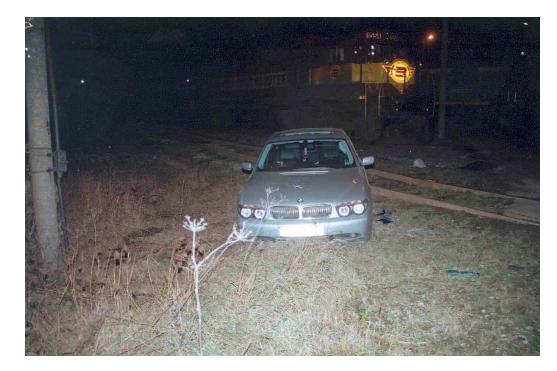
Maardu level crossing on 16.12.2006

At night, at 00.57 a diesel locomotive of train no. 4201 collided with a BMW car at Maardu automatically regulated level crossing.

The locomotive of train was approaching the level crossing at low speed of 16km/h. The traffic lights at the crossing were functioning and the exterior of the locomotive was illuminated. The car was approaching the level crossing at high

speed in order to cross it before the locomotive reached the crossing. As a result of collision there were neither casualties nor injuries, the locomotive and car suffered slight damages. The driver had no right to drive (no driving licence).

As a result of investigation it was recommended in the context of general railway safety to analyse the speed limits established for trains, to take a census of road traffic intensity. Relevant institutions were recommended to take a position as regards possible equipping of the level crossing with a barrier.

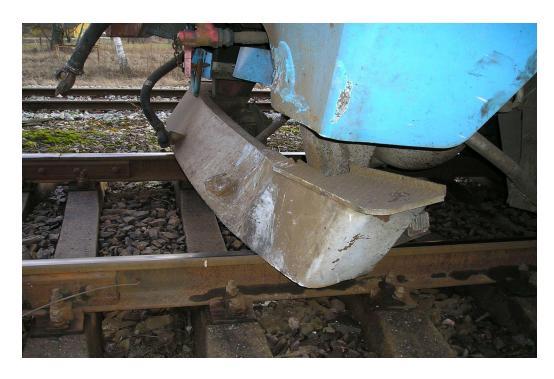
Antsla on 27.12.2006

In the daytime, at 13.57 a freight train collided with a Ford Mondeo car at Antsla automatically regulated level crossing. In the conditions of limited visibility due to low sunlight the driver drove to the level crossing ignoring the signal of flashing red lights, the simultaneous sound signal and the traffic sign "Stop and give way" and was not making sure that no rolling stock was approaching. As a result of collision

both the locomotive in front of the train and the car suffered damages, but there were no human injuries

The driver's driving manner and negligence concerning traffic safety in combination with low sunlight disturbing the visibility of traffic lights were the causes of the accident

The driver was recommended to analyse his driving manner in order to improve traffic safety and the railway infrastructure undertaking was recommended to install signal background plates of appropriate size to compensate possible low sunlight.

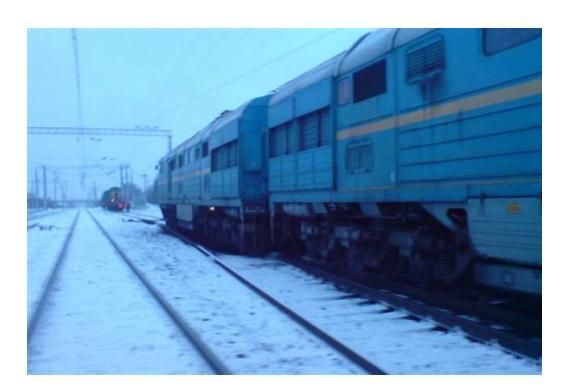
Lagedi on 13.01.2007

Early morning, at 05.34 a freight train drove past signals with prohibiting traffic lights at Lagedi station. After that the locomotive crew switched the prohibiting red light over into white. The train continued moving and cut through the switch no.6 and then stopped. Reacting to the front lights of an oncoming train the train started to reverse. This resulted in the derailment of the locomotive. There was

immediate danger of the collision of two trains. There were no casualties and nobody was injured in the accident. Railway infrastructure suffered damages, but the locomotive was not damaged.

By the time of driving past prohibiting traffic lights the locomotive crew had lost vigilance. One reason of that could have been tiredness. They had started work previous night at 23.00 and the break for rest before that had been 7.5 hours. It was established after the accident that the locomotive driver was intoxicated by alcohol. In order to prevent such accidents the rail transport undertaking was recommended to revise the regulations for permission of locomotive crews to work, to draw up a training programme of operation in critical situation for locomotive drivers, to revise the principles of alternation of work and rest time and to ensure sufficient periods of rest so that they would come to work well rested. The railway infrastructure undertaking was asked to review the interaction of the entry and exit traffic lights and

work of isolated areas of the station, and to ensure switching off the entry traffic lights if rolling stock passes the exit traffic lights and vice versa. The Railway Inspectorate was asked to review "The Rules for technical use of railway" to have abetter definition of the requirements for pre-shift control of locomotive crews. In addition they were asked to take a position concerning the instructions on the maintenance of national railway tracks and on the instructions of technical service of signal interlocking, blocking devices and automatic signalling and automatic stopping devices of locomotives.

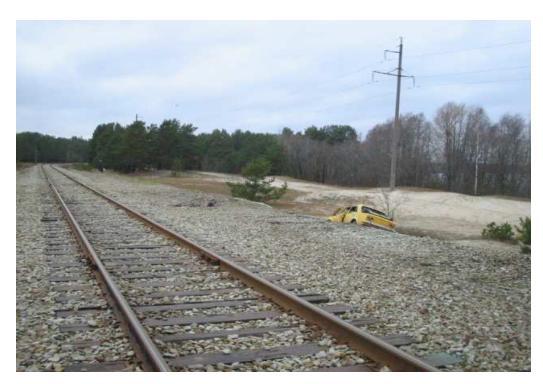
Pärnu on 14.01.2007

In the evening, at 19.05 a passenger train collided with a VAZ car left in the structure gauge of railway, but not on the level crossing.

The driver of the car had no right to drive and had decided to drive to his destination along remote forest and dirt roads. The trackside covered with crushed stone on the track bed next to rail tracks was wide enough to drive a car there and he

continued driving on the track bed, next to rail tracks. The driver met his friends and at some moment decided to turn the car back. The trackside was not wide enough and during manoeuvring the left front wheel of the car crossed the rail. The driver could not finish the manoeuvre and the car stopped. A train appeared from behind a curve and seeing it the driver and his companions panicked. They abandoned the car and ran away. Collision followed. The train hit the side of the car and the car was thrown off the railway structure gauge. The train stopped. The car driver had failed to meet the following requirement - receiving of approval from the rail dispatcher concerning staying in the rolling stock structure gauge.

As a result of collision the car became unfit for use and the front part of the motor car of the passenger train suffered minor damages. There were neither casualties nor human injuries in the accident.

In order to improve traffic safety the railway infrastructure undertaking was recommended take measures to limit access of occasional drivers to the crushed stone on trackside of track bed. The Railway Inspectorate was asked to assess the need and expediency of specifications added to legal acts concerning possible occurrence of unauthorised objects in the structure gauge of rolling stock on open track.

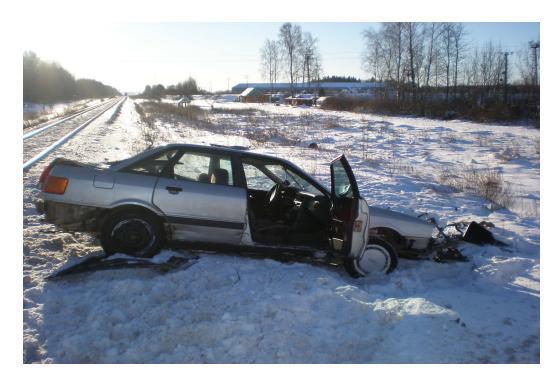
Tiksoja on 29.01.2007

In the morning, at 10.00 a passenger train collided with an Audi car at Tiksoja automatically regulated level crossing.

The car driver, deep in his thoughts, had been driving at stable speed, not exceeding the speed limit. He did not pay attention to traffic signs which were warning him of approaching a level crossing. He was not aware of the flashing red traffic lights ahead and did not hear any sound signals.

There were neither casualties nor human injuries in the accident. The diesel train suffered damages and the car became unfit for use.

In order to improve traffic safety it was recommended to install additional devices to the level crossing, to carry out the census of road traffic intensity and to take a position concerning grade-separating the railway and roadway in future.

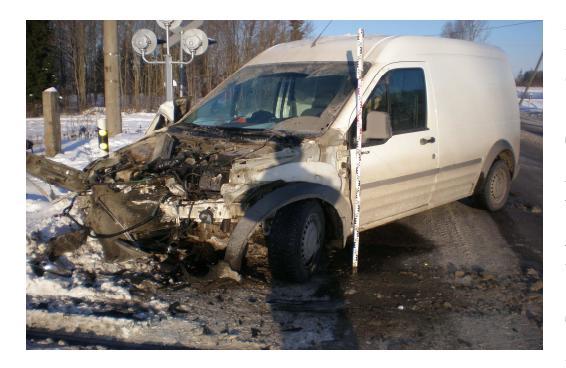
Nõo on 01.02.2007

In the morning, at 10.02 a passenger train collided with a Ford Transit van Nõo at automatically regulated level crossing.

The driver crashed into the side of the passenger train driving too fast on a slippery road with low sunlight blinding him. The accident was caused by wrong assessment of circumstances by the driver. There were neither casualties nor human injuries in the accident. The first railcar

trailer and the front of the van suffered damages.

In order to improve traffic safety it was recommended to plan measures for ensuring better visibility of traffic lights in low sunlight and efficient implementation mechanisms for carrying out sufficient winter maintenance of roads.

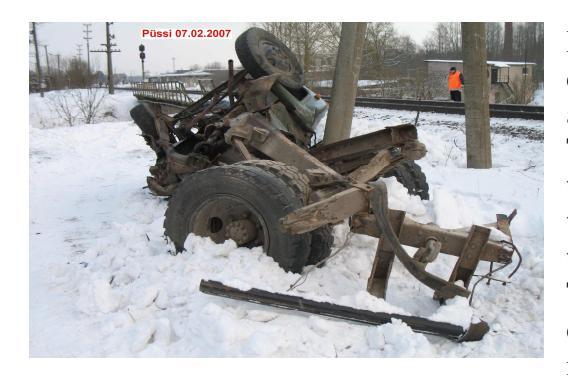
Püssi on 07.02.2007

Before noon, at 11.29 a freight train collided with a GAZ truck at Püssi automatically regulated level crossing.

The truck was driving at low speed along the road, covered with soft snow, parallel to railway tracks, and was making a turn to the left in order to cross the rail tracks. The red flashing traffic lights were directed at the approaching truck and indicated that the level crossing was

closed. The driver was busy keeping the truck on the road and did not pay attention to prohibiting traffic lights. He should have stopped or if impossible, should have continued driving. He drove the truck to the rail tracks and the truck was hit by the train. The driver's inattentiveness was the direct cause of the accident. The driver died in the accident. The truck was deformed and became totally unfit for

The driver died in the accident. The truck was deformed and became totally unit for use. The first section of the double locomotive in the front part of train was damaged. The signalling devices of railway infrastructure also suffered damages. In order to improve traffic safety it was recommended to review the principles of organisation of winter maintenance of roads, to plan for closing down of Püssi level crossing and to reroute street traffic to a less dangerous level crossing situated in the vicinity.

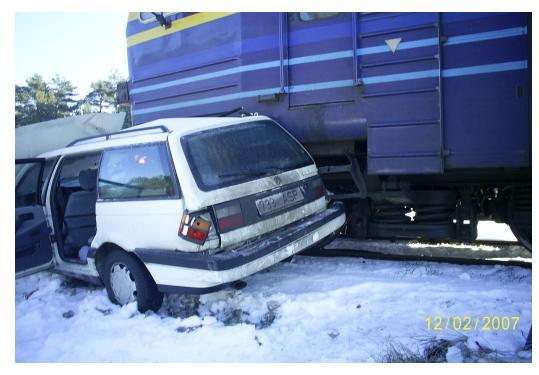
Kloogaranna on 12.02.2007

In the morning, at 10.02 a passenger train collided with a Volkswagen Passat car at Kloogaranna unregulated level crossing. The car driver was ignoring traffic signs in the conditions of low sunlight and hoped to be lucky, but drove into collision with the passenger train. Since it was winter the road conditions were not very good and the accident was caused by the wrong driving manner of the driver.

The driver suffered slight bodily injuries. A car of the passenger train and the right side of the car suffered damages. In order to improve traffic safety it was recommended to draw special attention to changes in traffic intensity and accordingly plan equipping of level crossings with necessary devices. In addition it was recommended to review the contractual obligations of companies responsible for winter maintenance to ensure effectiveness of work done.

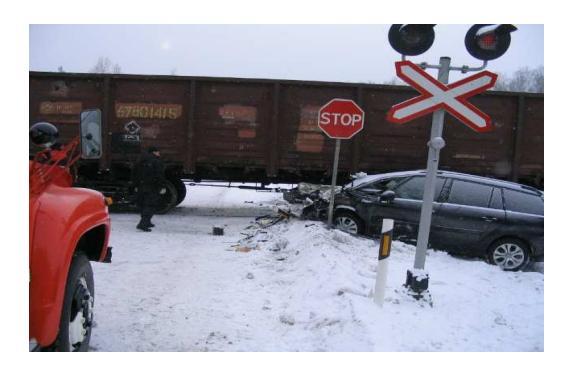
Ilumetsa on 20.02.2007

In the afternoon, at 14.28 a freight train collided with a Citroen Picasso car at Ilumetsa automatically regulated level crossing.

The roadway was slippery, covered with hard-packed snow and it was snowing. Driving on the straight road the driver did not reduce speed and did not pay attention to the signs warning him of approaching a level crossing. He did not look far ahead

The accident was directly caused by the fact that the driver had not taken into account the road and weather conditions as well as the speed limits established in traffic rules. The driver and the fellow passenger suffered slight bodily injuries as a result of collision. The locomotive was slightly damaged, but the car became unfit for use.

In order to improve traffic safety it was recommended to review the contractual obligations of companies responsible for winter maintenance

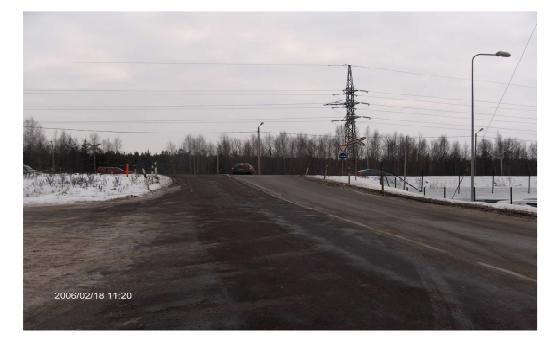
Veerenni on 22.02.2007

In the evening, at 20.32 a lone locomotive of train collided with a Ford Transit van at Veerenni unregulated level crossing.

When driving to the level crossing of limited visibility the driver noticed the locomotive approaching the level crossing from the right. The driver was not sure whether he would be able to stop the van before the level crossing. He braked, but

then decided to slip over the rail tracks before the locomotive reached the level crossing. He stepped on the gas. The van had almost crossed the level crossing when it was hit at its rear corner by the right corner of the locomotive. The accident was caused by wrong driving speed chosen by the driver while approaching the level crossing.

There were no human injuries as a result of collision, but the locomotive and van suffered slight damages.

In order to improve traffic safety it was recommended to hold a traffic intensity census. Based on available data on traffic intensity it was recommended to equip the level crossing with automatic traffic lights.

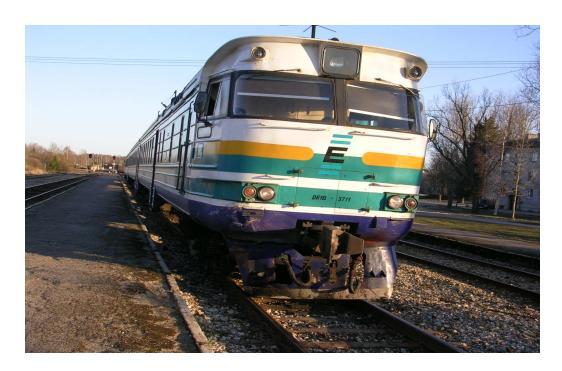
Hertu on 14.04.2007

In the afternoon, at 18.08 a passenger train collided with a BMW car at Hertu unregulated level crossing.

The driver was approaching the level crossing without exceeding the speed limit. During driving she was talking with her child over her right shoulder. The child was at the back seat on the right. The passenger train was approaching the level crossing from the left. The driver did not

The accident was caused by inattentiveness of the driver.

The car driver died as a result of collision and her fellow passenger suffered slight bodily injuries. The car became unfit for use. The motor car of the diesel train suffered damages. In order to improve traffic safety it was recommended that in future, during inspection, possible problems of visibility caused by the specific features of landscape should be assessed.

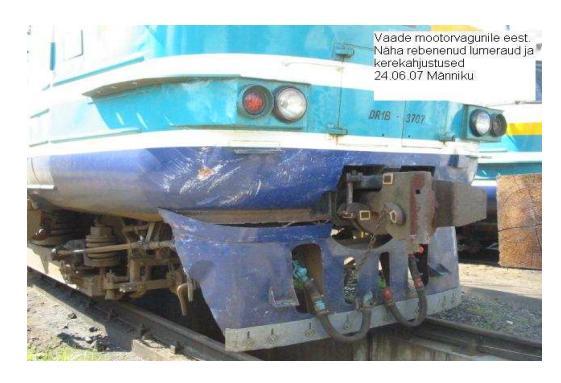
Männiku on 24.06.2007

In the evening, at 20.30 a passenger train collided with an Alfa Romeo car at Männiku unregulated level crossing.

The car was driving at high speed to the level crossing of limited visibility. Before level crossing the driver braked and reduced speed of the car. When the car reached the level crossing, the train was approaching from the right and the car collided with the train.

The driver and the follow passenger died as a result of the accident. The car became unfit for use. The motor car of the diesel train suffered damages.

In order to improve traffic safety it was recommended to equip the level crossing with additional traffic control devices, to carry out traffic intensity census and to plan for closing down the level crossing in future and to reroute street traffic to other level crossings situated in the vicinity.

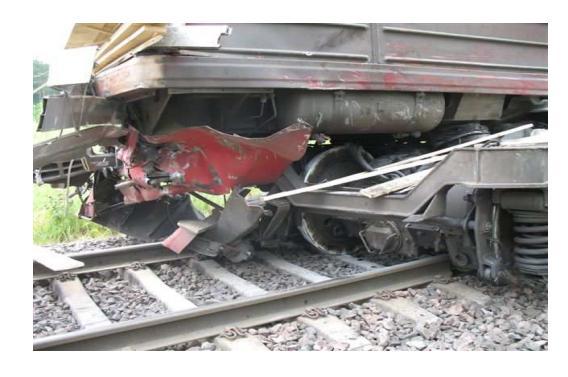
Toila on 10.07.2007

In the morning, at 08.32 a freight train collided with a Scania truck at Toila unregulated level crossing.

The driver stopped before the priority sign and glanced in both directions on the railway. He did not notice the approaching train. After having started driving he reached the level crossing and then noticed the train approaching from the right. Collision followed as a result of which six wheelsets of the first section of the diesel locomotive were derailed.

The locomotive driver suffered slight and the truck driver severe bodily injuries. The locomotive and the truck with trailer were seriously damaged. The railway infrastructure was damaged in a 325m section.

In order to improve traffic safety it was asked to make equipping of Toila level crossing with automatic traffic lights a priority. It was recommended to ensure following of valid legislation concerning permission of locomotive crews to work and to analyse the case in the truck company

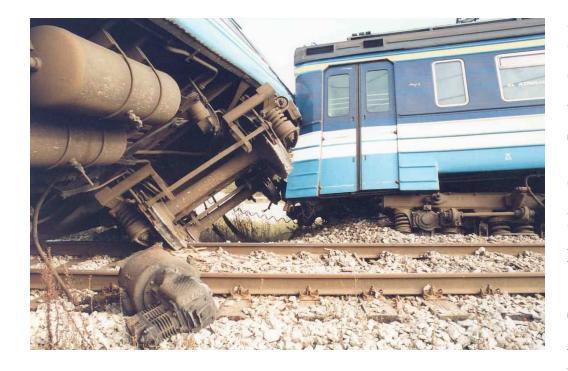
Paldiski on 08.09.2007

In the morning, at 08.52 a passenger train collided with a MAN truck at Paldiski unregulated level crossing.

The truck driver was driving to the level crossing at the speed of 52km/h. He did not pay attention to warning signs, did not reduce speed, nor did he notice the approaching passenger train.

As a result of the accident the locomotive driver and the truck driver suffered severe bodily injuries. In addition, two railwaymen and one passenger suffered slighter injuries. The railway infrastructure was damaged in a section of 40m, including breakage of rails. The first two cars of the passenger train were derailed and suffered damages. The truck with trailer was deformed.

In order to improve traffic safety it was recommended to analyse the traffic situation at the level crossing and to equip it with traffic lights. The truck company was asked to discuss and analyse the case.
