# ANNUAL REPORT 2025

Norwegian Safety Investigation Authority

Rail Department

Lillestrøm 30 September 2026

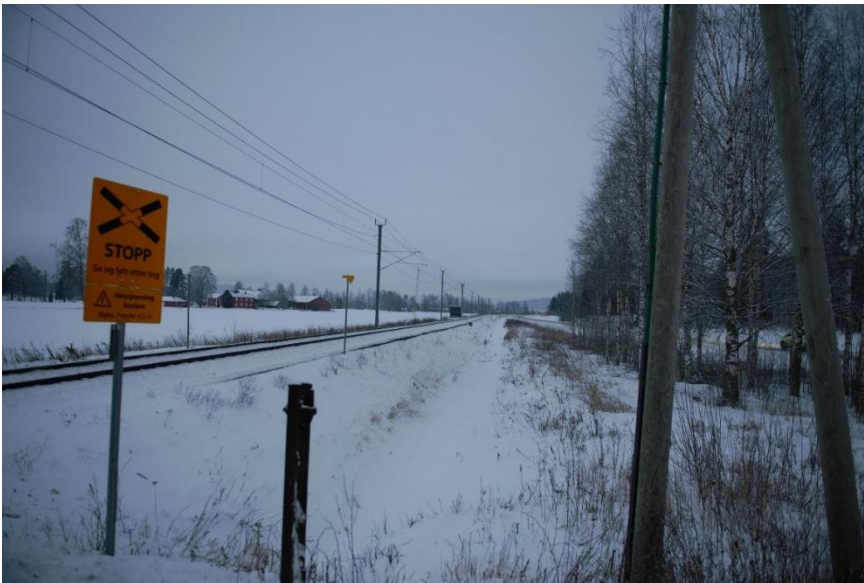
On Wednesday 22 January 2025, train 1020 operated by Vygruppen AS collided with a lorry at Pran level crossing on the Kongsvinger Line. The lorry driver was killed in the accident, and one passenger on the train sustained minor injuries.

Line of sight from the level crossing in the direction from which the train came. Photo: NSIA

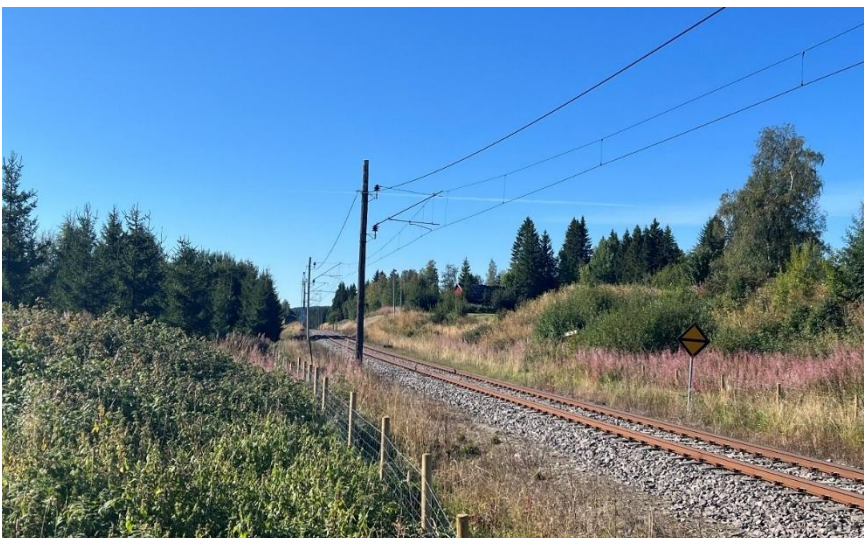
On Monday 25 August 2025, train 17401 operated by Vygruppen AS collided with a tractor at Gamme level crossing on the Gjøvik Line. The tractor driver was killed in the accident.

Line of sight from the level crossing in the direction from which the train came. Photo: NSIA

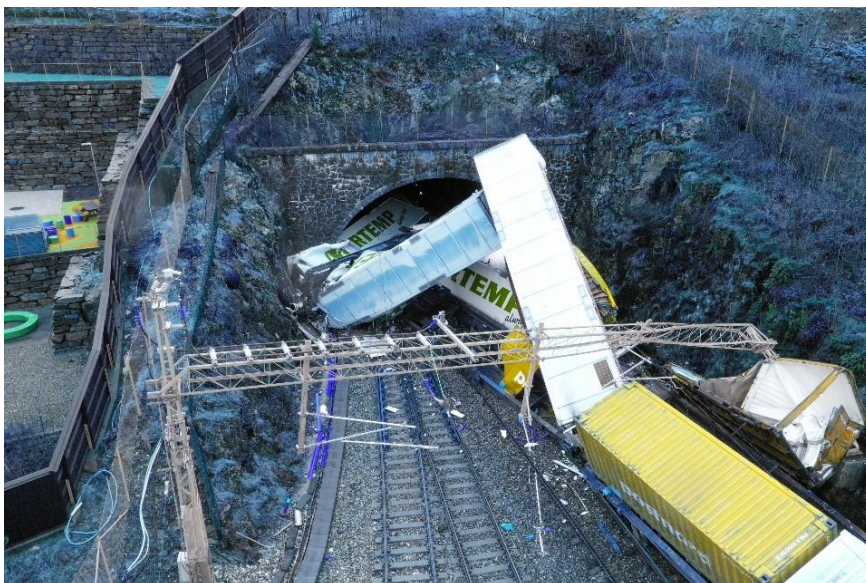
*Derailed wagons in the tunnel opening of the Arnanipa tunnel. Photo: NSIA*

The direct cause of the accident was that freight train 5924 departed Bergen terminal with greatly reduced braking power, making it impossible for the train to stop at Arna station where it was to cross with a passenger train. Several factors contributed to the accident occurring.

The brake pipe cocks between the locomotive and the first wagon were closed in connection with troubleshooting on the locomotive (type BR187). This was done to prevent the brake pipe from emptying when the driver decided to shut down and restart the locomotive in order to rectify a fault on the TDD monitor in the driver's cab. The fault rectification was neither planned nor carried out according to a fixed procedure, and the train dispatcher contacted the driver to ask whether departure could be brought forward. This happened while the driver was working on the fault

rectification. Neither the driver nor the terminal worker remembered to reopen the cocks before departure, and no continuity test was therefore performed. As a result, the driver was only able to apply the brakes on the locomotive itself, not on the wagons.

The driver performed a brake test in the Ulriken tunnel, which is a mandatory operational barrier. The brake test was performed on an ascending gradient, and the driver perceived the braking effect as normal, despite the train having greatly reduced braking power.

OnRail AS had not risk-assessed the BR187 locomotive type before the company started using it. The company also lacked written procedures for fault rectification involving the closing of brake pipe cocks. Frequent faults on the TDD monitor on BR187 locomotives, which made troubleshooting necessary, increased the likelihood of errors.

The NSIA issues three safety recommendations following the accident. Two safety recommendations concern the use of the BR187 locomotive type, both generally and in OnRail AS. One safety recommendation concerns exercises between Bane NOR SF and the emergency services.

The Norwegian Safety Investigation Authority recommends that the Norwegian Railway Authority request OnRail AS to risk-assess the use of Traxx F160 AC3 (BR187), particularly with regard to situations that may require the closing of brake pipe cocks.

The Norwegian Safety Investigation Authority recommends that the Norwegian Railway Authority ensure that users of Traxx F160 AC3 (BR187) in Norway have addressed the manufacturer's conditions of use relating to the locomotive's braking systems.

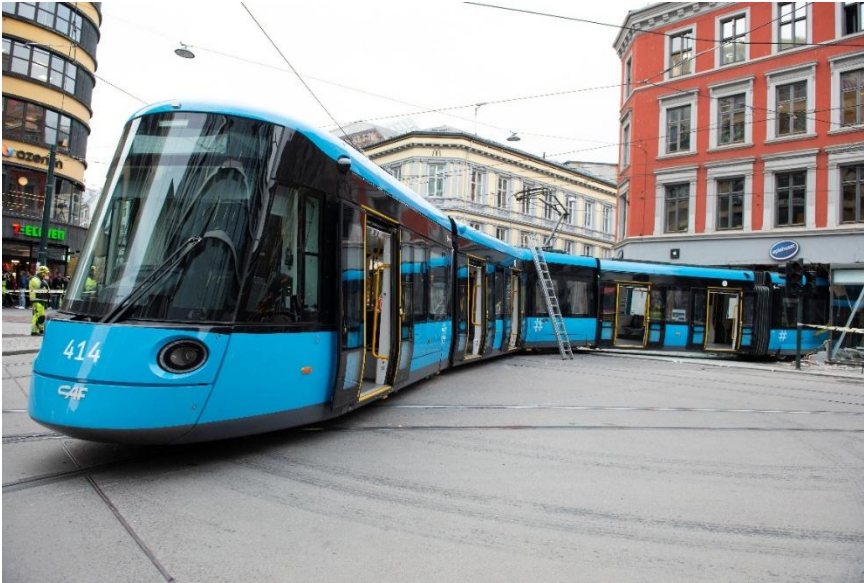
*Tram 414 derailed at the intersection between Nygata and Storgata. Photo: NSIA*

The accident was caused by overspeed through the points. The overspeed was caused by an acute medical event involving the tram driver, which resulted in loss of consciousness. At the same time as the driver lost consciousness, the power handle was placed in the full traction position and the driver vigilance device was released.

Immediately before losing consciousness, the driver experienced sudden and very severe abdominal pain and a strong urge to vomit, which was later found to be caused by Norovirus. Medical assessments concluded that the virus caused strong activation of the vagus nerve, leading to reduced heart rate, low blood pressure and fainting (vasovagal syncope). The condition arose acutely, with no possibility of preventing it.

The SL18 is equipped with a driver vigilance system intended to stop the vehicle if the driver loses consciousness. The system functioned as intended, but the sequence of events was very short (approximately eight seconds from full traction/release of the vigilance device to the collision). The system takes 10 seconds to activate the brakes, which was too long in this case. The SL18 is not fitted with collision avoidance systems (CAS) or automatic tram speed monitoring (ATSM). The NSIA's investigations have not identified any matters relating to tram maintenance or other technical or organisational factors that are considered relevant to the accident.

The tram driver and three passengers sustained minor injuries, while no one in the shop was injured. The tram sustained extensive damage (estimated repair costs of up to NOK 33 million), and the shop was badly damaged. The accident had far less serious consequences than it could have had, as at other times or locations it could have affected many more people.
