MINISTRY OF TECHNOLOGY AND INDUSTRY TRANSPORTATION SAFETY BUREAU

FINAL REPORT (EXTRACTION)

2022-0381-5 (HU-10217)

Railway accident / Level crossing accident Mindszent - Hódmezővásárhelyi Népkert, 5th April 2022

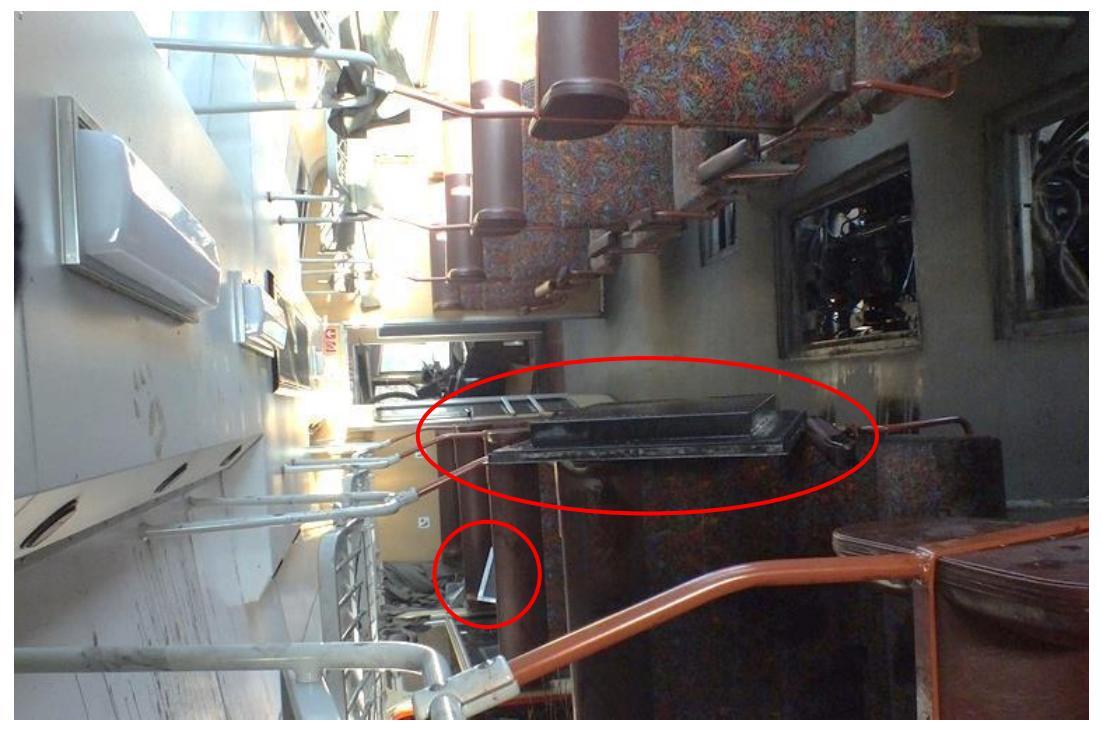
- the covers of the mounting holes in the floor, which have sharp, angled edges, fell between the seats (Figure 1);
- oil was leaking into the passenger compartment through some mechanical openings that opened during the accident, and the oil must have been at a high temperature due to the engine and propulsion system;
- the driver's cab's door;
- the seat pans of two seats, and;
- a number of smaller parts and accessories.

Figure 1: Mounting holes in the floor, and loose covers

These parts could have caused injury to passengers or aggravate injuries they suffered from other causes.

The covers built into the floor cannot be fixed, i.e. their displacement is a design feature. The seat covers can be fixed, i.e. their displacement is a maintenance and operational deficiency.

The TSB recommends that the technical certificates for the 117 series (Bzmot) motor vehicles be reviewed and, if necessary, amended to ensure that there are no unsecured parts in the passenger compartment that could cause injury to passengers if the vehicle derails or even turns over.

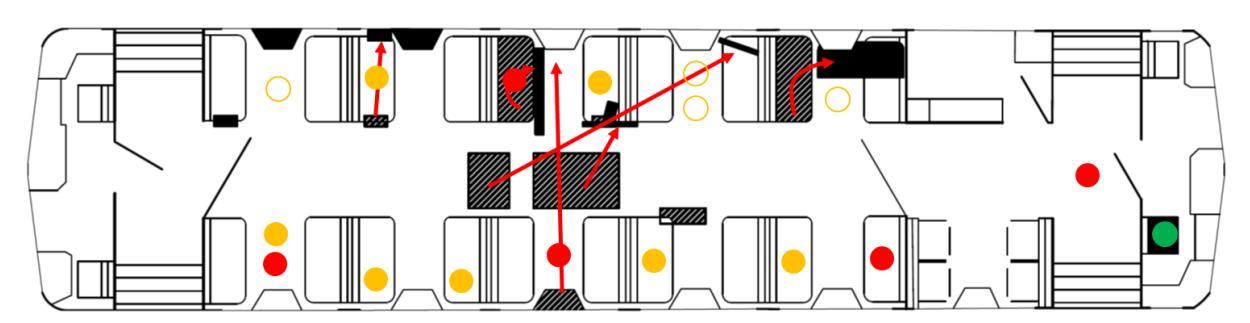
Figure 2: Location of the displaced parts and passengers: red circle: seriously injured, orange circle: slightly injured; green circle: not injured orange ring: not identified, 3 of them lightly injured, 1 of them not injured banded objects, arrows: displaced vehicle parts

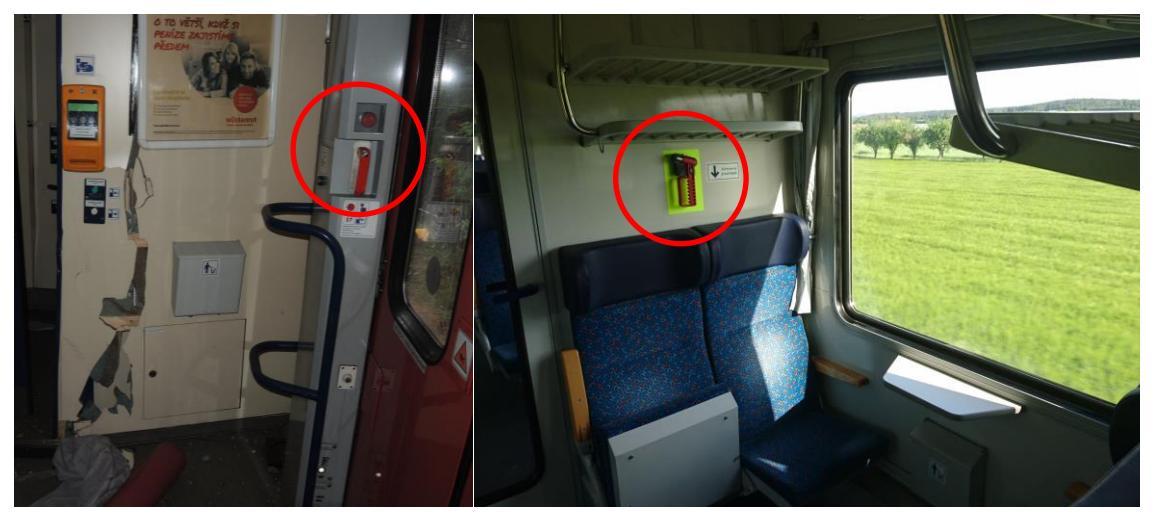
- the access doors were significantly redesigned, with the addition of a more easily accessible emergency opening;
- a window on each side is fitted with breakable glass designed for escape and the passenger compartment is fitted with window-breaking hammers (Figure Figure 3).

Figure 3: modernisation of similar vehicles in the Czech Republic

The TSB recommends that the technical approvals of the Series 117 (Bzmot) motor vehicles and their trailers be reviewed and, if necessary, amended to ensure that the vehicles are fitted with the necessary emergency exits (doors and windows that can also be used as emergency exits) and that the vehicle is equipped with the necessary accessories.
