**Railway Accident  
Investigation Unit**

**Ireland**

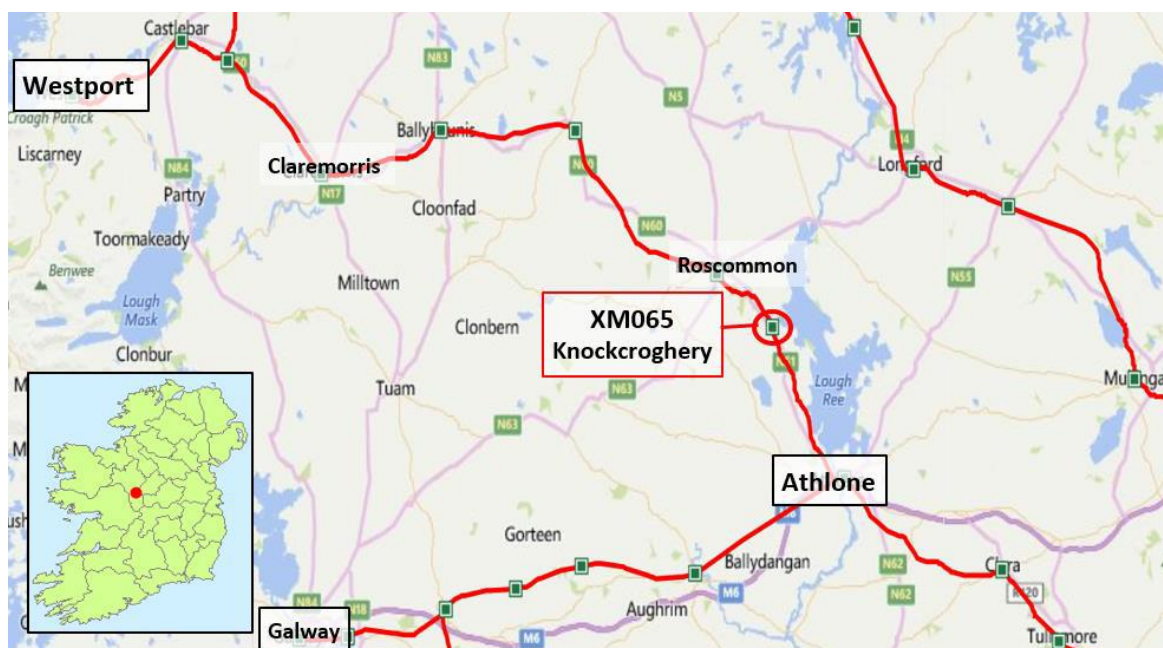
**Figure 2 – Location of the incident**

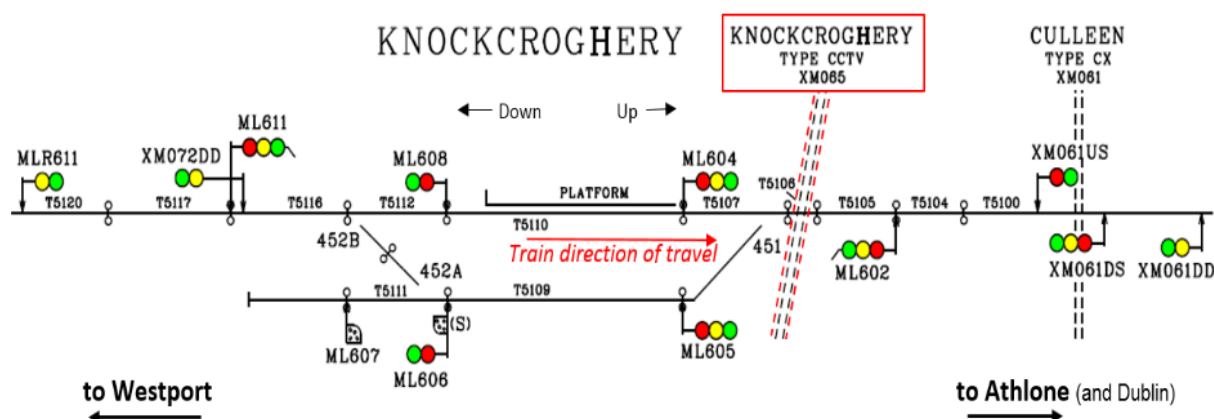
### Figure 3 – Signalling layout

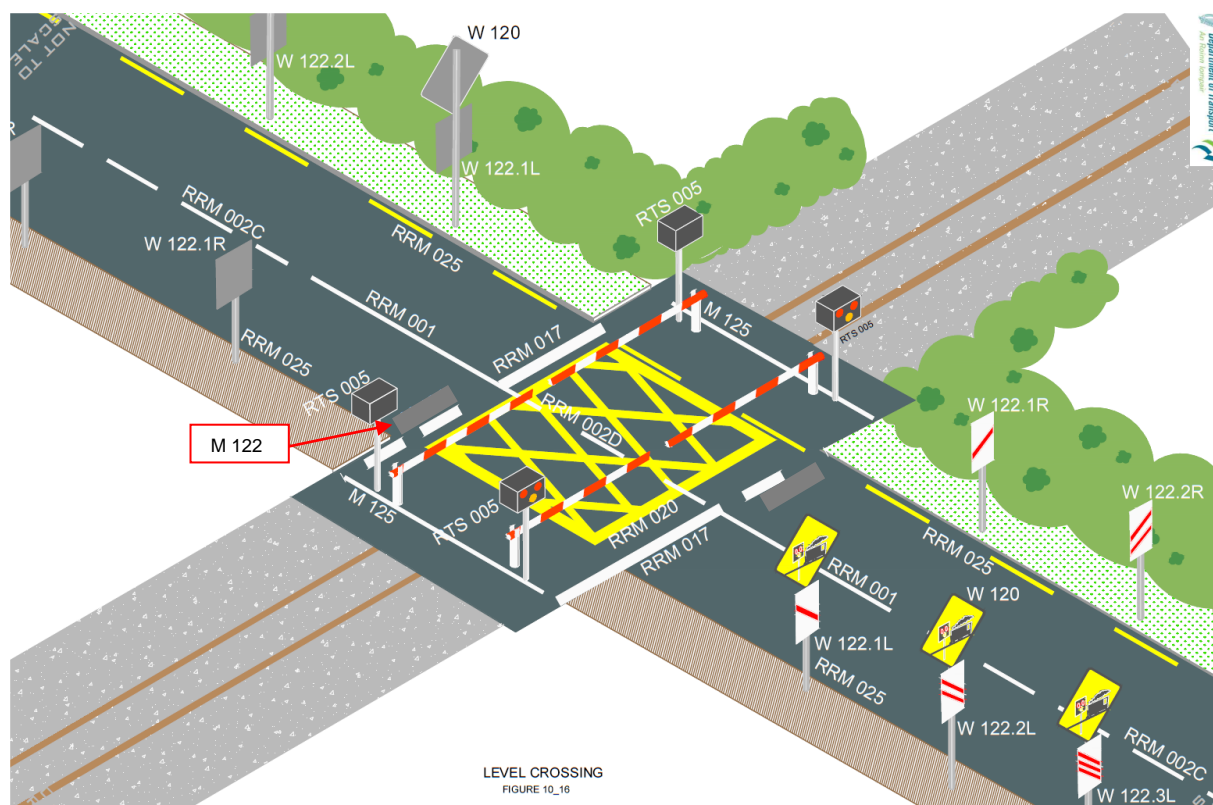
**Figure 10 – Layout for a level crossing with barriers & flashing signals**

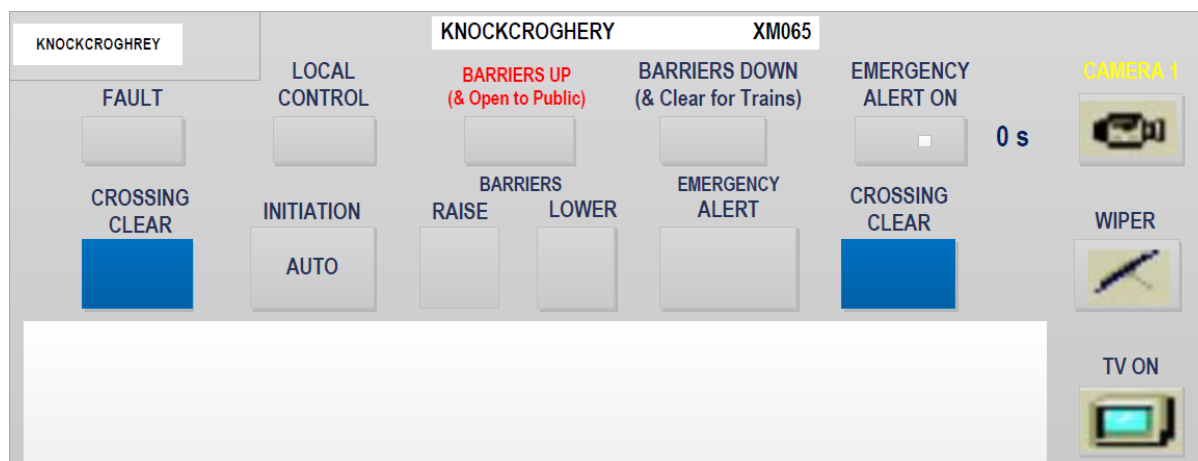
Figure 15 – Knockcroghery Touchscreen

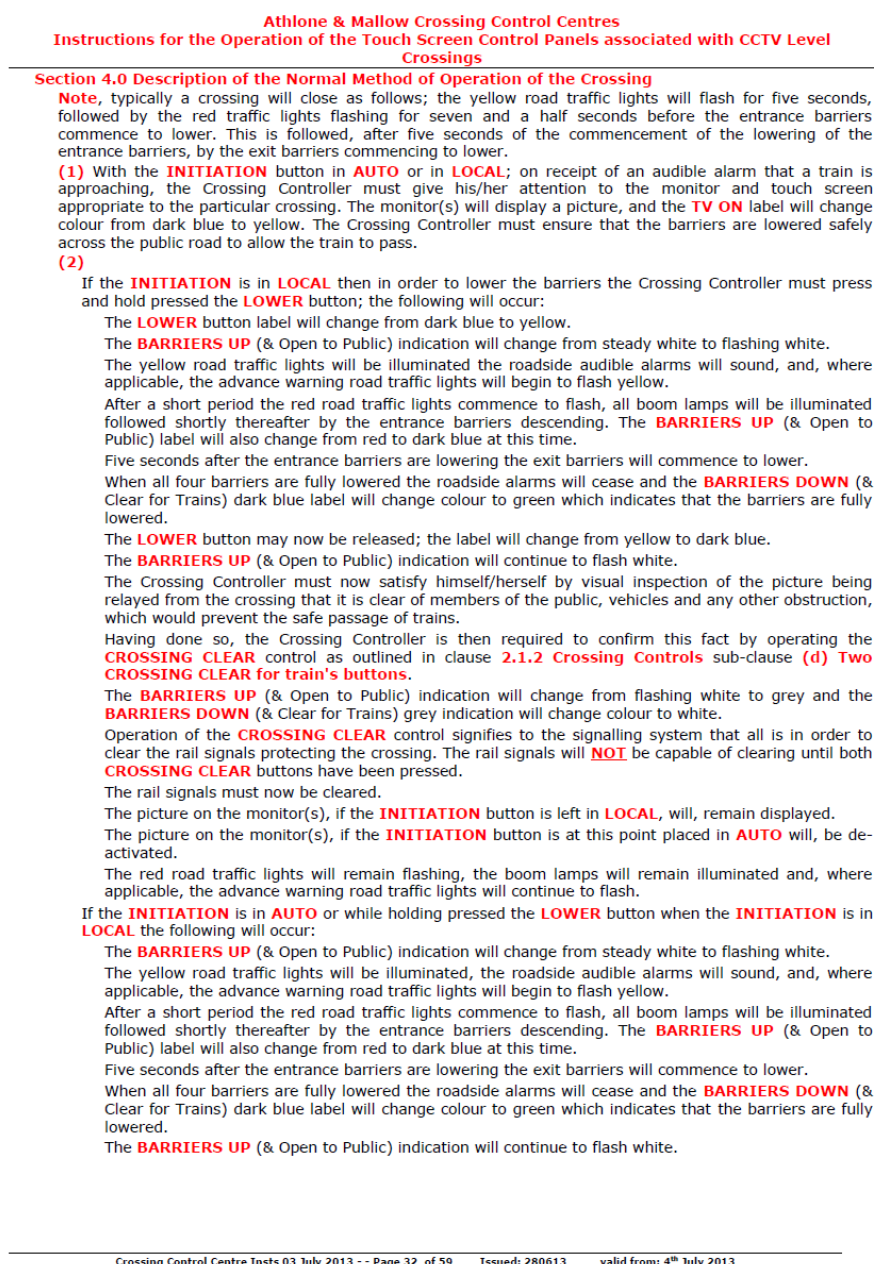
**Figure 21 – Typical page from LCCC Instructions**

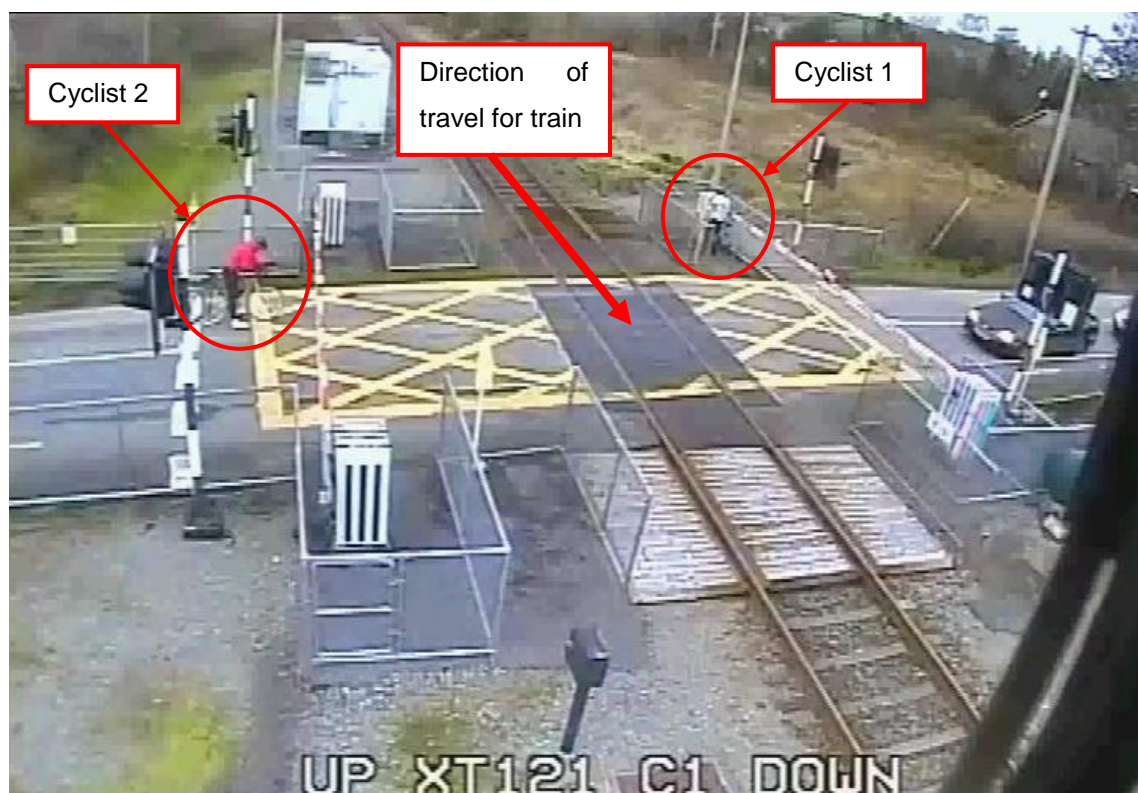
**Figure 30 – Cyclist 2 within the confines of the Level Crossing**

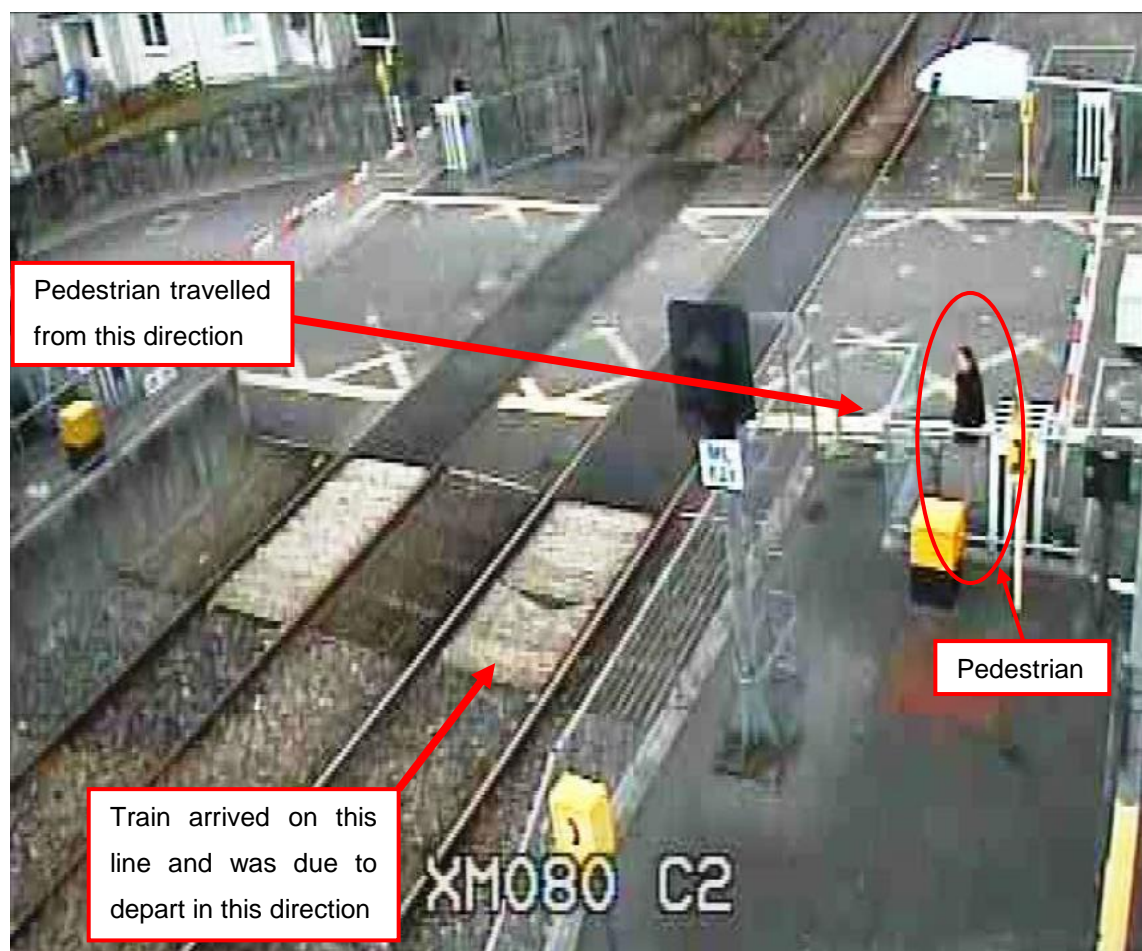
**Figure 32 – Pedestrian within the confines of LC XM080 while the barriers are lowered**
