Accident Investigation Report

Collision between trains

at Hordorf crossover

Bonn, 14 September 2011

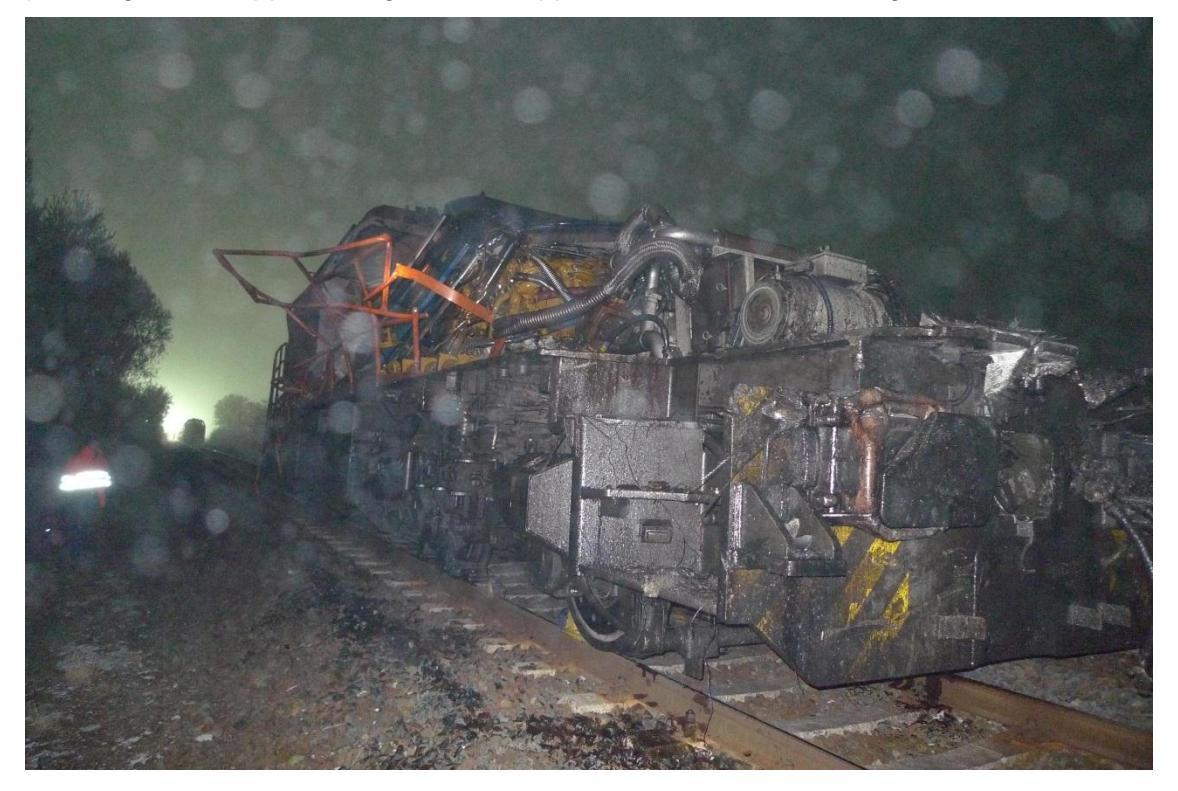
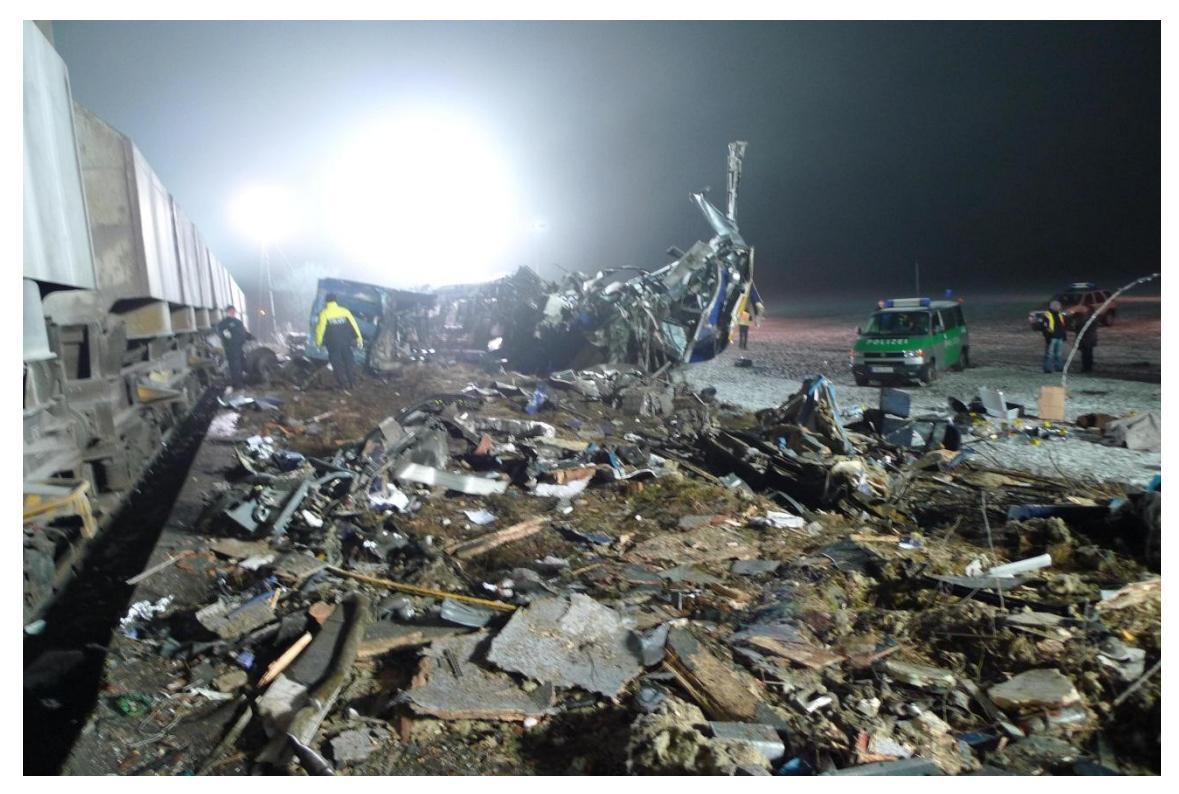
Passenger train DPN 80876, operated by Veolia Sachsen-Anhalt GmbH, was flung off the track by the force of the impact and came to rest, severely damaged, beside the track.

Freight train DGS 69192, operated by VPS (Verkehrsbetriebe Peine-Salzgitter), remained completely on the track. After the impact, the leading locomotive of the two on the freight train was pulled off the track and came to rest some 130 m from the track. This locomotive was very severely damaged.

Illustrations 1 and 2 – photographs at the site of the accident

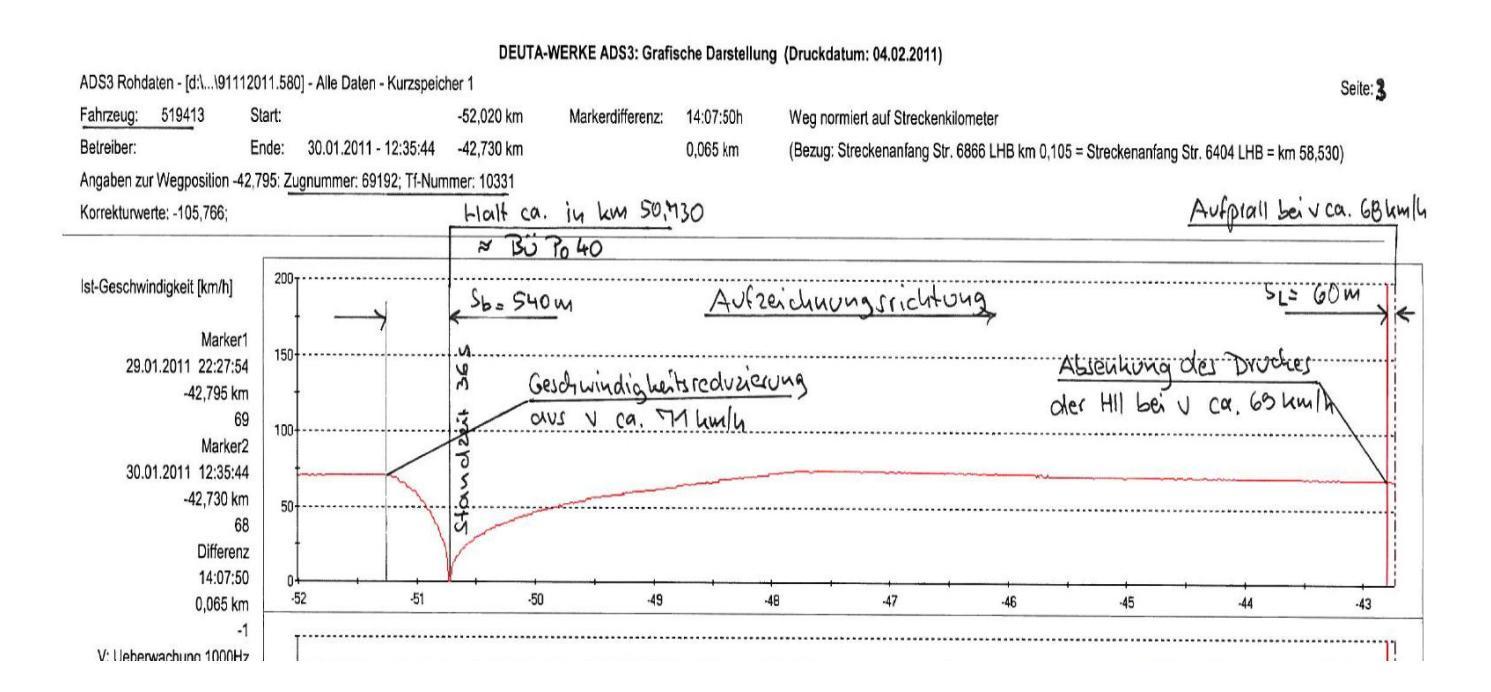
At the time of the event, a drop in pressure was indicated of less than 2.2 bar. At that time (22:27:54), the speed was 69 km/h. After some 60 m the recording stopped. The collision with DPN 80876 took place at a speed of 68 km/h.

Figure 2: Excerpt from the evaluation of the record of the journey: DEUTA-WERKE ADS3 graphic representation of DGS 69192 with handwritten additions

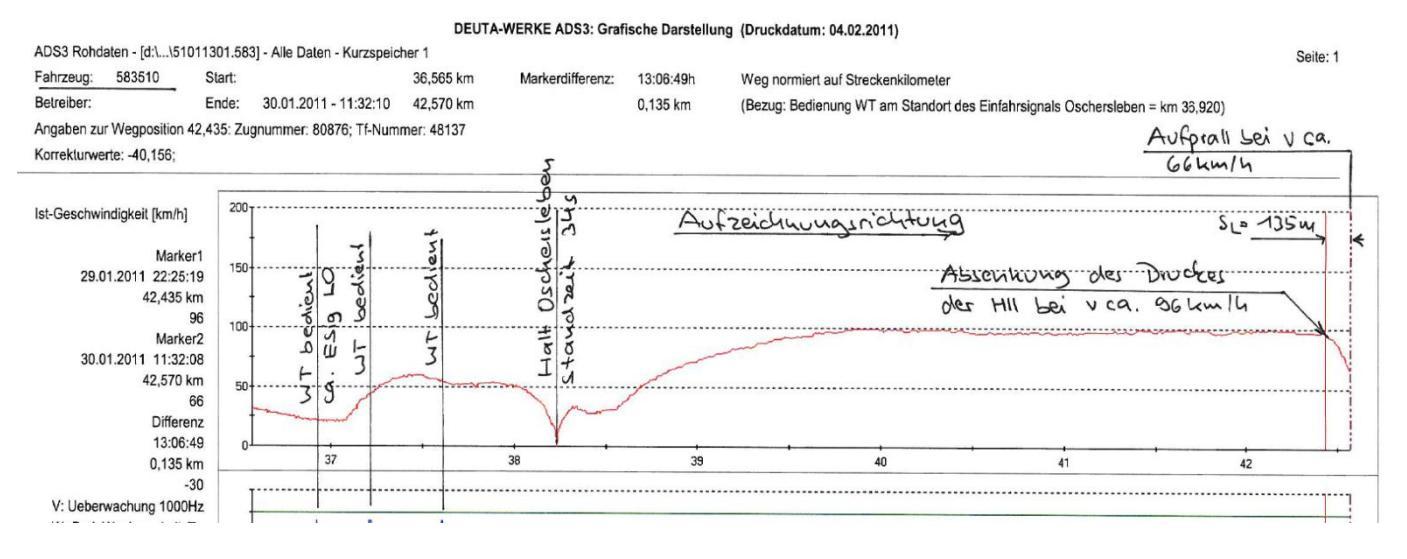
Evaluation of the record of the journey of passenger train DPN 80876 up to the time of the event revealed that at 22:25:19 (time according to the recording equipment) a fall in the pressure of the main brake-pipe was recorded of less than 2.2 bar. The cause could be a rapid brake application by the driver.

After some 135 m and at a speed of 66 km/h the recording broke off.

Figure 3: Excerpt from the evaluation of the record of the journey: DEUTA-WERKE ADS3 graphic representation of DPN 80876 with handwritten additions

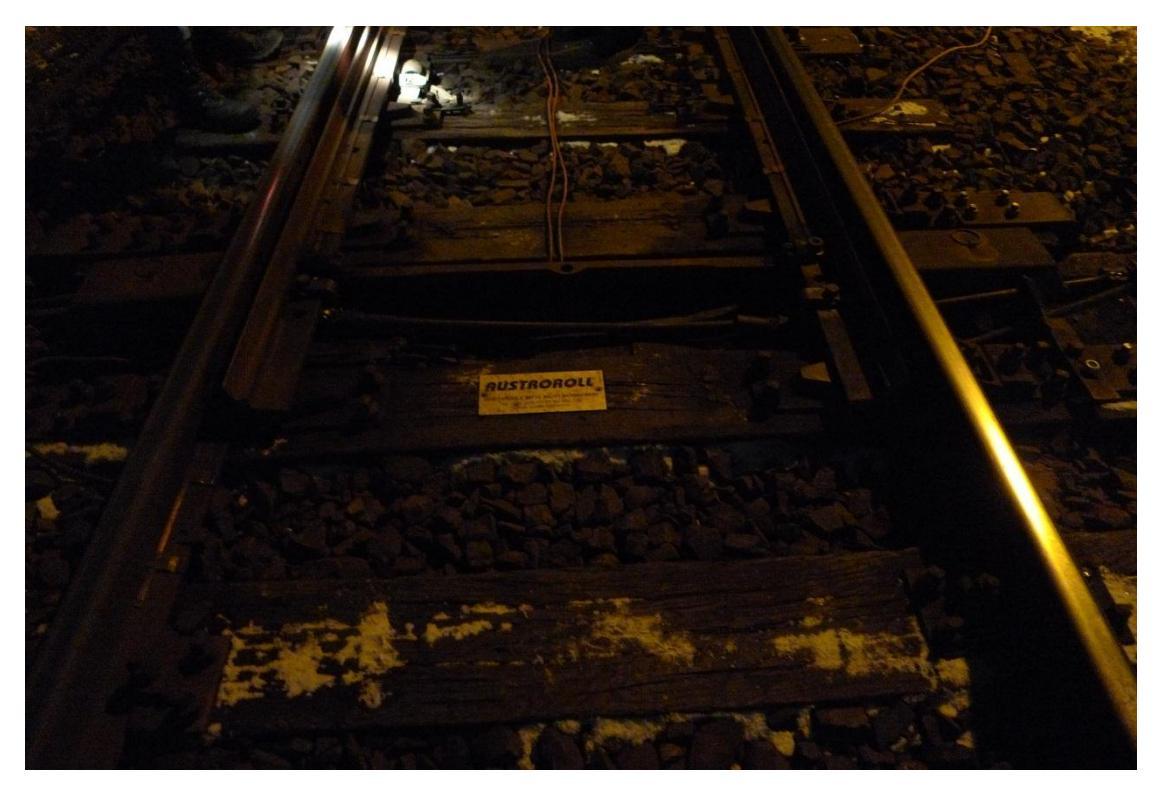
The damage from No 1 switch being run through was one of the pieces of evidence from the accident which was noted immediately after the collision.

The switch was run through by freight train DGS 69192 proceeding from the Nienhagen direction. The switch was locked. The locking bar went though the slot in the locking plate and hence prevented any further movement of the switch.

Illustration 3: No 1 switch run through, Hordorf crossover

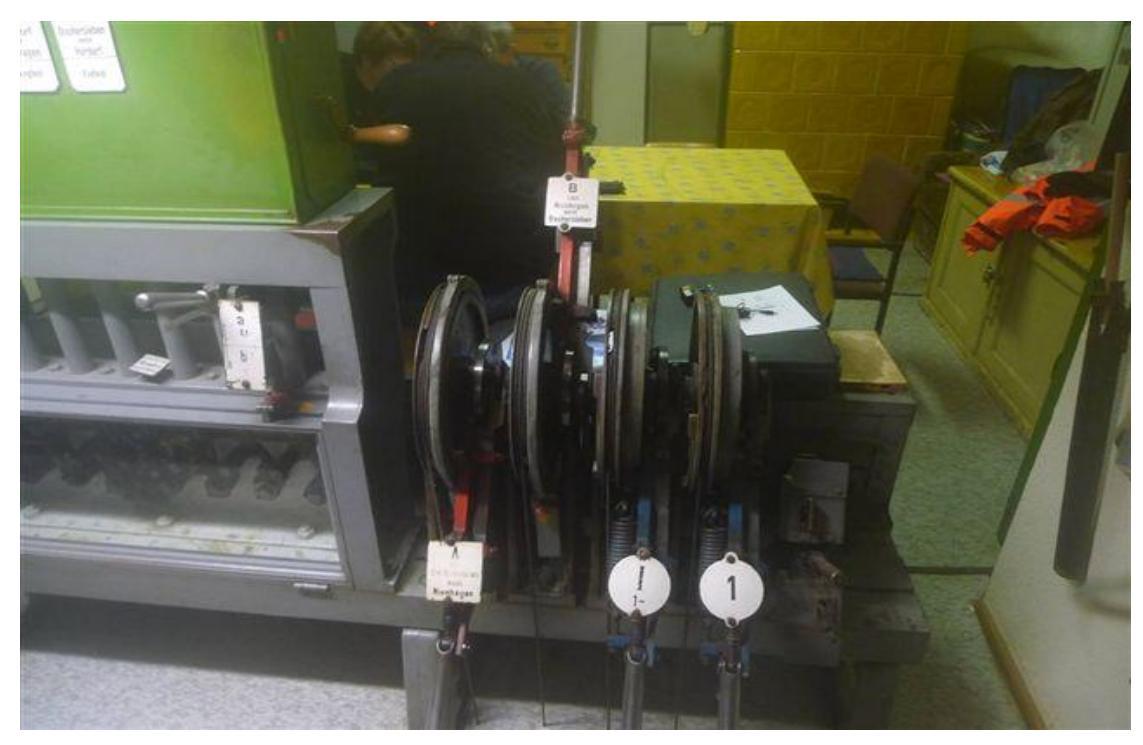
Illustration 4: signal box, Hordorf crossover

This evidence from the accident proves that the operator in Hordorf signal box set up the route from Oschersleben towards Nienhagen for signal A in accordance with the regulations.

The route for the opposite direction, for signal B, was not set up. It was not possible to clear signal B [set to the proceed aspect].
