Rail Accident Report

Collision at Pickering station North Yorkshire Moors Railway 5 May 2007

Report 29/2007 August 2007 This investigation was carried out in accordance with:

Investigation into collision at Pickering station North Yorkshire Moors Railway, 5 May 2007

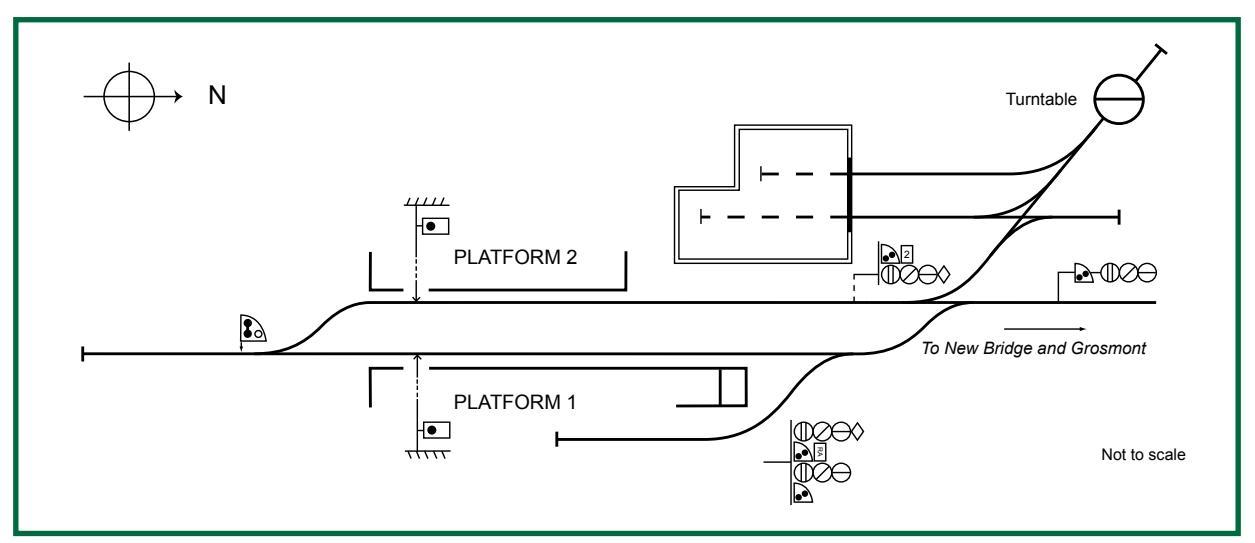
Figure 2: Track layout at Pickering

10 Pickering station is the southern terminus of the line. There are two running lines passing between the two platforms. At the southern end of the station is a single pair of points, leading from both lines into a headshunt (Figure 2).

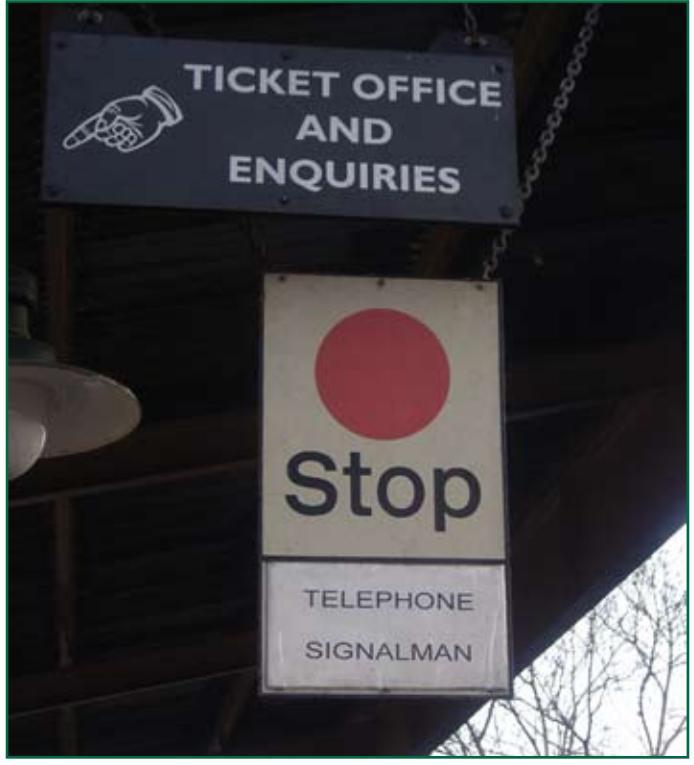
Figure 3: Stop board at the south end of Pickering station

- 12 At the south end of platforms one and two running lines are *stop boards* (Figure 3). A train arriving at Pickering that is short enough to fit in the platform line with its engine has to stop before reaching these boards, which are effectively signals. The locomotive is then uncoupled from the train, and moved into the headshunt, before returning through the other platform to run round. If a train is longer than normal it can be given a written permit by the signaller at New Bridge to pass the stop board, drawing forward to a position where the locomotive can still run round its train, but preventing the risk of the carriages fouling the other line.

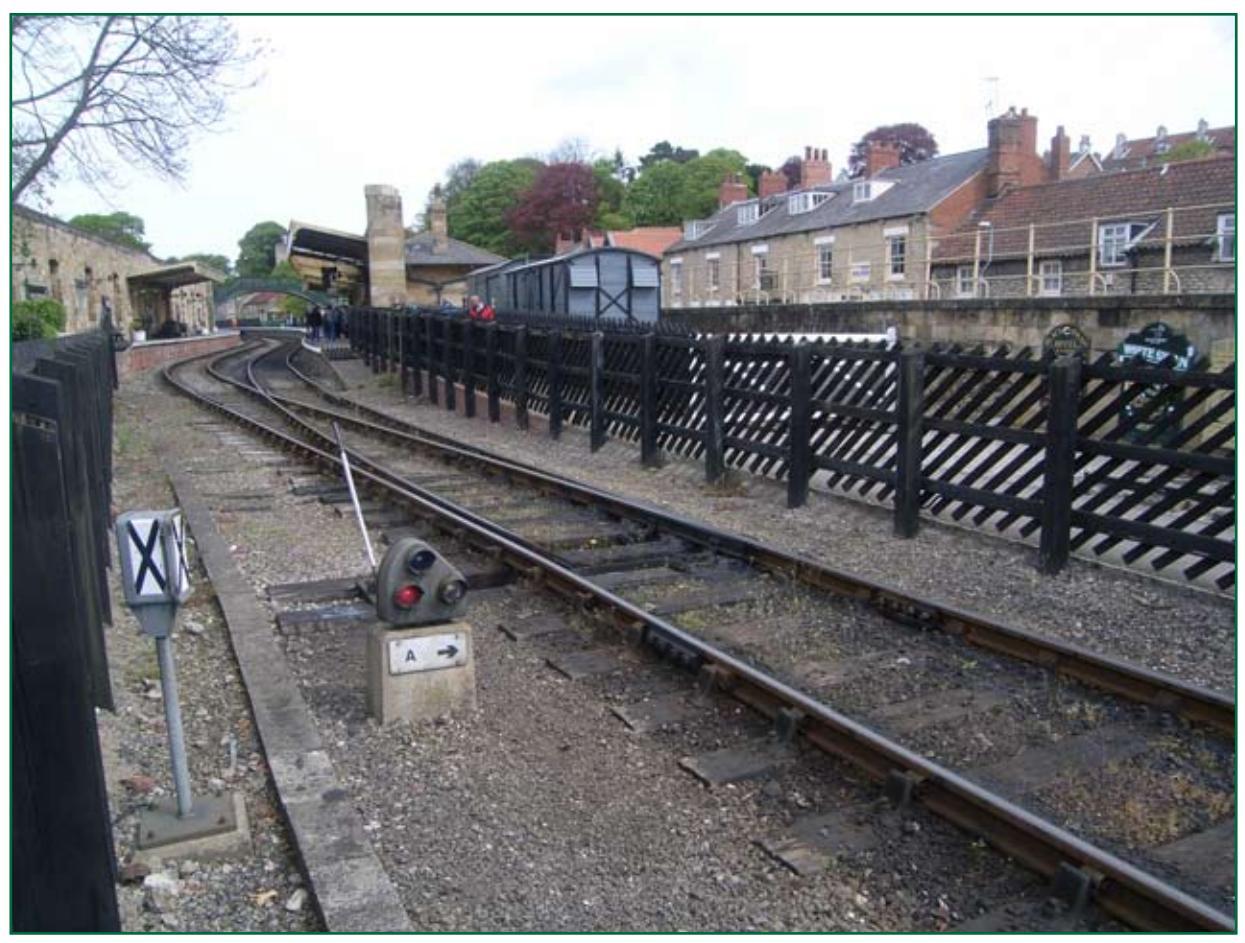
Figure 4: Points lever and ground signal at Pickering south

- 13 The points at the south end of the station are not traversed by any passenger trains, and are operated by a hand lever. A single *ground signal* (Figure 4) is provided, which can be *cleared* by the signaller at New Bridge when there is no train detected by a *track circuit* as standing on the south end points. The ground signal can only be cleared two minutes after the track circuit has itself cleared and is intended to ensure that a locomotive only runs round when the signaller wishes it to. This is to avoid the risk of a collision being caused by a locomotive running round one train at the same time as another train enters the second platform.

- 14 The ground signal gives no indication as to which direction the points are set in, only permission to enter the platform loop area. Discussion with Network Rail indicates that this arrangement of signals is not used on the national network.

- 39 A further contributory factor was that the ground signal only indicated that the locomotive could enter the station, but did not indicate the lie of the points.

The NYMR should install a system at Pickering south that provides an indication to the train crew in the cab as to the lie of the points (paragraph 41).

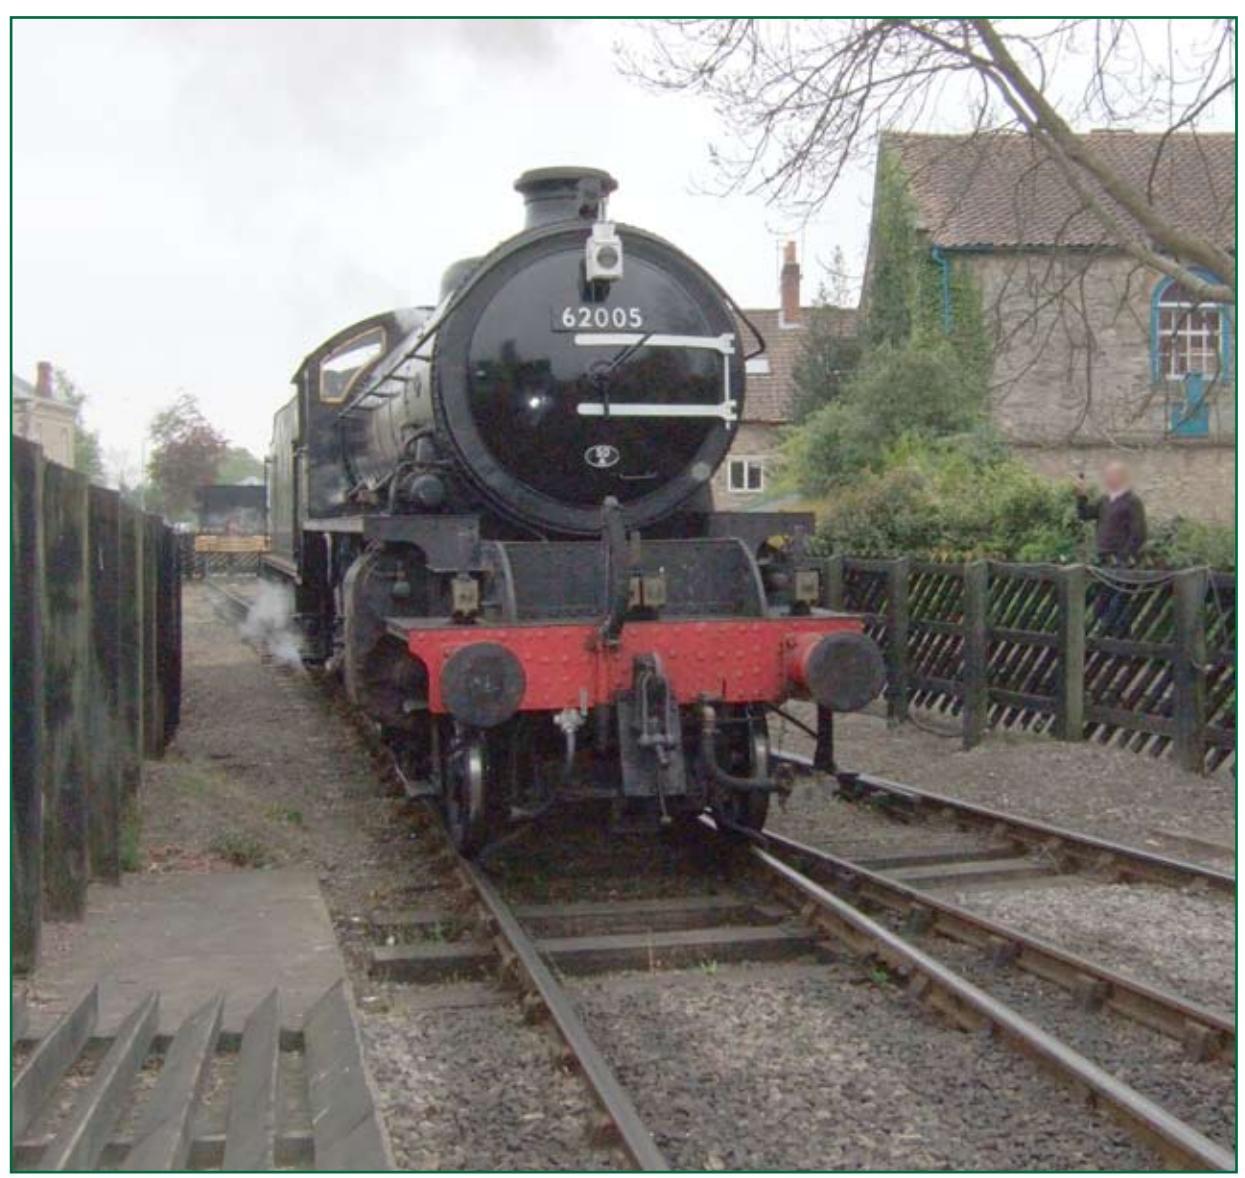
Figure 6: Train re-entering platform one at Pickering (photograph courtesy of site witness)

- 31 At 15:24 hrs the locomotive re-entered platform one and the crew realised that they were on the wrong line; the driver immediately applied the brakes (Figure 6). However, it was too late for the locomotive to stop and it collided at slow speed with the carriages it had hauled, moving the train northwards by about 0.5 m.
- 32 There were four passengers in the observation saloon of the General Manager's saloon at the time of the collision. Some of them saw the locomotive approaching, and realising that a collision was imminent, attempted to leave the carriage. A number of passengers were knocked over by the collision; none were seriously injured, and first aid was provided by NYMR staff. One of these passengers was taken to hospital as a precaution, but was discharged the same evening.

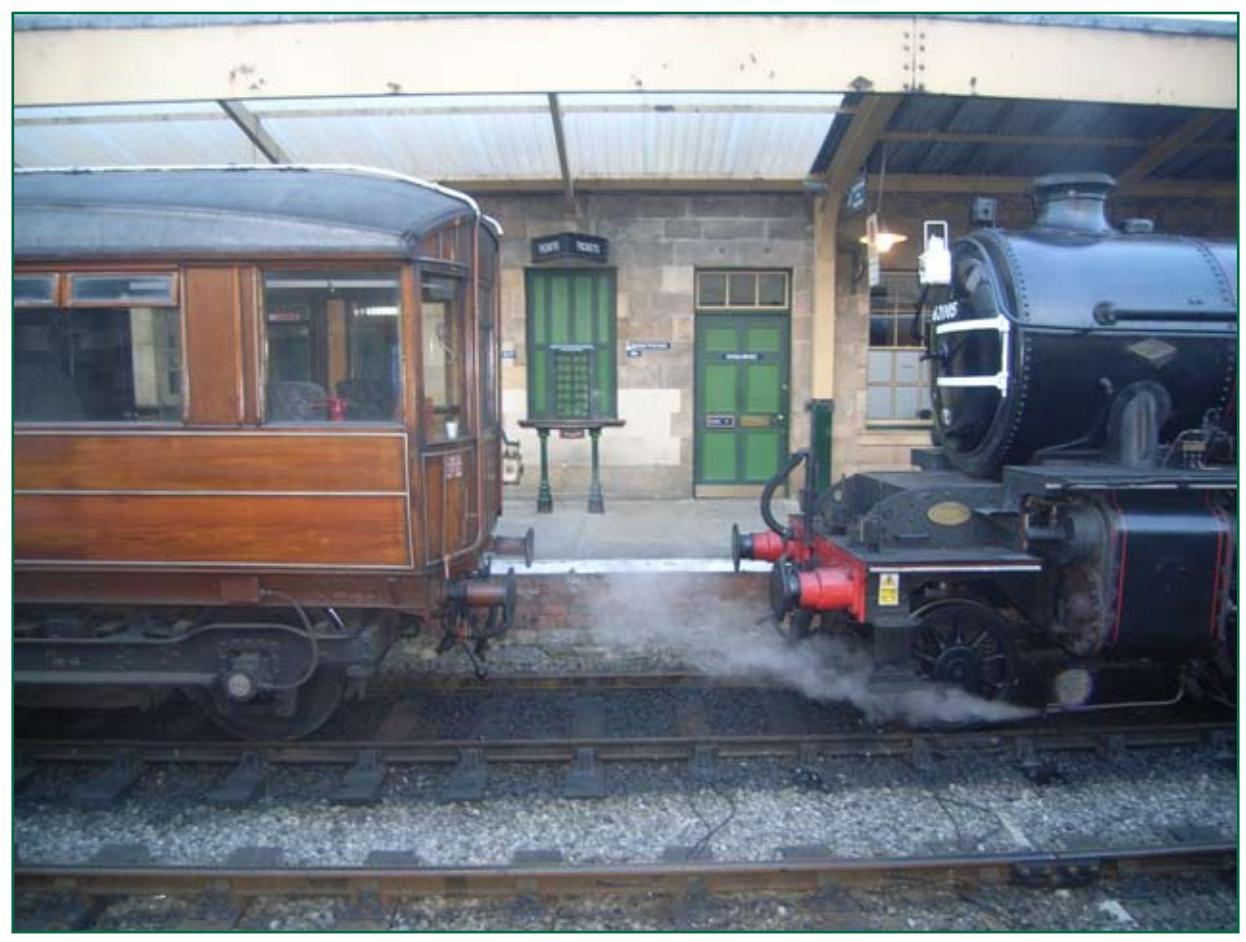
33 The collision had lifted the body of the General Manager's saloon a small amount (probably less than 25 mm) off its south end bogie. The collision also resulted in compression of the buffers between the two vehicles. Shortly after the collision occurred the driver eased off the locomotive steam brake in order to then apply the handbrake. The buffer springs expanded and moved the locomotive back, and the driver let it roll back to a natural stop and re-applied the brakes about a metre away from the carriages. In doing this he considered he was making the train safer. However, as a result the saloon dropped back onto its bogie; the shock and noise of this caused further distress to those passengers who were still inside. Moving the locomotive in this way also disturbed evidence without the agreement of the RAIB, contrary to the Rail Accident (Investigation and Reporting) Regulations, 2005 (Figure 7).

Figure 7: Locomotive and saloon after locomotive had been moved clear

- 34 There was no damage to the locomotive. There were several items of minor damage to the General Manager's saloon (Appendix B) and minor damage to a coupling on one other carriage.
- 35 As a result of the collision two trains were cancelled, and two others turned back short of Pickering. Other trains were delayed by up to 65 minutes. Normal service on the NYMR resumed the following morning, 6 May 2007.

42 Releasing the locomotive brakes to allow it to move away from the train after the collision without ensuring that those involved were aware of the imminent movement caused further distress to the passengers and in addition disturbed evidence of the accident without permission from the RAIB.

2. The NYMR should introduce procedures to ensure that after an accident no rolling stock or other evidence is moved without considering the effect on people involved, and only in compliance with the Rail Accident (Investigation and Reporting) Regulations, 2005.

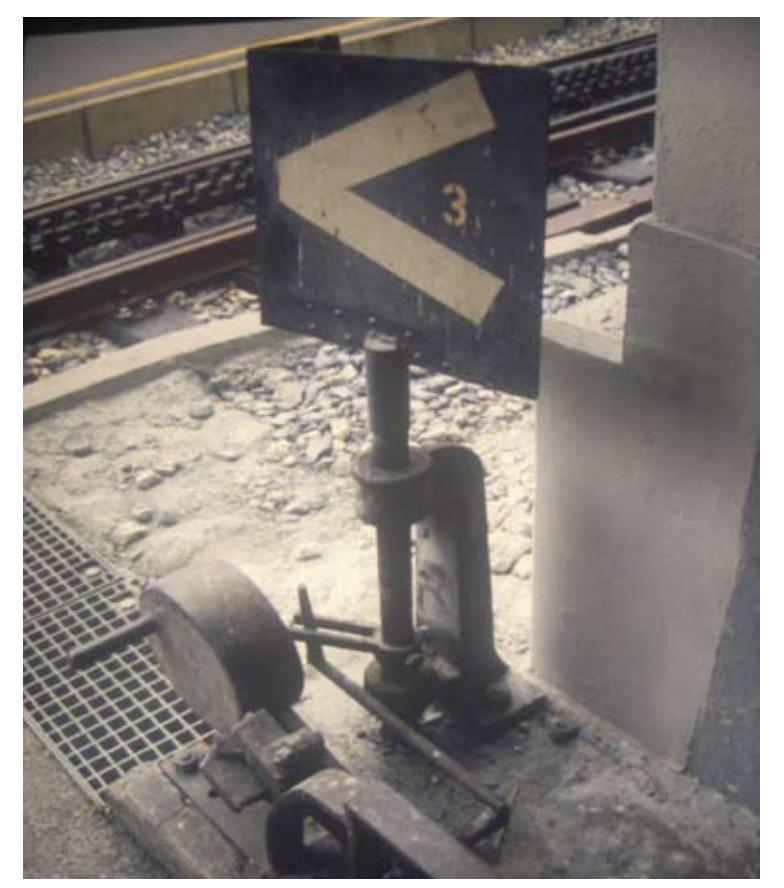
- 41 Either a person standing by the points, observing their lie, and calling the train forward or a suitably designed hand worked lever mechanically linked to an indicator (Figure 8) would have adequately mitigated the risk identified at Pickering from this incident.

Figure 8: Point lever and indicator combined (photograph courtesy of private collection)

1. The NYMR should immediately mandate that the person who operates the hand points at Pickering south should remain at the points after operating them, and should only call a locomotive past them when the ground signal clears, after again checking the lie of the points (paragraphs 41 and 43); or
