Rail Accident Report

Freight train collision at Leigh-on-Sea 26 April 2008

Report 24/2009 September 2009 This investigation was carried out in accordance with:

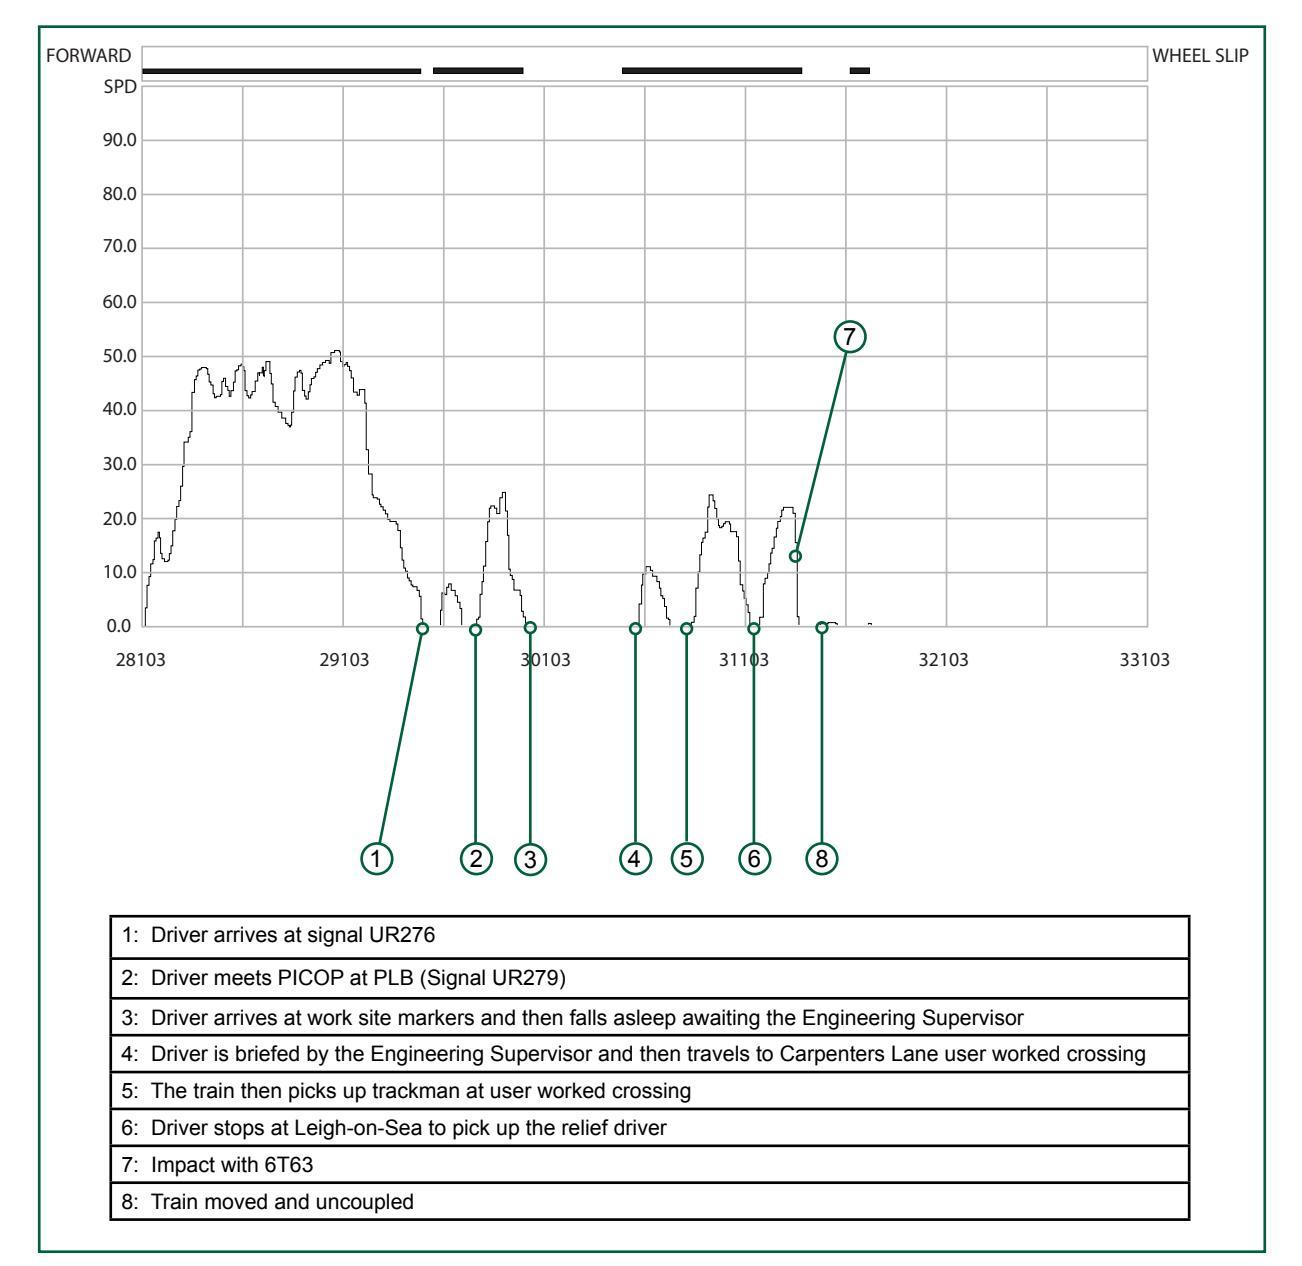
- 50 The OTDR, from which all train speeds were recovered, confirmed the train had stopped at Carpenters Lane user worked crossing.
- 51 At 06:23 hrs the train left Leigh-on-Sea station; the driver increased the train's speed to 20 to 25 mph (32 to 40 km/h). As the train entered the left-hand curve on the approach to Chalkwell station, the driver, relief driver and trackman observed the flashing tail lamp on the rear wagon of train 6T63.
- 52 The driver applied the brake at 22 mph (35 km/h) at 06:27:15 hrs. Four seconds later he applied the emergency brake; the driver, relief and trackman anticipated the collision and braced themselves. The train travelled a further 31.3 metres before colliding with the rear of train 6T63 at 06:27 hrs whilst travelling at 15.7 mph (24 km/h). The train travelled a further 7.6 metres after the impact.

Figure 5: OTDR diagram from train 6T64 showing train speeds and locations within the Leigh-on-Sea possession and work site

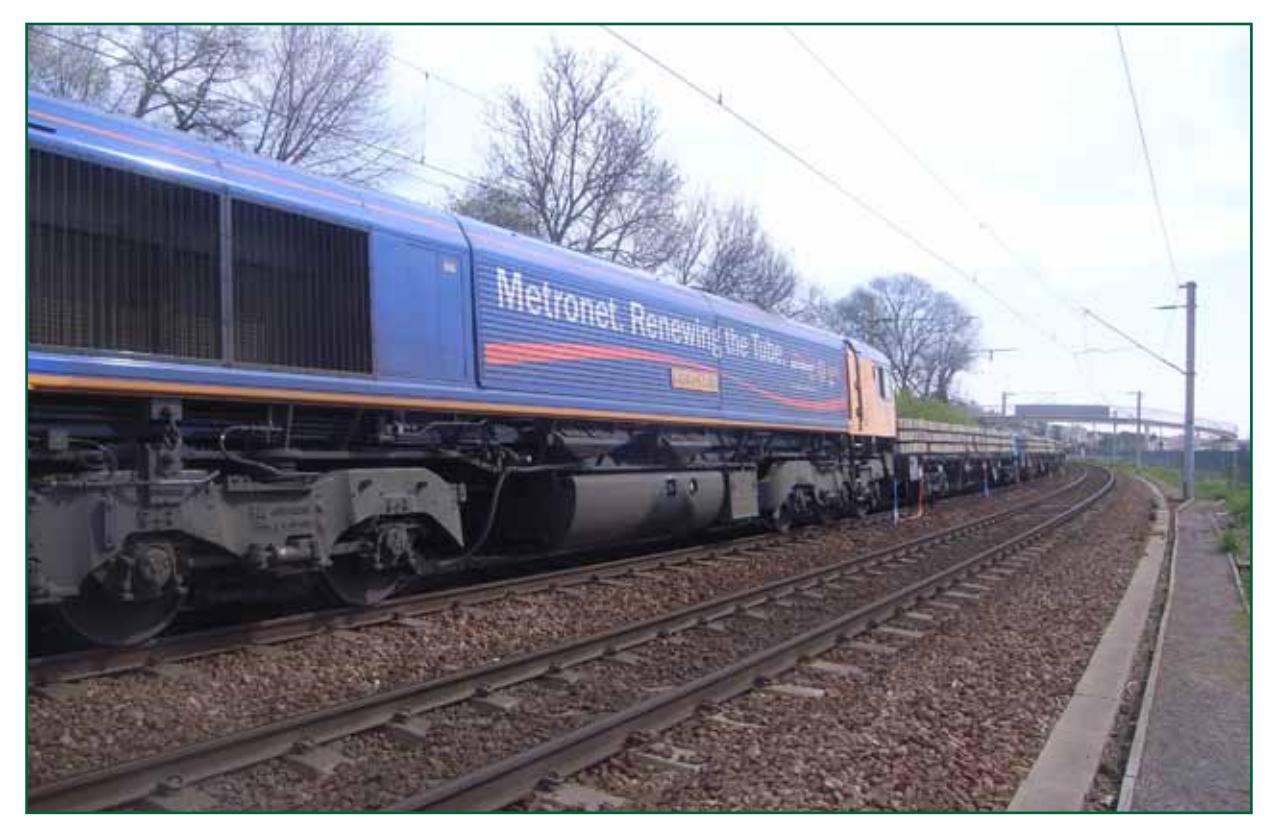
53 The front buffers of locomotive 66719 of train 6T64 were compressed and damaged. The central spines on two FEA wagons, 640658 and 640633, were severely damaged and caused the wagons to become raised off the rails as a result of the impact. The remaining wagons were undamaged.

- 55 The driver examined the leading locomotive on train 6T64. He noted the collision had damaged the front buffers. He was not aware of any other damage to the train. The incident was not reported by the driver, relief driver or trackman immediately after the collision.
- 56 The driver detached the front locomotive of 6T64 and coupled it to train 6T63. The driver then proceeded to walk alongside train 6T63 taking the hand brakes off. As he walked along the train he also noticed the straps used to restrain the loaded sleepers on train 6T63 were hanging down next to each of the wagons. He then began to throw the straps over the wagons so that they could be re-attached.
- 57 The relief driver and trackman left the cab and began to walk back along the train to inspect for further damage (Figures 6 to 9).

Figure 6: Front Locomotive of 6T64 after collision with the rear wagon of 6T63

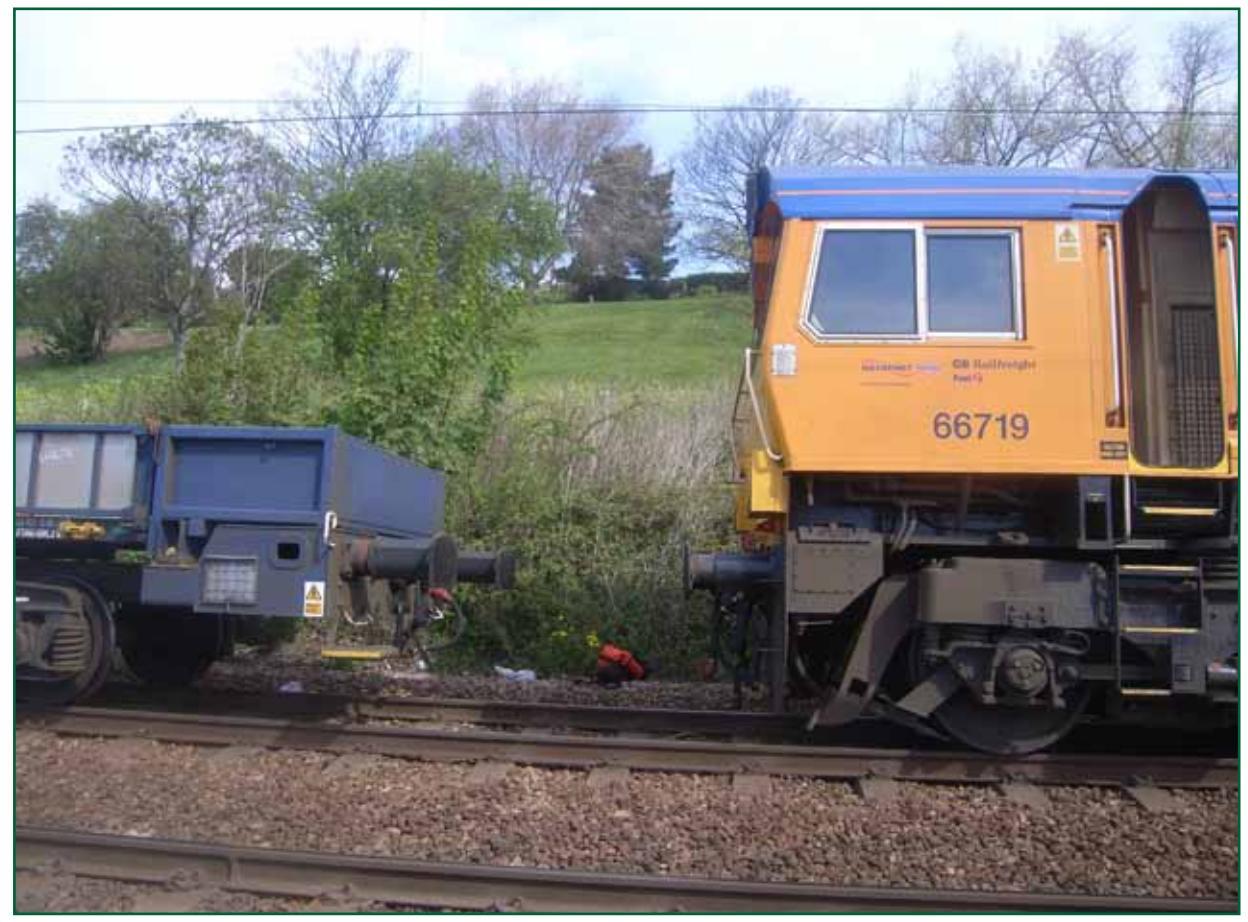
Figure 7: Rear cab of front locomotive of 6T64 after collision

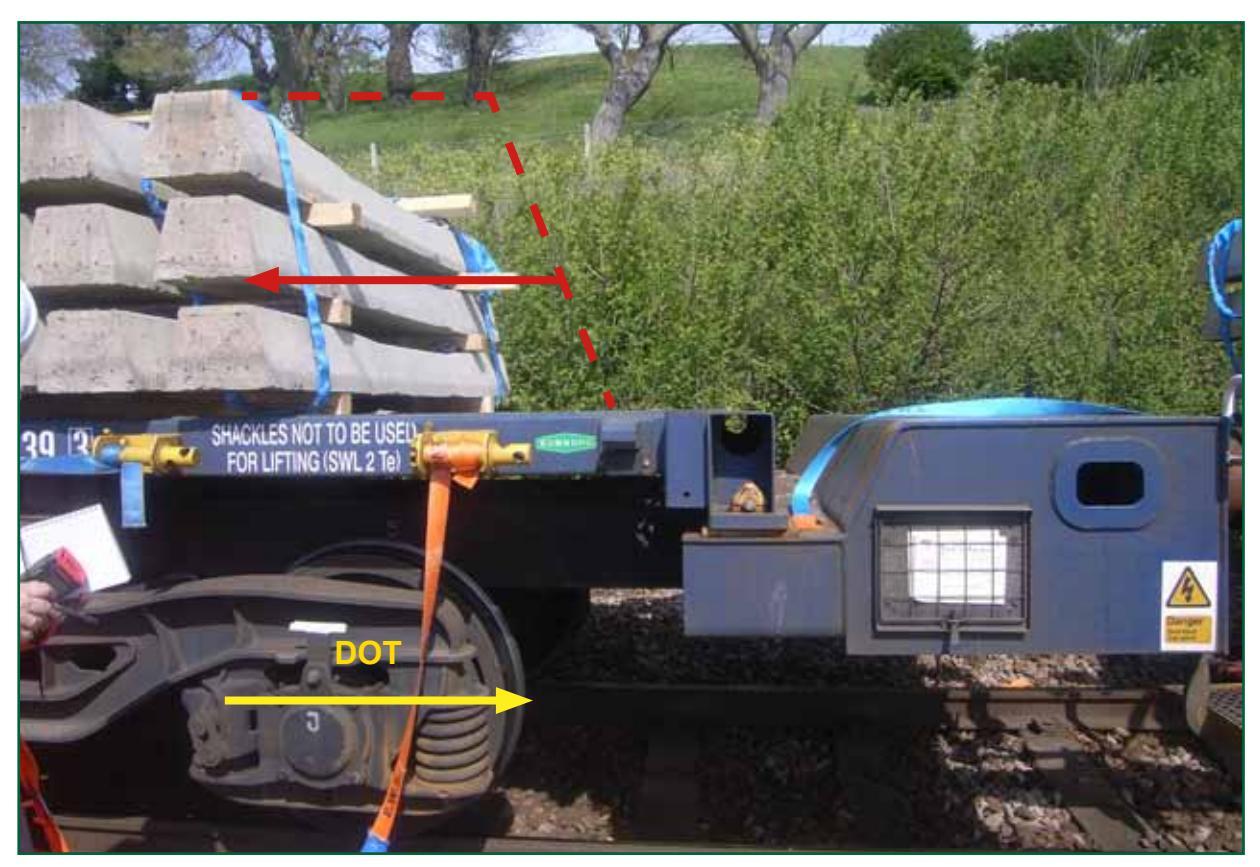
Figure 8: Rear wagon of 6T63 showing the direction of travel (yellow arrow) and the movement of the load (sleepers) from its original position to its final position to its final position after the collision (red dotted line)

- 183 The driver's fatigue and state of sleep inertia continued after the incident, when he observed the retaining straps on the wagons of train 6T63 to be insecure. The driver believed that another member of staff had mistakenly left the straps insecure and if he was later requested by the Engineering Supervisor to take charge of 6T63 he would have to reconnect the straps. The driver's level of fatigue and confusion at this point was such that he did not realise that the straps that were hanging down had been severed by the movement of the sleepers on the wagons during the collision (paragraph 56).

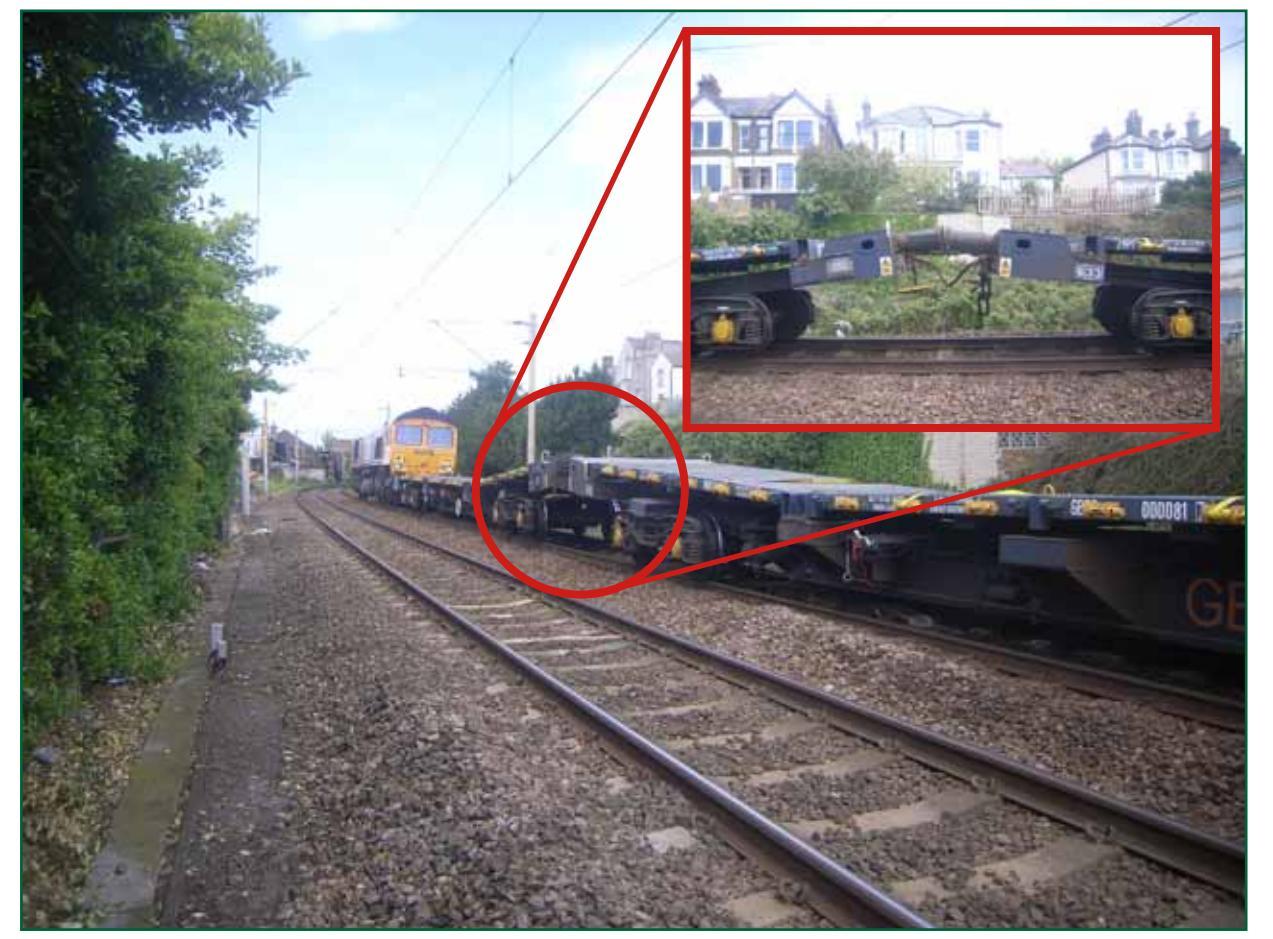
Figure 9: Photograph and (inset photograph) of train 6T64 and FEA wagon damage sustained as a result of the collision

- 59 At 06:51 hrs the relief driver telephoned the Engineering Supervisor when he observed the two severely damaged FEA wagons at the rear of train 6T64.

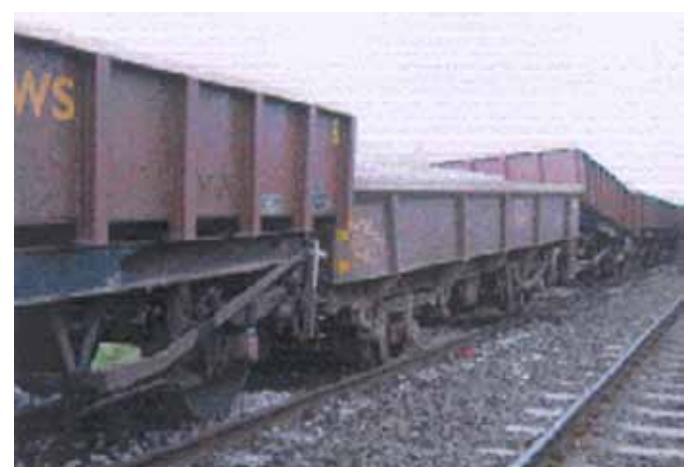
- 6 The incident occurred when an engineers' train 6P27, consisting of a locomotive and 40 loaded ballast wagons collided with wagons of another train, 6P26, standing in a work site in a possession (Figure 12).
- 7 The train had travelled just over one mile (1.6 km) from the work site marker boards, reaching speeds of up to 17 mph (27 km/h). It was alleged that there was no tail lamp on the stationary vehicles at the time of the collision, and the locomotive driver did not see the rear of the train until it was too late to stop. The collision occurred at 5 mph (8 km/h); there were no injuries. The investigation concluded that the cause of the incident was the train driver travelling within a long possession and the driver not having accurate knowledge of the train location. The speed of the train was such that the driver was unable to stop short of the obstruction.

Figure 12: Image of derailed rear wagons of train 6P26 caused by the collision
