Rail Accident Report

Serious injury sustained by a signal technician at Kennington Junction 23 May 2008

Report 29/2009 November 2009 This investigation was carried out in accordance with:

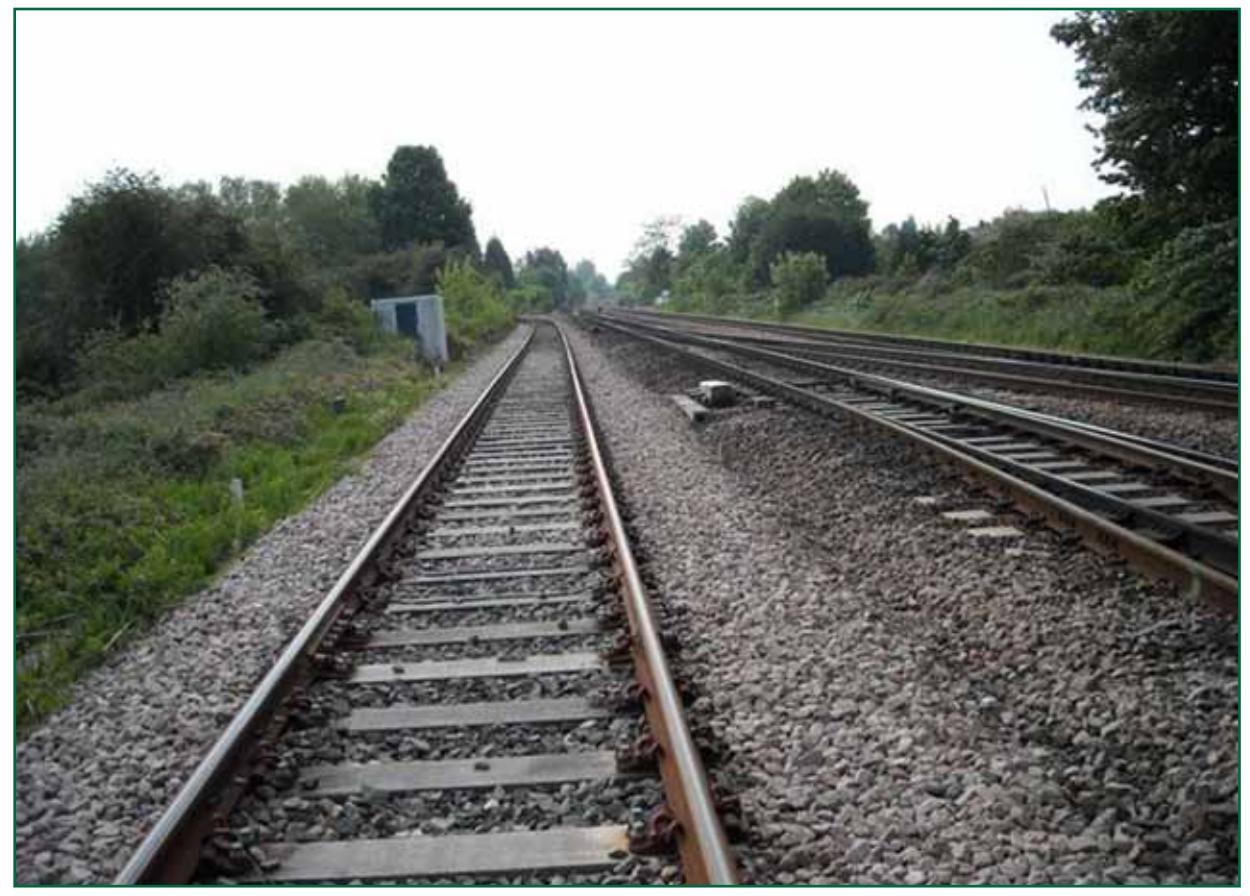
37. Whilst the team leader and his assistant were unloading tools from the van the lookout went to the other side of the line and took up his duties in the customary place for work on 207 points. He was not instructed by the team leader (COSS) where to stand or given any other instruction. He stood at various times in the cess or *4 foot* of the up goods loop from where the best possible sighting of approaching trains on the down line could be obtained. However, a passing up train would cut off the lookout's line of sight for the down line.

Figure 5: View from the lookouts position of the line towards Didcot (Photo courtesy of Network Rail)

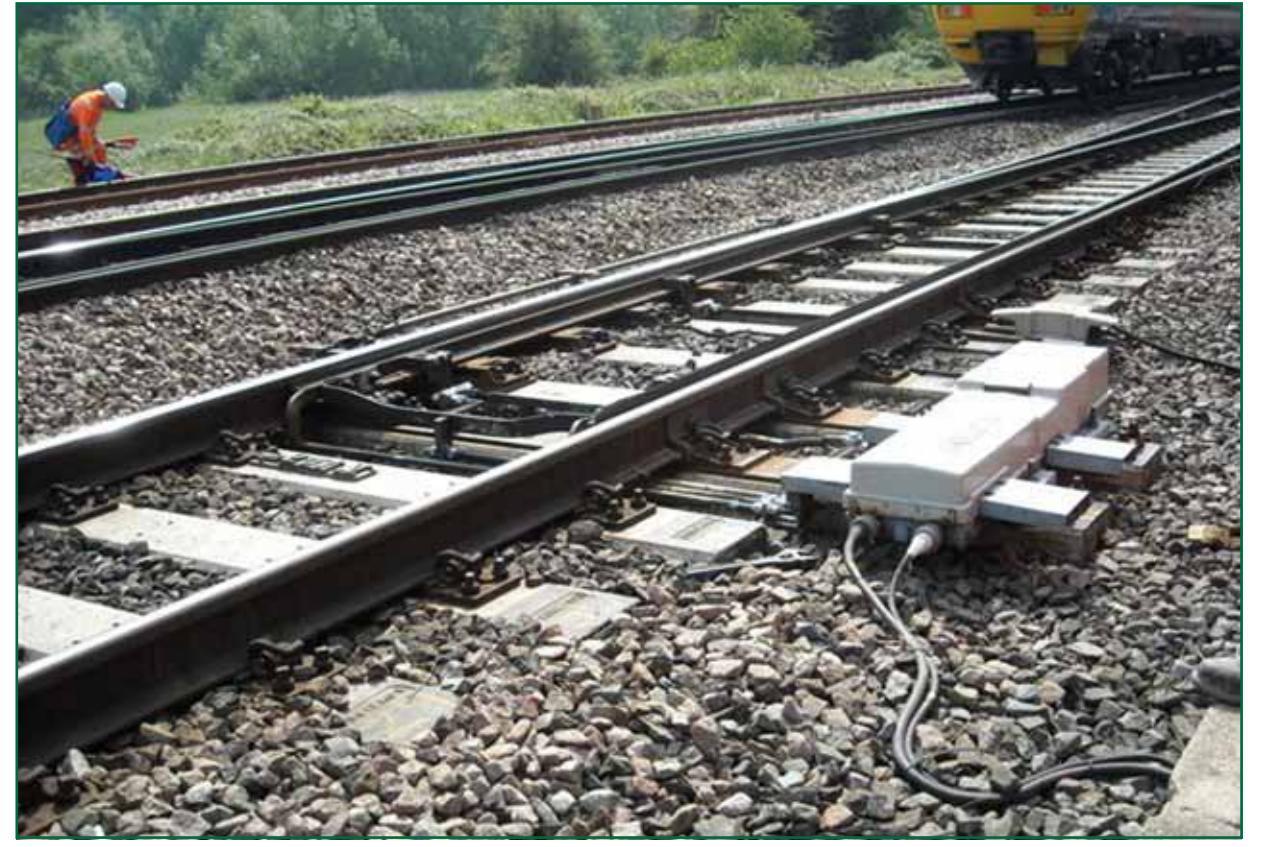
Figure 6:207A point machine. The down line is closest to the camera (Photo courtesy of Network Rail)

- 41. At 21:24 hrs the team leader (COSS) requested a further period in which to continue the test which the signaller provided. Soon after, the test unexpectedly failed with the switch rails in the *reverse* position (in this position the points were set for a route between the up and down lines). The team leader and his assistant were then faced with the task of adjusting one or more of the rods linking the point machine to the rails (Appendix F). They commenced this activity immediately.

- 89. Network Rail has a policy that work activities on or about the line should take place in a Green Zone whenever reasonably practicable. However, to create a Green Zone it is necessary to arrange for there to be no train movements through the site of work. To ensure that trains cannot approach, the site of work must be located within a *possession* or given other protection that will ensure workers are not placed at risk from the movement of trains.

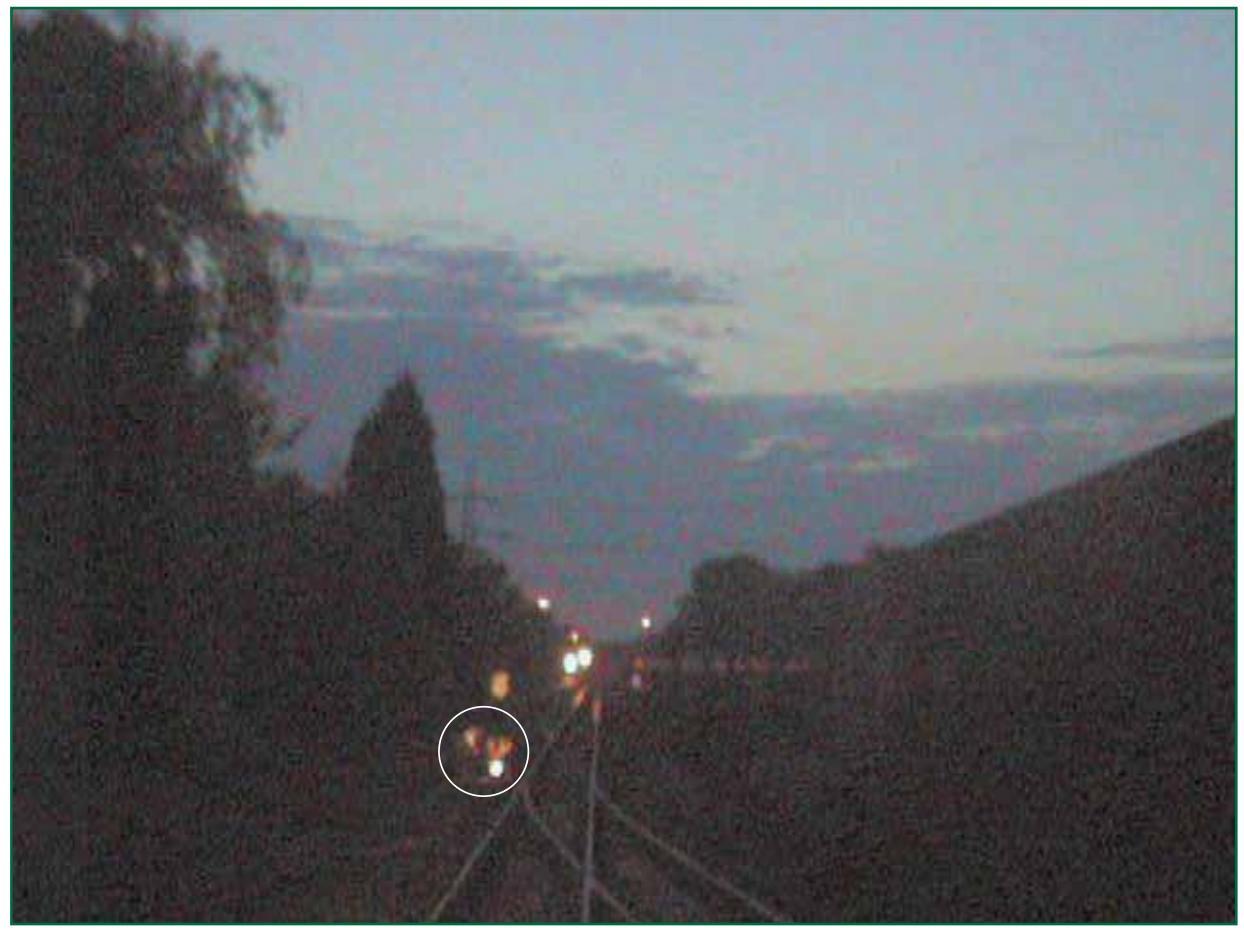
Figure 9: Still frame of the forward facing camera - Distant view. The picture is taken facing Oxford with the down line visible (from centre bottom). The orange Hi-Vis jackets of the technicians can be discerned just to the left of the points and the outline of the freight train on the up line can be seen (lower right quadrant).

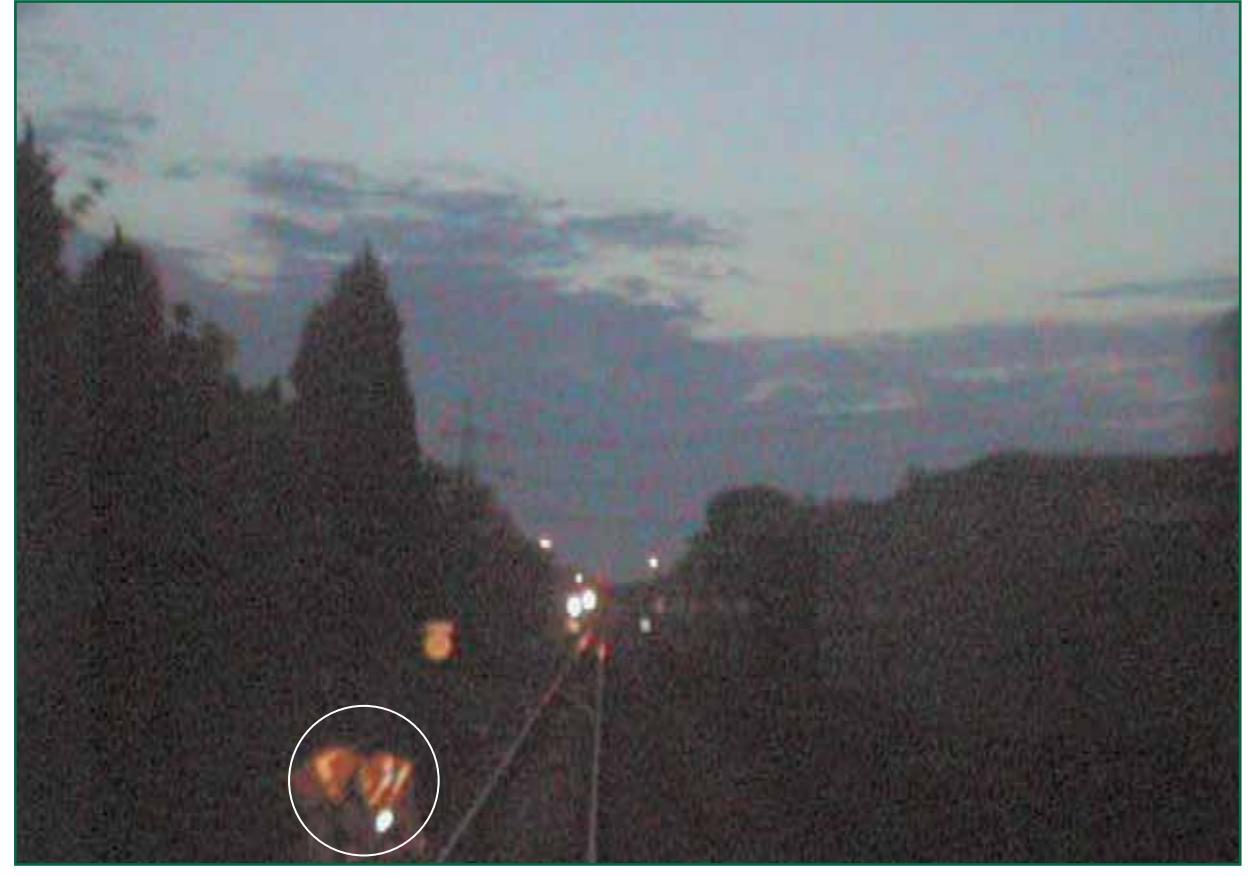
Figure 10: Still frame of the forward facing camera - Immediately before the accident. The two technicians can be seen working with a torch (left-centre bottom).
