Rail Accident Report

Passenger train struck by object at Washwood Heath 6 March 2010

Report 01/2011 January 2011 This investigation was carried out in accordance with:

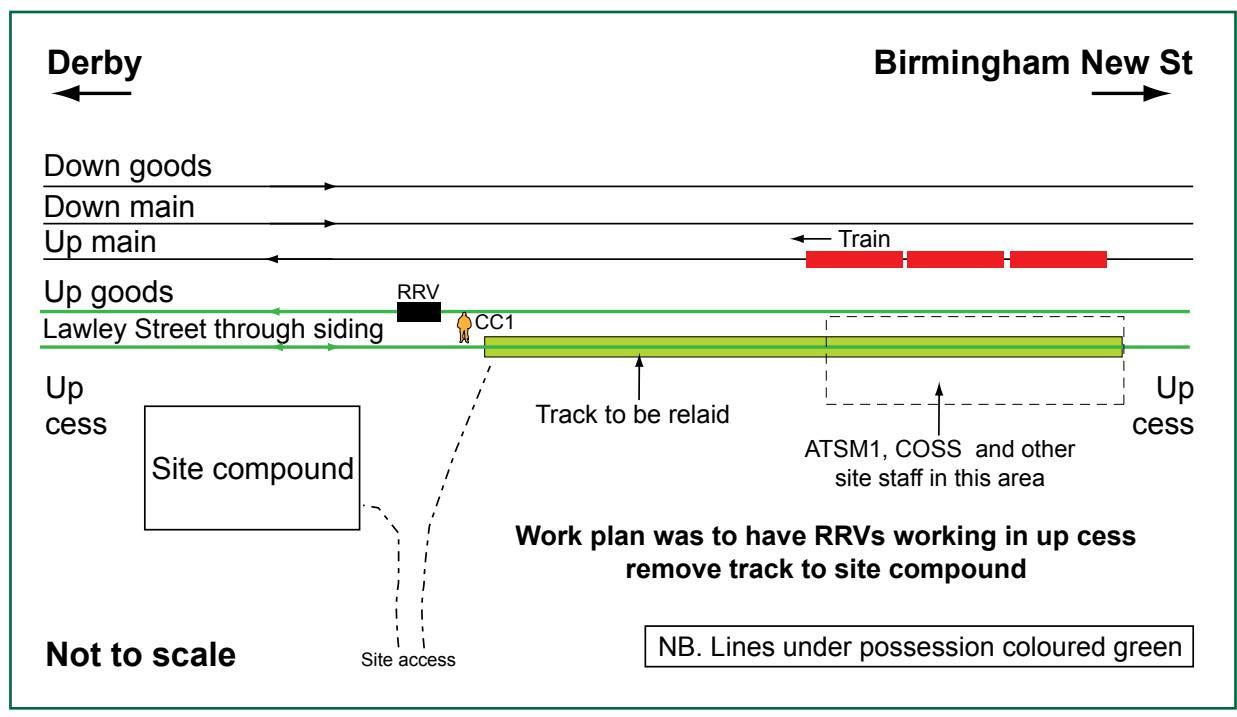
Figure 2: Plan of the site

- 19 The accident occurred close to Washwood Heath no.1 signal box, which was not manned at the time. The railway at this location consists of five tracks (figure 2):
 - Lawley Street through siding (which was being relaid at the time);
 - up goods;
 - up main;
 - down main; and
 - down goods.

- The original 'safe system of work' planned for the work involved a Separated Green Zone (see paragraph 46) with the RRVs operating on the up and down Lawley Street through siding (the line to be renewed figure 2), ie with another line between it and the nearest open line. This arrangement was in accordance with the rule book, but would have caused the renewal to take longer than the revised method of work as each track panel would have had to be picked up twice; once to lift it to the lineside and later, when the new track was in place, each panel would have had to be picked up again and carried to the stacking area. ATSM1 changed the 'safe system of work' on site to one that was not allowed by the rule book or the engineering acceptance certificate. This involved the RRVs working on the up goods line which was adjacent to the up main line that was open to traffic. The use of RRVs adjacent to open running lines is only allowed if specific additional arrangements are adopted, none of which were implemented.

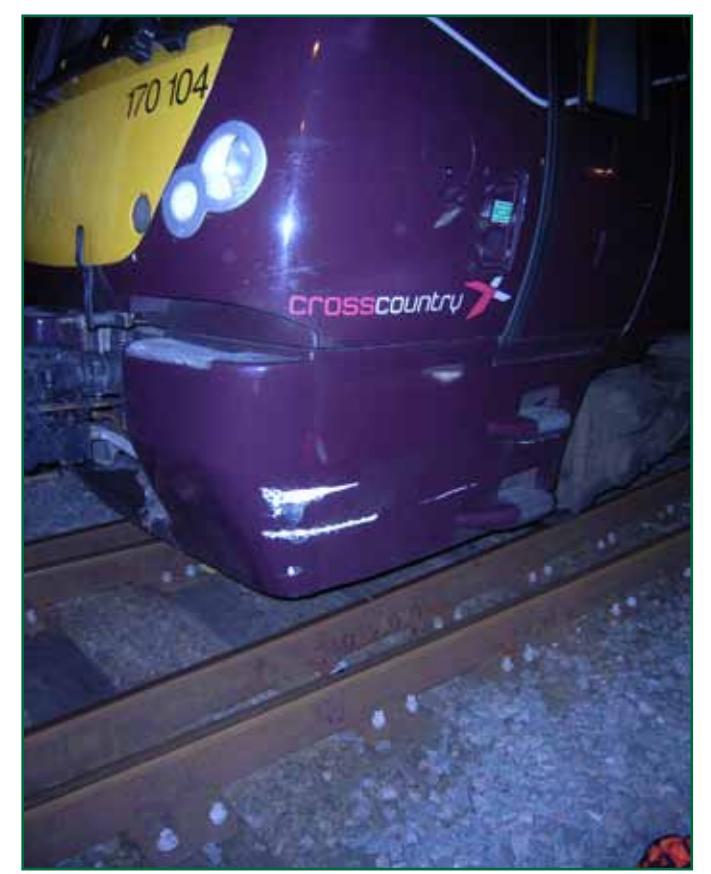
Figure 3: Damage to the front of the train

- 27 The plastic fairing on the front of the train was broken and gouged in four places and loosened from its mountings (figure 3). The *bogie* sideframe was dented above the *axle box* and the *yaw damper* was gouged at one end (figure 4). The train was returned to Birmingham New Street station and taken out of service.
- 28 The rail end was damaged by the impact (figure 5).

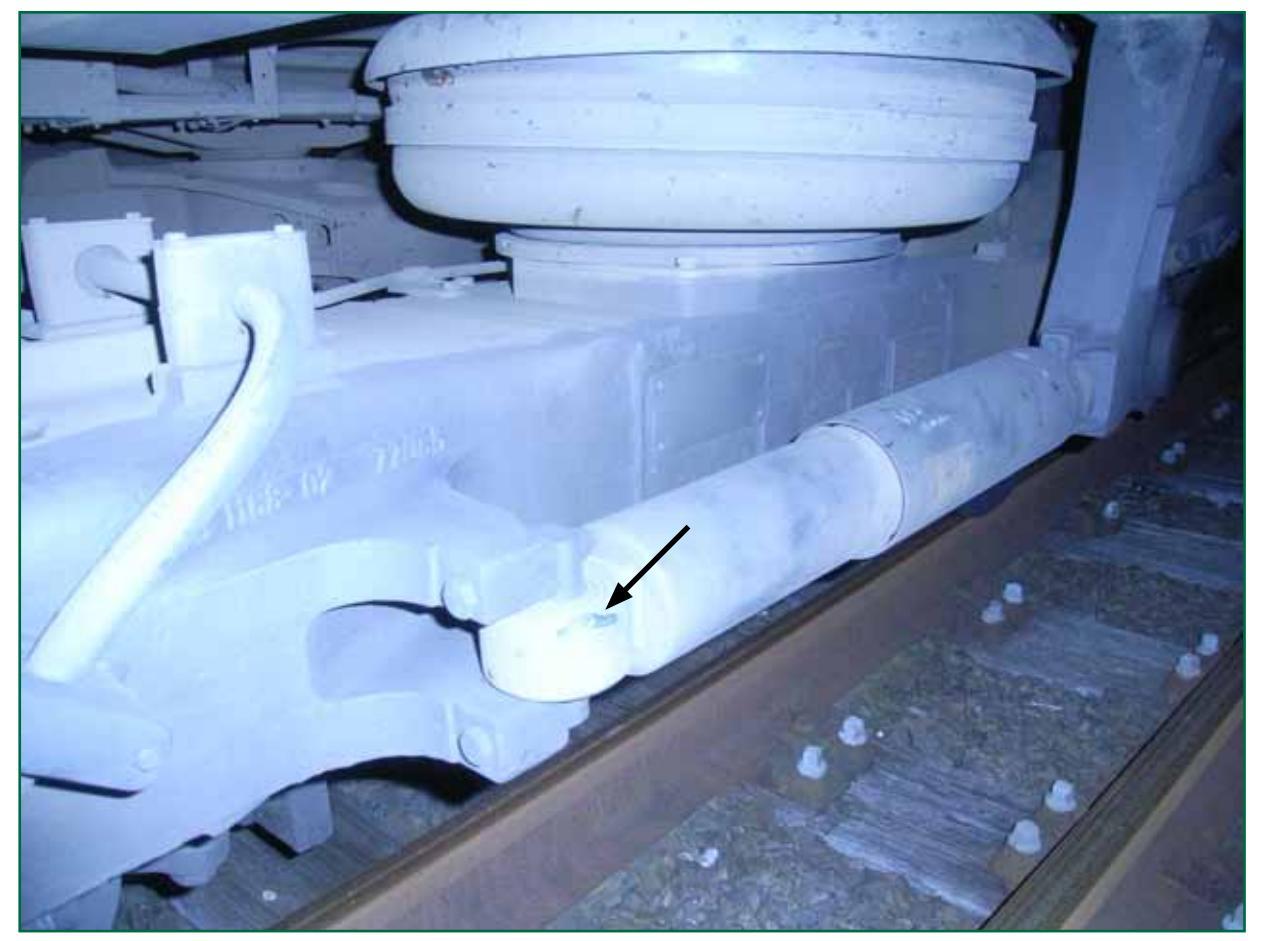
Figure 4: Damage to the leading bogie of the train

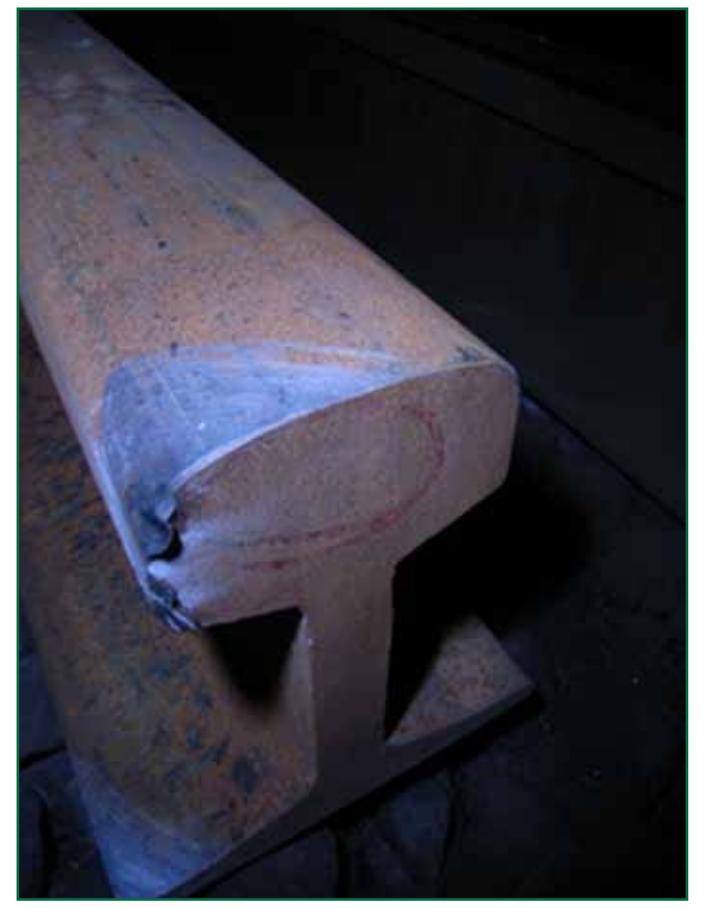
Figure 5: Damaged rail end
