Rail Accident Report

Accident at Falls of Cruachan, Argyll 6 June 2010

Report 11/2011 July 2011 This investigation was carried out in accordance with:

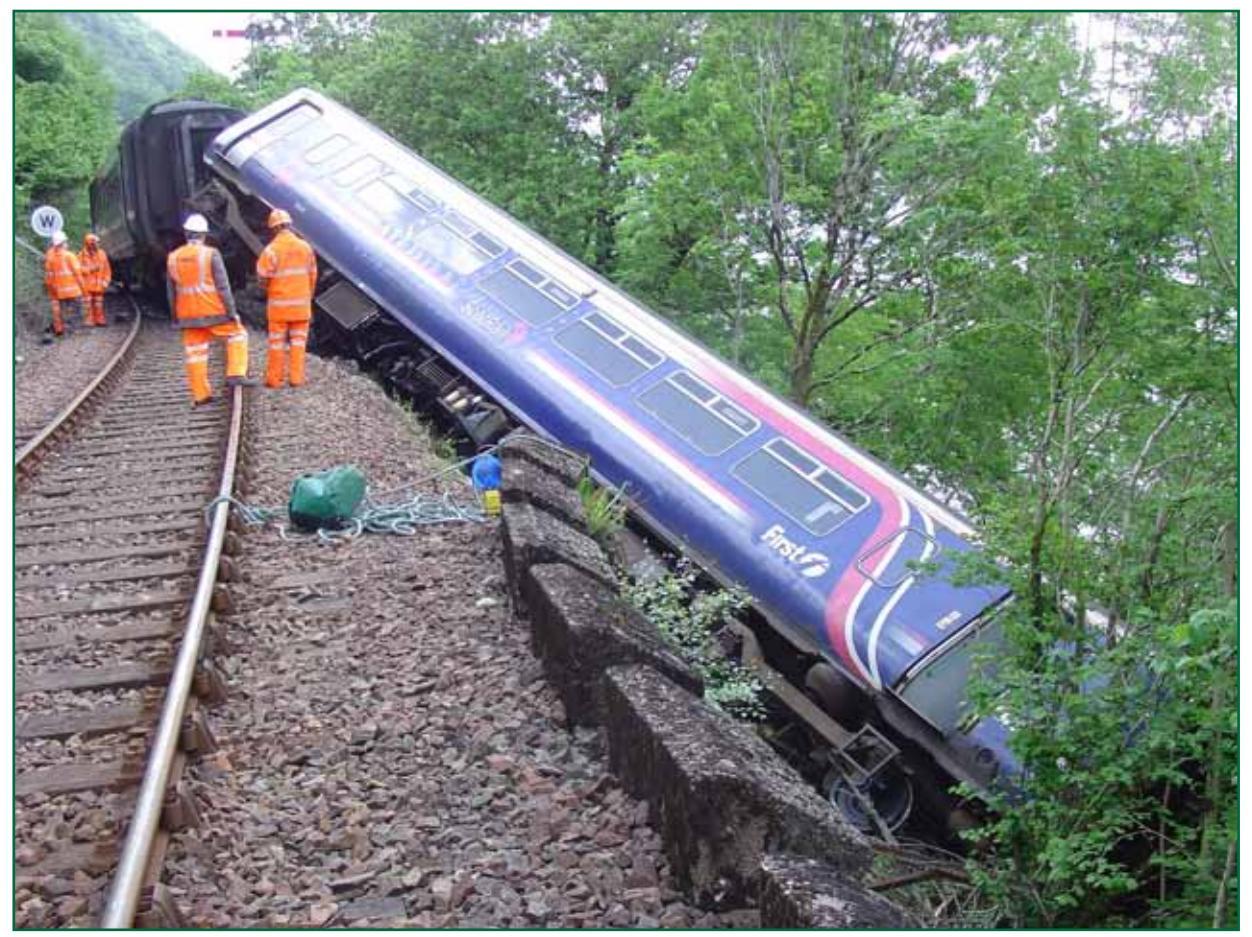
- 6 At 20:55 hrs on Sunday 6 June 2010 train 1Y27, the 18:20 hrs from Glasgow Queen Street to Oban, struck a boulder that had fallen onto the track just west of the station at Falls of Cruachan, in the Pass of Brander, on the line from Crianlarich to Oban. The boulder had fallen onto the track from its position on the slope within the railway boundary because of *root jacking* and soil erosion.
- 7 The evidence from the site of the accident was that the train, consisting of a 2-car class 156 *diesel multiple unit*, drove over the boulder, which lifted up the front car and derailed it to the left and down an embankment (figure 1). The leading bogie of the rear car ended up supported by the boulder with the rear bogie still on the track (figure 2).

Figure 1: The derailed train following the accident

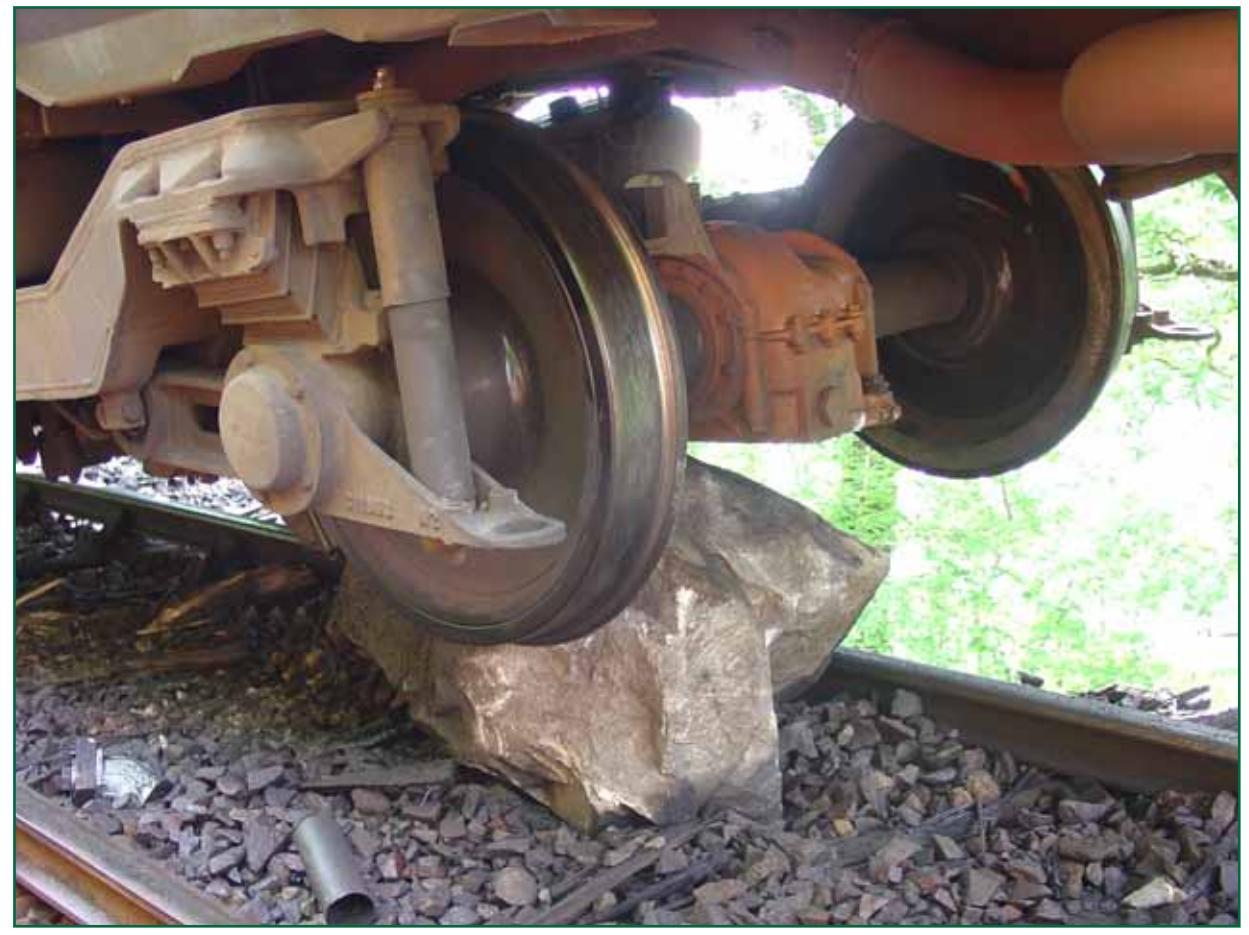
Figure 2: Final position of boulder under the leading bogie of the rear car

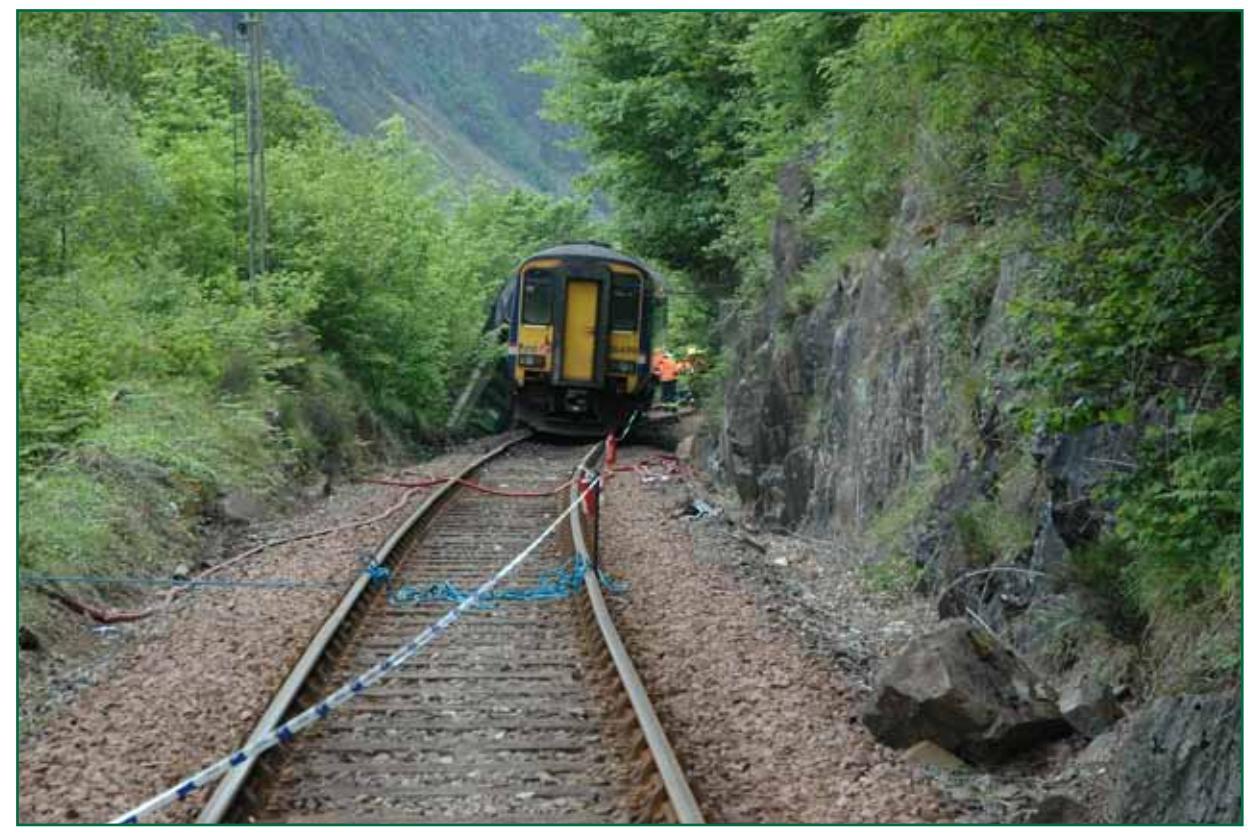
- 19 As a result, the slope on the north side of the railway comprises:
 - areas of exposed rock face with *blocks* that could potentially fail and break away from the face (failed blocks seen beside the track were evidence that this had occurred) (figure 6); and, above and between these rock faces,

Figure 6: Exposed rock face area of the slope showing blocks

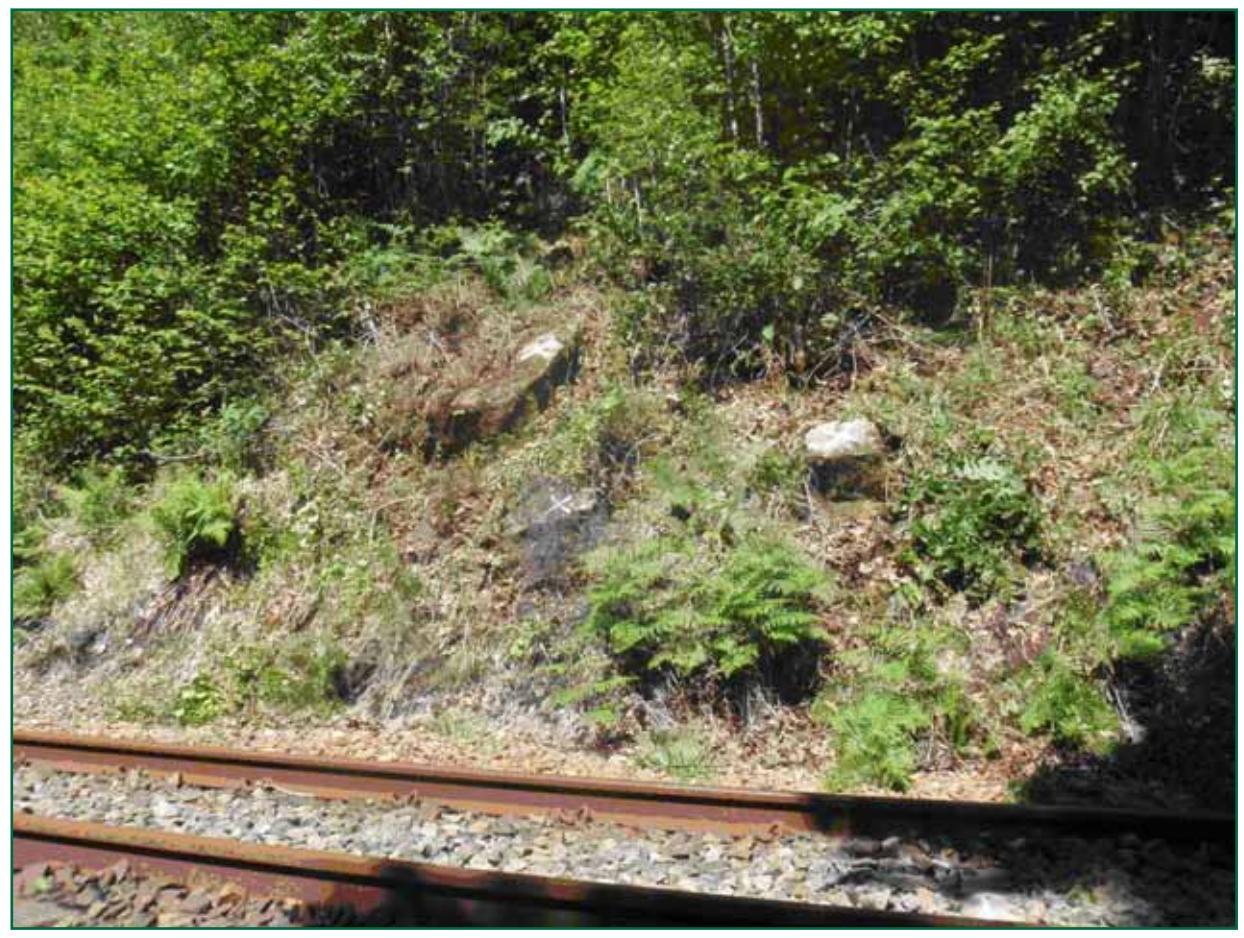
- areas of soil slope dotted with isolated boulders (figure 7).

Figure 7: Area of soil slope containing isolated boulders (following post-accident de-vegetation) (image courtesy of Network Rail)

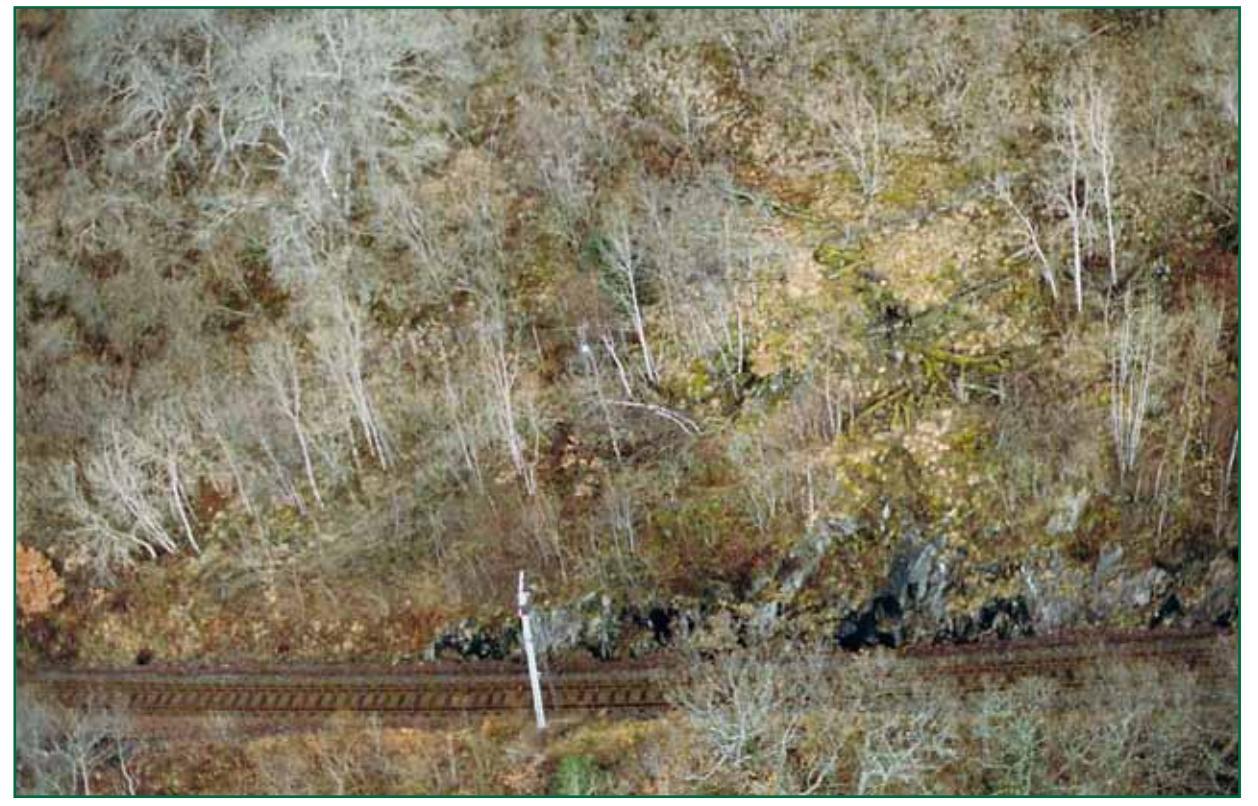
20 The areas of soil slope between the northern boundary fence and the railway line and top of the rock faces was covered with a dense growth of heather, bracken and trees, even in winter, when much of it dies back (figure 8).

Figure 8: Winter's view of the slope in the Pass of Brander (image courtesy of Network Rail)

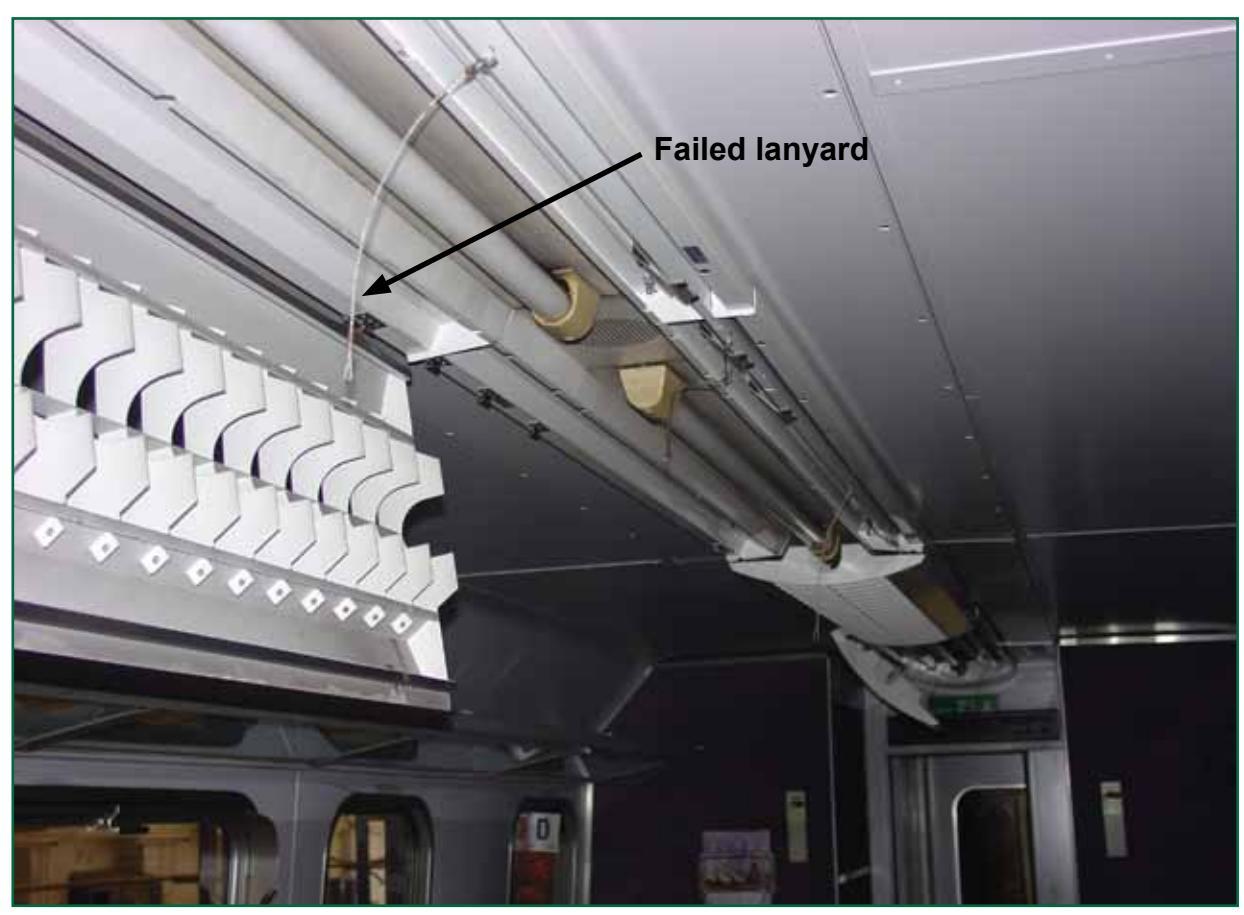
40 Most of the *budget locks* securing the lighting diffusers in the leading car failed to retain the diffusers when the impact with the boulder occurred. This resulted in lighting diffusers swinging down on their hinges either to a point where they were stopped by the wire lanyards used for *secondary retention* (figure 11), or completely in cases where the lanyard also failed. Six lighting diffusers came free from their hinges and fell to the floor. They could have caused serious injury to those on board in view of their weight (5.7 kg each) and sharp edges. However, the RAIB found no evidence that anyone on the train was hit by a detached lighting diffuser. Only three diffusers remained in place. These diffusers had budget locks that were defective and cable ties had been used to secure them.

Figure 11: Lighting diffusers hanging down as a result of the collision

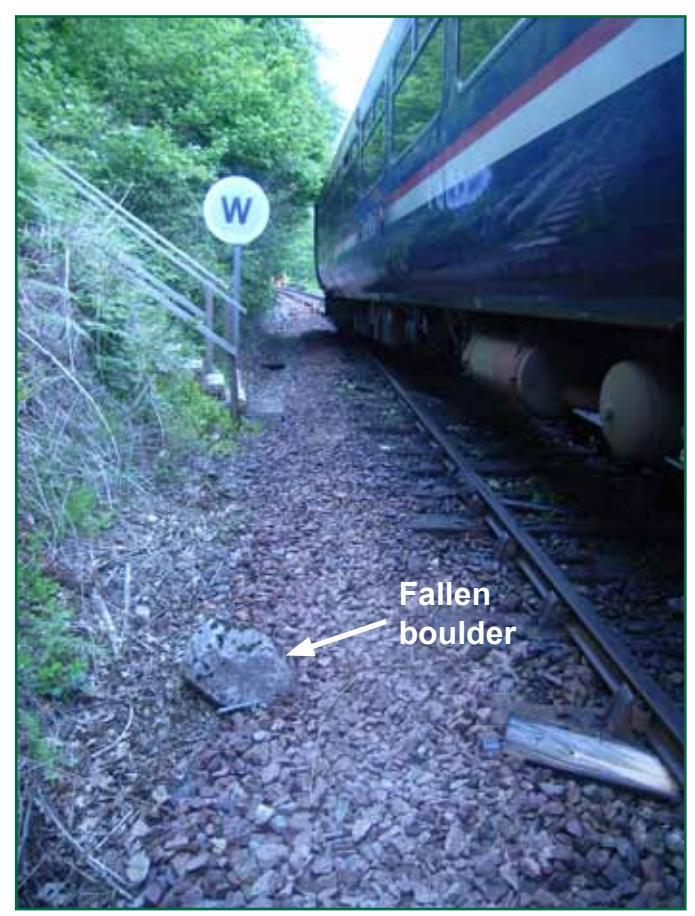
- 76 Close to the accident site, the soil slope below the railway boundary fence extends right down to the railway and is the same in character as the soil slope between the rock face and the boundary fence. Post accident investigations close to the accident site found loose boulders on the areas of soil slope after the partial removal of vegetation.
- 77 A photograph in the examination report dated 11 February 2007 shows a boulder in the *cess* which was not reported by the examiner. The boulder had apparently fallen from a soil slope and was still present when the accident occurred (figure 12).

Figure 12: Previous fallen boulder from the soil slope

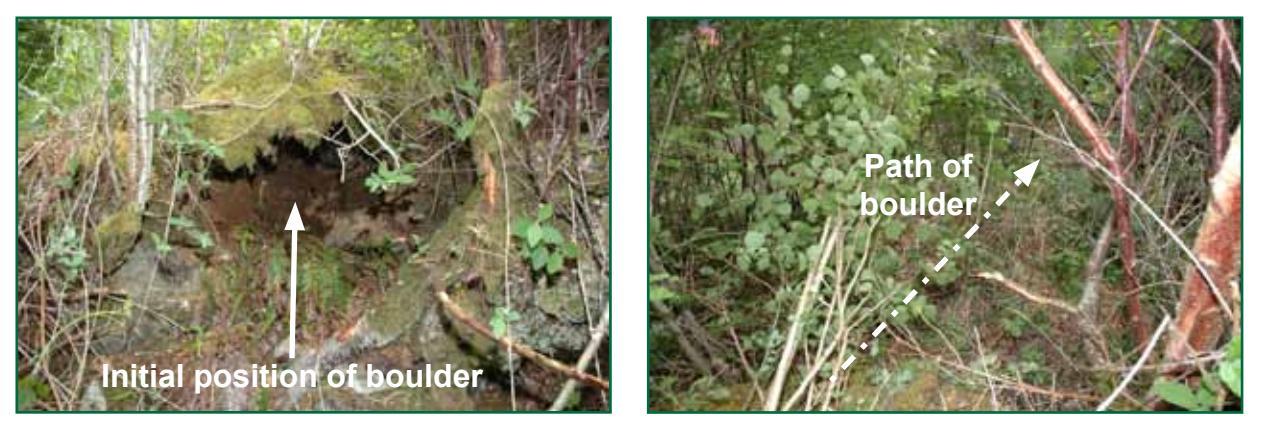
- 92 The immediate cause of the accident was that a boulder, within the railway boundary, became dislodged from the cutting slope on the north side of the railway and fell into the four-foot. The train struck the boulder causing it to derail.
- 93 Inspection of the site after the accident identified the original location of the boulder and its path onto the railway (figures 13a and 13b).

Figures 13a and 13b: Initial position of and subsequent path of the boulder onto the railway

- 96 The boulder became dislodged through natural processes that included root jacking and soil erosion. This was a causal factor.
- 97 The boulder had been located in a socket surrounded by soil and tree roots and its path onto the railway track was apparent from damage to vegetation. The RAIB observed on site that the socket was surrounded by tree roots positioned in a manner likely to have prised the boulder from its socket; a process that would have been exacerbated by erosion of the surrounding soil through normal rain fall. The potential for root jacking to cause instability on the soil slopes was not identified as a risk because of shortcomings in the examination and evaluation system (described in paragraphs 98 to 115).
